TRANSPORTATION RESEARCH
RECORD

No. 1468

**Recent Research on
Roadside Safety
Features**

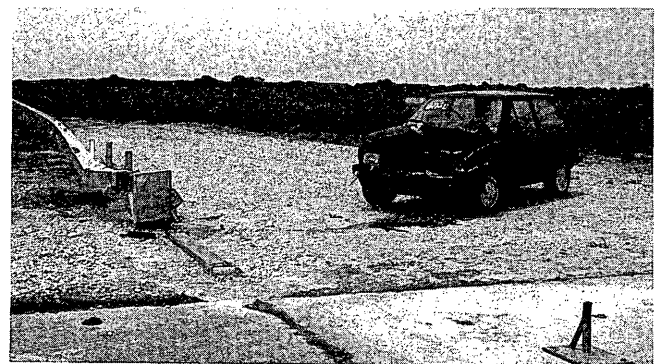
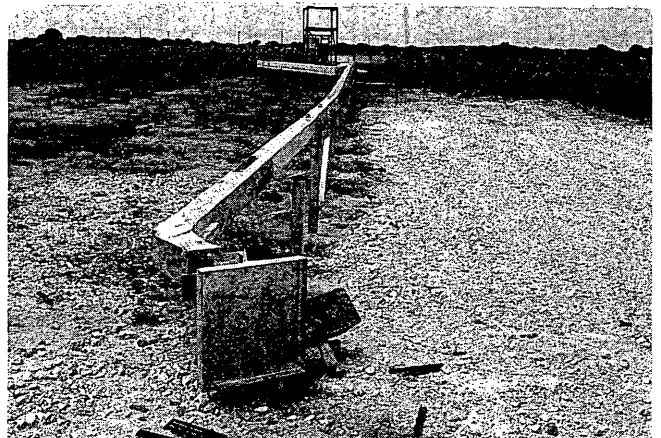
FIGURE 3 Damaged test vehicle and terminal after small-car head-on test.

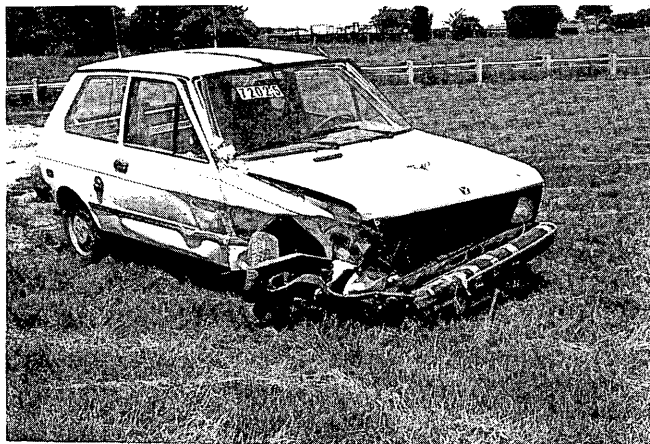
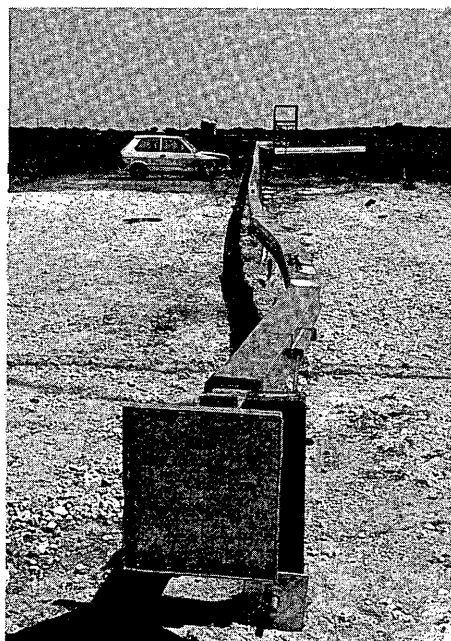
FIGURE 5 Damaged test vehicle and terminal after small-car redirection test.

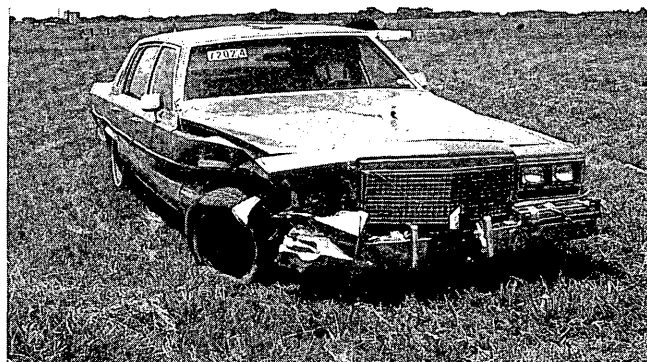
FIGURE 6 Damaged test vehicle and terminal after large-car redirection test.

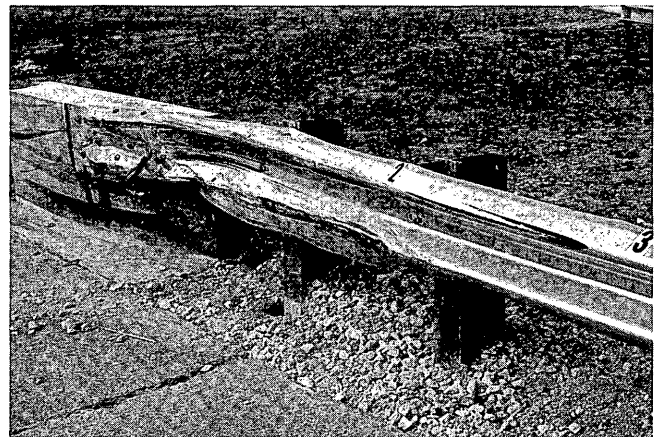
FIGURE 6 Barrier (*top*) and vehicle (*bottom*) damage after testing of System 1.

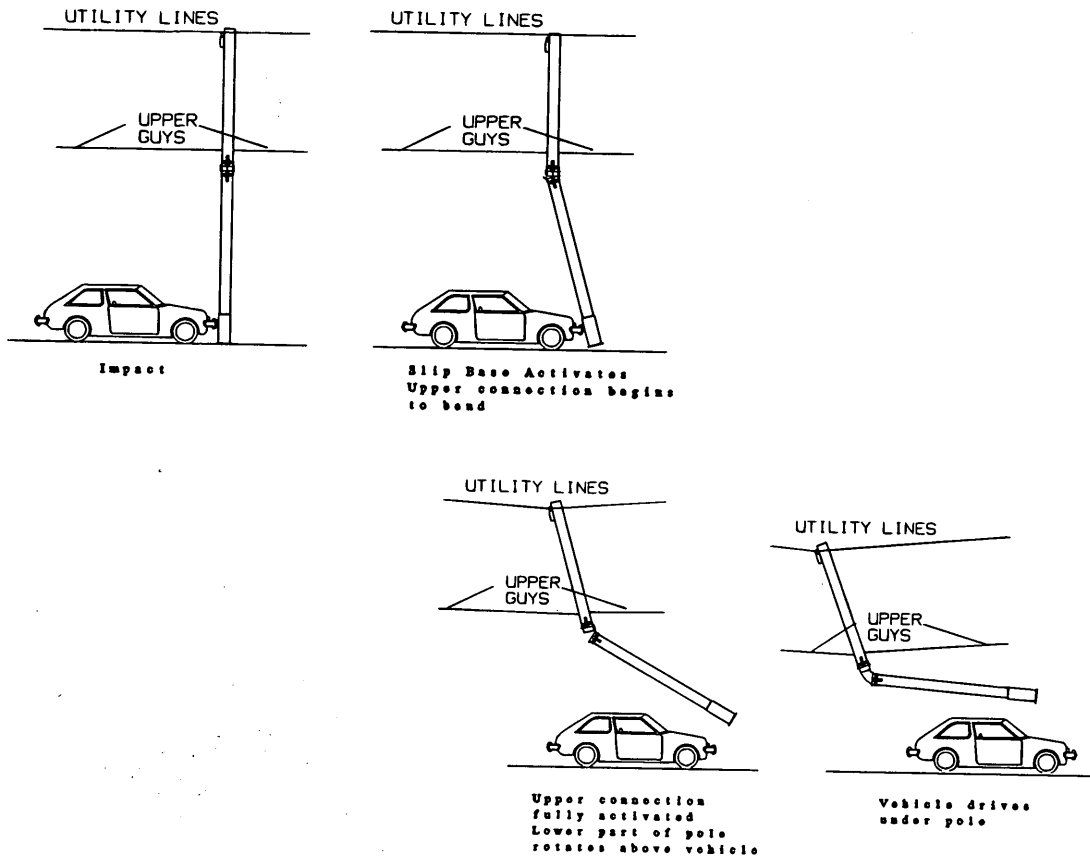
FIGURE 1 Proper function of breakaway utility pole.

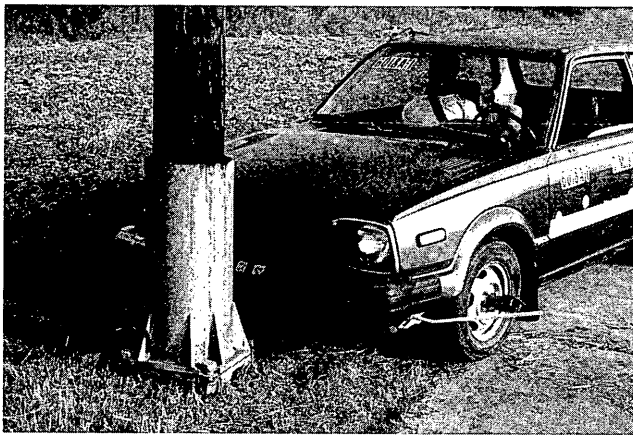
FIGURE 9 Vehicle and utility pole geometrics for Test 6018A-1.
