Sulfate Expansion of Cement-Treated Bases

GEORGE HUNTINGTON, KHALED KSAIBATI, AND WARREN OYLER

The causes of the destructive expansion and weakening of cement-treated bases (CTBs) on two sections of US-85 in northeastern Wyoming are examined. The research project was jointly conducted by the University of Wyoming and the Wyoming Department of Transportation. One-dimensional expansions, unconfined compressive strengths and X-ray analyses were performed to determine the causes behind the expansion of the CTBs. It was found that chemical reactions among clay, cement, and sulfate caused most of the deterioration.

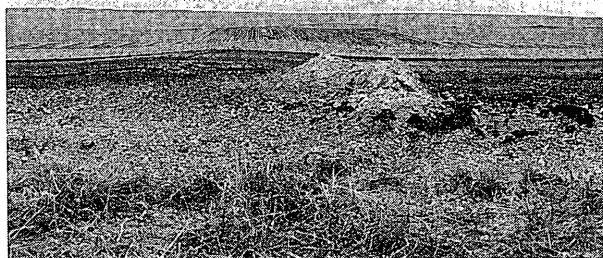
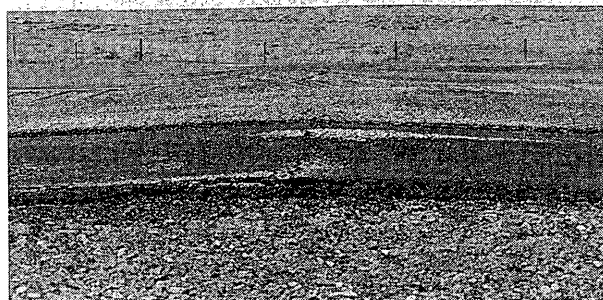
FIGURE 1 Damaged pavement sections after milling.

The Wyoming Department of Transportation (WYDOT) has extensive experience in the design and construction of cement-treated bases (CTBs). Over the years, this type of construction has performed well and provided cost-effective service life. However, two recently built pavement sections on US-85 between Newcastle and Lusk have shown excessive deterioration. Shortly after construction, the CTB buckled substantially, requiring repeated millings to remove heaves in the road surface. Two years later the road was still expanding, and it was being milled to lower the still-growing bumps. Although the initial bumps appeared at construction joints, subsequent bumps appeared between the construction joints. The road buckled and cracked at intervals as short as a few hundred feet. Figure 1 shows the deterioration of a representative pavement section. Some local truckers used unpaved county roads parallel to US-85 instead of traveling on the rough section.

The first section just north of Mule Creek Junction was constructed in summer 1991. Expansion was first noticed after asphalt was placed over the CTB. Initially this expansion was believed to be due to a flaw in the construction process. Therefore, more attention was given to the construction of expansion joints in the second section, which was built the following summer. Excessive expansions were later observed in the second construction project. To determine the causes of pavement deterioration and to prevent similar failures in the future, the University of Wyoming and WYDOT initiated a major research project. Some of the findings from that research study are presented in this paper.

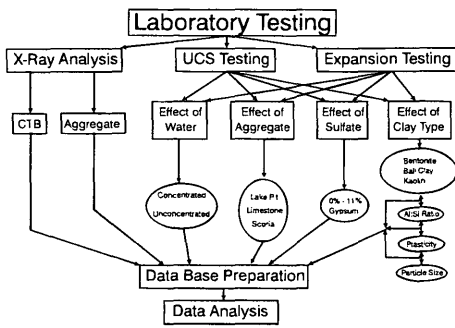
The laboratory testing experimental design is presented in Figure 3. The effects of curing time, water concentration, clay type, aggregate type, and sulfate amount on expansion were examined. CTB bars and UCS cylinders were prepared, cured, and tested according to ASTM C 157 and ASTM D 1633 for each matrix. Bars exhibiting over 0.1 percent expansion were considered failed. Specimens with unconfined compressive strengths less than 3.45 MPa (500 psi) were also considered failed.

FIGURE 3 Laboratory testing experimental design.
