Triple T: Truck Thrie Beam Transition

WANDA L. MENGES, C. EUGENE BUTH, AND CHARLES F. MCDEVITT

The Truck Thrie Beam Transition (Triple T), an 813-mm (32-in.) thrie beam transition, was developed under a recently completed pooled funds study. The study involved 23 states, the District of Columbia, and the Federal Highway Administration. The Triple T was crash-tested according to Performance Level 2 (PL2) requirements of the 1989 AASHTO guide. The transition performed acceptably after modifications were made to the end terminal connection. For testing, the transition was attached to the end of the 813-mm (32-in.) vertical-faced concrete parapet bridge railing. The Triple T is acceptable for use on other PL2 bridge railings if suitable attachment to the bridge railing (such as the modified end terminal connector) is used.

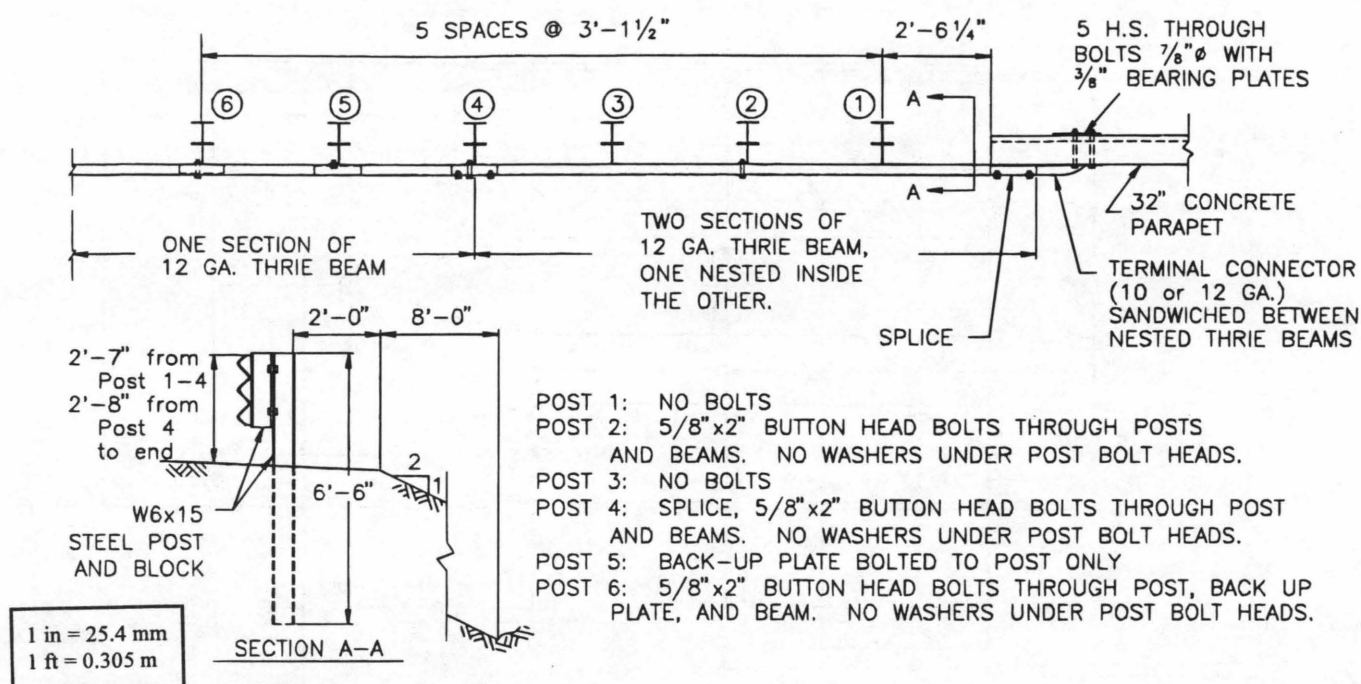
FIGURE 1 Triple T installation.

The prototype Triple T was attached to an 813-mm (32-in.) vertical-faced concrete parapet bridge railing for testing. Elevation and cross-section views of the transition are shown in Figure 1. The height to the top of the transition thrie beam rail element is 790 mm (31 in.) above the ground. The transition is supported by W6 × 15 posts and 152-mm (6-in.) blocks spaced at 1-m (3-ft 1½-in.) intervals, center-to-center, with a 768-mm (2-ft 6 ¼-in.) space adjacent to the end of the concrete parapet. The transition is composed of two 3.8-m (12 ft-6 in.) sections of 12-gauge thrie beam, one nested inside the other. One 3.8-m (12-ft 6-in.) section of 12-gauge thrie beam is spliced into the nested thrie beams. The single 12-gauge thrie beam transitions to a 3.8 m (12 ft 6 in.) long section of standard W-beam guardrail. The standard W-beam guardrail terminates with a 11.4-m (37-ft 6-in.) breakaway cable terminal. The total installation is 26 m (85 ft) long. Photographs of the completed installation are given in Figure 2.

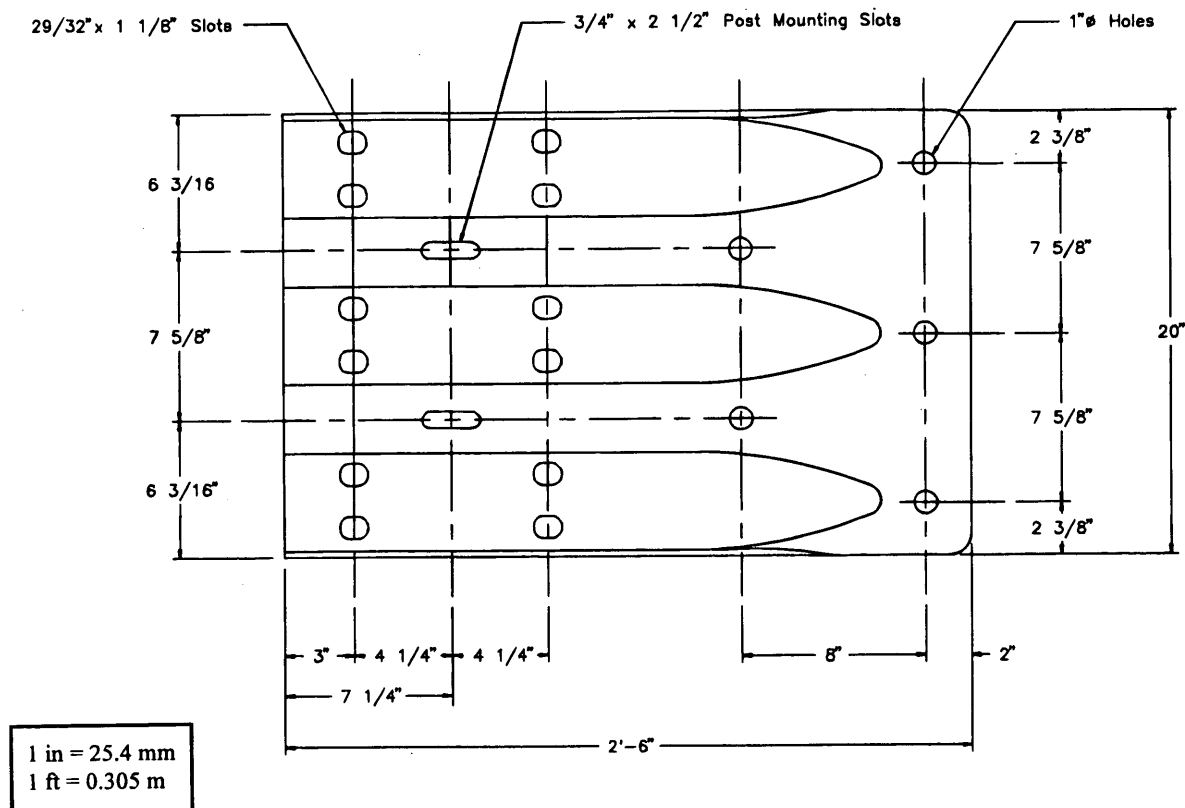
FIGURE 3 Standard ARTBA thrie beam end terminal connector.

The nested thrie beams are attached to the 813-mm (32-in.) vertical-faced concrete parapet with a standard American Road and Transportation Builders Association (ARTBA) terminal connector (see Figure 3). The standard ARTBA terminal connector is a section formed in the shape of a thrie beam at one end and tapered to a flat section at the other end. The flat portion of the terminal connector attaches to a bridge abutment or parapet wall, and the rail end is spliced to the guardrail. It is impossible to connect the two layers of nested thrie beam elements to a standard ARTBA terminal connector without damaging the elements. For the first two tests, the terminal connector was lapped onto the traffic face with two layers of thrie beam sandwiched between the terminal connector and the parapet. During the test with the pickup (Test 20), the vehicle's door was peeled off by the exposed edge of the terminal connector. This unacceptable performance showed that a more suitable attachment to the concrete parapet was needed.

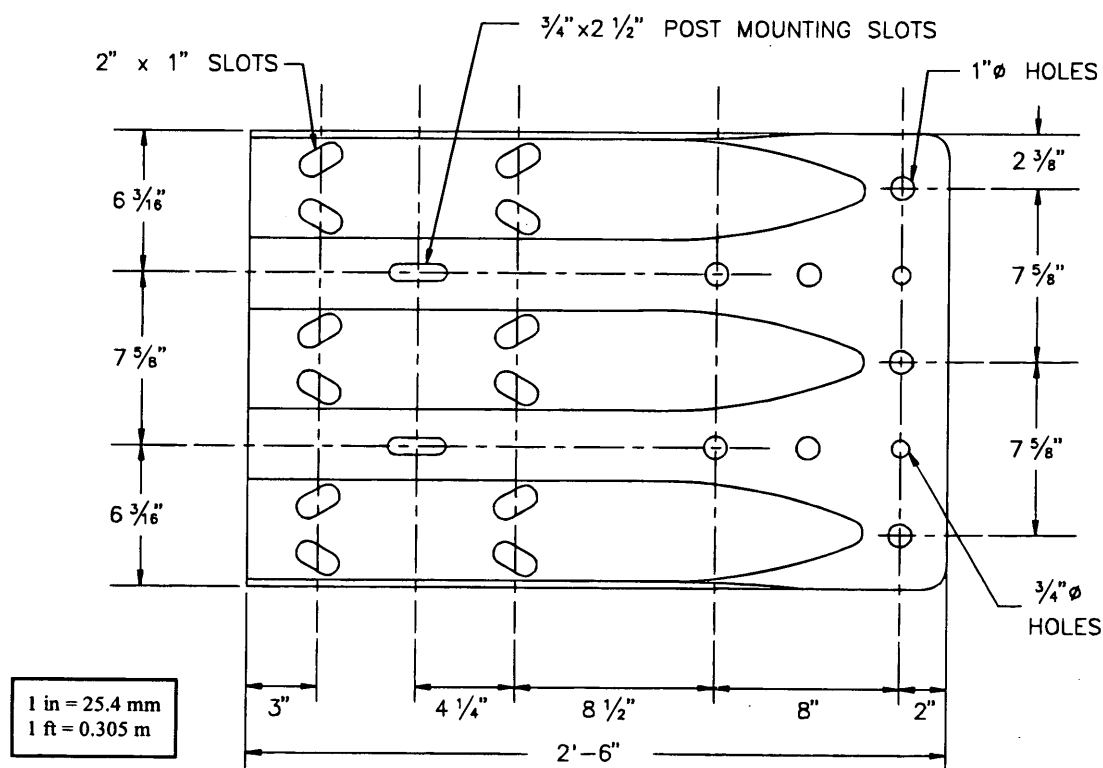
FIGURE 5 Modified end terminal connector used in Tests 21 and 29.

Modifications were made only to the terminal connector that connects the transition to the concrete parapet. No modifications were made to the transition area; therefore, the small car test was not repeated. The modified terminal connector shown in Figure 5 was used for retesting the pickup truck (Test 21) and for testing the 8,172-kg (18,000-lb) single-unit truck (Test 29). The modified terminal connector has slanted, slotted holes to ease the assembly of the splice. The connector is sandwiched between the two layers of thrie beam rail element. In Test 21, the connector thickness was 12-gauge; in Test 29, it was 10-gauge.

CONNECTOR WAS 12 GA. IN TEST 21
10 GA. IN TEST 29

The pickup test was repeated on the Triple T with the modified 12-gauge terminal connector. The modified end terminal was slotted, angled splice bolt holes. A 1984 Chevrolet custom pickup with test inertia mass of 2,452 kg (5,400 lb) and gross static mass of 2,526 kg (5,565 lb) was directed into the transition. The pickup contacted the transition 2.1 m (7.0 ft) from the end of the concrete para-

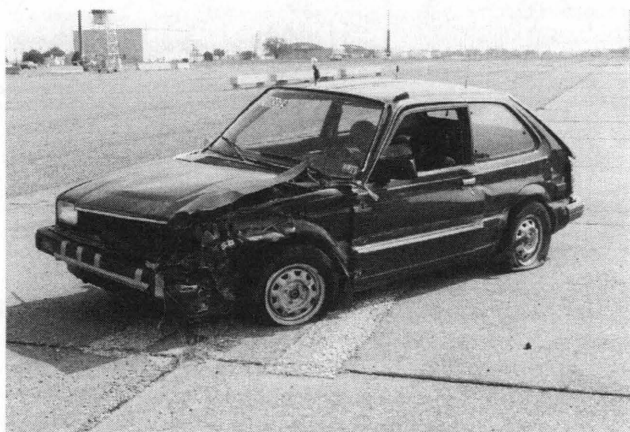
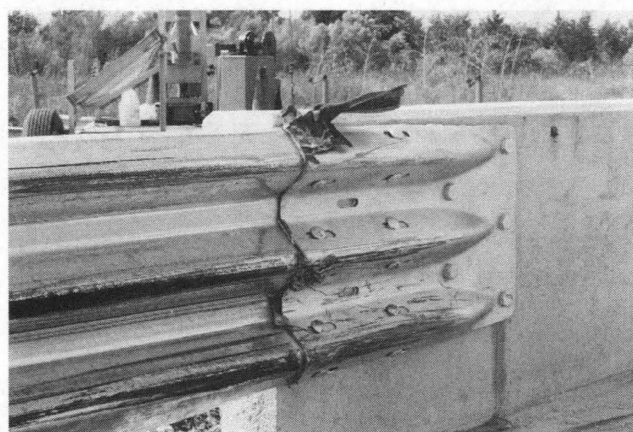
FIGURE 6 Vehicle and end terminal after Test 19.

The transition received minor cosmetic damage (see Figure 6). Maximum lateral deformation of the transition was 13 mm (0.5 in.) and occurred at Post 2. Damage to the vehicle included the strut and constant velocity joint on the left side. The left front wheel was canted inward at the bottom and pushed back into the fender well. Maximum crush of the vehicle was 279 mm (11.0 in.) at the left front corner at bumper height.

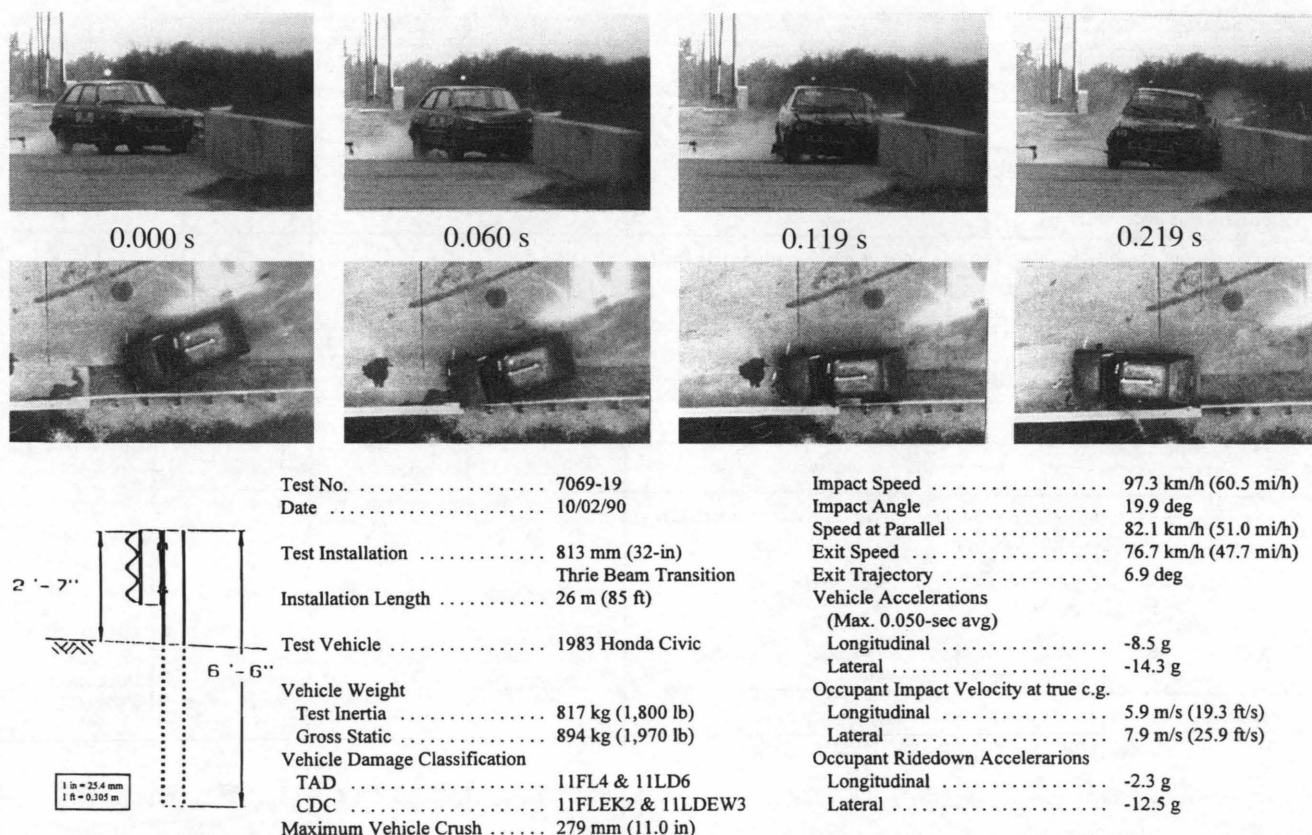
FIGURE 7 Summary of results for Test 19.

The transition contained the test vehicle with minimal lateral movement of the transition. Although there was minimal deformation to the occupant compartment, there was no intrusion. The vehicle remained upright and relatively stable during and after the impact sequence. The transition smoothly redirected the vehicle. Effective coefficient of friction (smoothness of the interaction of the vehicle and the transition) was considered fair.

The lateral occupant impact velocity of 7.9 m/sec (25.9 ft/sec) in this test was marginally over the 7.6 m/sec (25 ft/sec) limit speci-

fied in the 1989 AASHTO guide. The longitudinal occupant impact velocity and the longitudinal and lateral occupant ridedown accelerations were within the limits. The vehicle trajectory at loss of contact with the transition indicated minimum intrusion into adjacent traffic lanes.

Although the lateral occupant impact velocity was technically over the limit specified in the 1989 guide, performance of the transition in this test was judged acceptable (see Figure 7 and Table 2).

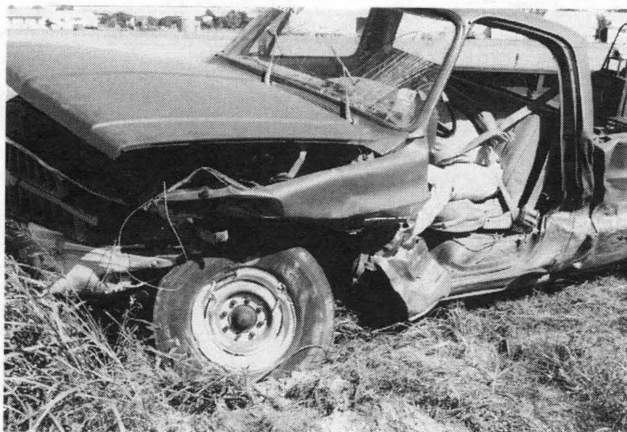
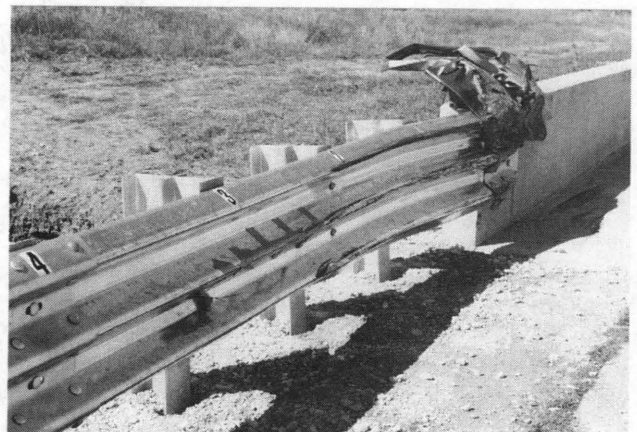
FIGURE 8 Vehicle and transition after Test 20.

The transition received moderate damage, with a maximum lateral deformation of the transition of 165 mm (6.5 in.). The vehicle sustained damage to the left side as shown in Figure 8. Maximum crush at the left front corner at bumper height was 559 mm (22.0 in.). The sway bar and upper and lower control arms on the left side were damaged. The roof was bent and the driver's-side door was detached. The left front wheel was canted inward at the bottom and pushed back into the fender well.

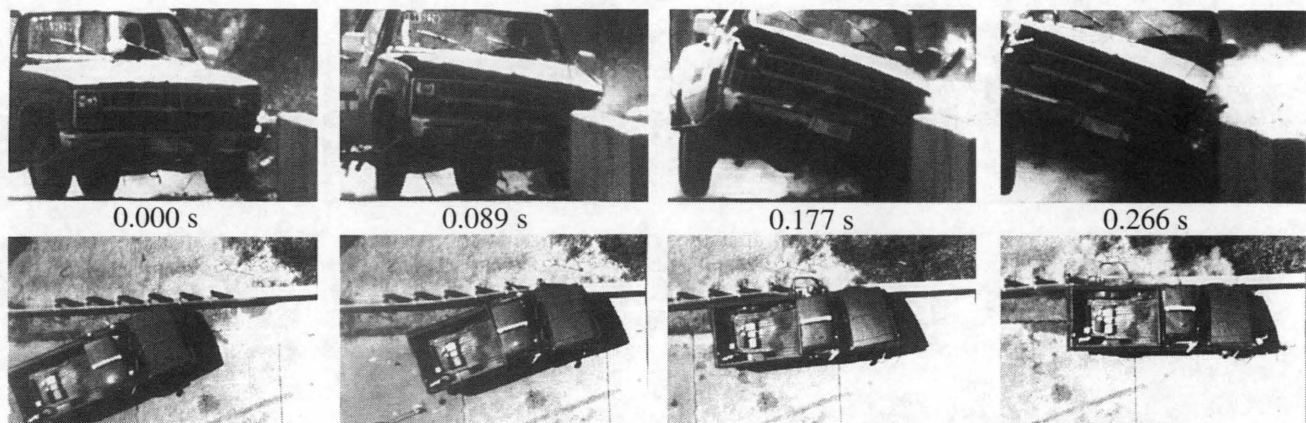
FIGURE 9 Summary of results for Test 20.

The transition performed as designed for this test; however, the exposed end of the terminal connector peeled the door from the vehicle. Because of the undesirable performance of the end terminal connector, performance of the transition in this test was judged to be unacceptable (see Figure 9 and Table 2).

Test No.	7069-20
Date	10/19/90
Test Installation	813 mm (32-in)
Installation Length	Thrie Beam Transition
Test Vehicle	26 m (85 ft)
Vehicle Weight	1981 Chevrolet
Test Inertia	C-20 Pickup
Gross Static	
Vehicle Damage Classification	
TAD	2 452 kg (5,400 lb)
CDC	2 529 kg (5,570 lb)
Maximum Vehicle Crush	11FL5 & 11LD7
	11FLEK3 & 11LDEW3
	559 mm (22.0 in)

Impact Speed	100.9 km/h (62.7 mi/h)
Impact Angle	19.0 deg
Speed at Parallel	75.3 km/h (46.8 mi/h)
Exit Speed	67.4 km/h (41.9 mi/h)
Exit Trajectory	9.0 deg
Vehicle Accelerations	
(Max. 0.050-sec avg)	
Longitudinal	-6.4 g
Lateral	-7.7 g
Occupant Impact Velocity at true c.g.	
Longitudinal	5.9 m/s (19.3 ft/s)
Lateral	5.3 m/s (17.3 ft/s)
Occupant Ridedown Accelerations	
Longitudinal	-5.4 g
Lateral	-13.0 g

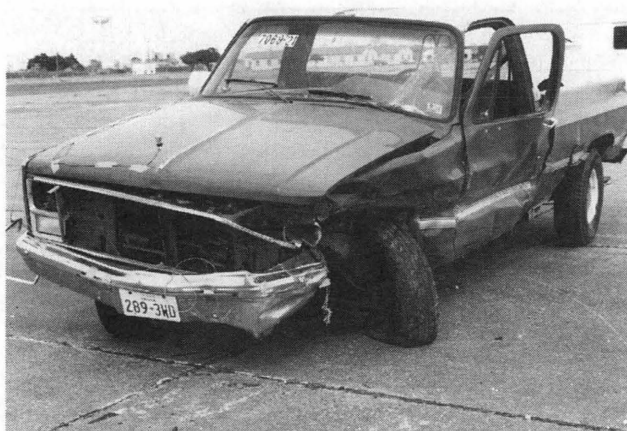
FIGURE 10 Vehicle and transition after Test 21.

The transition received moderate damage with a maximum permanent deformation of 127 mm (5.0 in.). The vehicle sustained damage to the left side with a maximum crush of 381 mm (15.0 in.) at the left front corner at bumper height. The right front corner was deformed outward approximately 121 mm (4.8 in.). The sway bar, A-arms on the left side, and gas tank were damaged. The drive shaft, frame, and roof were bent. The floor pan was pushed into the occupant compartment approximately 127 to 178 mm (5 to 7 in.). The instrument panel moved inward approximately 76 mm (3 in.). The left front wheel was canted inward at the bottom and pushed back into the fender well, reducing the wheelbase on the driver's side by 356 mm (14.0 in.) (see Figure 10).

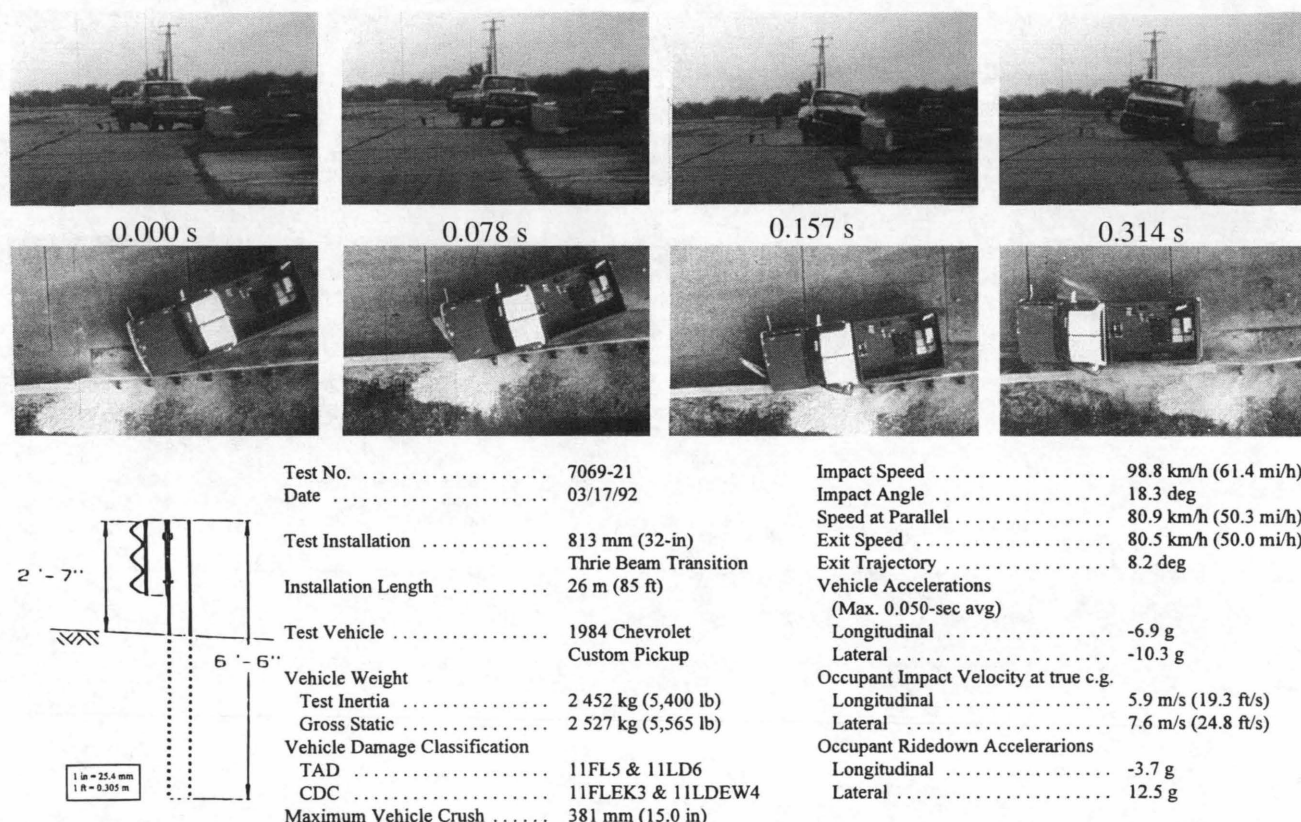
FIGURE 11 Summary of results for Test 21.

The deformation of the floor pan was of some concern, but was not considered life-threatening. Performance of the transition in this test was judged acceptable (see Figure 11 and Table 2).

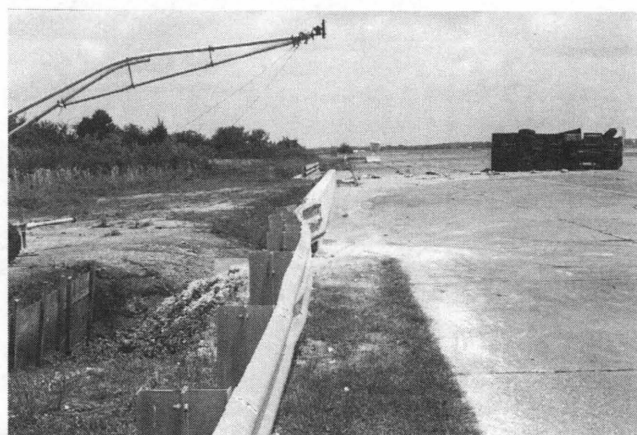
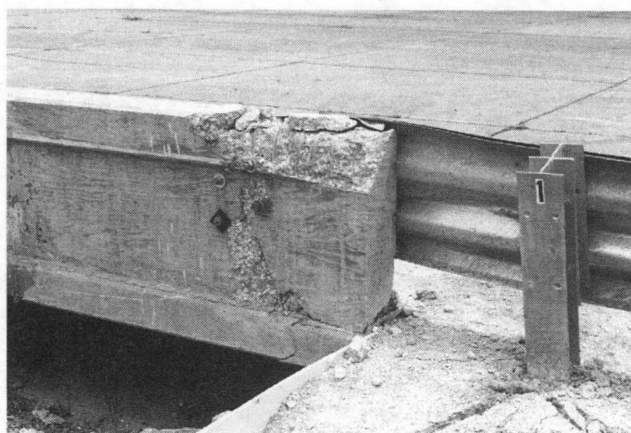
FIGURE 12 Transition after Test 29.

The transition received moderate damage with a maximum permanent deformation of 254 mm (10.0 in.). The end of the concrete parapet where the terminal connector attached was cracked, as shown in Figure 12. The vehicle sustained damage to the left side. Maximum crush at the left front corner at bumper height was 330 mm (13.0 in.). The floor pan was pushed inward, and the cab was bent and twisted. The windshield and rear glass were broken. The frame at the rear axle was bent, and the van box was twisted and torn.

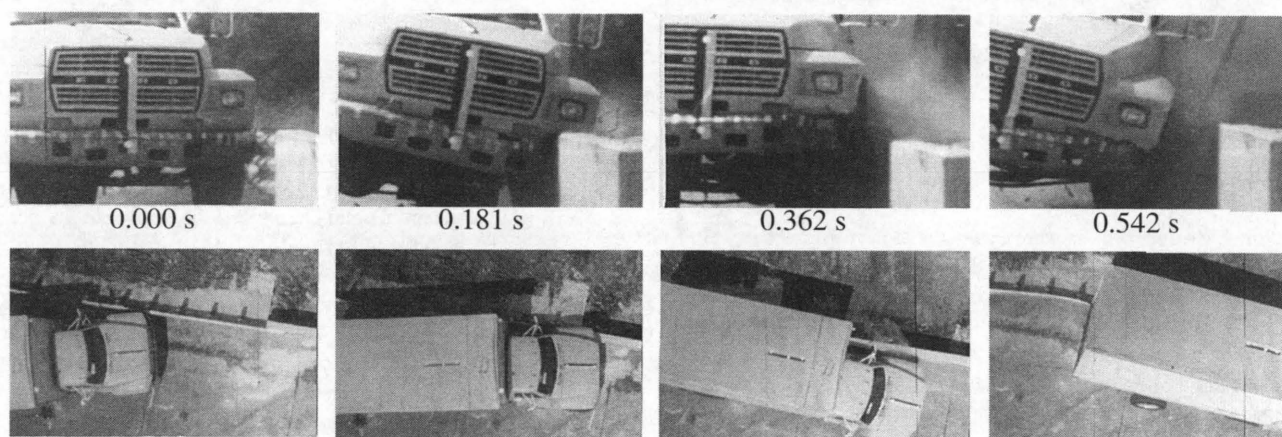
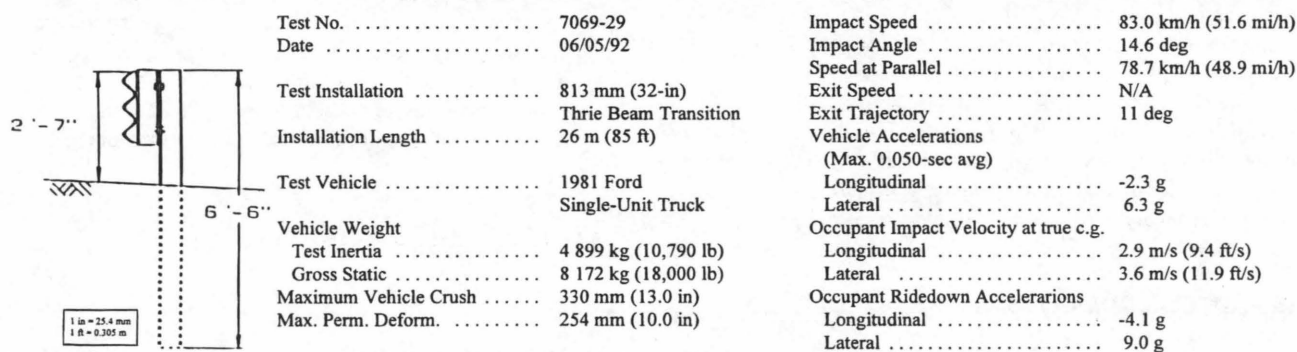
FIGURE 13 Summary of results for Test 29.

The transition contained the test vehicle with minimal lateral movement of the transition. The floor pan was slightly deformed into the vehicle; however, there was no intrusion of railing components into the occupant compartment. The vehicle remained upright and relatively stable during the test sequence. After exiting the immediate area of the test installation, the vehicle rolled onto its left side. This rollover behavior was attributed to asymmetrical brake application as the vehicle exited the test site. The transition redirected the vehicle with the effective coefficient of friction rated as good. The vehicle trajectory at loss of contact indicates minimal intrusion into adjacent traffic lanes. Performance of the transition in this test was judged acceptable (see Figure 13 and Table 2).
