# Performance Level 3 Bridge Railings

WANDA L. MENGES, C. EUGENE BUTH, D. LANCE BULLARD, JR.,  
AND CHARLES F. McDEVITT

This report documents the design and testing of two PL3 bridge railings: the 1.07-m (42-in.) F-shape bridge railing and the 1.07-m (42-in.) concrete parapet.

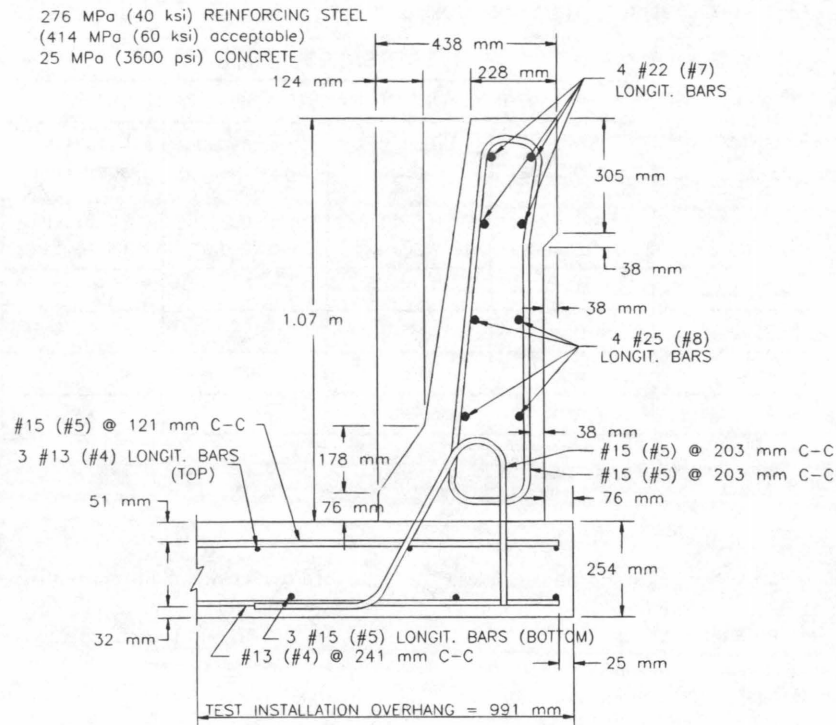
FIGURE 1 Cross section of 1.07-m (42-in.) F-shape bridge railing.

A cross section of the 1.07 m (42 in.) high F-shape is shown in Figure 1. The cross-sectional width of the railing is 439 mm (17.3 in.) at its base and tapers inward along the height with an increased cross-sectional width at the top of 230 mm (9 in.) along the top 304.8 mm (12 in.) of the rail. The slope at the bottom of the railing minimizes vehicle damage at low-impact angles by causing the tire to ride up the railing and redirect itself back to the pavement. The increased cross-sectional width at the top of the railing acts as a continuous beam and enhances the longitudinal distribution of forces in the parapet and deck.

Four No. 7 longitudinal bars were used in the increased cross-section at the top of the F-shape and four No. 8 longitudinal bars were placed throughout the tapered portion of the railing. The vertical steel consisted of No. 5 bent stirrups spaced at 203 mm (8 in.) on center. Specified concrete strength was 24,804 kPa (3,600 psi). The cantilevered deck was supported on a foundation so that the deck overhang was 991 mm (39 in.).

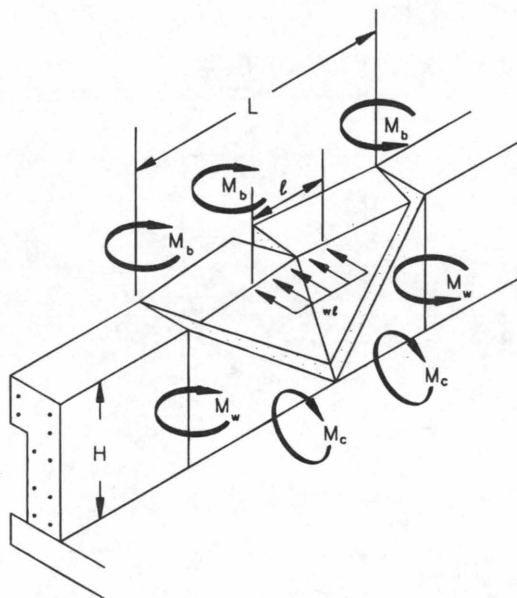
FIGURE 2 Yieldline failure mechanism for concrete parapet.

$$L = \frac{l}{2} + \sqrt{\left(\frac{l}{2}\right)^2 + 8H\left(\frac{M_b + M_w H}{M_c}\right)}$$

$$(wl)_{ult} = \frac{8M_b}{L - \frac{l}{2}} + \frac{8M_w H}{L - \frac{l}{2}} + \frac{M_c L^2}{H\left(L - \frac{l}{2}\right)}$$

- H = height of wall (FT)
- L = critical length of wall failure (FT)
- l = length of distributed vehicle impact load on railing (FT)
- M<sub>b</sub> = ultimate moment capacity of beam at top of wall (KFT)
- M<sub>c</sub> = ultimate flexural resistance of wall about horizontal axis
- M<sub>w</sub> = ultimate flexural resistance of wall about vertical axis (KFT/FT)
- (wl)<sub>ult</sub> = total ultimate load (KIPS)

Analysis of the strength of the railing is based on the yieldline failure pattern shown in Figure 2 (5). The length of the yieldline

failure pattern depends on the relative bending moment capacities of the various railing elements. The computed cantilever moment capacity of the parapet,  $M_c$ , is 69.9 m-kN/m (15.7 ft-k/ft). The average moment capacity of the parapet about a vertical axis,  $M_w$ , is 67.6 m-kN/m (15.2 ft-k/ft). The additional average moment capacity of the stiffening beam along the top of the parapet is 32 m-kN (23.6 ft-kips). The length of the yieldline failure pattern, computed from the equation in Figure 2, is 5.4 m (17.6 ft) and the ultimate strength of the parapet is 565.2 kN (127 kips), which is greater than the design force of 552 kN (124 kips).

Analysis of the strength of the railing is based on the yieldline pattern shown in Figure 2. The force from a colliding vehicle is idealized as being a uniformly distributed line load extending 2.4 m (8.0 ft). The load may be applied at any location along the railing.

The length of the yieldline failure pattern depends on the relative bending moment capacities of the various railing elements. The computed cantilever moment capacity of the parapet,  $M_c$ , is 95.2 m-kN/m (21.4 ft-k/ft). The moment capacity of the parapet about a vertical axis,  $M_w$ , is 73.4 m-kN/m (16.5 ft-k/ft). The additional moment capacity of the stiffening beam along the top of the parapet is 59.6 m-kN (43.9 ft-kips). The length of the yieldline failure pattern, computed from the equation in Figure 2 is 4.9 m (16.2 ft), and the ultimate strength of the parapet is 881 kN (198 kips).

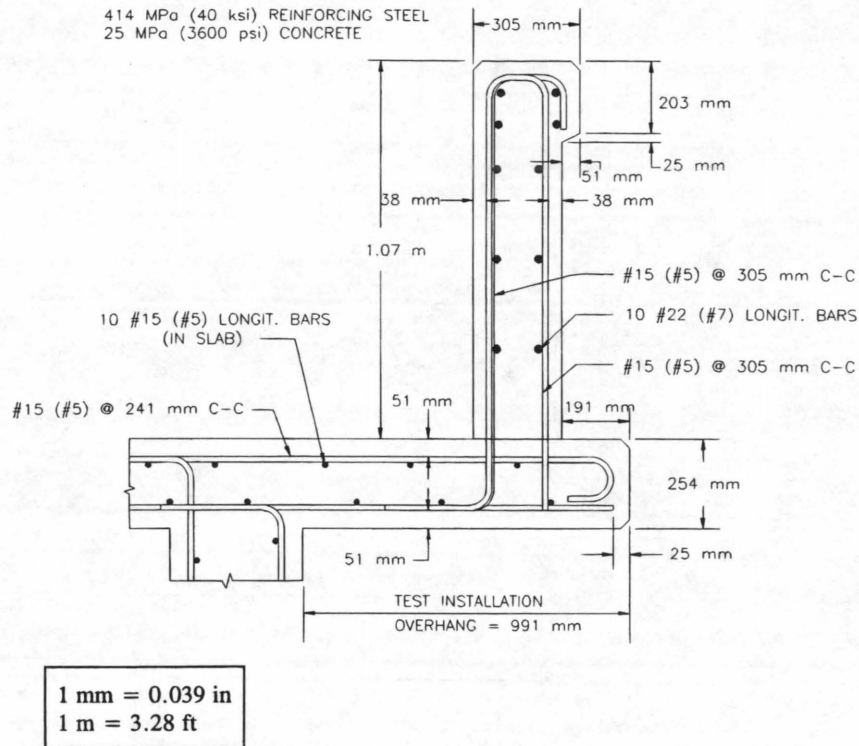
FIGURE 3 Cross section of 1.07-m (42-in.) concrete parapet.

The concrete parapet, shown in Figure 3, is 254 mm (10 in.) wide at the base and 305 mm (12 in.) wide at the top. The "beam" along the top edge enhances the longitudinal distribution of forces within the parapet and the deck. Two types of vertical reinforcing bars are alternated to provide No. 5 bars spaced at 152 mm (6 in.) in the traffic side face.

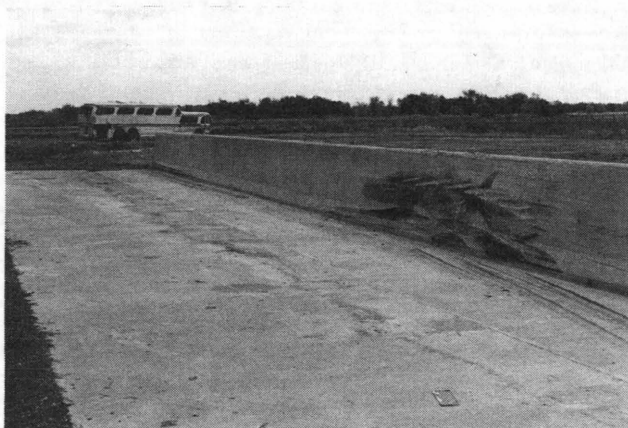
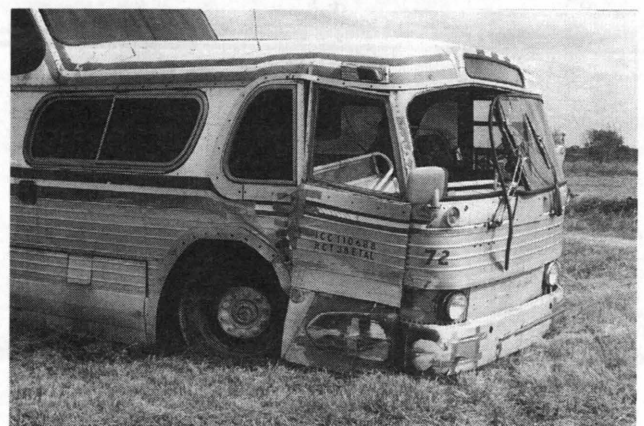
FIGURE 4 Damage to F-shape bridge railing and bus, Test 7069-7.

There was no measurable movement of the bridge railing; however, a longitudinal hairline crack developed in the bridge deck, starting approximately at the point of impact and extending about 11 m (35 ft) parallel to and nominally 610 mm (24 in.) from the base of the railing. Damage to the bridge railing and vehicle is shown in Figure 4. Maximum crush at the right front corner at bumper height was 102 mm (4.0 in.). The front wheel assembly and suspension were damaged.

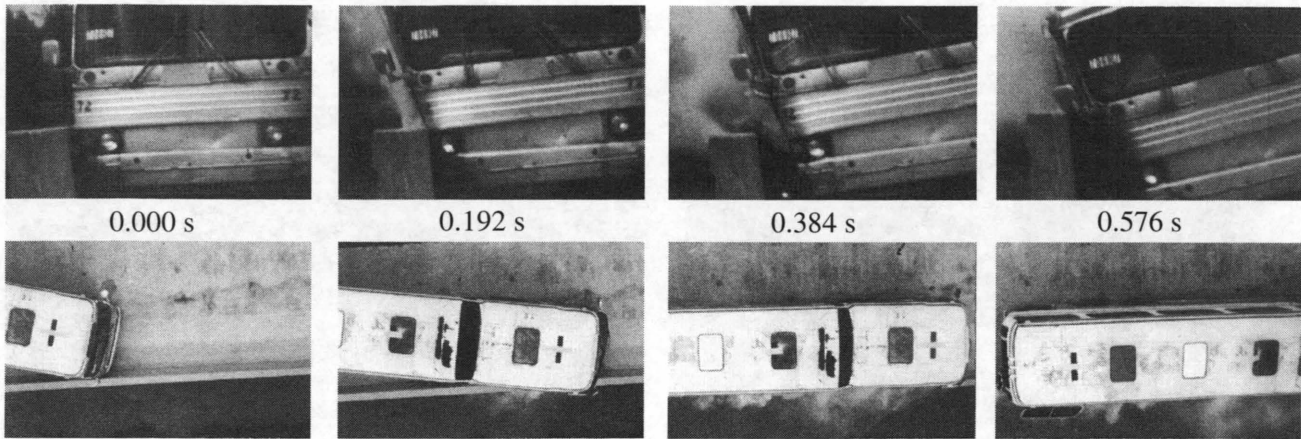
FIGURE 5 Summary of results for bus test on F-shape bridge railing, Test 7069-7.

Test No. ....	7069-7	Impact Speed .....	89.6 km/h (55.7 mi/h)
Date .....	11/19/87	Impact Angle .....	15.7 deg
Test Installation .....	1.07 m (42-in)	Exit Speed .....	68.4 km/h (42.5 mi/h)
Installation Length .....	F-shape Bridge Railing	Exit Trajectory .....	0 deg
Test Vehicle .....	1954 GMC	Vehicle Accelerations	
	Scenicruiser Bus	(Max. 0.050-sec avg)	
Vehicle Weight		Longitudinal .....	-1.5 g
Empty Weight .....	13 547 kg (29,840 lb)	Lateral .....	6.5 g
Test Inertia .....	18 414 kg (40,560 lb)	Occupant Impact Velocity at true c.g.	
Vehicle Damage Classification		Longitudinal .....	2.4 m/s (7.9 ft/s)
TAD .....	N/A	Lateral .....	1.6 m/s (5.4 ft/s)
CDC .....	N/A	Occupant Ridedown Accelerations	
Maximum Vehicle Crush .....	102 mm (4.0 in)	Longitudinal .....	-2.4 g
		Lateral .....	21.7 g

The F-shape bridge railing contained and smoothly redirected the vehicle with no lateral movement of the bridge railing. There was no debris or detached elements. There was no intrusion into the occupant compartment, although a minimal amount of deformation occurred on the right door. The vehicle trajectory at loss of contact indicated minimum intrusion into adjacent traffic lanes. The vehicle remained upright and stable during and after the crash. Additional information pertinent to this test is presented in Figure 5. Performance of the bridge railing was judged acceptable, as indicated in Table 3.

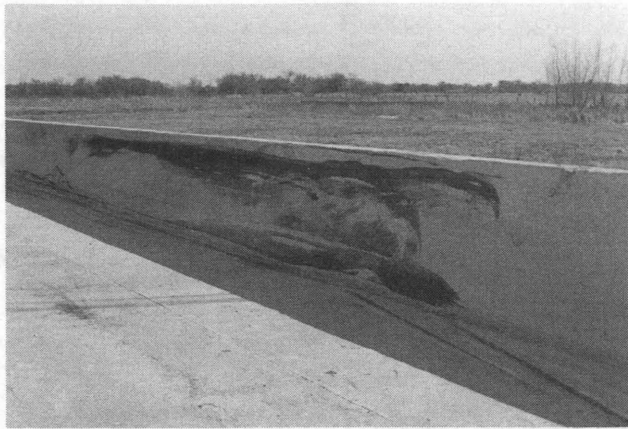
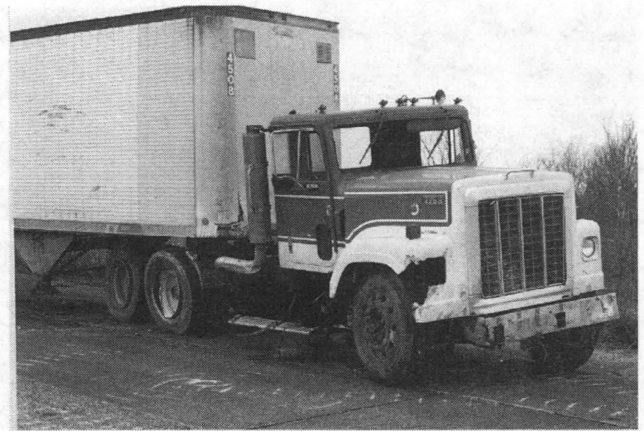
FIGURE 6 Damage to F-shape bridge railing and tractor trailer, Test 7069-10.

There was no lateral movement of the bridge railing. A small piece of the top of the bridge railing chipped off where the edge of the trailer hit the railing. Both outside right rear wheel rims of the tractor were bent and the tires deflated (see Figure 6). The front wheel assembly and suspension were damaged. The shock mounts were broken, the tie rods and the steering rod were bent, and the springs were loosened. Maximum crush at the right front corner of the vehicle at bumper height was 457 mm (18.0 in.).

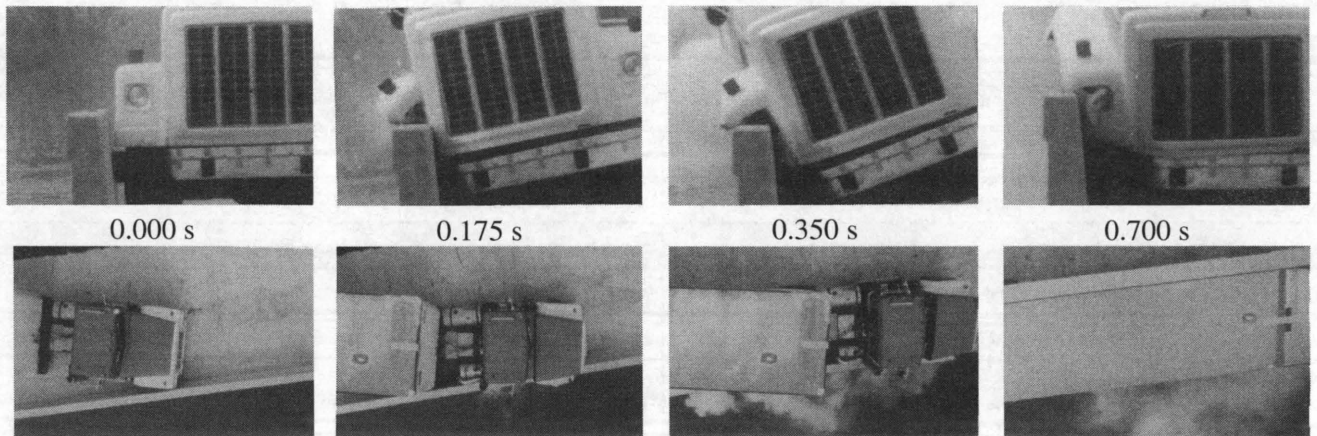
FIGURE 7 Summary of results for tractor-trailer test on F-shape, Test 7069-10.

Test No. ....	7069-10
Date .....	3/3/88
Test Installation .....	1.07 m (42-in) F-shape Bridge Railing
Installation Length .....	30 m (100 ft)
Test Vehicle .....	1979 International Transtar 4200 Tractor
Vehicle Weight	
Empty Weight .....	13 574 kg (29,900 lb)
Test Inertia .....	22 700 kg (50,000 lb)
Maximum Vehicle Crush .....	457 mm (18.0 in)

Impact Speed .....	84.0 km/h (52.2 mi/h)
Impact Angle .....	14.0 deg
Exit Speed .....	N/A
Exit Trajectory .....	0 deg
Vehicle Accelerations (Max. 0.050-sec avg)	
Longitudinal .....	-2.2 g
Lateral .....	4.7 g
Occupant Impact Velocity at true c.g.	
Longitudinal .....	2.8 m/s (9.1 ft/s)
Lateral .....	2.8 m/s (9.3 ft/s)
Occupant Ridedown Accelerations	
Longitudinal .....	-4.7g
Lateral .....	3.7 g

The F-shape bridge railing contained and smoothly redirected the vehicle with no lateral movement of the bridge railing. There was no debris or detached elements. There was no intrusion into the occupant compartment, although minimal deformation of the right door occurred. The vehicle trajectory at loss of contact indicated minimal intrusion into adjacent traffic lanes. The vehicle remained upright and stable during and after the crash. Additional information pertinent to this test is presented in Figure 7. Performance of

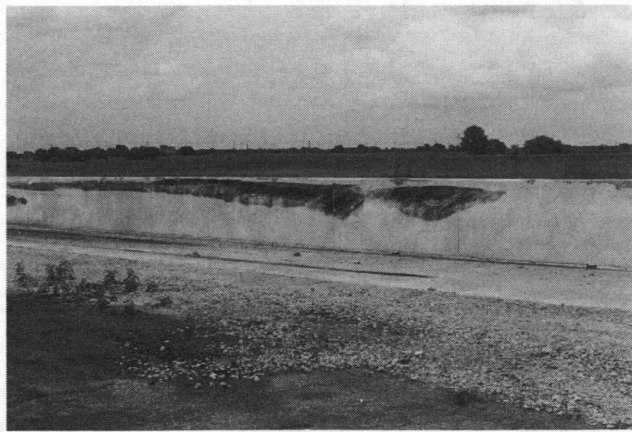
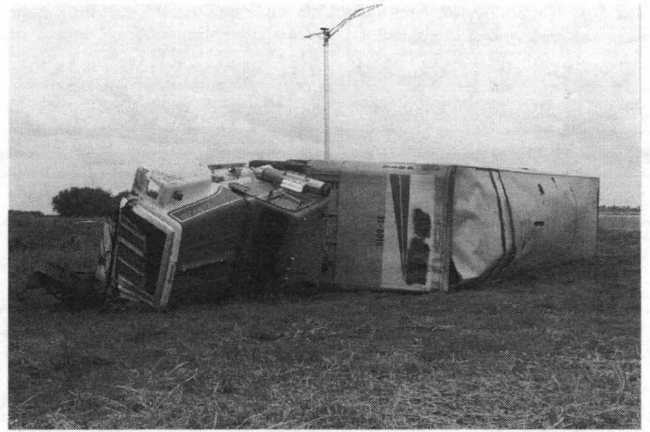
FIGURE 8 Damage to concrete parapet and tractor trailer, Test 7069-13.

The parapet received minor damage with a small chip at the top. Damage to the bridge railing and vehicle is shown in Figure 8. The vehicle received damage to the front axle, pitman arm, U bolts, front

leaf springs and bolts, front shock mounts, air brake lines, right fuel cell, left rear spring pin and clamp, and exhaust pipe. Maximum crush at the right front corner at bumper height was 457 mm (18.0 in.).

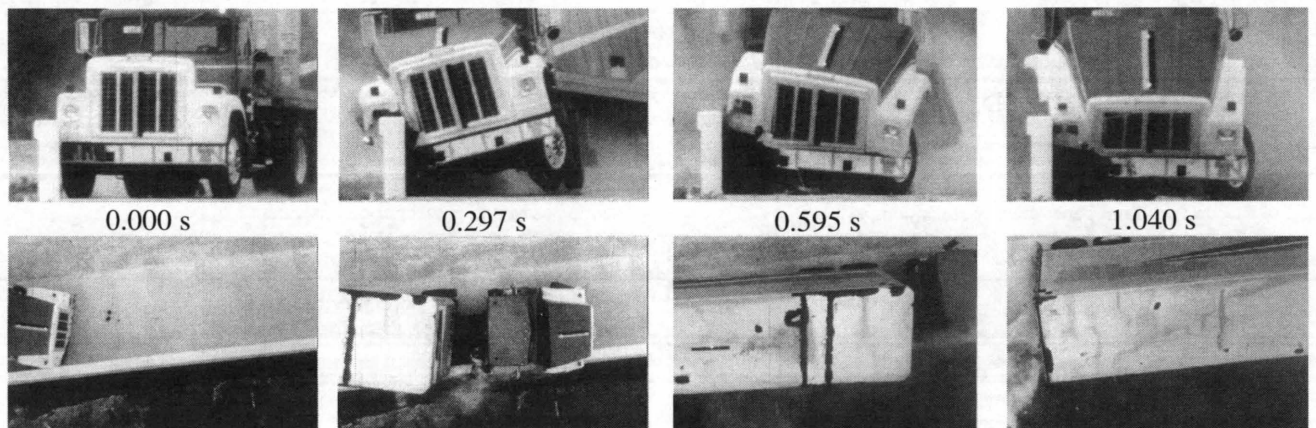
FIGURE 9 Summary of results for tractor-trailer test on concrete parapet, Test 7069-13.

Test No. ....	7069-13
Date .....	7/11/88
Test Installation .....	1.07 m (42-in) Concrete Parapet
Installation Length .....	30 m (100 ft)
Test Vehicle .....	1979 International Tractor w/van-trailer
Vehicle Weight	
Empty Weight .....	12 571 kg (27,690 lb)
Test Inertia .....	22 723 kg (50,050 lb)
Maximum Vehicle Crush .....	457 mm (18.0 in)

Impact Speed .....	82.7 km/h (51.4 mi/h)
Impact Angle .....	16.2 deg
Exit Speed .....	N/A
Exit Trajectory .....	0 deg
Vehicle Accelerations (Max. 0.050-sec avg)	
Longitudinal .....	-3.3 g
Lateral .....	3.7 g
Occupant Impact Velocity at true c.g.	
Longitudinal .....	3.2 m/s (10.5 ft/s)
Lateral .....	3.8 m/s (12.5 ft/s)
Occupant Ridedown Accelerations	
Longitudinal .....	-2.2 g
Lateral .....	4.6 g

cle from penetrating or rolling over the bridge railing. The vehicle remained upright during contact with the bridge railing; however, the vehicle rolled on its side after exiting the installation. As indicated in Table 5, it is desirable, but not required, that the vehicle remain upright after the test. Additional information pertinent to this test is presented in Figure 9. Performance of the concrete parapet bridge railing was judged acceptable.
