# Nature and Detection of Void-Induced Pavement Failures

H. TOMITA, H. TADA, T. NANBU, K. CHOU, T. NAKAMURA, AND  
T. MCGREGOR

Pavement failures caused by substructure cavities, or voids, have recently become a widespread problem in Japanese roads. Several cities in Japan have reported these problems. To ensure the safe flow of traffic and to avoid pavement failure-induced traffic accidents, the detection of sinkholes became a top priority. Acting on this situation, the Ministry of Construction developed a sinkhole detection vehicle that makes it possible to detect subsurface cavities with higher speed and precision. The Ministry of Construction formed a coordinating agency to oversee the implementation of this technology. This agency made actual site surveys and analyzed the results to ascertain the mechanical properties of subsurface cavities. With this knowledge, in 1992 an effective sinkhole detection method was developed. The method utilizes ground penetrating radar and a bore hole camera as field data acquisition tools. The detection method relies on using the analysis tools to provide an increasingly detailed look at the pavement substructure: from a general survey to a sp

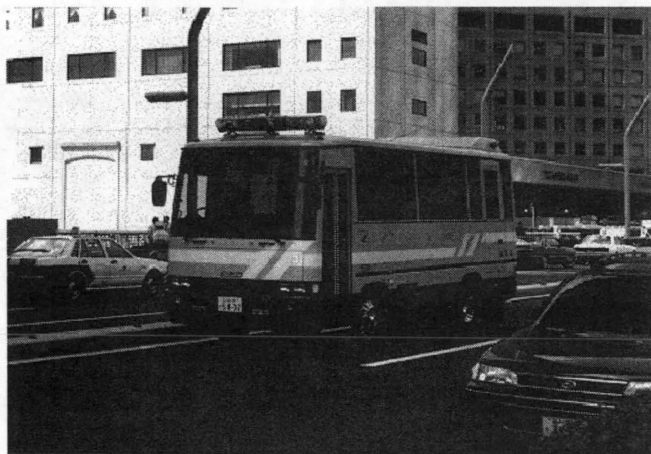
FIGURE 1 Sinkhole detection vehicle.

the survey was too slow. Therefore, before development, the Ministry of Construction constructed a test field in which sample voids, pipes, and other subsurface anomalies were buried. Various methods of detection (not immediately relevant to this discussion) were used in this controlled environment to determine which method was the most effective at subsurface detection. The public dissatisfaction over the many sinkholes in Japan caused this situation to be pursued on an emergency basis. The analysis tools were mounted in a convenient vehicle as shown in Figure 1.

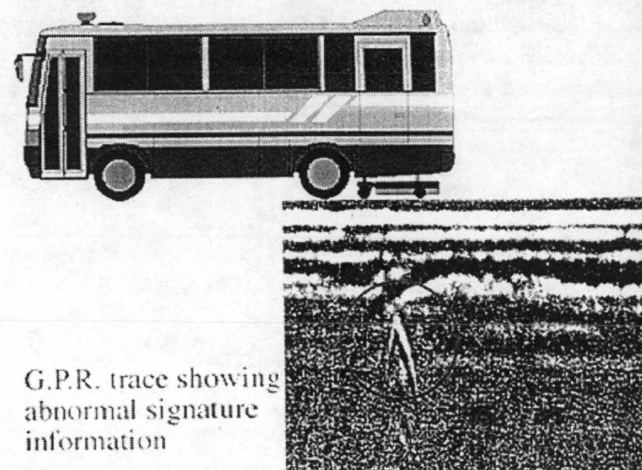
**FIGURE 7** Detection vehicle with GPR trace juxtaposed showing orientation of data acquisition sequence.

In the first look at the substructure of the pavement, the low-frequency radar vehicle detects the location of substructure anomalies such as voids. The survey vehicle is positioned at the start of the target lane segment, the GPR equipment is initiated, verbal cues are inserted onto the eight-track tape, and the investigation of the pavement substructure begins. The vehicle gradually achieves a speed of 20 km/hr and moves forward along the designated route. As the completion of the lane segment is achieved, the machinery is placed on standby mode, the vehicle is turned around and positioned to survey the opposite lane, and the procedure is repeated (2).

After the field survey has been accomplished, the data that have been acquired are turned over to the office staff for the post-data acquisition analysis. The storage media delivered to the analysis crew are the roll of chart paper on which the radar data has been recorded (a sample of a GPR trace on chart paper and its relationship to the position of the vehicle is shown in Figure 7), the backup 8-track magnetic tape that contains the radar and audio information, and the 8-mm videotape. The chart paper is examined by trained readers for examples of anomalies. If no anomalies are determined, the report is made and delivered to the pavement engineer. If abnormal points are determined by the trained data readers within the target pavement, the secondary survey is implemented.

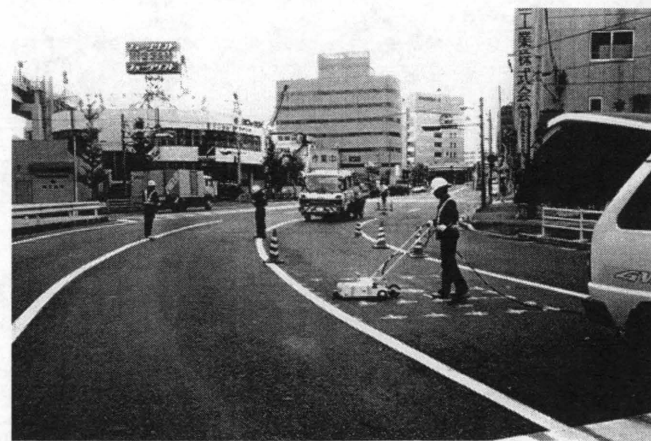
**FIGURE 8** Void area on a city street isolated by portable GPR units and marked with spray paint.

feet data, as well as the verbal cues and radar data from the 8-track magnetic tape. On arrival at the investigation site, the field crew uses special portable radar gear developed for the purpose of void detection to determine the exact parameters of the subsurface anomaly. The portable radar unit is passed over the target area and as the borders of the void are located, spray paint determines the location of these borders. This process is shown in Figure 8. The operators of the radar gear in the vehicle (the comfortable interior of which is shown in Figure 9) transmit to the radar transducer operators when and where the anomaly border has been detected by means of a two-way radio. In a short time, the subsurface void has been mapped with surface-applied spray paint.

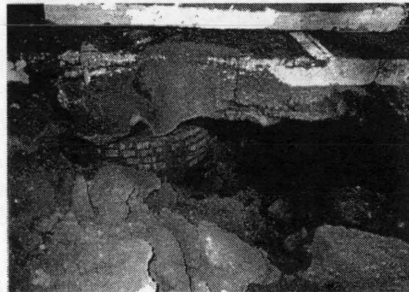
Size of Void  
(L 3.0 m x W 3.0 m x H 1.0 m)

It appears that a broken link of underground sewer pipe causes a leak of sewer water which erodes the soil.

FIGURE 12 Photographs showing excavation of detected voids.

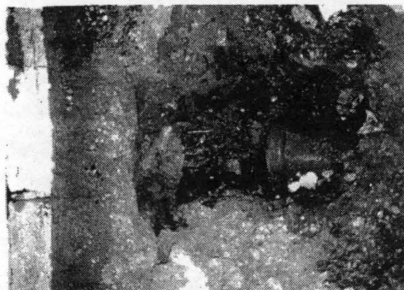
Size of Void  
(L 2.5 m x W 3.0 m x H 0.5 m)

The connector of a rainwater drainage pipe broke causing the soil to be eroded by rainwater runoff.
