# Speed Reduction Effects of Speed Monitoring Displays with Radar in Work Zones on Interstate Highways

PATRICK T. MCCOY, JAMES A. BONNESON, AND JAMES A. KOLLBAUM

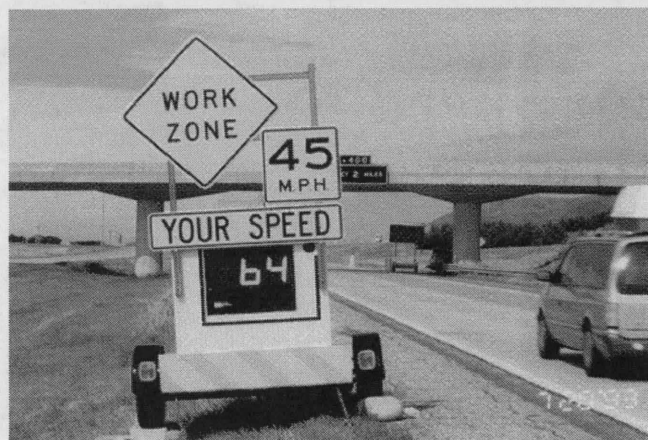
The particular speed monitoring display evaluated in this study is shown in Figure 1. It was a portable, self-contained, solar-powered trailer unit that was fabricated by the SDDOT. The speed display panel was 508 mm (20 in.) high and 711 mm (28 in.) wide, and it had a three-digit readout with 229-mm (9-in.) high digits. The sign assembly mounted above the speed display panel included a WORK ZONE warning sign [914 mm (36 in.) by 914 mm (36 in.)], an advisory speed plate [W13-1, 610 mm (24 in.) by 610 mm (24 in.)], and a YOUR SPEED guide sign [305 mm (12 in.) by 1524 mm (60 in.)]. All of the signs in the assembly were orange with black legends. A Type I barricade panel [305 mm (12 in.) by 1524 mm (60 in.)] was mounted below the speed display panel.

FIGURE 1 Speed monitoring display.

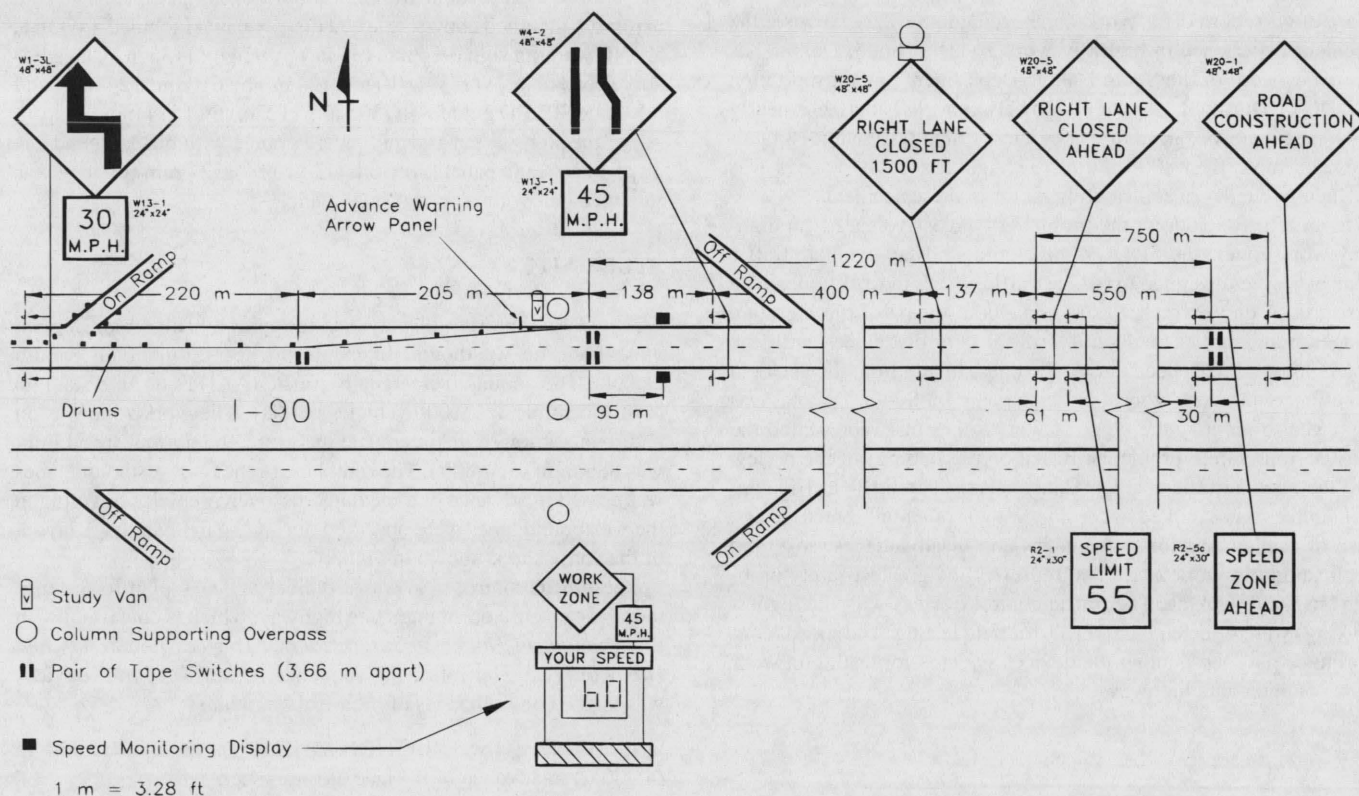
The speed monitoring display was tested at a bridge-replacement work zone on westbound Interstate 90 near Sioux Falls, South Dakota. The annual average daily traffic (AADT) on Interstate 90 at this location was 9,000 vehicles per day. The work zone was on an urban section of the interstate; therefore, the normal speed limit was 88 km/hr (55 mi/hr). The right lane of the two westbound lanes was closed in advance of a median crossover. Vehicles traveling in the westbound lanes were observed during the field study. A layout of the study site is shown in Figure 2.

FIGURE 2 Study site plan.

The data were collected with tape switches at three locations in advance of the work zone as shown in Figure 2. The first location (Station 1) was about 200 m (650 ft) downstream of the ROAD CONSTRUCTION AHEAD signs and 1,220 m (4,000 ft) in advance of the lane closure taper. The second location (Station 2) was at the beginning of the lane closure taper, and the third location (Station 3) was at the end of the taper. At each location, tape

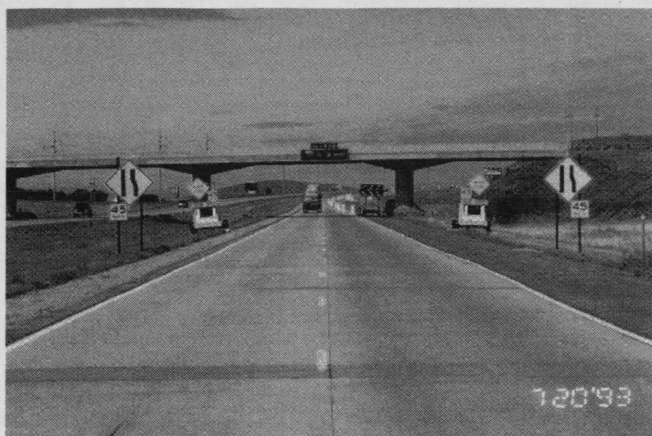
Two speed monitoring displays were installed about 95 m (310 ft) in advance of the lane closure taper. The displays were positioned at the edge of the shoulder on each side of the roadway. The placement of the displays is shown in Figure 3.

FIGURE 3 Speed monitoring display installation.

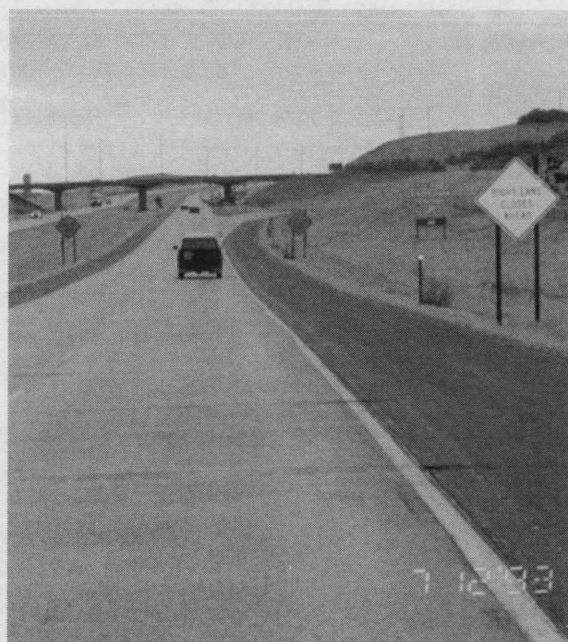
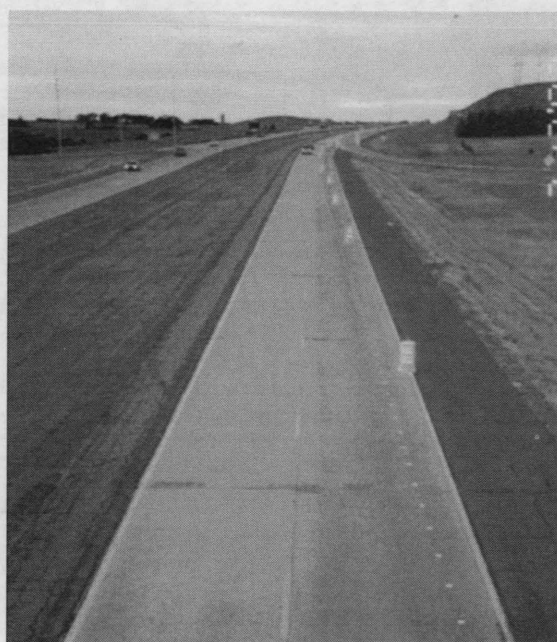
Two photographs of the study site are shown in Figure 4. The photograph in Figure 4(a) was taken about 702 m (2,300 ft) in advance of the lane closure taper. It shows the approach to the lane closure, which was on a tangent, nearly level section of roadway. It also shows the exit ramp that was located on the approach about 183 m (600 ft) in advance of the lane closure taper. The photograph in Figure 4(b) was taken from the overpass at the beginning of the taper. It shows the taper and the entrance ramp located at the end of the taper.

FIGURE 4 Views of study site: (a) approach; (b) lane closure taper.

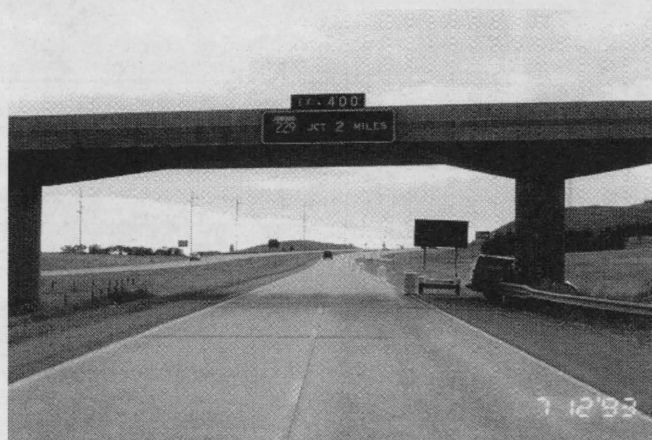
FIGURE 5 Location of data collection van.

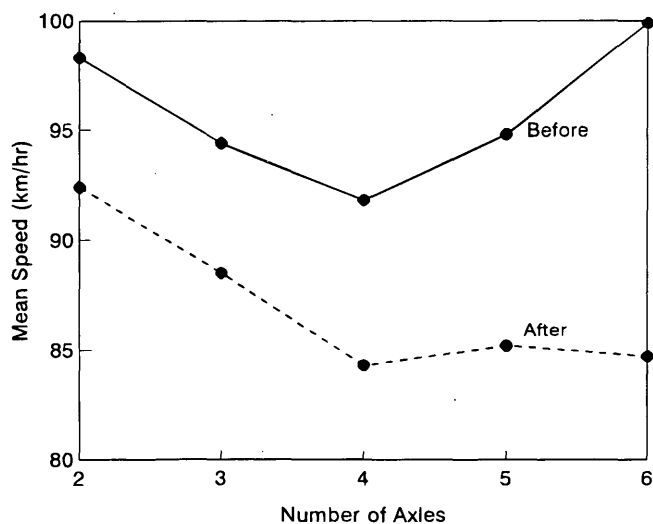
FIGURE 6 Mean speeds at Station 2.

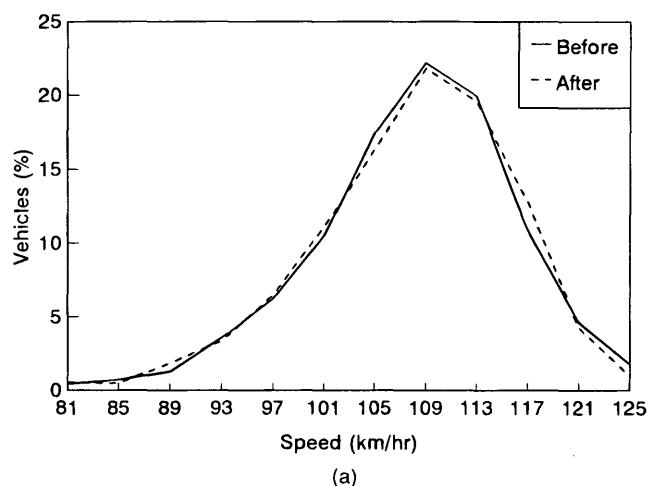
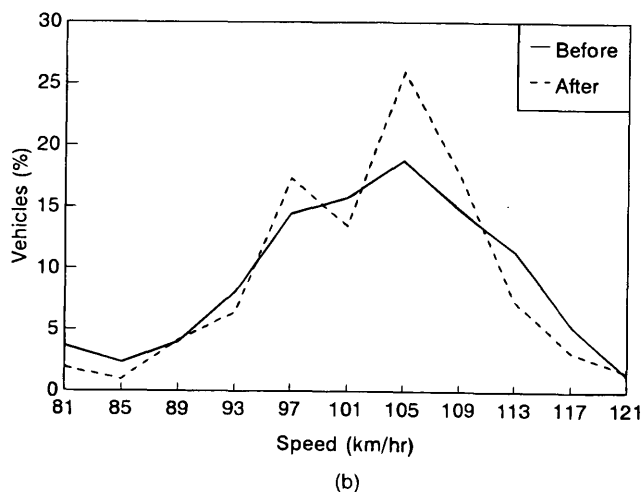
The speed distributions at Station 1 are shown in Figure 7. At this location, 1,220 m (4,000 ft) in advance of the taper, where the speed limit was 105 km/hr (65 mi/hr), the speed distributions within each vehicle class were about the same before and after the speed monitoring displays were installed. The results of chi-square tests indicated that there was no significant difference between the distributions within each vehicle class at the 0.05 level of significance.

FIGURE 7 Speed distributions at Station 1: (a) two-axle vehicles; (b) vehicles with more than two axles.

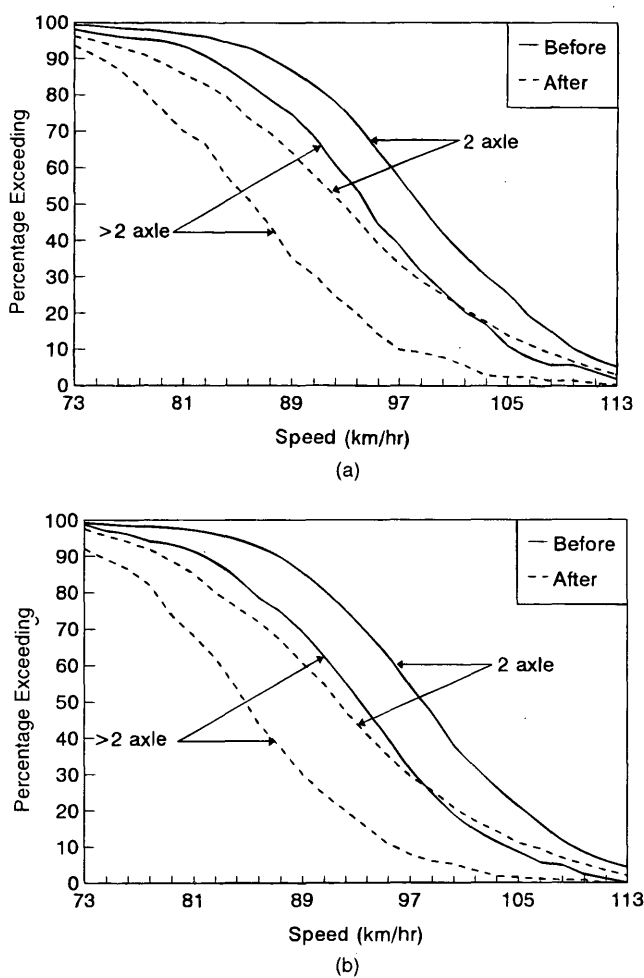
The percentages of vehicles exceeding the advisory speed limit of 72 km/hr (45 mi/hr) at Stations 2 and 3 are shown in Figure 8. At each station, the percentages of vehicles traveling at excessive speeds within each vehicle class were reduced after the speed monitoring displays were installed. The results of chi-square tests of these percentages within each vehicle class, at each station, indicated that these reductions were significant at the 0.05 level of significance. Comparison of the percentages between vehicle classes suggests that the reductions in excessive speeds at Stations 2 and 3 were greater for vehicles with more than two axles than they were for two-axle vehicles.

FIGURE 8 Percentage of vehicles exceeding advisory speed limit: (a) Station 2; (b) Station 3.

monitoring displays were installed, the percentages of two-axle vehicles exceeding the advisory speed limit of 72 km/hr (45 mi/hr) at Stations 2 and 3 were reduced by about 20 to 25 percentage points. The reductions in the percentages of vehicles with more than two axles were much higher. They were reduced by about 40 percentage points.
