Uplift Failures of Corrugated Metal Pipe

R. A. LOHNES, F. W. KLAIBER, AND T. A. AUSTIN

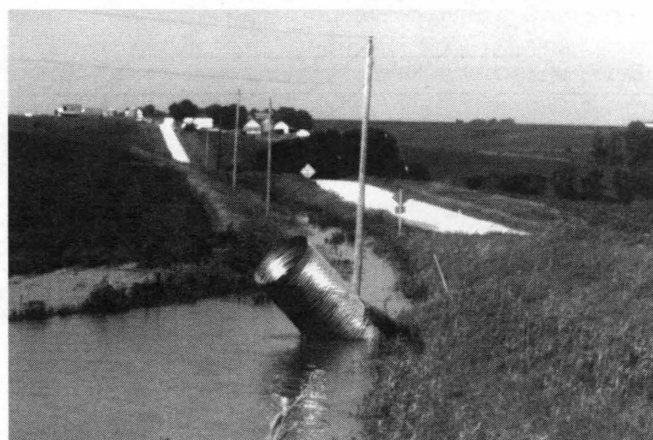
a. FAILED CMP WITHOUT TIE-DOWN SYSTEM.

This site had a corrugated structural steel plate culvert installed in February 1954 that failed in June 1976. The pipe was circular with a diameter of 3.66 m, a length of 29 m, a beveled inlet 1.5 to 1, and a slope of 3.81 percent. The fill above the pipe was 853 mm deep and the roadway 8.53 m wide with a slope of 8 to 1 at the inlet and 6 to 1 at the outlet. The fill extended to the top of the beveled inlet. No information was found on high water marks or discharge through the pipe during the flow that caused the failure.

The pipe bent at a distance of 7.92 m from the inlet until it was at about the same elevation as the shoulder of the roadway. This type of bending failure is illustrated in the photograph of Figure 5a. The pipe bottom collapsed inward beginning at about 6.71 m upstream of the centerline of the road and extended approximately to the centerline. Subsequent to the bending, the road grade washed out, but it was not clear whether water overtopped the road or undermined the pipe to cause the embankment failure. No tie-down structure or cutoff wall was used.

Shear and moment diagrams were constructed from the soil loading. The maximum shear was found to occur at a distance of 8.84 m from the inlet. The bend in the pipe at a distance of 7.92 m occurred close to the point of maximum shear. The moment that must be resisted at 8.84 m is 643 kN.m and could be resisted by a force of 75.2 kN located 305 mm from the inlet. In this case, the calculated resisting force for this 3.66-m diameter pipe falls considerably below the extrapolated resisting forces specified by any of the state or provincial agencies.

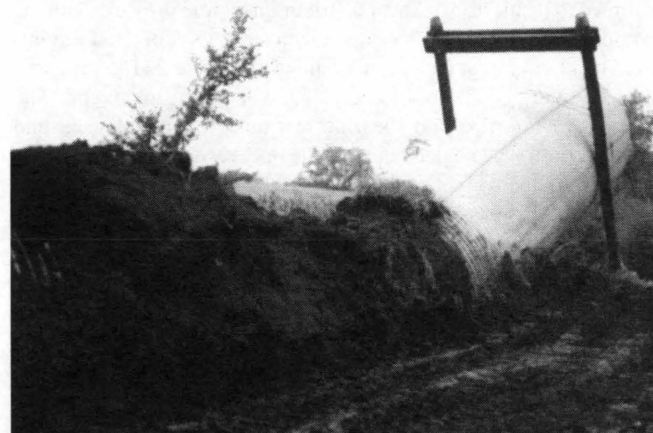
b. PULL-OUT OF TIE-DOWN SYSTEM.

The CMP at Site 2 was installed in July 1976 and failed in September 1986. The pipe was a structural plate pipe with a diameter of 3.05 m, a length of 36.6 m, a slope of 3.67 percent, and a projecting inlet. The roadway width was 8.53 m with slopes of 2.5 to 1 on both inlet and outlet ends and a depth of soil cover averaging 850 mm. A seepage collar was placed 6.1 m downstream from the inlet. A tie-down consisting of two wood piles driven on each side of the pipe with two 76×406 -mm horizontal wood planks across the top of the CMP and a 13-mm wire rope cable attached to the piles. Figure 5b shows a similar tie-down that failed by pulling the piles out of the ground.

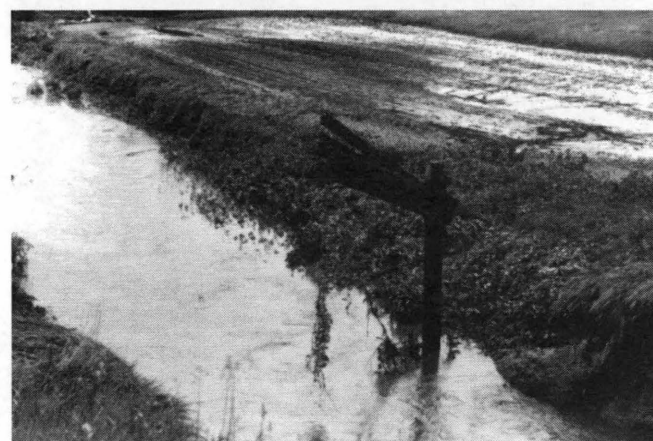
c. FAILED TIE-DOWN SYSTEM.

At Site 2 no data on high water or discharge were available, but the pipe failed by breaking the planks of the tie-down and stretching the cable. The broken tie-down at Site 2 is shown in Figure 5c. The road grade washed out and the culvert was moved 100 m downstream. The bottom of the pipe collapsed inward so there was only about 610 mm of clearance between the top and bottom of the failed pipe.

The force required to break the tie-down was estimated from available data. The flexural strength of the wood plank was assumed to be 49.6 MPa and the moment of inertia calculated to be 57.1 m^4 .

Using the flexural equation, the failure moment is estimated to be 160 kN.m. This moment corresponds to a uniform load of 52.5 kN acting over 1.52 m, the length where the pipe and planks are in contact. The indentation in the pipe made by the planks was obvious, so the total force acting on the planks is estimated to be 262 kN. In addition to the strength of the planks, the stretch of the cable must be included. If the cable is 13-mm wire rope with a yield stress of 11724 MPa, the ultimate load would be 160 kN; however the cable

was not new so its ultimate strength was reduced by 20 percent to account for corrosion. Thus, the two cables could carry an additional load of 258 kN making the total load to fail the tie-down estimated to be 520 kN. This failure load for the 3.05 m diameter pipe is greater than the specified resisting forces for 6 of the 9 specifications studied and approaches the force calculated in the simplified, conservative analysis.

The history of this pipe also points to the limitations of seepage cutoffs in eliminating uplift on CMP. It is often thought that cutoff walls and graded bedding are sufficient to mitigate CMP uplift problems; however, theoretical flow net analyses indicate that a cutoff needs to extend approximately 80 percent of the distance to an impermeable layer in order to reduce the quantity of seepage by 50 percent (4,5) and that incorrect placement of cutoffs can result in a redistribution of pore pressures that might exacerbate the problem (5,6). From a practical standpoint differential settlement, cracking, perforation, and burrowing animals can ruin the best designed seepage control system.
