15th International Managed Lanes Conference, Miami, FL

Edens Expressway Bus on Shoulder Study
Chicago, IL

Srikanth Panguluri, P.E.

CH2M

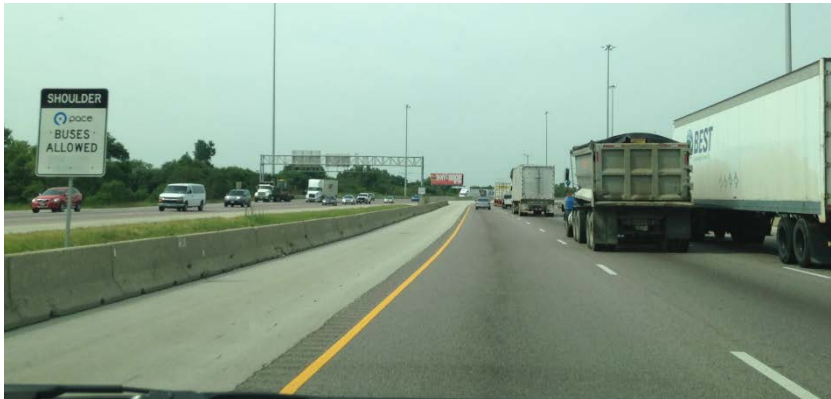
- Bus on Shoulder (BOS) current operations on Interstate 55

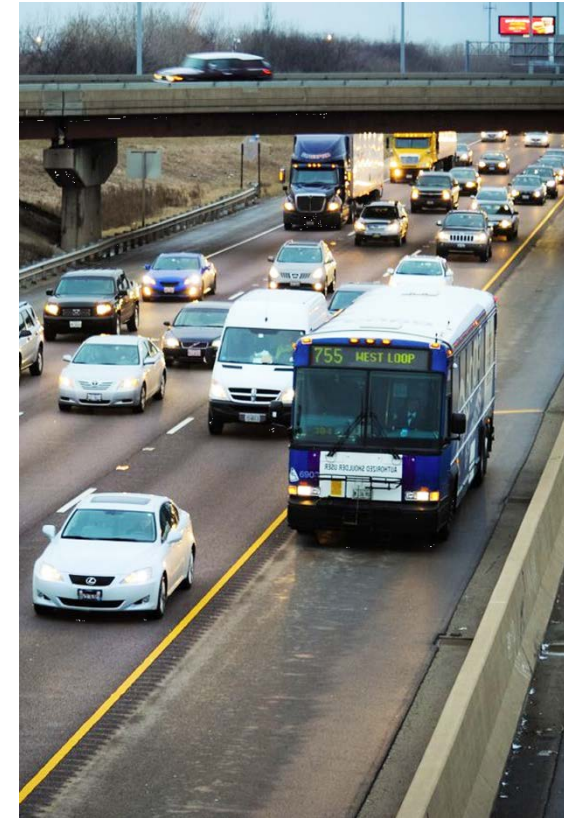
Bus on Shoulder (BOS) on Interstate 55

- Only pace buses are allowed
- Left side shoulder operations
- 18 miles implemented in 2011
- 4 additional miles of operation in 2014

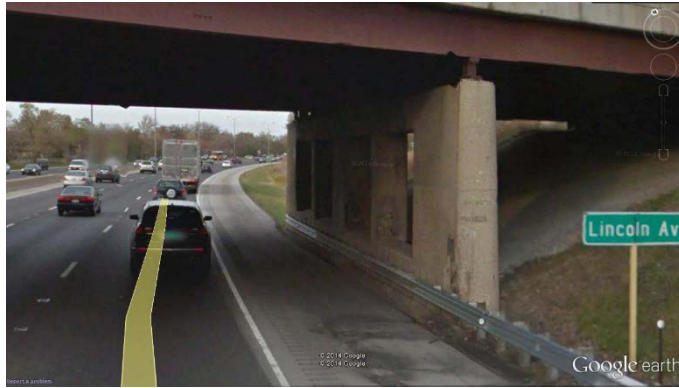
Bridges

Physical Constraints – Roadway Engineering

- Guardrails
- Shoulder widths
- Vertical clearance

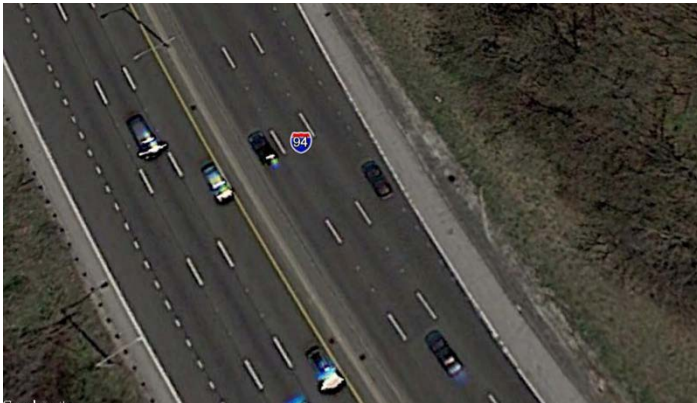
Shoulder condition and widths

- Left side
- Right side

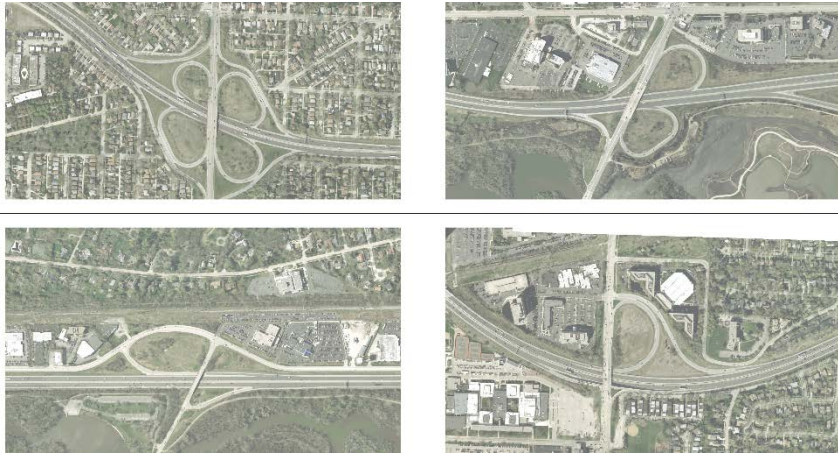
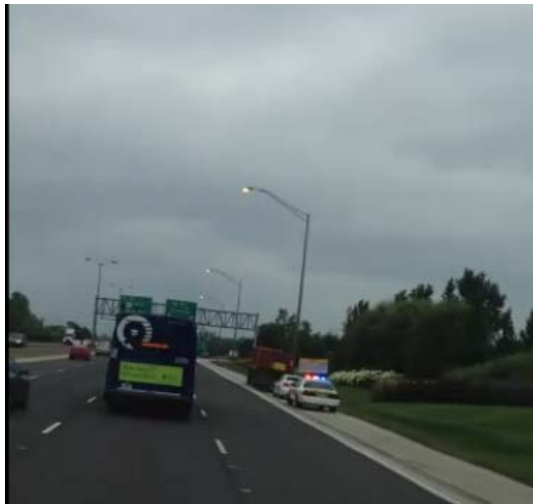
Traffic Operations:

- Weaving operations at interchanges
- Limited sight distance at interchanges
- Ramp metering compliance
- Existing “five percent” crash locations
- System Interchanges

Enforcement:

Only right side shoulder is effectively useable

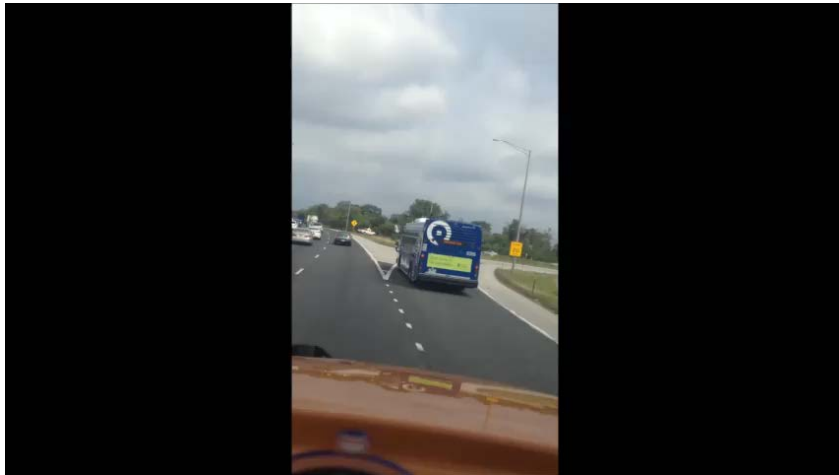
Field Trip – Test Drive

- Field Observations
- Stakeholders
 - Pace, the local suburban transit bus service
 - Illinois State Police
 - FHWA
 - IDOT Central office, District's Bureau of Traffic, Bureau of Maintenance

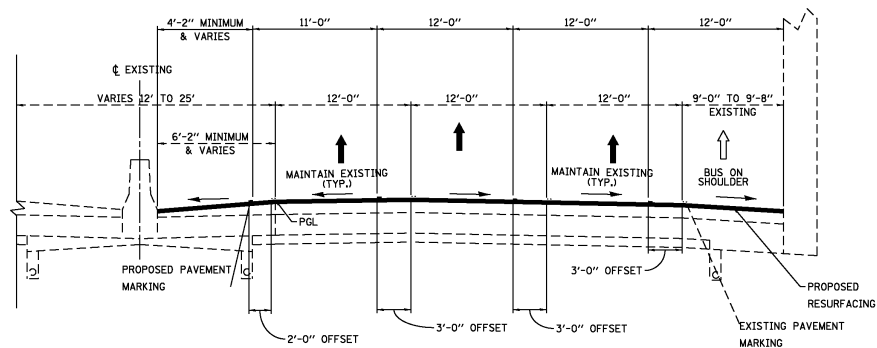
— Gap Sections

- Proposed Bus operations on right side shoulder
 - Resurfacing all the outside shoulders
 - Relocate rumble strips
 - Resurface and relocate mainline travel lanes at some locations
