High-Speed Rail IDEA Program

Reliability of Improved Thermite Welds

Final Report for High-Speed Rail IDEA Project 41

Prepared by:
Frederick V. Lawrence
Eric T. Ross
Christopher P. L. Barkan
University of Illinois at Urbana Champaign

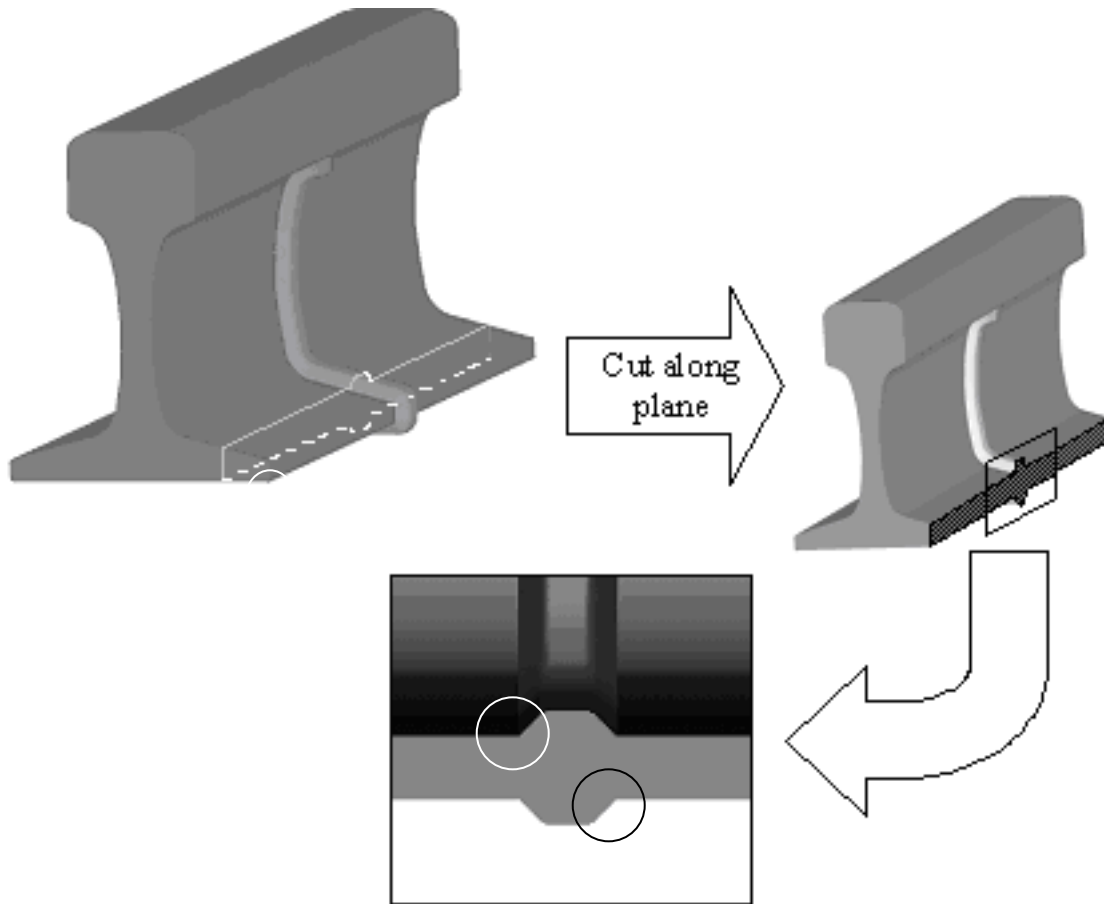
FIGURE 1 The thermite rail-weld weld-toe. Section of a thermite weld in the rail base. The circled regions are at weld-toes.

A previous concept-exploration project funded by the High-Speed Rail IDEA program (HSR-24) determined that thermite-weld fatigue resistance can be significantly increased by improving the shape of the weld-toe in the web-base fillet and rail base regions of the weld and by suppressing common weld-toe defects found there (FIGURES 1 and 2).

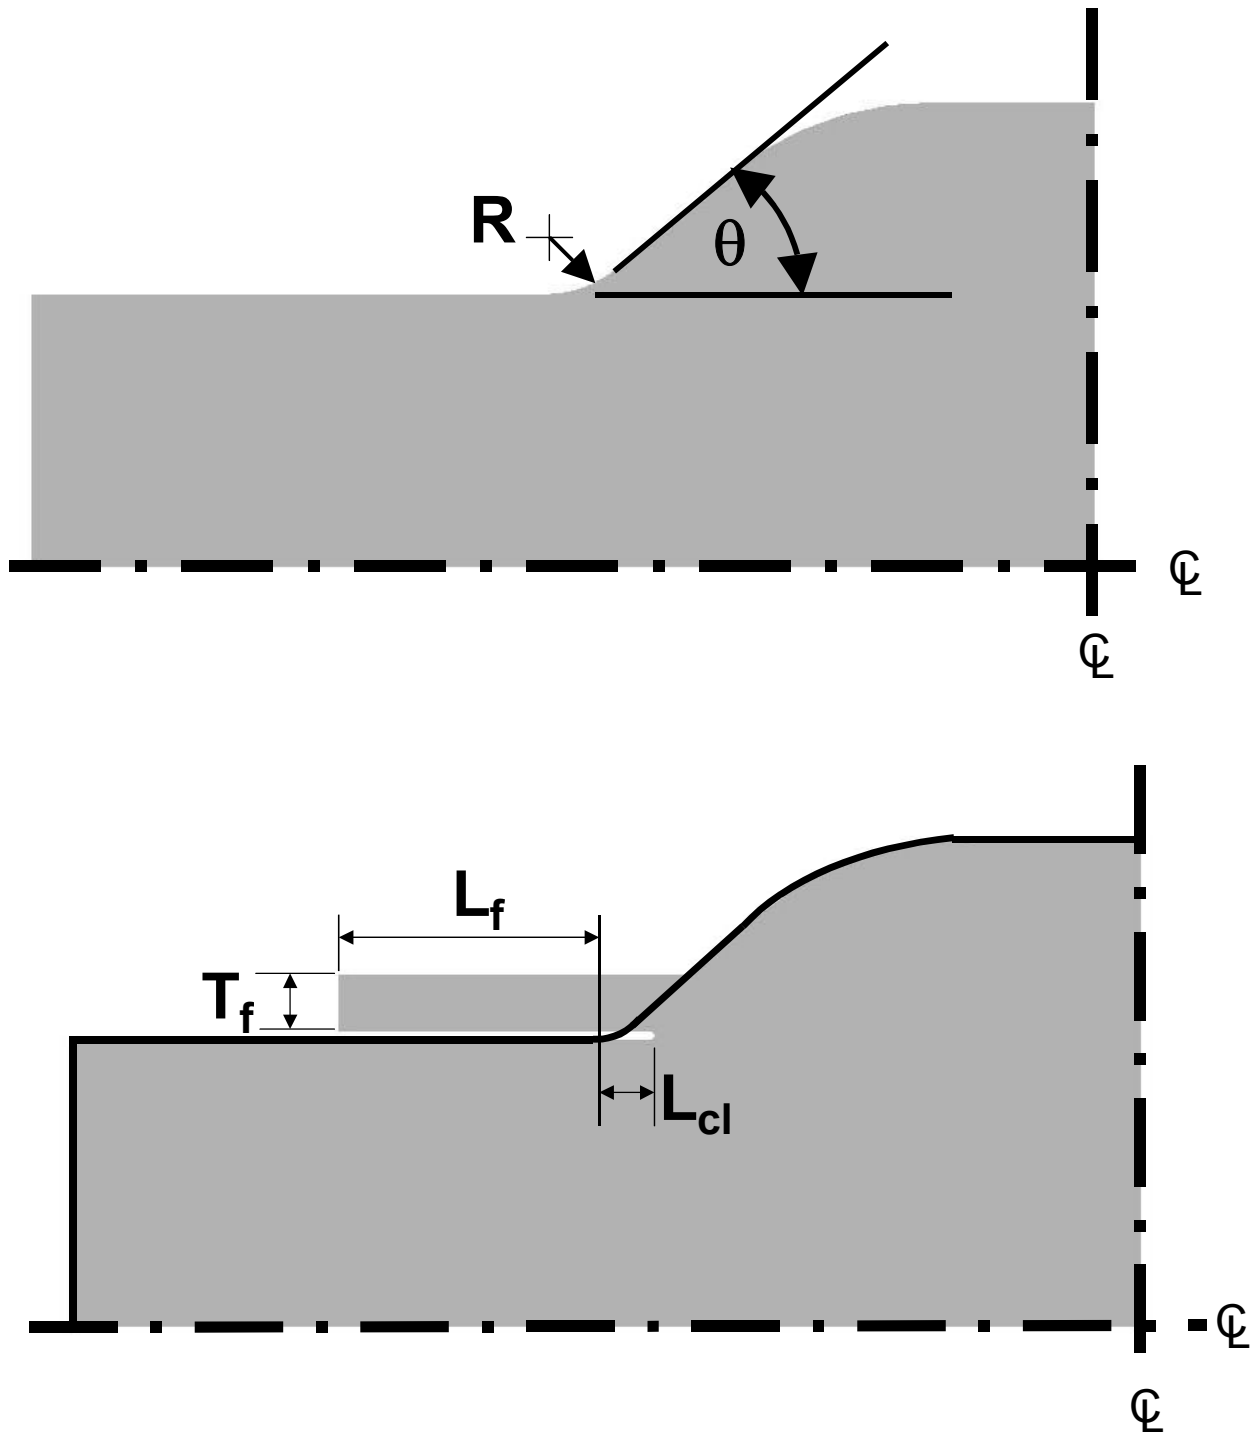
FIGURE 2 (above) Geometry of a thermite weld-toe without fins or cold laps: R is the weld toe radius and θ is the flank angle. (below) Geometry of a thermite weld-toe with both a fin and cold lap defect: T_f is the fin thickness, L_f is the fin length and L_{cl} is the cold lap length. All measurements originate at the point of tangency between the weld reinforcement and the rail. The solid outline indicates the defect-free geometry.

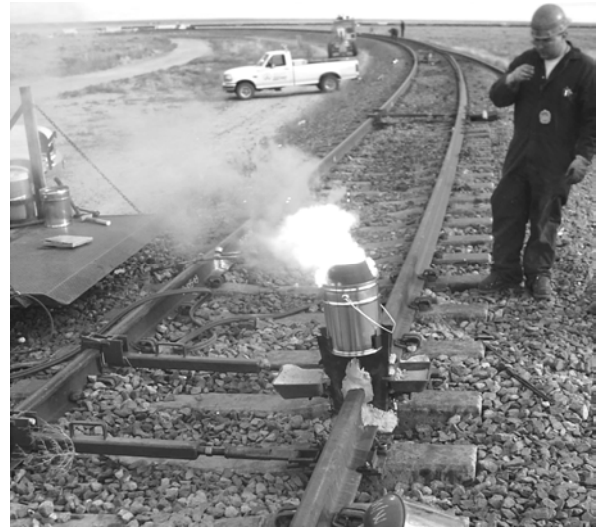
FIGURE 4 A thermite weld being fabricated at the Transportation Technology Center Inc. at Pueblo, Colorado. The weld is being produced using a single-use crucible. Picture taken shortly after ignition of the thermite charge and prior to self-tapping.

Twenty-one (21) “improved” welds similar to Series D and E were installed in curved sections of the TTCI FAST track facility in Pueblo Colorado (FIGURE 4). Five of the 21 welds failed at an unacceptably short fatigue life (<30 mgt); and to avoid further difficulties, all 21 welds were removed from the track. It is possible that the state of stress in the FAST track is characteristic of over-balanced curves and causes different regions of the weld to be more highly stressed than in this study’s laboratory 4-point bending tests. A small fabrication fault found in the web of all the improved welds - in a region remote from the improved regions in the base - caused the premature failures. The small

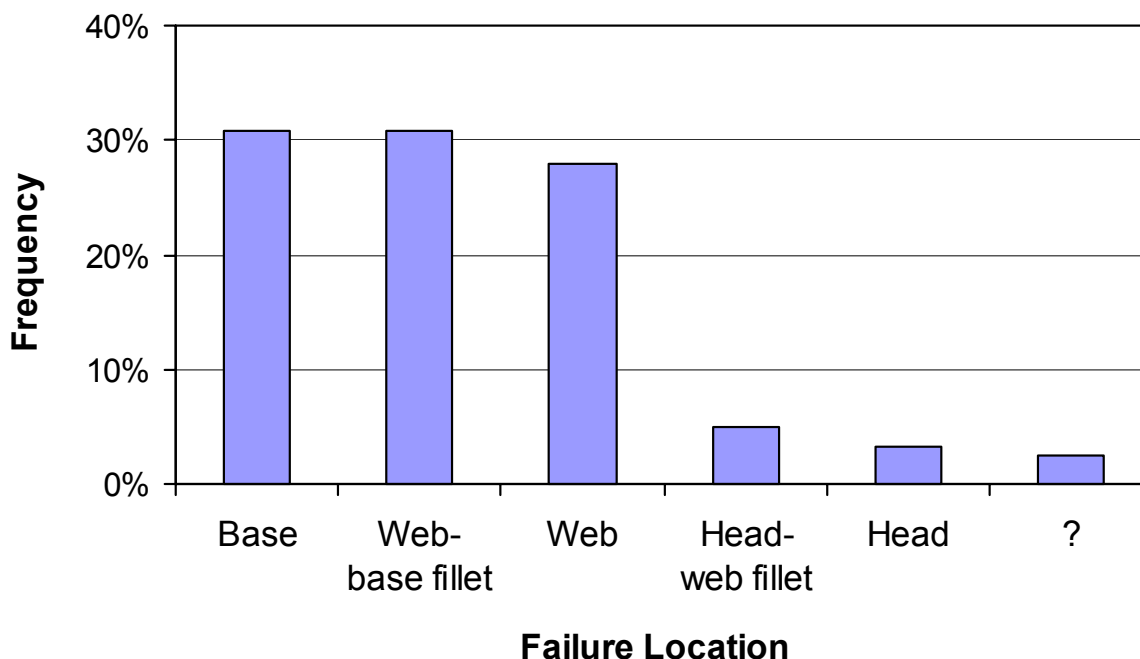
FIGURE 6 Histogram of failure locations for 244 service failures reported by a Class I rail-road to have been caused by thermite welds. [1, 5].

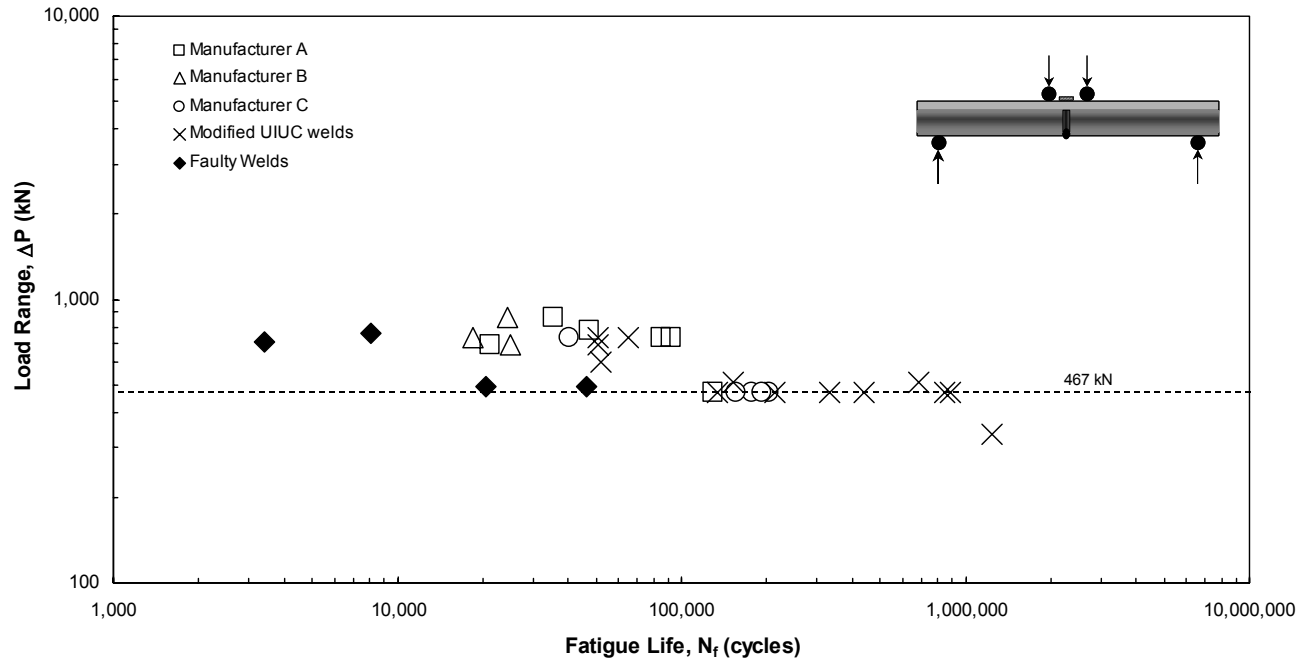
FIGURE 8 HSR-24 study fatigue test results [1]. Manufacturers A-C indicate standard welds from three different companies that chose to participate in the pilot study, all of which are comparable to Series A of the present study.

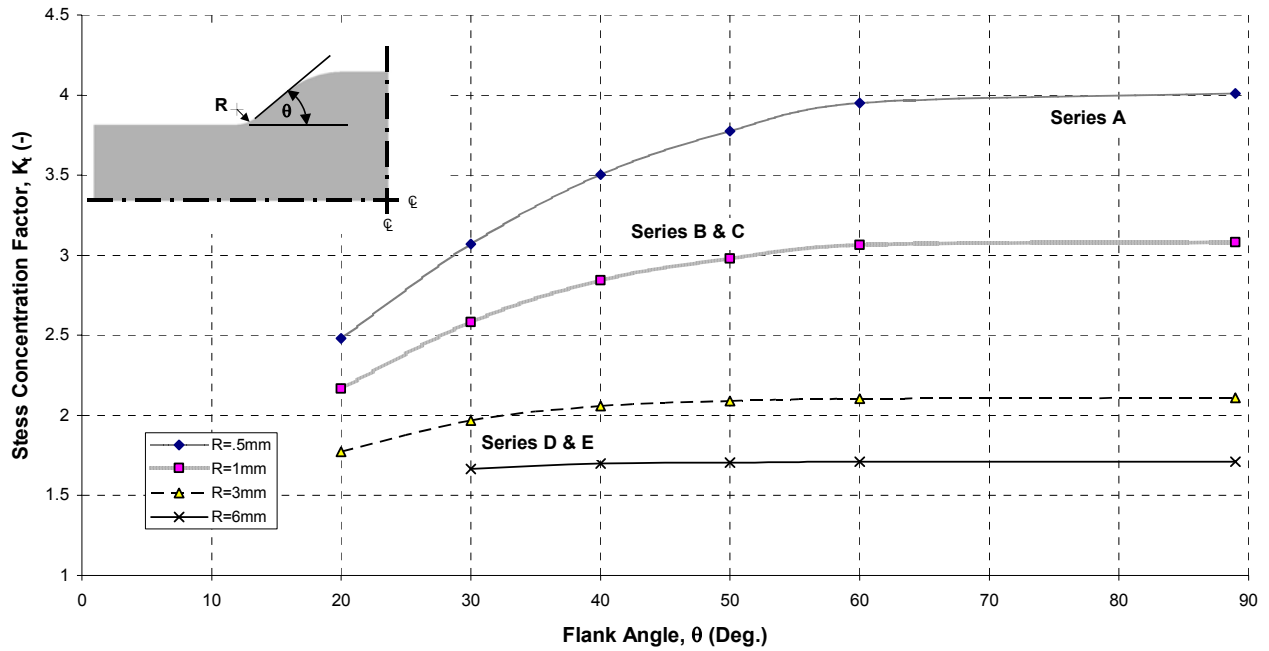
FIGURE 12 FEM predictions for the effect of flank angle and weld-toe radius on the stresses at the outer surface of the weld toe – the elastic stress concentration factor, K_t . Surface roughness effects are not considered [8].

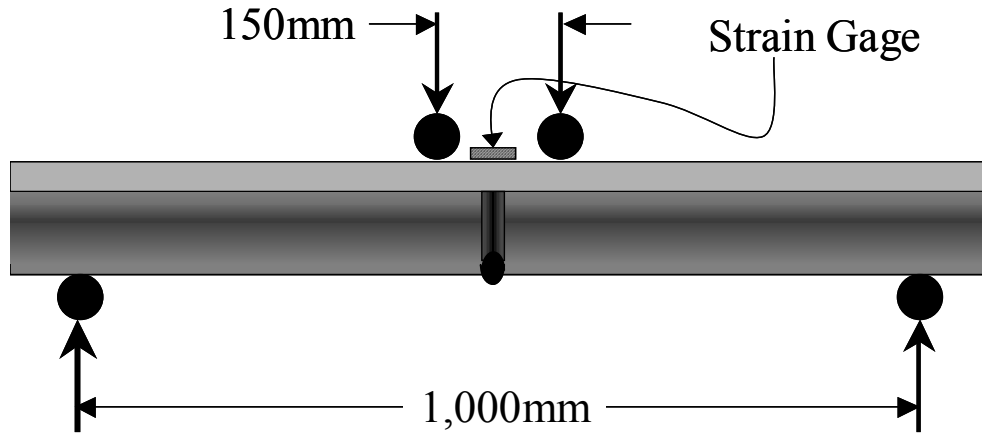
FIGURE 13 Schematic and dimensions of the 4-point bend test fixture used for fatigue testing. Due to the small separation of the points of load application, the stress state is in-between that of a true 4-point bend test and a 3-point bend test.

Fatigue testing was carried out using the industry-standard 4-point bending fixture, shown schematically in FIGURE 13. The servo-hydraulic load frame used is rated at 2,600 kN and in all tests applied a sine wave cyclic load at a frequency of 2 Hz under load control. A minimum load of 22.4 kN was used in all tests. After a few initial tests at various load ranges, one maximum load of 650 kN was utilized for all remaining tests. Thus, the load range for nearly all tests was 628 kN. This load is equal to 148 kips and is about 6 times greater than the wheel load of a 100 ton car (25 kips). A strain gage (FIGURE 13) was affixed to each weldment to check the applied loads. The strain readings were generally slightly lower than the strain range calculated for the section of the rail, presumably because the weld reinforcement locally increased the moment of inertia above that assumed in the calculations.

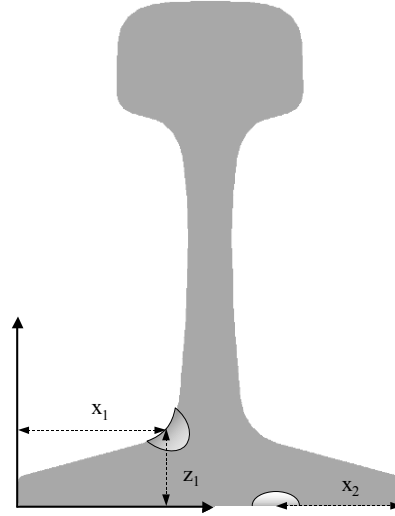
FIGURE 14 Measurement of the fatigue crack initiation sites. The origin of the coordinate system is the bottom corner of the rail base. Measurements are always taken from the corner nearer the fatigue crack initiation site. Two common locations are shown: site 1 is in the web-base fillet and is located at $(x=x_1, z=z_1)$ and site 2 is in the base and is located at $(x=x_2, z=0)$.

The location of the crack initiation site was measured on the fracture surface using the coordinate system shown in FIGURE 14. Then each fracture surface was longitudinally sectioned through the fatigue crack initiation site to determine the fin size, the plane of fatigue crack initiation relative to the weld-toe and the location of the line-of-fusion relative to the weld-toe. FIGURE 15 shows a section taken longitudinally through a typical crack initiation site and indicates the measured quantities. All measurements were made using the weld centerline as the origin of coordinates.

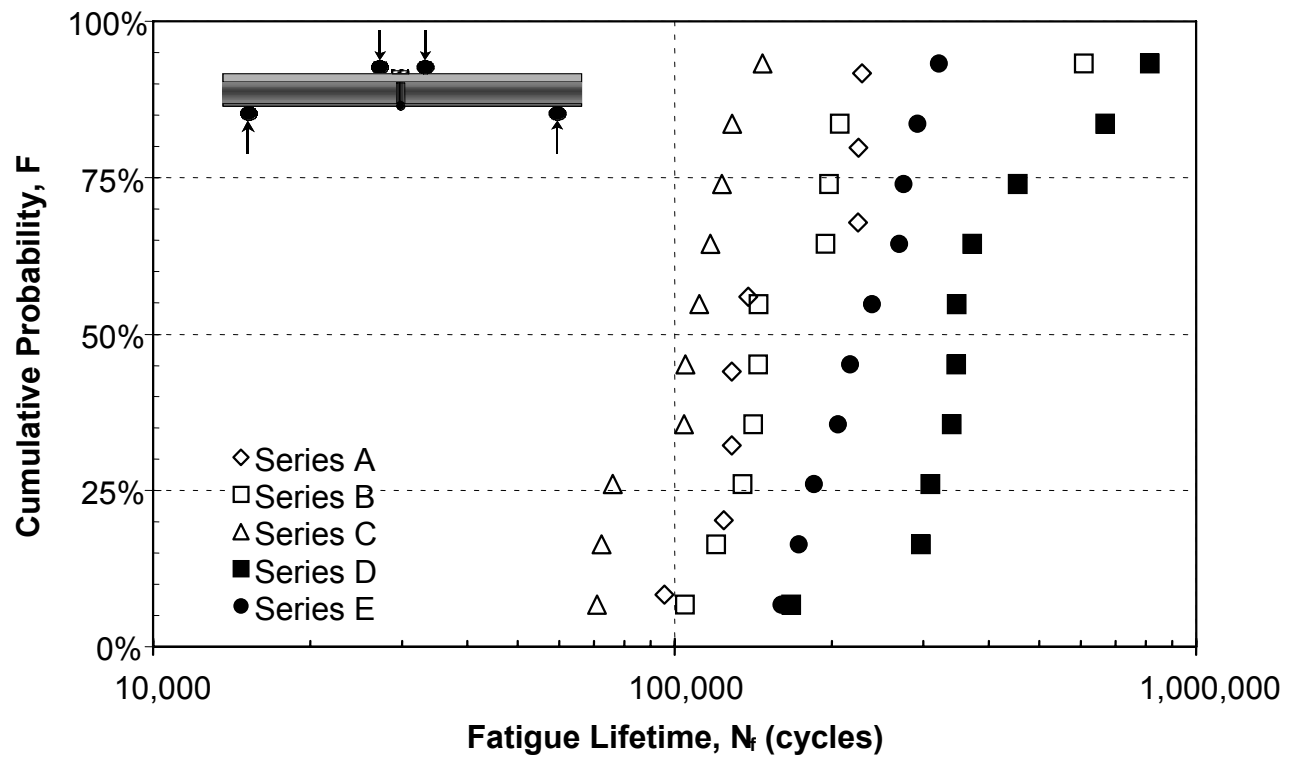
FIGURE 16 Cumulative probability distribution of fatigue lives of all welds of the five series tested at a load range, $\Delta P = 628$ kN.

The experimental results for Series A-E are summarized in Table 2, which lists the fatigue lives of each specimen, the location of failure, and the nature and size of any fin present at the site of crack initiation. FIGURE 16 is a plot of the cumulative probability distribution of failure for the five test series as a function of fatigue life. The probability of failure

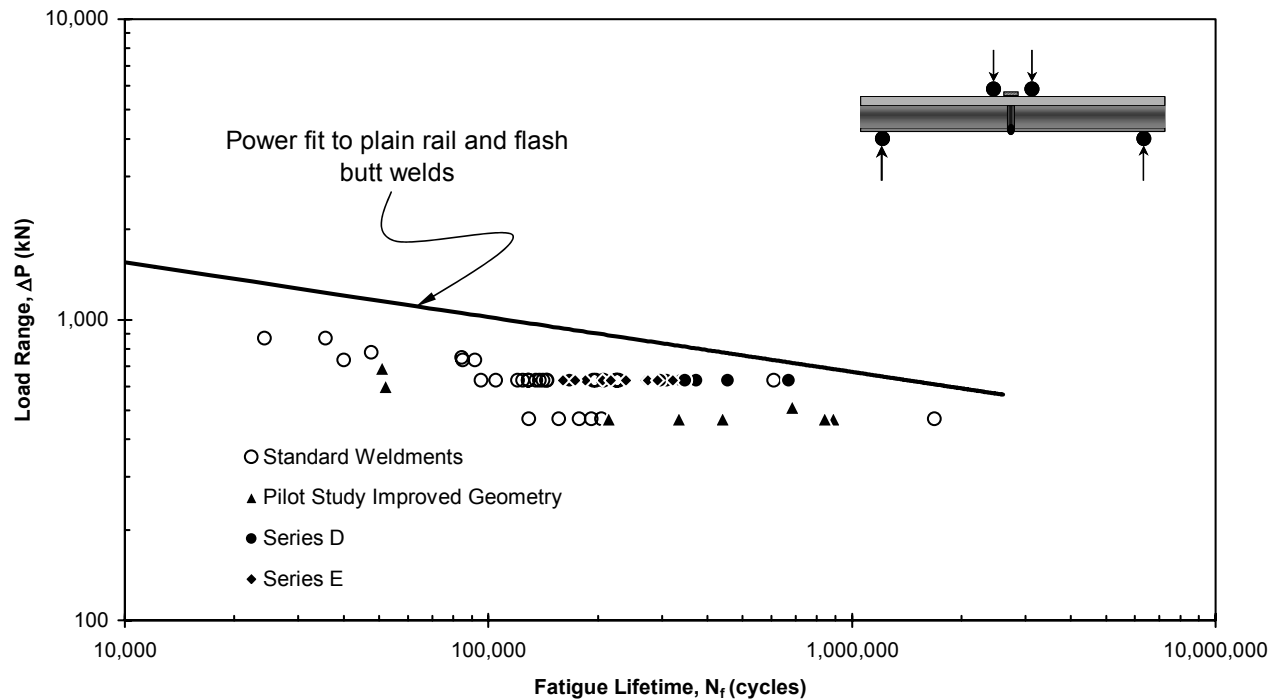
FIGURE 17 Fatigue performance of standard (production) thermite welds and improved geometry welds. Data for pilot study standard and improved geometry welds from [1, 2] and plain rail and flash-butt welds taken from [3, 4].

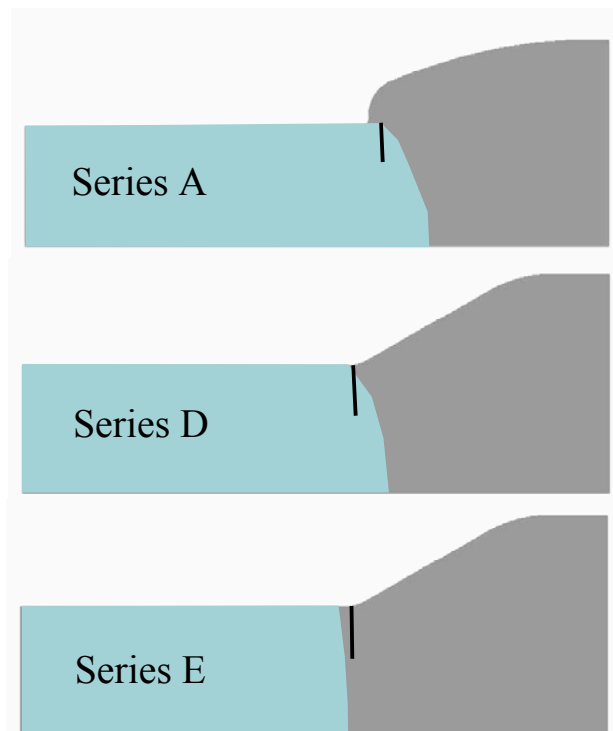
FIGURE 20 Schematic (roughly to scale) drawings showing the general effects of geometry and thermal conditions in Series A, D and E. The dark shaded region is weld metal. In Series E fatigue cracks may have both initiated and grown in weld metal.

- **Differences in material properties** - The wider weld gap of Series E resulted in a greater heat input and presumably greater melt back. FIGURE 20 shows the observed effect of the various thermal conditions on the position of the line of fusion relative to the weld toe in Series A, D, and E. The line of fusion is nearly vertical in Series E weldments, and this may frequently result in fatigue cracks both initiating and growing to failure in weld metal. However as Tables 2d and 2e show the frequency of HAZ and weld metal involvement was the same in both series. Both Rockwell hardness (HRC) and Vickers hardness were measured in the sites of crack initiation but no large difference was found between the sites initiating cracks in Series D and E. Results from a study in progress [10] indicate that there is probably little difference in hardness between the HAZ close to the line of fusion and weld metal close to the line of fusion FIGURE 21; also, rotating bending specimen fatigue tests on smooth specimens of these materials taken from the rail base of similar thermite welds [10] indicate that the HAZ and weld metal near the line of fusion may have about the same fatigue resistance; but weld metal from the near the weld centerline has a significantly lower fatigue resistance (FIGURE 22).

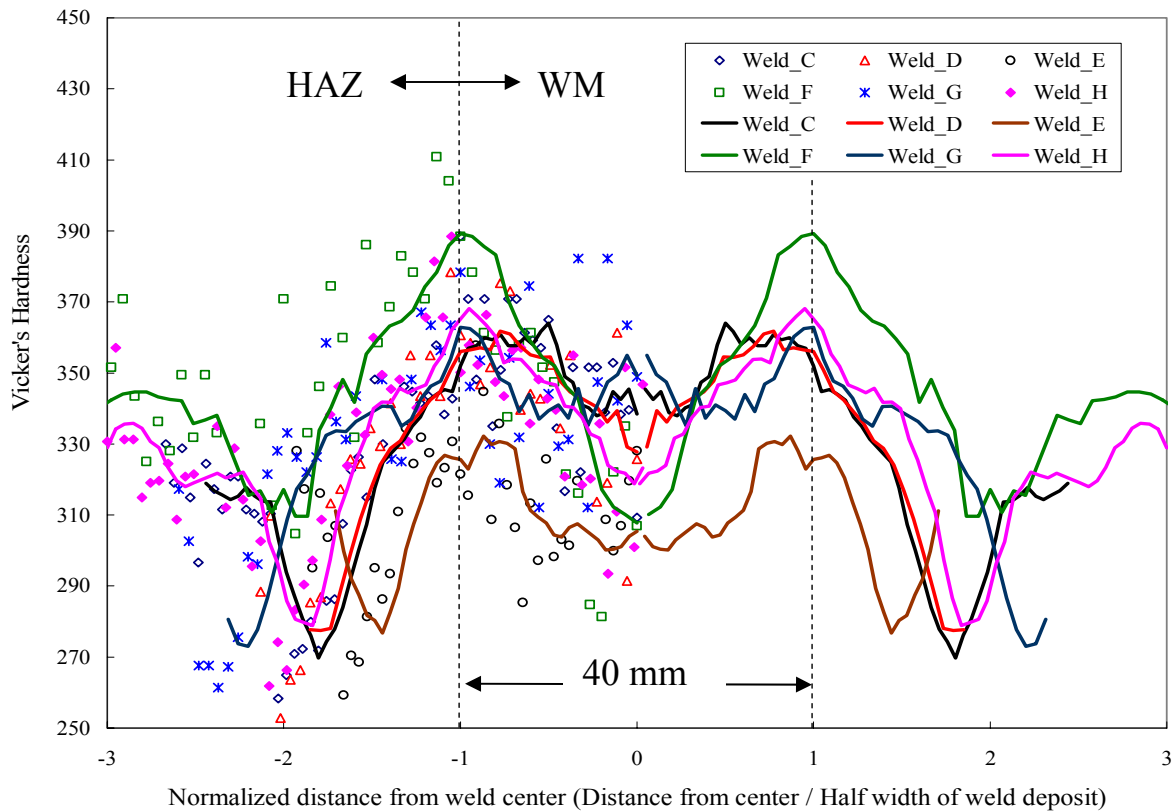
FIGURE 21 Vickers hardness measurements just below the toe of several standard thermite welds. The coordinate -1 is the line of fusion [10]. Note a peak in hardness at the line of fusion. HAZ and WM near the line of fusion appear to have about the same levels of Vickers micro-hardness.

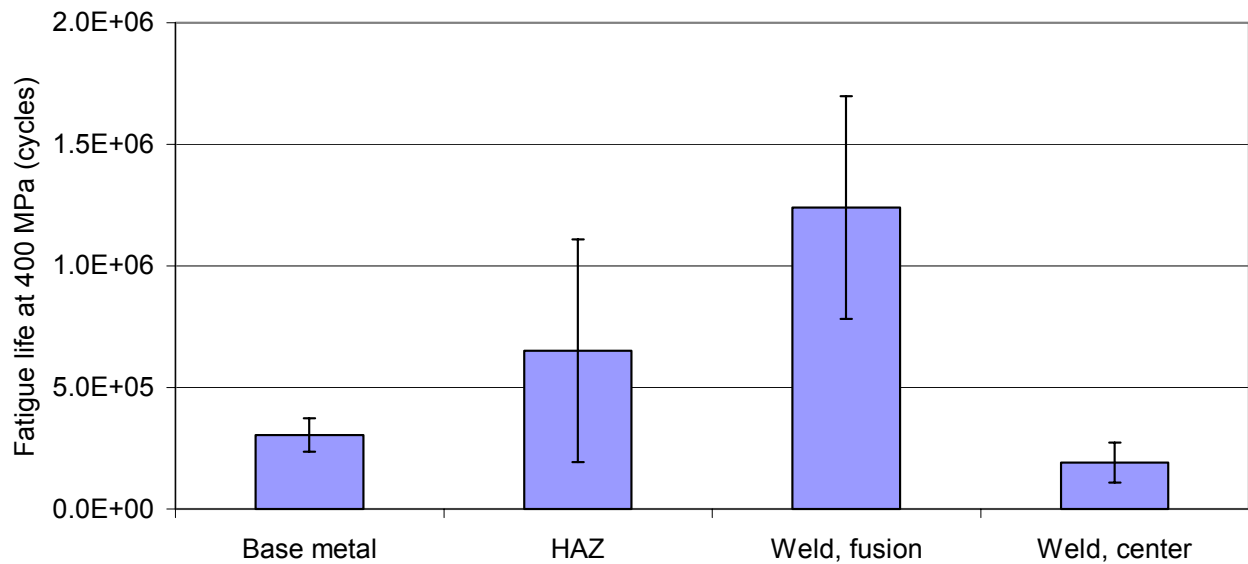
FIGURE 22 Rotating bending fatigue results for base metal, HAZ near the line of fusion, weld metal near the line of fusion, and weld metal near the weld centerline. Specimens taken from base of standard thermite weld [10].

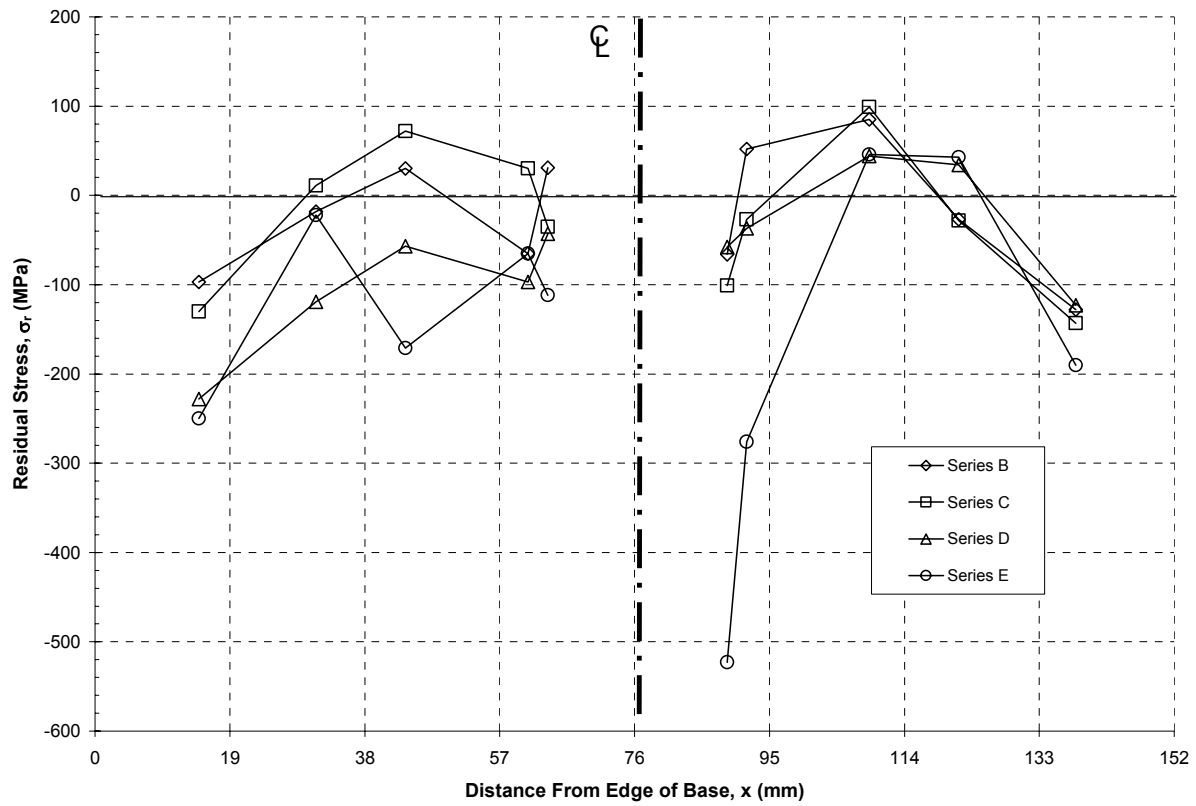
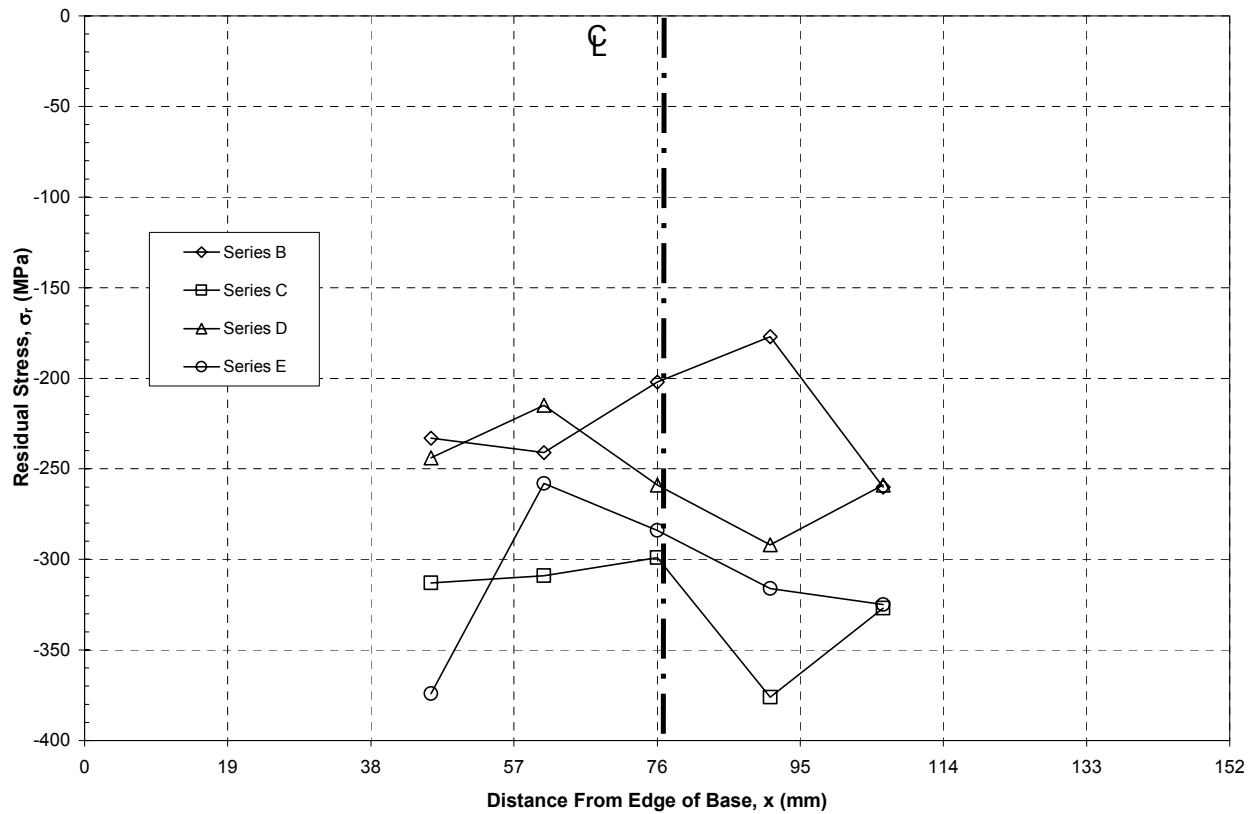
FIGURE 23 Residual stresses measured at the welds toes in the fillet and base of Series B, C, D and E weldments using X-ray diffraction. (above) Right and left fillets. (below) Base of weld near the center line.

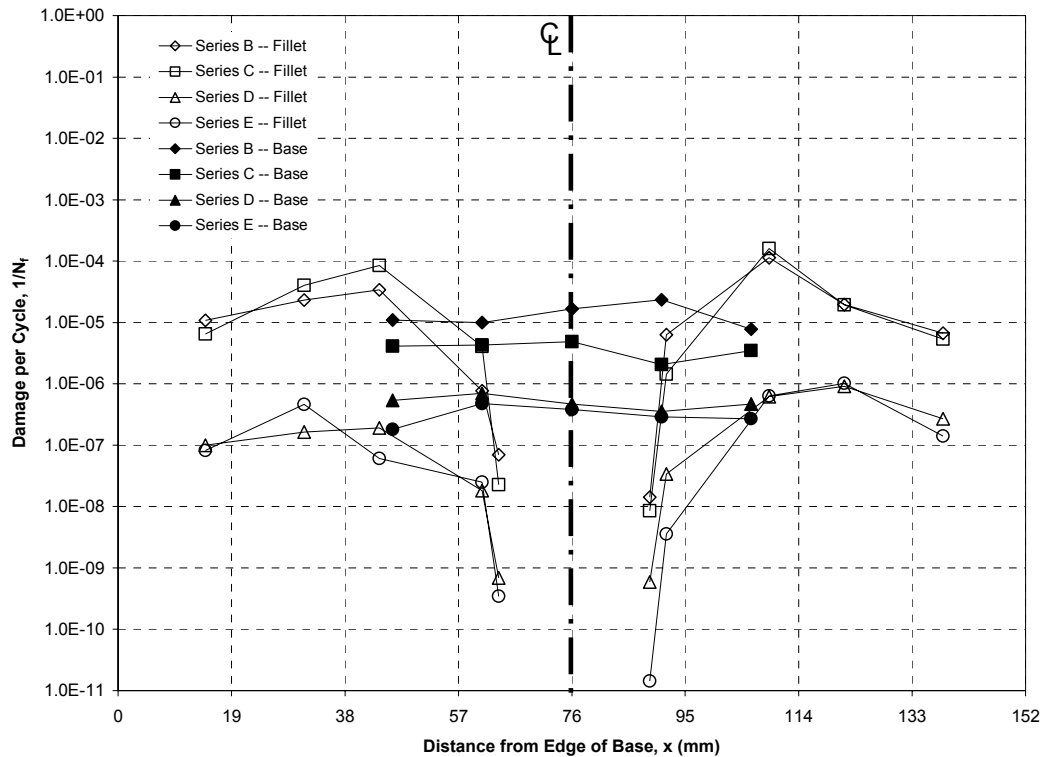
FIGURE 24 Estimated fatigue damage per cycle at the weld toes in the fillet and base of Series B, C, D, and E weldments. Highest values would give the shortest fatigue lives.

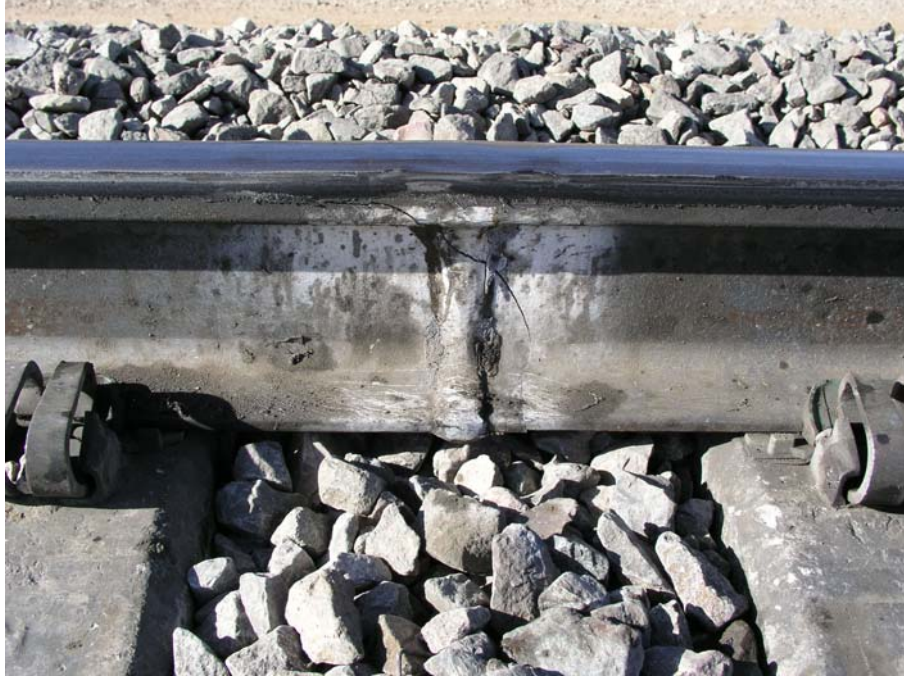
FIGURE 25 Photograph of one of 4 improved welds that failed shortly after the beginning of testing at the TTCI FAST test facility [4].

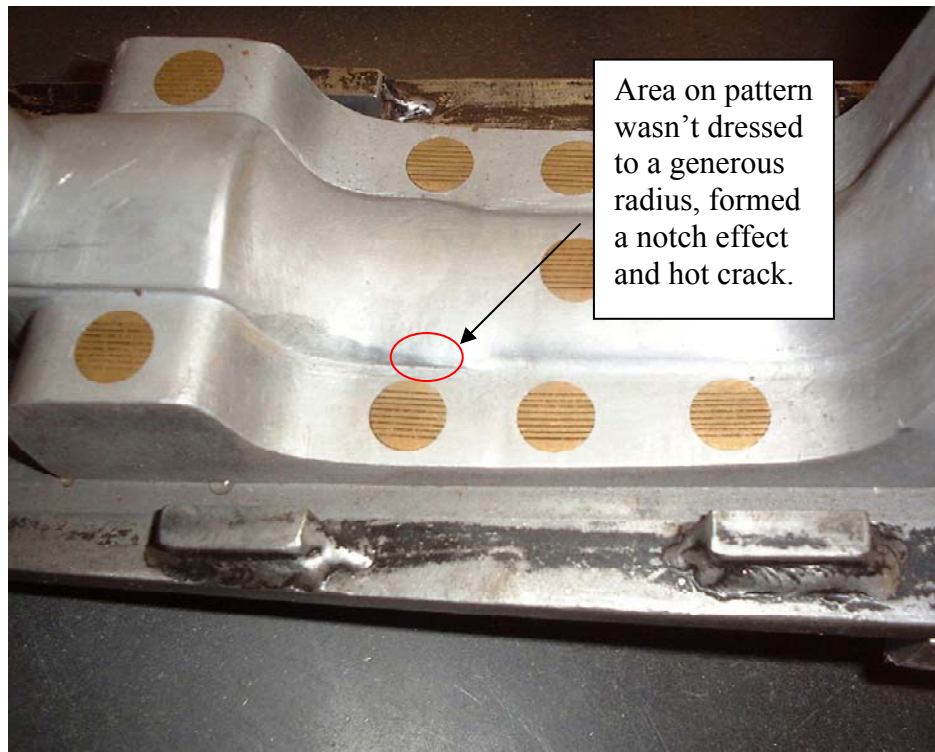
FIGURE 26 Weld mold pattern as modified by the investigators to produce the improved welds of Series D and E. Indicated weld toe region in web is approximately the location of the web failure observed in FIGURE 22. Area on pattern that was not dressed to a generous radius formed a notch and a hot crack. [11].
