Contract NCHRP-92-ID003

**SPRAYED ZINC GALVANIC
ANODE FOR CORROSION PROTECTION
OF MARINE SUBSTRUCTURE
REINFORCED CONCRETE**

Alberto A. Sagüés
University of South Florida
Rodney G. Powers
Florida Department of Transportation

**FIELD PERFORMANCE MONITORING
OF HOWARD-FRANKLAND BRIDGE**

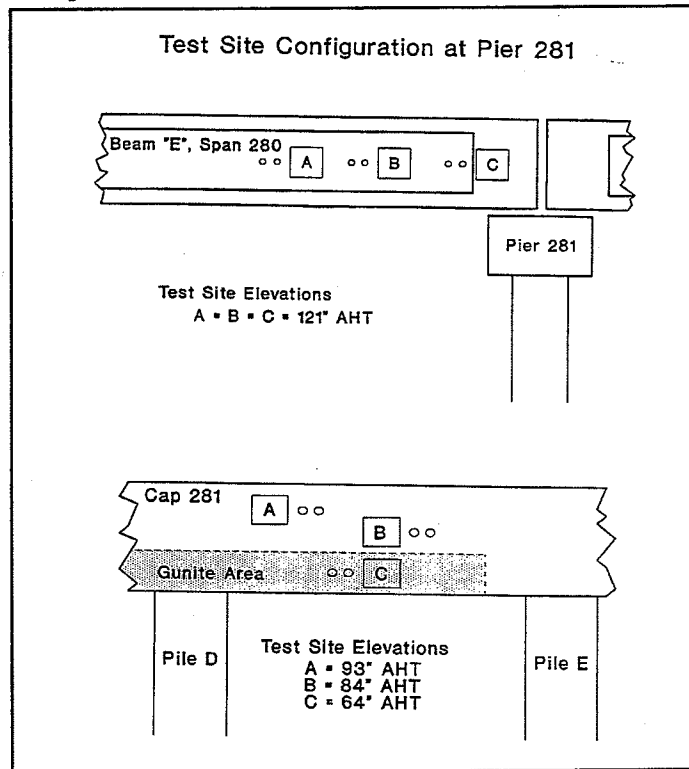
FIGURE 2 Test site configurations, Pier 281. The squares denote anode test windows; small circles denote location of rebar test probes. Elevations indicated are above high tide (AHT) level.

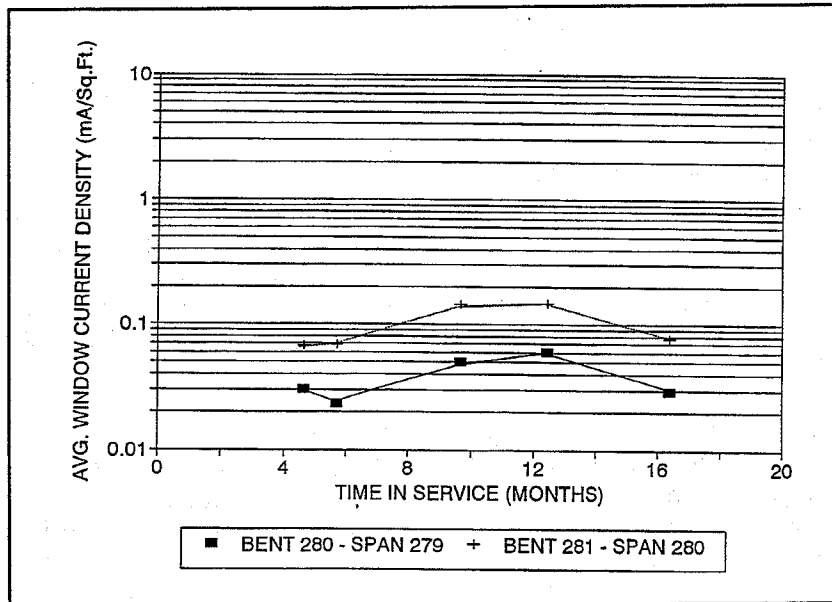
FIGURE 6 Average current densities of test windows at each pier beam as a function of time in service of anodes (1 mA/ft² = 1.09 μA/cm²).

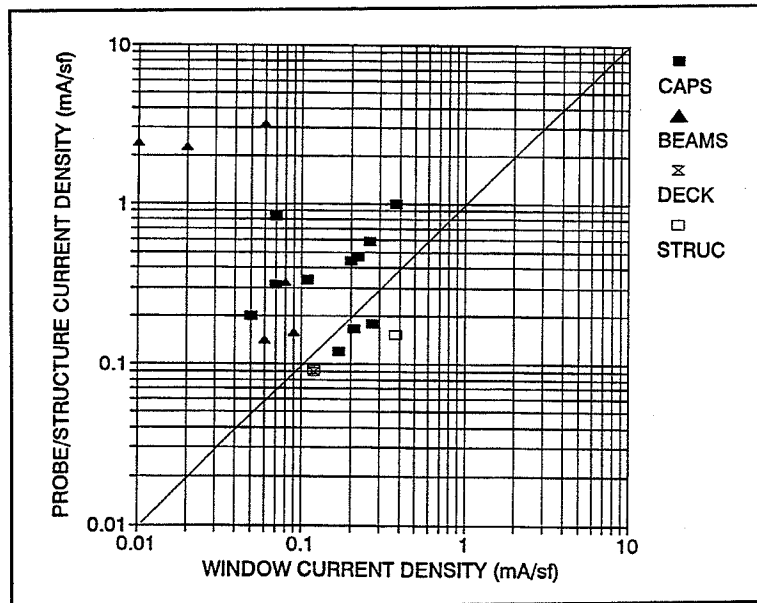
FIGURE 8 Comparison between current density of each zinc anode window and current density of corresponding adjacent rebar probe. Results for pier caps, beams, and deck locations are grouped separately. Average steel current densities for entire anode/structure locations in Bent 293 also are compared with corresponding probe current densities. Diagonal line indicates ideal 1:1 correspondence.

for the Bent 280 beam (current densities of the probes two orders of magnitude larger than those from the windows) cannot be explained at this time. Comparable discrepancies also were observed in the same three probes during previous site visits.

Figure 10 shows the polarization decay of all probes during the October 1993 test, when conditions were expected to approach those of a mature system. The probe current density is used as a parameter. Polarization decay over typical times of 20 hr exceeded 100 mV in all but one case. The results suggest some increase in the extent of polarization decay with the probe current density. The probe set with the largest average polarization decay and current densities is that of Bent 280 beam, which showed anomalous behavior in Figure 8.

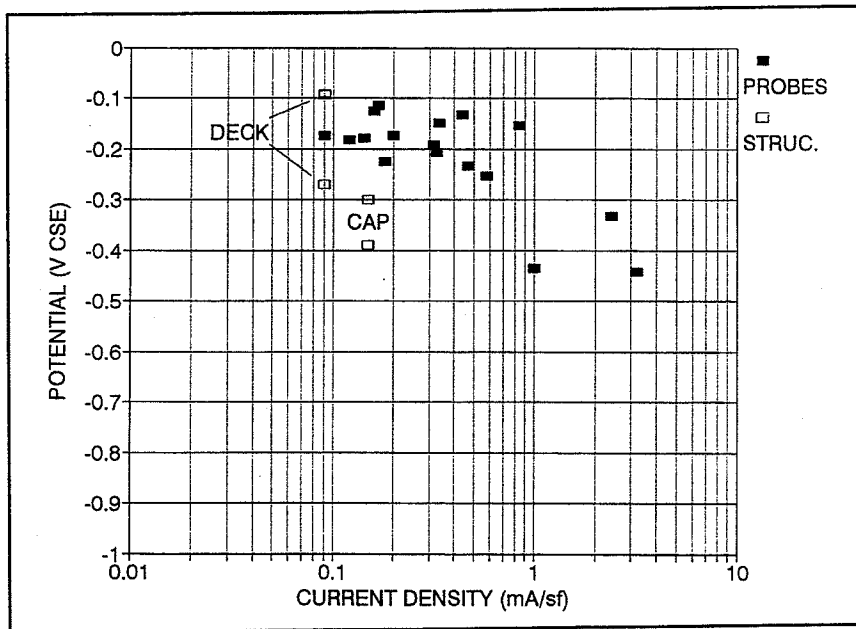
FIGURE 13 Potential of all rebar probes and structural steel elements at Pier 293 after 20-hr polarization decay as a function of steel current density just before disconnection.

Figure 13 shows the potentials for the same probes as in Figure 12, but after allowing for 20-hr polarization decay following disconnection.

Figures 12 and 13 also show the potential-current density locus before and after polarization decay for the Bent 293 cap and deck structure elements. The cap showed instant-off potentials that were among the most negative recorded with the probes. The depolarized cap structure potentials were well within the range of values commonly associated with active steel. In contrast, the deck showed much nobler potentials both before and after polarization decay, suggesting a generally passive condition.
