***In-Service Repair of Highway Bridges and
Pavements by Internal Time-Release Repair
Chemicals***

Final Report for Highway IDEA Project 37

Prepared by:
Carolyn Dry, University of Illinois, Urbana-Champaign, IL

August 2001

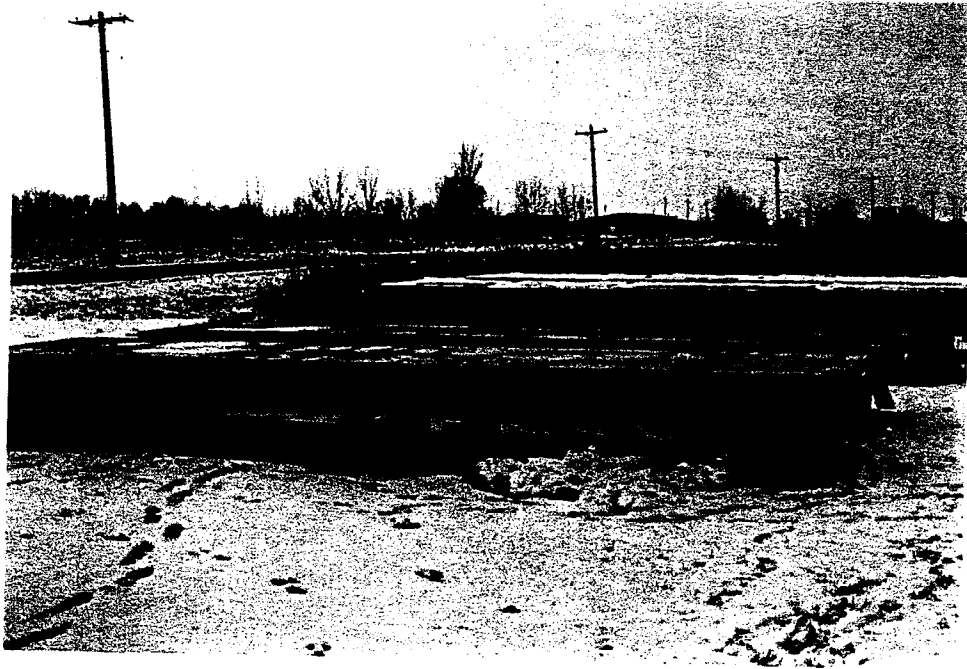
Figure 1) Photo of the four full scale bridge decks which were fabricated at ATREL Laboratory of the University of Illinois

Four full-scale bridge decks have been fabricated, with repair-sealant tubes embedded at various locations as seen in figure 1. Potential construction problems such as premature release during mixing, difficulty in finishing as well as temperature effects overtime were found not to be problems. Monitoring systems were also placed, including optical fibers, ETDR cables, and connection of reinforcing bars for corrosion monitoring.

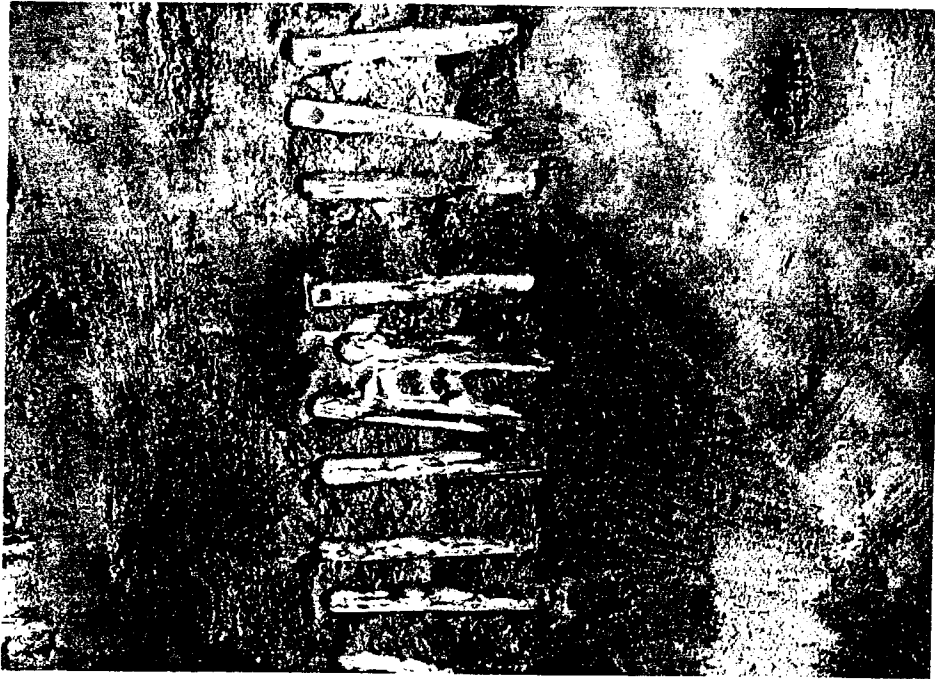
Figure 3) Photo showing the adhesives which stayed fluid in the tubes

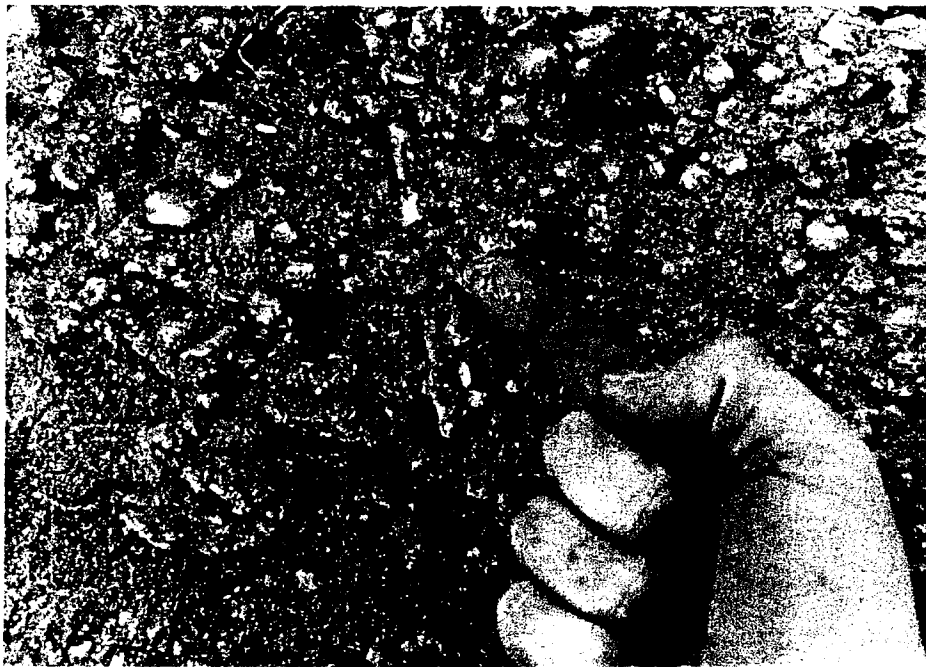
Figure 4) Photo showing the 2 ½" long fibers in the concrete , all of which survived the mixing.

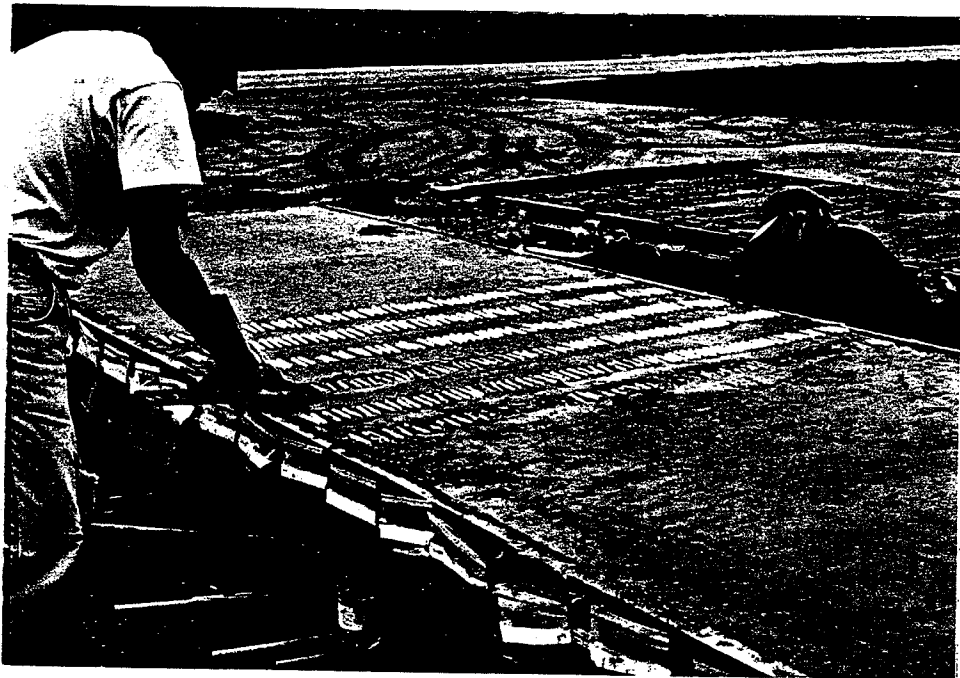
Figure6) A photo of the tubes embedded at the top surface of the deck.

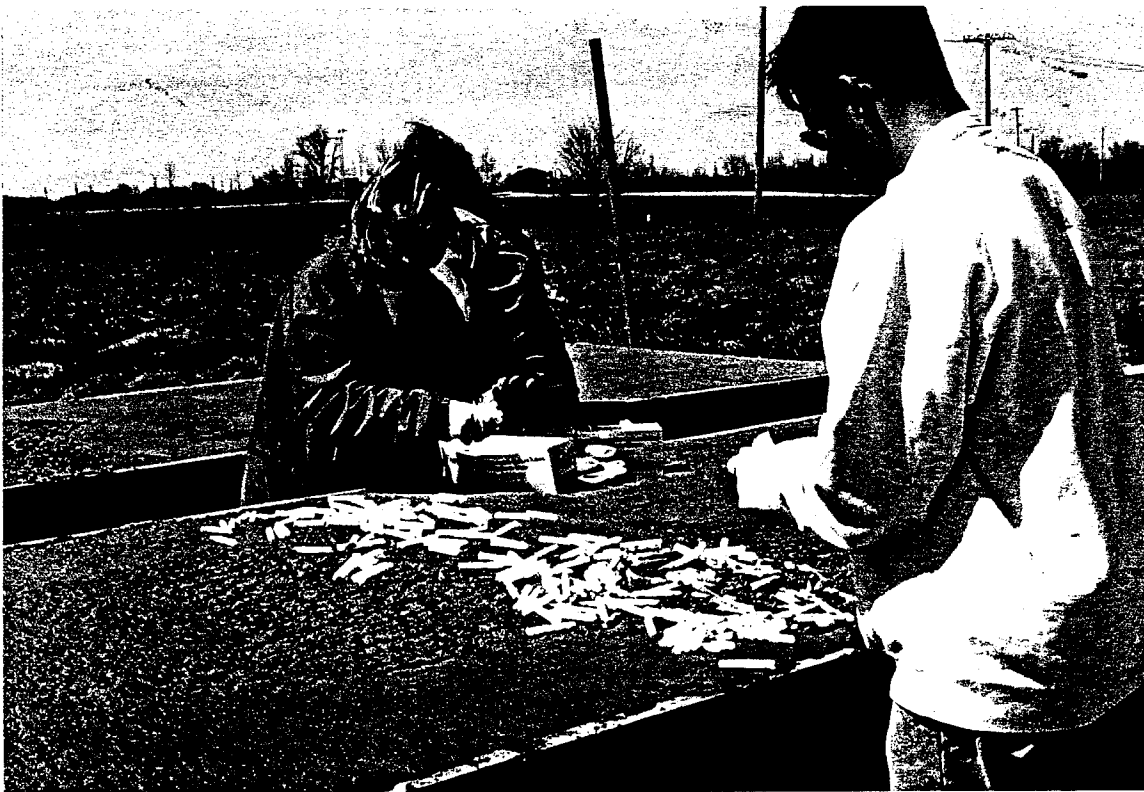
Figure 15) A photo of VOC filled tubes ready to be pushed onto the interior of decks 3 and 4 to repair shear cracks

These two additional bridge decks were fabricated on a windy, sunny, 60deg. F April afternoon in 1998. Decks 3 and 4 were composite with W16x26 beams and had 1/2" shear studs placed every 12" (see figure 11). VOC and Rotile adhesive filled glass tubes were embedded in the surface along the top and bottom of the deck as shown in figures 12,13,14. Also VOC filled glass tubes were embedded half way into the deck's depth at the midsection of the deck, for repair of shear cracks testing as seen in figure 15.
