Report of Investigation

IDEA PROJECT FINAL REPORT CONTRACT NO. NCHRP–94–ID038

PAINT REMOVAL FROM STEEL STRUCTURES (PHASE II)

Prepared by: Rudolf Keller EMEC Consultants

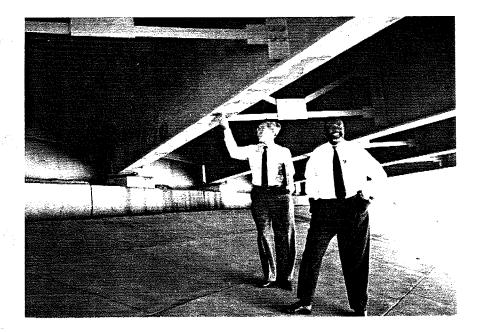
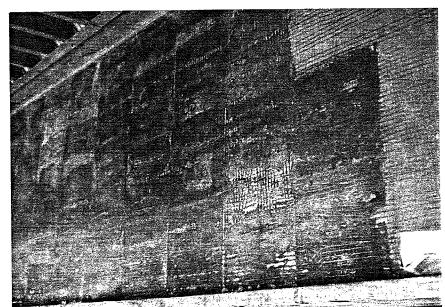
ElectroStrip [™] Demonstration
I-66 Overpass in Arlington, VA
May 1998

- <1> VDOT Structure for Demonstration
- <2> Array of ElectroPads™
- <3> John Korfiatis adding liquid
- <4> Resulting surface, not showing flash rusting
- <5> Surface after removal of pads and cleaning

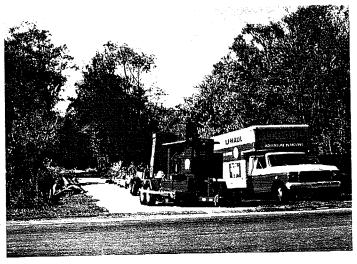
Bridge of Montour Trail near Brownsville Road, South Park, Pittsburgh, Pennsylvania

<1>	
<2>	Trail and equipment (rectifier and generator)
<3>	Surface to be treated, showing paint remnants
<4>	Washing of treated surface with Recyclean unit
<5>	Repainted bridge

Description: The object was a former railroad bridge constructed in 1929. It was heavily corroded, covered with rust and to about a fourth with remaining paint. Paint was removed and rust was transformed by the ElectroStrip[™] treatment and could be washed off. The area treated was about 500 ft². The contractor applied a three-coat paint system supplied by ICI Devoe Coatings: a penetrating sealer (Pre-Prime 167), an epoxy coating (Bar-Rust[™] 235), and an aliphatic acrylic urethane (Devthane[™] 369).
