***Long Gage-Length Interferometric Fiber-  
Optic Sensors for Damage Detection in  
Bridge Structures***

Final Report for Highway IDEA Project 58

Jeffrey A. Laman, and Karl M. Reichard, The Pennsylvania State University

*February 2002*

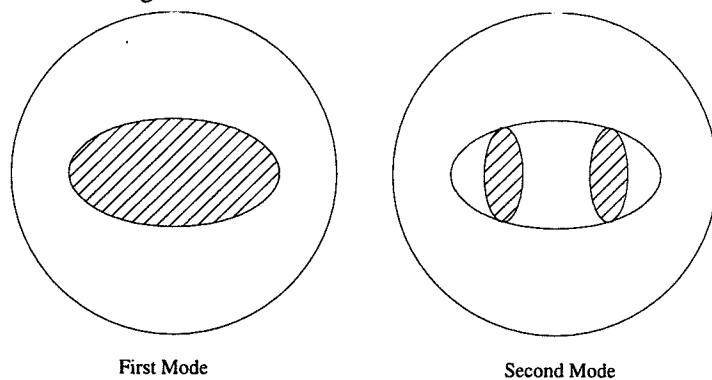
**FIGURE 2. Geometric positioning of first two modes in elliptical core fiber.**

The geometric positioning of the light modes within the elliptical core fiber provides a basis for measurement. As seen in Figure 2, the second mode is discretized in the fiber cross-section to two distinct lobes of light in the core that are opposite in phase (see Dakin and Culshaw, 1988). The two out-of-phase lobes of the second mode interfere constructively and destructively with the light of the first mode, generating a two-lobe output. As the fiber is strained, the two lobes alternate in intensity in a sinusoidal pattern. By blocking off one of the lobes, the sinusoidal variation of intensity of one of the lobes can be measured and correlated to strain, assuming that the variation of the output is between a successive peak and valley in the semi-linear output range.

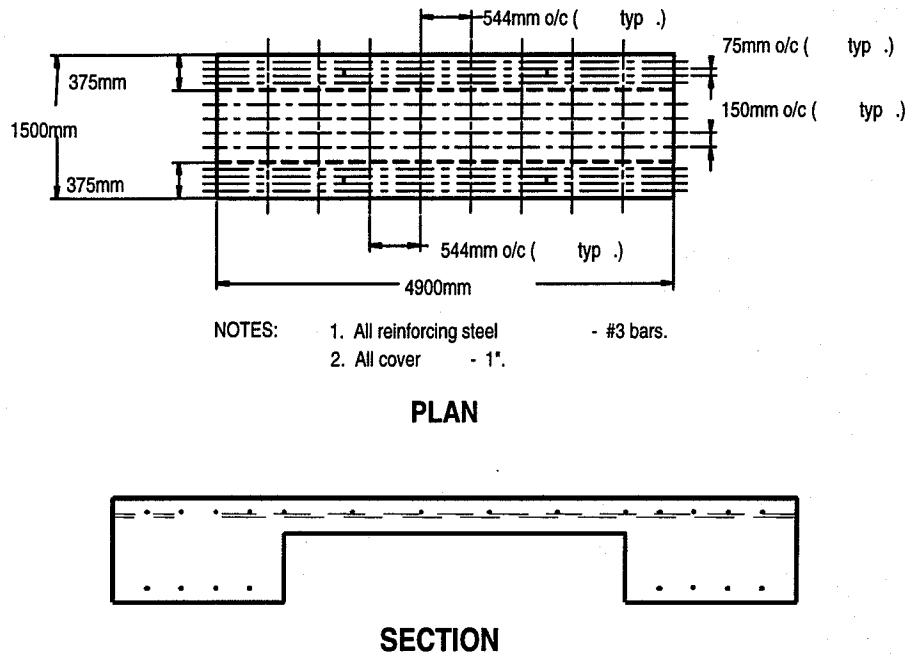
**FIGURE 12 Schematic Drawing of Laboratory Concrete Test Structure.**

The large laboratory concrete test structure design and sensor location was based on the long-gage-length characteristics of the optical sensor. The schematic design of the test structure is shown in Figure 12, indicating overall dimensions and rebar placement. The sensor location design is based on the recognition of the various mode shapes of the test structure and the integrative properties of the sensor. As shown in Figure 13, the sensor must be strategically placed to properly respond to particular modes of vibration. The seven sensors were, therefore, placed so as to respond to

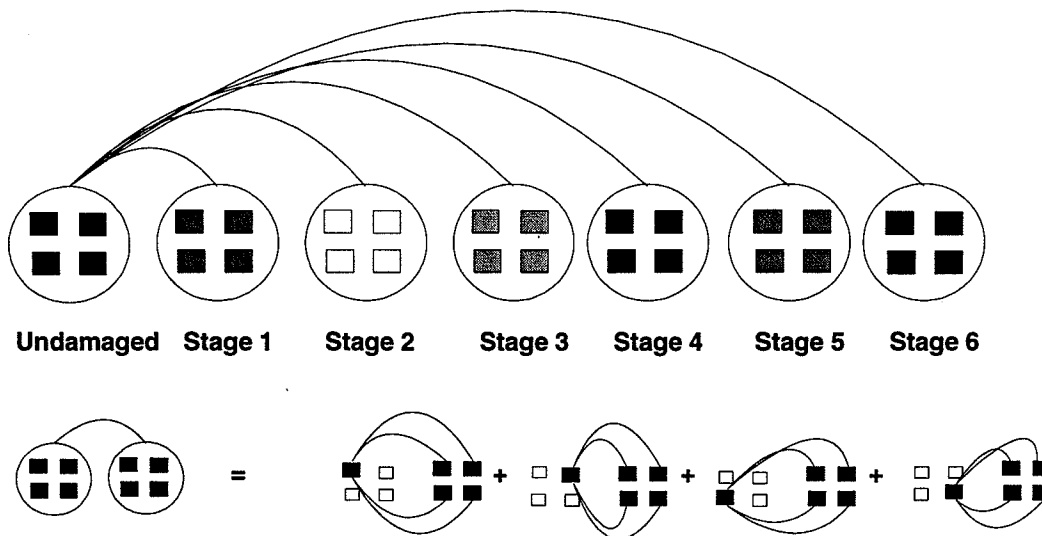
**FIGURE 27 Correlation Procedure Between Stages of Damage and Correlation of Individual Tests.**

For each case, data were taken in several sets as described previously at each stage of damage. Correlation coefficients between data from the impacts before the structure was damaged and from impacts at each stage of damage were computed. The average of these coefficients was computed, resulting in one average correlation coefficient relating the undamaged state with a stage of damage. The standard deviation of the set of correlation coefficients was also computed. Finally, the average correlation coefficient and standard deviation were computed, comparing each stage of damage with the undamaged state. See Figure 27 for a diagram of the general correlation coefficient analysis.
