**Geocomposite Capillary Barrier Drain for Limiting Moisture Changes in  
Pavement Subgrades and Base Courses**

**Final Report for NCHRP-IDEA Project 68**

**Karen S. Henry, U.S.A.C.R.R.E.L., and  
John C. Stormont, University of New Mexico**

***October 2002***

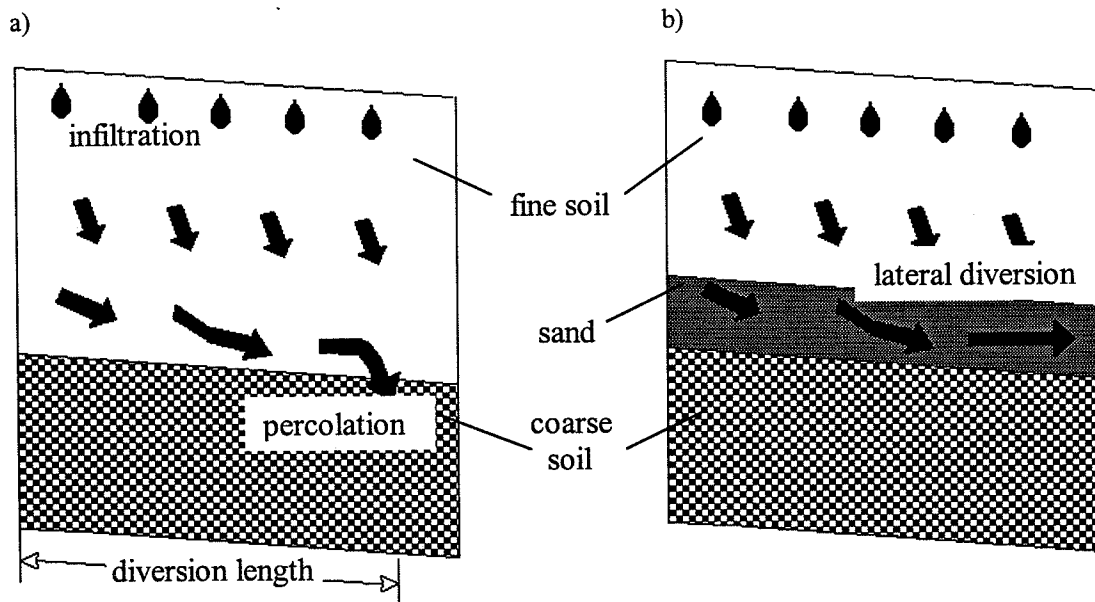
**Figure 2.** Lateral drainage in unsaturated soil with: a) a simple capillary barrier and b) capillary barrier with an overlying transport layer

Lateral drainage in unsaturated soils occurs when downward moving water encounters dipping layers of underlying coarse-pored soil (a capillary barrier). Water accumulates near the fine/coarse interface and drainage is concentrated here because the hydraulic conductivity increases with water content (Fig. 2a). The soil moisture content continually increases down dip, and the horizontal distance at which breakthrough into the lower layer occurs (at near-saturated conditions) is called the lateral diversion length. Using a 'transport layer,' such as fine sand, between the two layers significantly increases the amount of unsaturated drainage (Fig. 2b). The transport layer has hydraulic properties intermediate between the fine and coarse soil. It drains water and yet remains unsaturated for a considerable distance so as to preserve the capillary barrier.

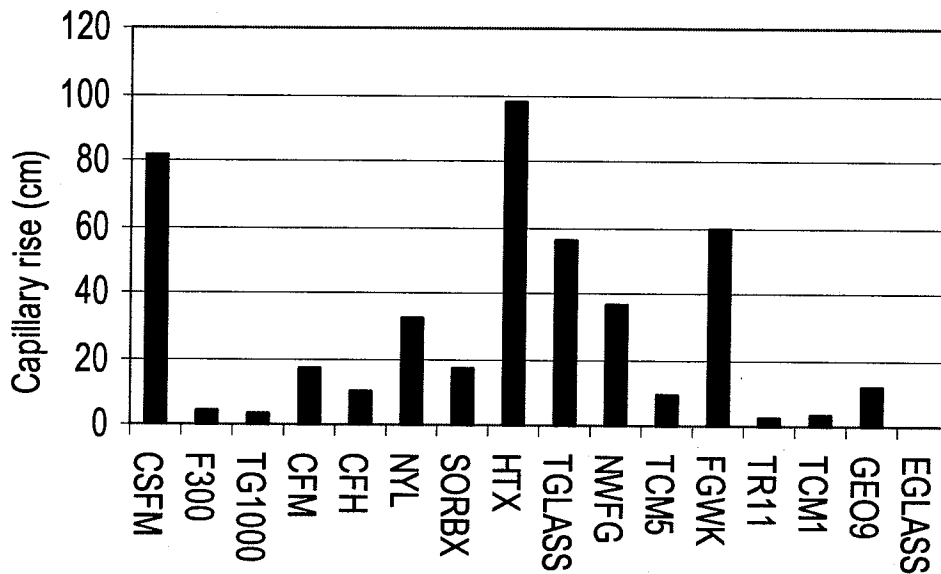
**Figure 3.** Forty-eight-hour capillary rise measurements.

Capillary rise above a free water surface provides a measure of the wetting and unsaturated transmitting behavior of a porous material. The capillary rise of water was measured in 16 materials (Fig. 3). We selected 4 materials for further evaluation based on the results, and determined their moisture retention functions: CSFM, NYL, HTX and TGLASS. Even though it had a relatively great capillary rise, the NWFG specimen was not tested further because it was too thin to serve as a transport layer. The FGWK material was only available as a rope, and thus was not further evaluated.

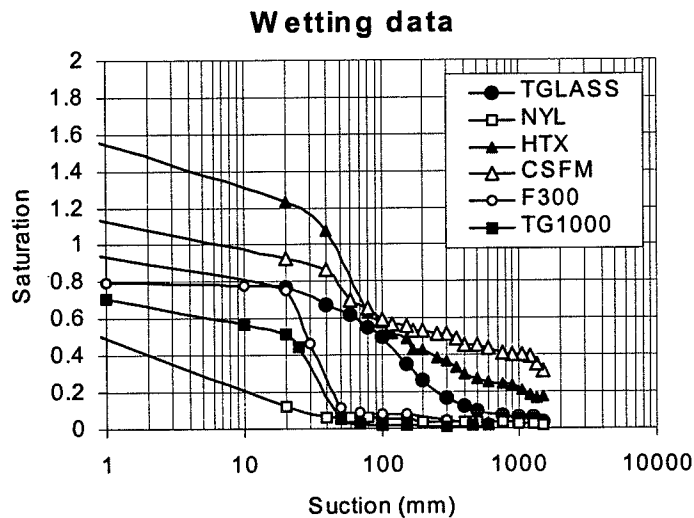
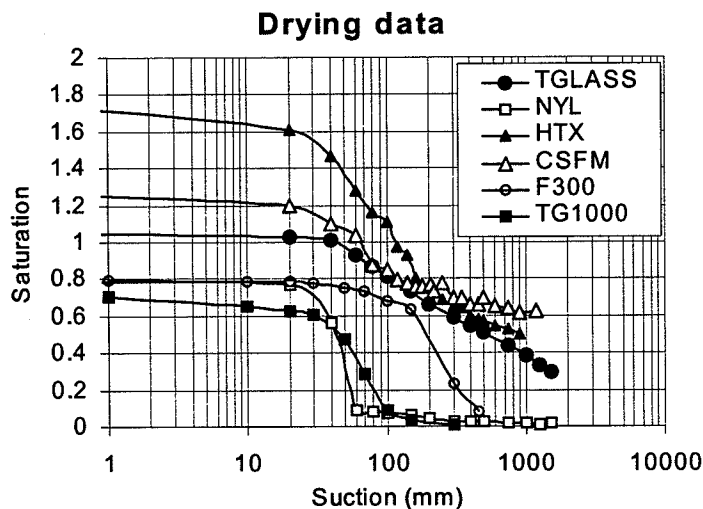
Figure 4. Moisture retention functions obtained from hanging column method for six candidate transport layer materials during wetting and drying.

The moisture retention function (or, moisture characteristic curve) describes the relationship between negative water pressures (or suctions) and water content (or saturation) of a material. We used the hanging column method to obtain these data (5). Wetting and drying paths for six materials are shown in Figure 4. In addition to the most easily wetting materials as determined by the capillary rise testing (NYL, TGLASS, HTX and CSFM), the moisture retention functions curves from two conventional geotextiles (F300 and TG1000) are given. All of the moisture retention functions are hysteretic--the materials contain more water during drying compared to wetting at the same suction.

There is a considerable difference in the moisture retention functions among the various materials. The HTX, CSFM and TGLASS materials all contained more water than the other materials at comparable suctions, whether following a wetting or drying path. (Saturations greater than 1 are believed to be a consequence of the change in sample thickness when the surcharge was placed and removed.)

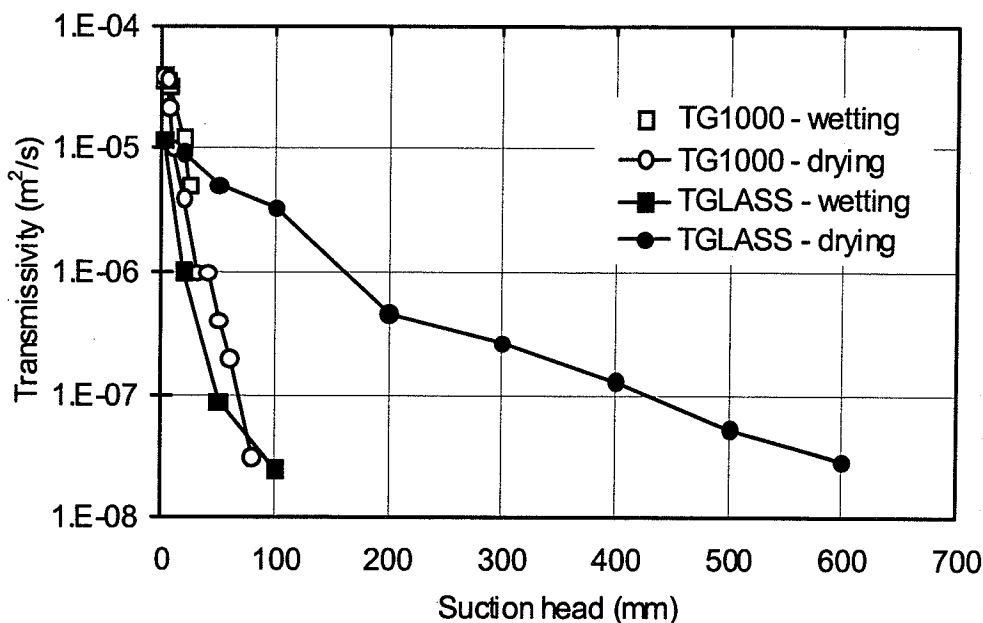
Figure 5. Transmissivity of TGLASS and polypropylene (TG1000) geotextiles using constant suction permeameter.

A siphon test was used to measure the ability of a geotextile to transmit water in-plane under suction. The HTX (silica) material was not transmissive at any suction, and thus was eliminated as a candidate transport layer. The other three materials did not become transmissive in wetting until 130 mm of suction head. At this suction, the TGLASS material conveyed approximately one order of magnitude more water than the NYL and CSFM materials. As the suctions were increased (drying), only the TGLASS remained transmissive above suction heads of 400 mm.

much more conductive at the same suction head compared to wetting, and remained measurably transmissive to 600 mm. The transmissivity under suction for a nonwoven polypropylene (TG1000) geotextile is also given. Compared to TG1000, TGLASS is significantly more transmissive over a greater range of suctions during both wetting and drying.

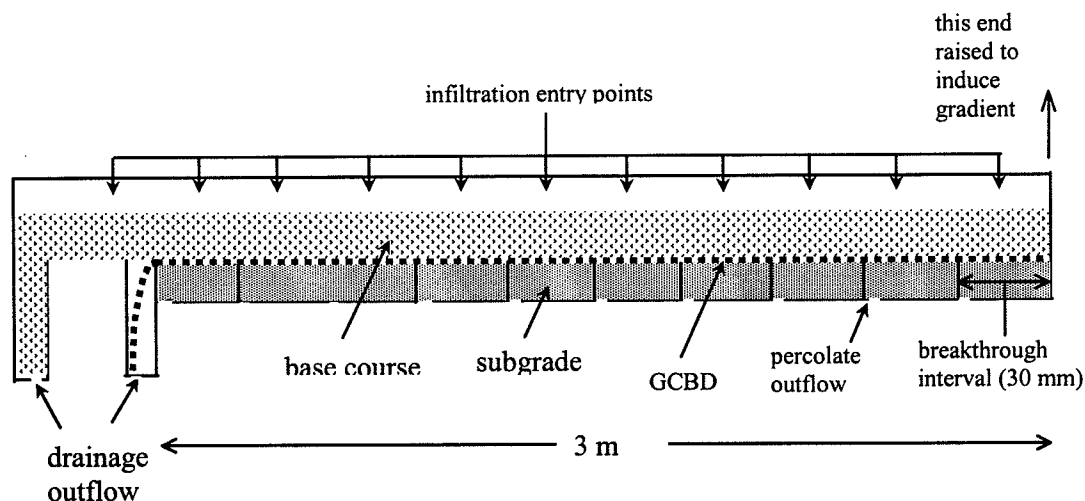
Figure 6. Lateral diversion test apparatus.

The drainage capacity of the GCB was tested in a 3-m-long box (Fig. 6) (8). The profile was 100 mm of SC subgrade, the GCB, and 150 mm of GP-GW on the surface. The GCB performance was evaluated during three phases: (1) constant rate infiltration, (2) subsequent drainage with no infiltration, and (3) transient infiltration. Measurements were made of water infiltrated onto the surface, water drained out of the GCB, water laterally drained in the overlying soil and water produced out of the bottom of the subgrade. Soil suction above and below the GCB was also monitored.

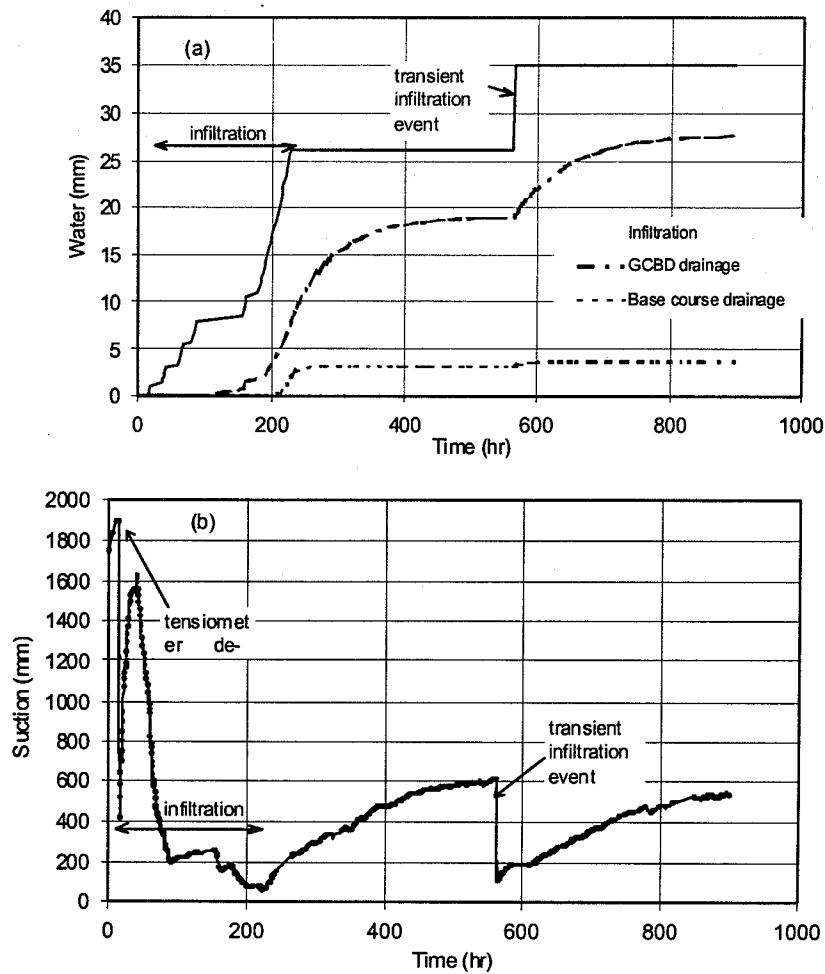
**Figure 7.** Summary of test results. (a) History of infiltration, drainage from GCB and drainage from overlying soil, and (b) average suction history immediately above GCB.

Infiltration and drainage histories for the test are given in Figure 7a. The suction heads measured by the tensiometers immediately above the GCB D are reported in Figure 7b. The average suction head is given because the tensiometers all had similar responses. The water in the soil above the GCB D remained in tension as water laterally drained from the base through the GCB D. Water also drained from the overlying soil while the water pressures remained negative.

The suctions in the soil immediately above the GCB D decreased rapidly in response to infiltration from a pre-infiltration value of more than 1500 mm. The very sharp decline and recovery of suction head in the first 50 hrs is due to de-airing of the tensiometers. Water first drained from the GCB D system at an average suction head value of 260 mm. With continuing infiltration, suction heads decreased further and the GCB D produced increasing amounts of water. The suction heads reached a minimum value of about 70 mm when steady state was achieved and the constant rate infiltration portion of the test was terminated. The overlying soil also laterally drained some water while the water pressures remained negative. At no time during the infiltration did any of the tensiometers above the GCB D indicate that the overlying soil reached saturation.

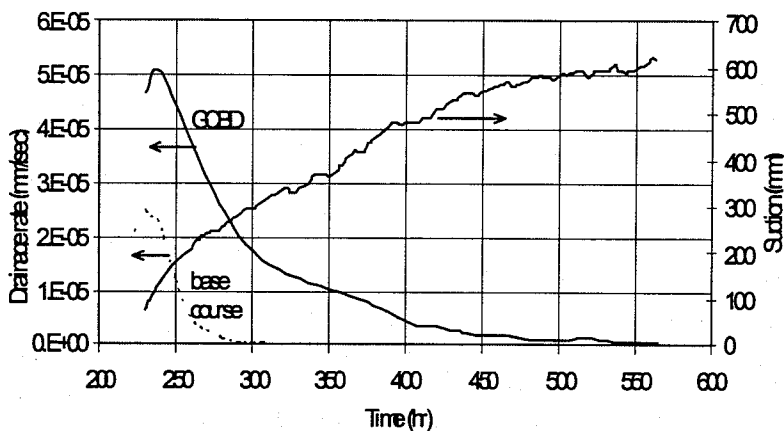
**Figure 8.** Drainage rate from GCB and overlying soil during period between constant rate infiltration and transient infiltration. The average suction in the overlying soil immediately above the GCB is also shown.

The post-infiltration drainage rate as a function of time is given in Figure 8 along with the average suction head from the ten tensiometers above the GCB D. The rate of drainage from both the GCB D and the overlying base soil decreased with time as suction increased. A total of 126 mm of water was collected during this test phase: the GCB D drained 11.3 mm of water over 14 days and 1.3 mm of water drained from the overlying soil for about 4 days. The GCB D was still draining a small amount of water at suction heads in excess of 600 mm when this test phase was terminated. The overlying soil remained in tension during transient infiltration, indicating that its storage capacity was sufficient to accommodate the added water without reaching saturation.

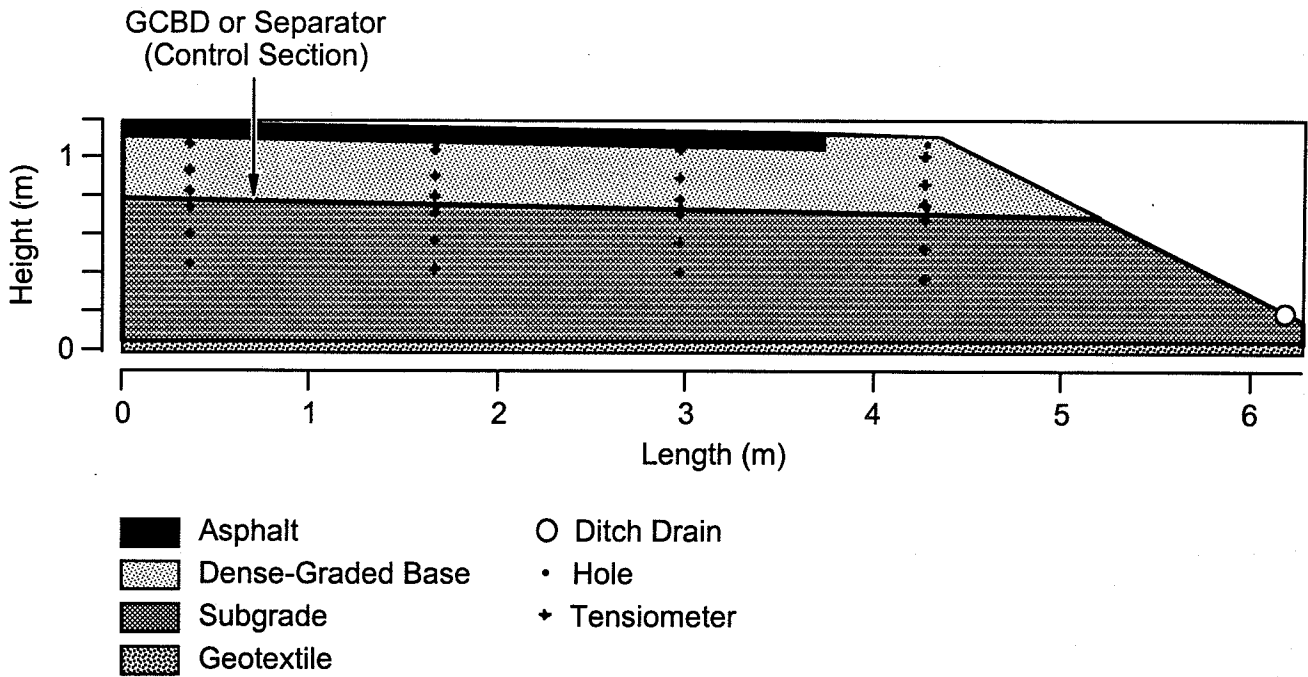
**Figure 9.** Cross-section of the pavement configuration tested, with the GCBD included between the base and subgrade.

The test box for performing large-scale tests of the GCBD was constructed of welded steel plates and is 6.2 m in length, 1.2 m high and 1.3 m wide (Fig. 9). The interior of the box is painted with primer for water tightness and to resist rusting. In order to facilitate internal water flow and drainage, the box is tilted by 2% from south to north and from east to west. In addition, the soil layers were emplaced at a 2% grade from east to west. The ditch, at the west end of the box, has a slope of 2:1, and there is an outlet drain at the bottom. On the long sides of the box, waterproof outlets are located for tensiometers, thermocouples and drains (Fig. 10).

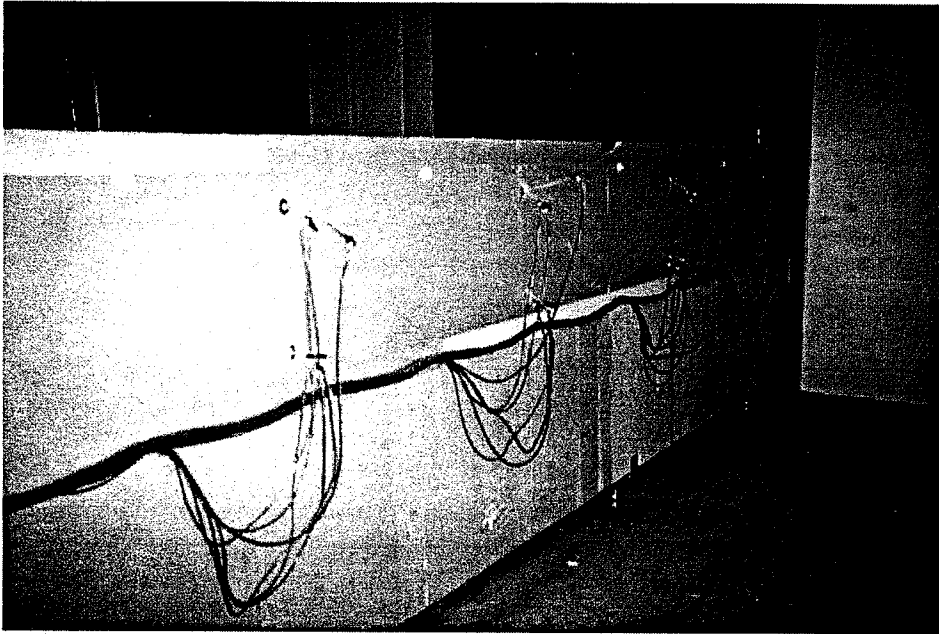
**Figure 10.** Photograph of test box with tensiometer tubes connected to pressure transducers exiting the side of the box.

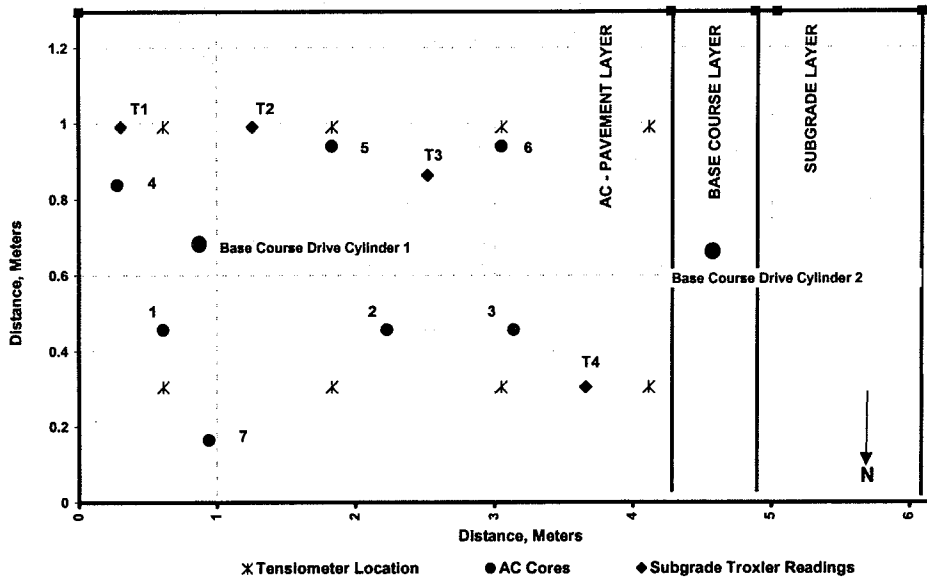
Figure 12. Plan view of test section showing locations of soil testing during deconstruction.

After the control tests were completed and prior to removing the asphalt for reconstruction with the GCBD, seven asphalt specimens were cored for permeability and density testing in the future (Fig. 12). One core was sampled in the northeast section to check for variability in density or permeability since water ponded at this location during testing and a leak occurred from tensiometer holes that were located closest to this area. The specimens were 102 mm in diameter and cut down to the surface of the base. The thickness of the asphalt specimens ranged from 64-89 mm.

After removing the asphalt, two drive cylinders were collected from the base to test for the soil moisture (Fig. 12). Nuclear gage readings for dry density and moisture content were recorded for the base (Table 3). The density readings are comparable to the readings taken during the construction of the control section. We also recorded nuclear gage readings for the subgrade (Fig. 12, Table 4).

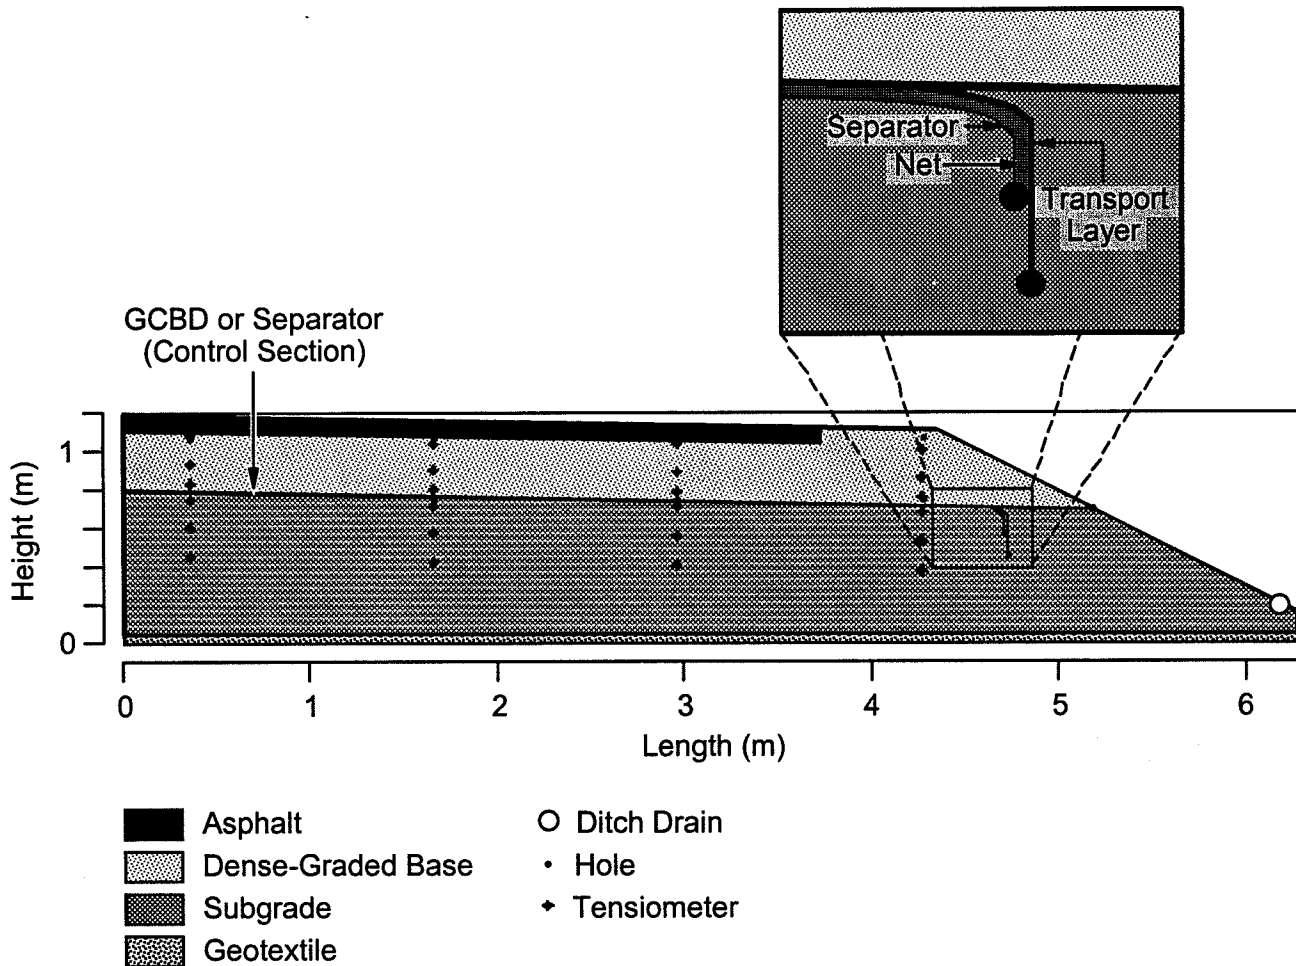
**Figure 16.** Cross-section of the GCBD test section with vertical drop for water collection.

We placed three layers of eight tensiometers in the subgrade and base, for a total of 48 tensiometers. They were located in vertical columns at increasing depths (Figs. 9, 16, 17). The subgrade tensiometers were located 0.3 m from each edge of the box (horizontally) at depths of 330, 179 and 25 mm below the base/ subgrade interface, respectively. The tensiometers in the base were located at 13, 127 and 279 mm above the base/ subgrade interface. The tensiometers in the lowest layer were labeled 1 through 8. One through four were on the north side of the box from west to east and 5-8 were on the south side of the box from west to east, and so forth for each layer. It is noted that the westernmost tensiometers were not located beneath asphalt, but below the shoulder area.

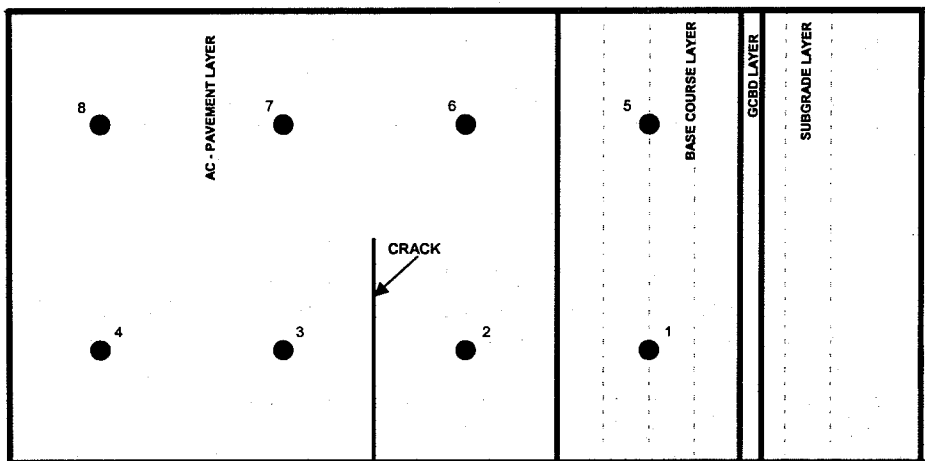
**Figure 17.** Plan view of tensiometers located 25 mm below the separator or GCBD (17-24) and 13 mm above the separator or GCBD (25-32). The box, as depicted, tilts from left to right and top to bottom by 2%. The soil layers also slope 2% from left to right.

Figure 17 depicts the layout of tensiometers located 13 mm above and 25 mm below the separator geotextile or the GCBD. Due to the slope of the box, the tensiometer with the lowest elevation is located in the lower-right-hand corner (i.e., tensiometers 17 and 25). This is helpful in interpreting suction head measurements recorded during the tests and discussed below.

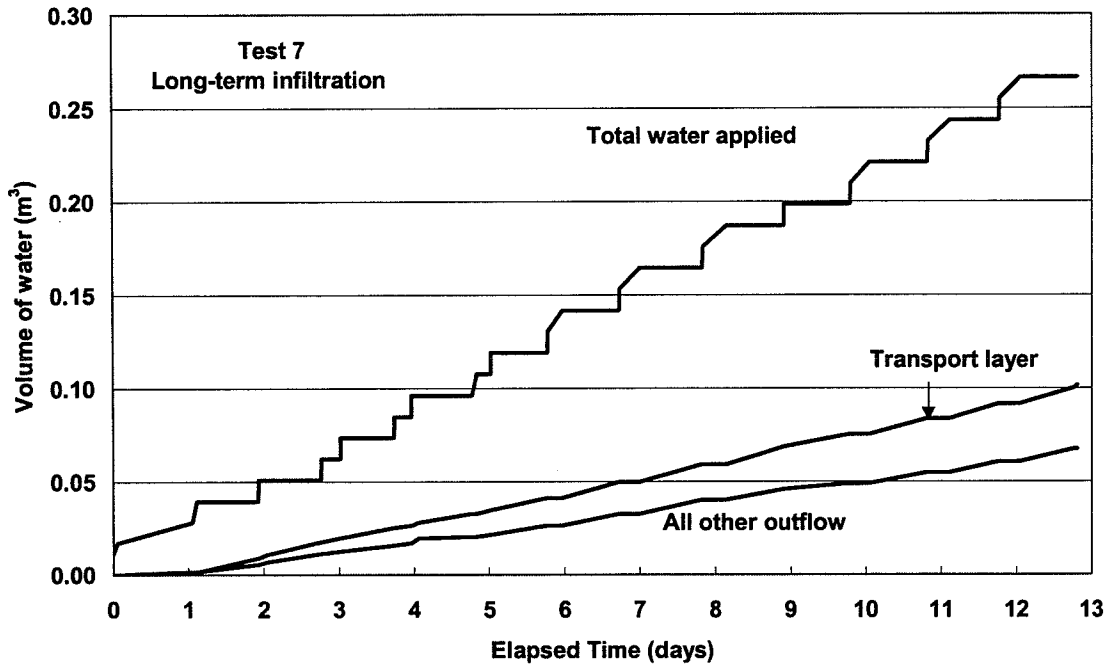
Figure 18. Outflow from long-term infiltration test with GCBD (Test 7).

For the long-term infiltration test in which we applied approximately  $0.1 \text{ mm day}^{-1}$  in two daily applications, the transport layer drained more water than the ditch (Figs. 18, 19). The GCBD also protected the subgrade—the water table actually decreased in elevation during this test, and only a small percentage of the water applied was stored in the subgrade.

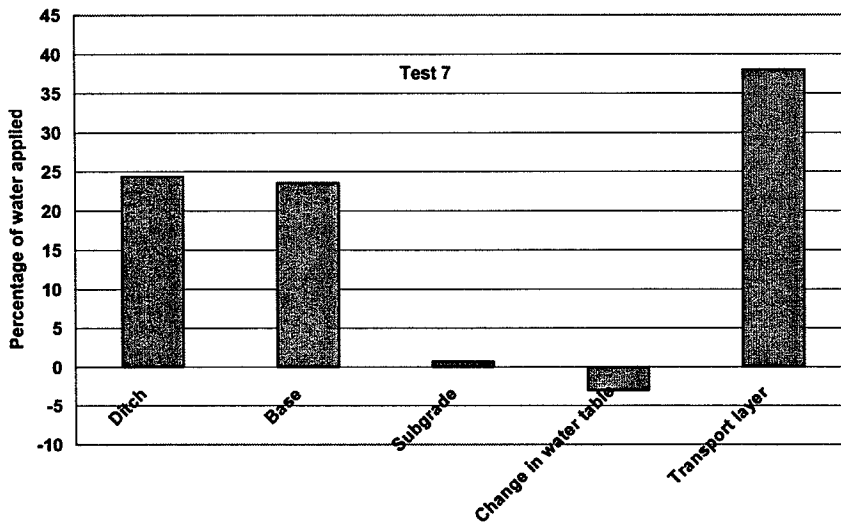
Figure 19. Percentage of water applied that was drained from the ditch, stored in the base and subgrade, in changing the elevation of the water table and drained from the transport layer in long-term infiltration with GCBD (Test 7).

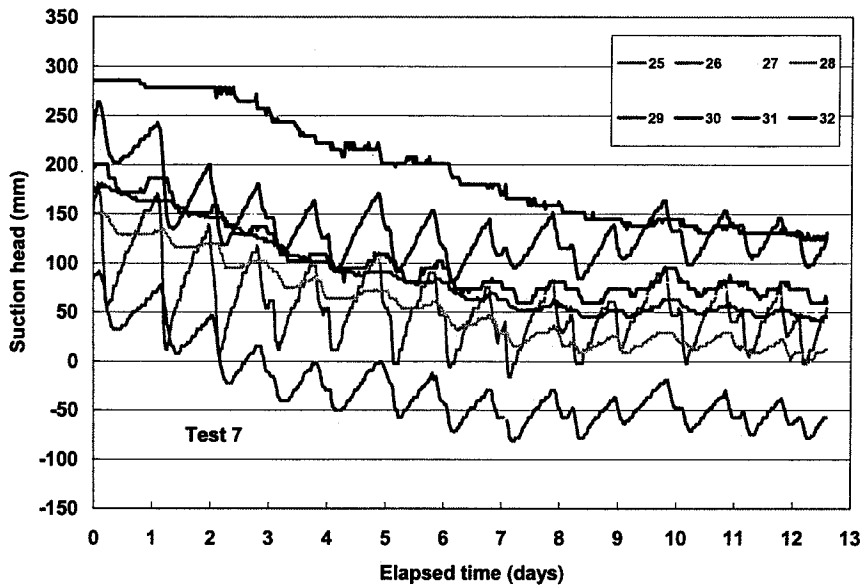
Figure 20. Soil suction heads in the base, 13 mm above the GCBD in a long-term infiltration test (Test 7).

The water content of the base layer increased significantly during this test; but the water content of the subgrade increased only slightly. This is reflected in the tensiometer readings, which decrease in the base and remain nearly constant in the subgrade (Figs. 20, 21). All the tensiometers in the base layer immediately above the GCBD, except 31 and 32, responded to the daily application of water, whereas those immediately below the GCBD in the subgrade did not—indicating that the transport layer was draining water from the base while the subgrade was being protected from wetting. The subgrade did moisten somewhat, due at least in part to the fact that the subgrade was subjected to infiltration where it intersected the ditch.

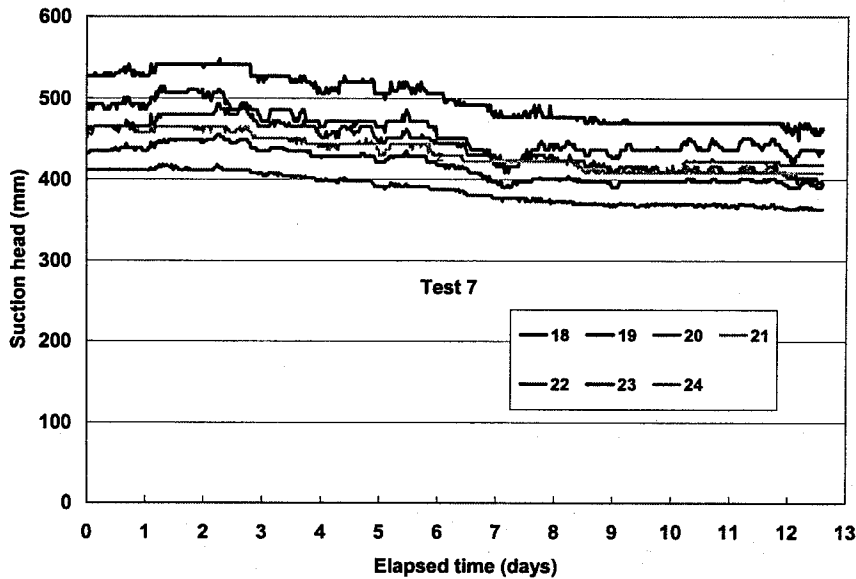
Figure 21. Soil suction heads in the base, 25 mm below the GCBD in a long-term infiltration test (Test 7).

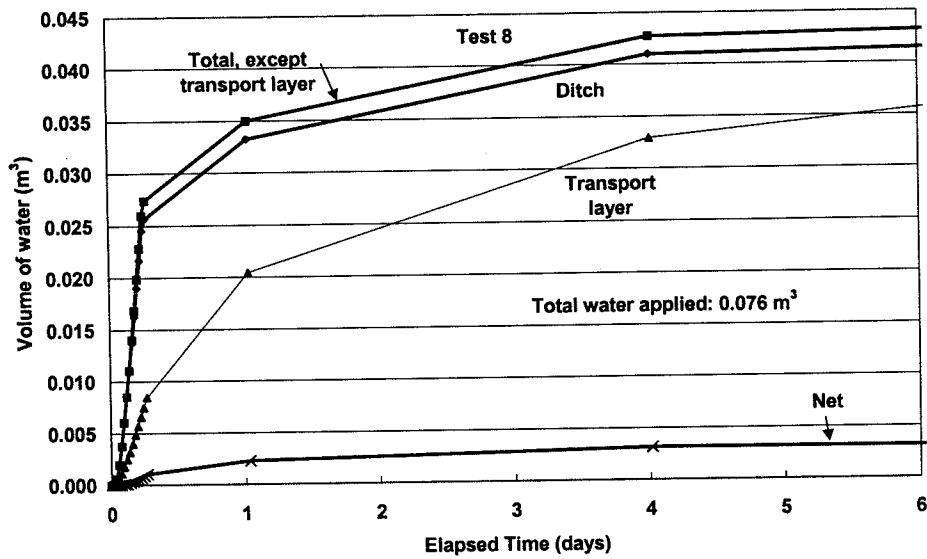
Figure 22. Outflow for six- hour storm in test section with GCBD (Test 8).

Tests 4 and 8 represent a rain of six hours in duration. After we stopped applying water in test 8 (at day 0.25), the transport layer drained water at a greater rate than the ditch; and it did so while the water was under suction. (Fig. 22). While the transport layer was producing water, the water in the base overlying the transport layer was in tension. Six days after the storm, the minimum suction head of water in the base was 100 mm (Fig. 23).

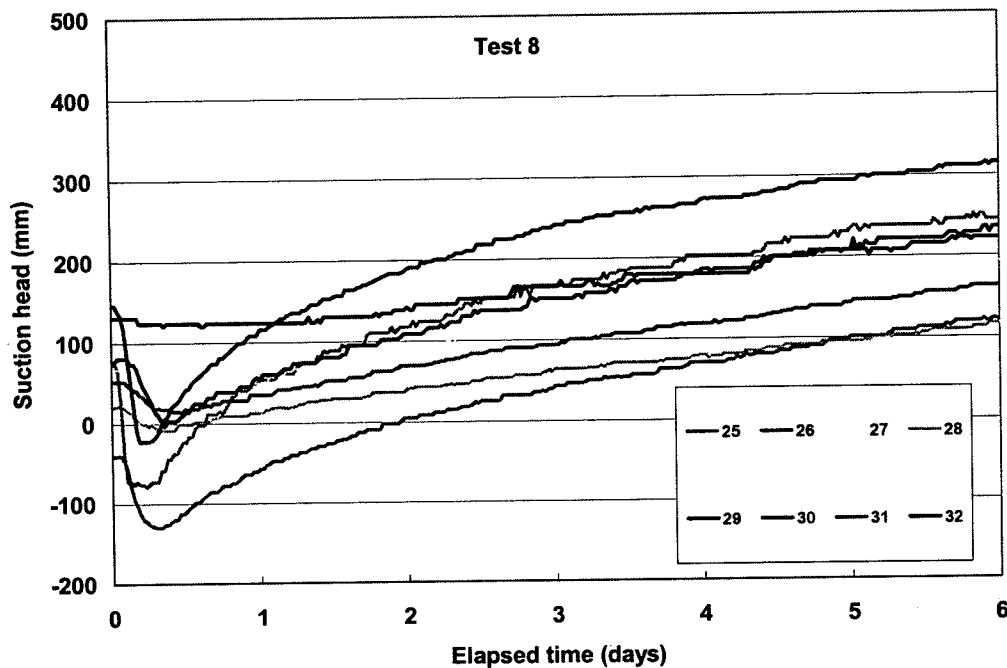
Figure 23. Soil suction heads in the base at 13 mm above GCBD for Test 8.

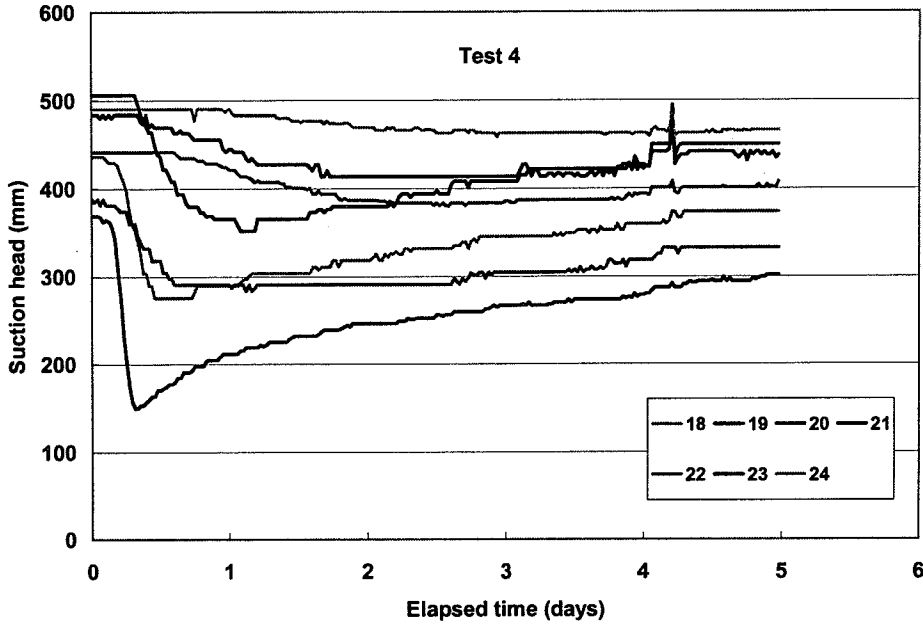
Figure 24. Soil suction heads in the subgrade at 25 mm below the geotextile separator in the control section for Test 4.

The GCBD protected the subgrade for the six-hour storm (Figs. 24 and 25). The suction heads below the interface decreased in the control section (test 4), whereas below the GCBD they remained approximately constant except for the subgrade located beneath the unpaved shoulder. In this region, tensiometers 17 and 21 indicate water breakthrough shortly after water was applied (Fig. 25).

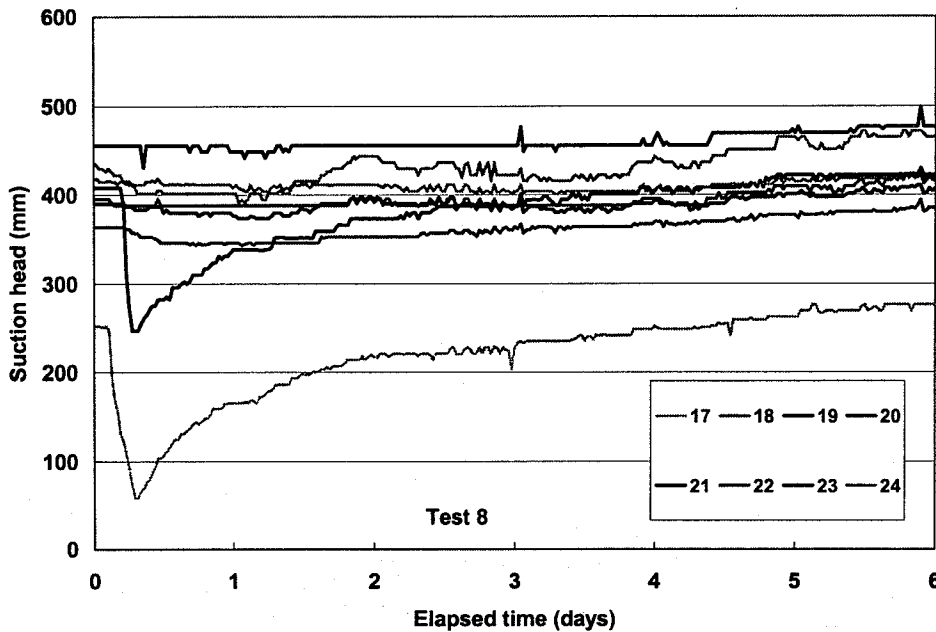
Figure 25. Soil suction heads in the base at 25 mm below the GCBD for Test 8.

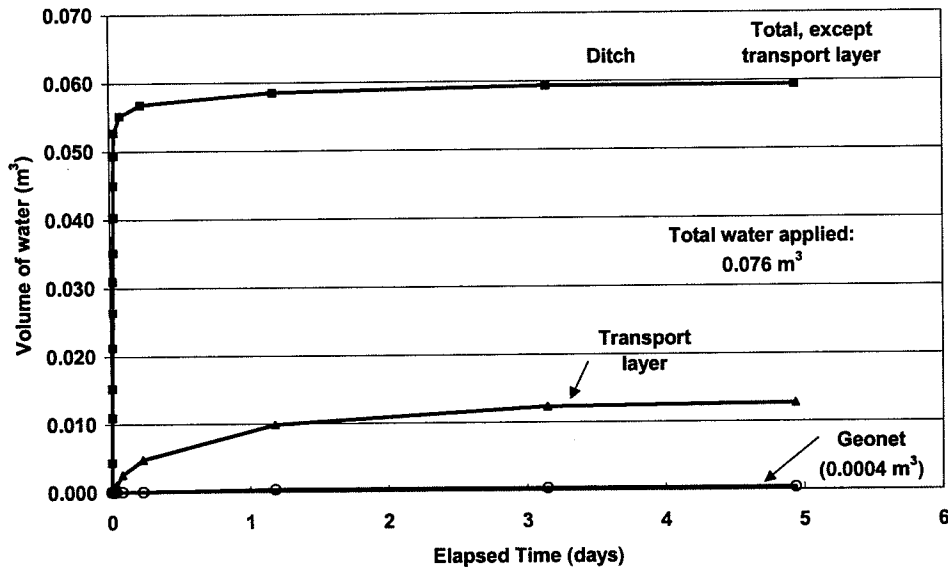
Figure 26. Outflow for one-hour storm with GCBD (Test 9).

There was a larger volume of runoff for the one-hour storm compared to the six-hour storm. The transport layer evacuated water at a greater rate than the rate of water flow from the ditch after we stopped applying water (at 0.04 days); however, the transport layer discharged a smaller percentage of the water applied due to the high runoff rate (Fig. 26). On day 5 the transport layer drained water at suction heads ranging from 175 to 360 mm (Fig. 27).

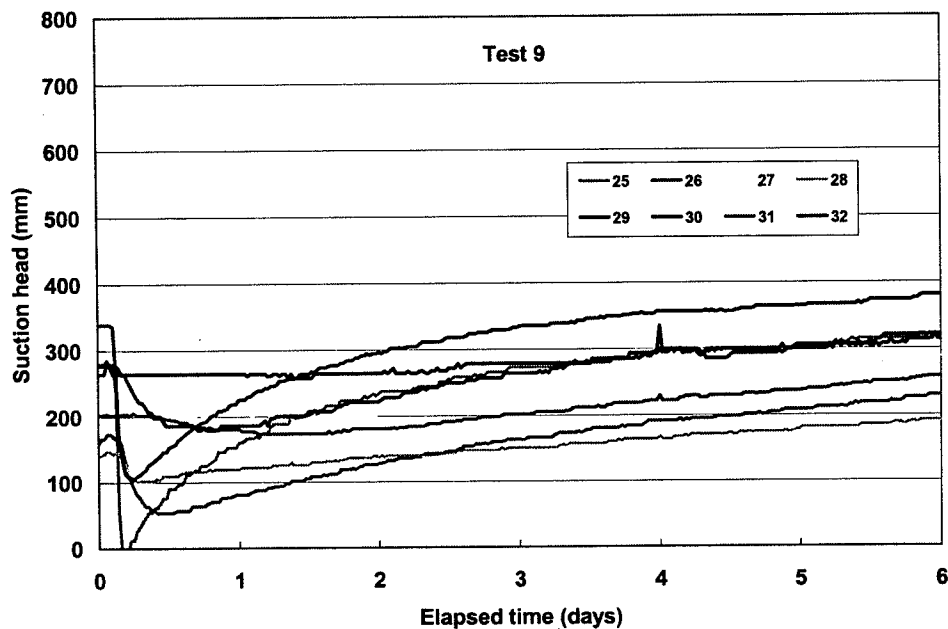
Figure 27. Soil suction heads in the base at 13 mm above the GCBD in Test 9.

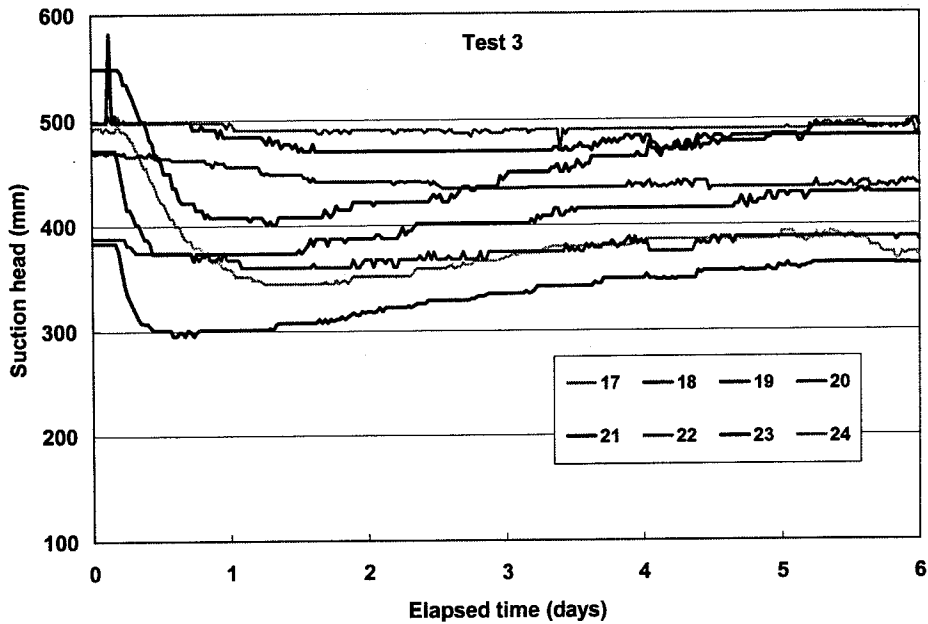
Figure 28. Soil suction heads in subgrade, 25 mm below the geotextile separator in the control section in Test 3.

The GCBD completely protected the subgrade from changes in moisture content due to this storm whereas the subgrade of the control section was not (Figs. 28 and 29). The suction head readings in the subgrade immediately below the base/ subgrade interface were similar at the beginning of each test—468 and 420 mm average for tensiometers 25-32 in tests 3 and 9 respectively. Thus, even though the subgrade of the control test started out slightly drier than test 9, the separator allowed significant wetting of the subgrade. However, the GCBD protected the subgrade in test 9 after it had allowed some water to pass through in the previous test. Thus, that once allowed to 'dry,' the GCBD functioned well after it 'failed.'

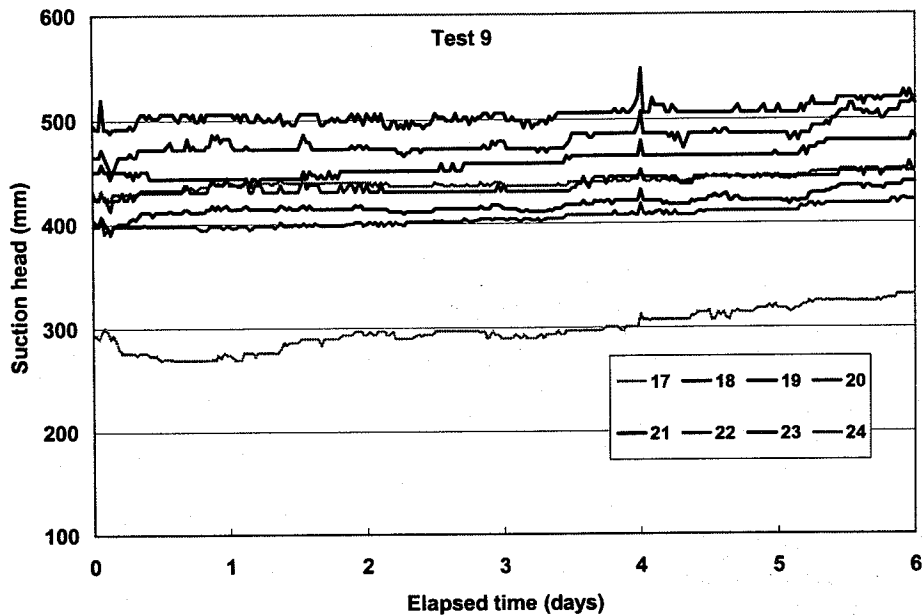
Figure 29. Soil suction heads in subgrade, 25 mm below the GCBD in Test 9.
