## **Landslide Stabilization Using Wick Drains**

Final Report for Highway-IDEA Project 76

Paul M. Santi, and C. Dale Elifrits,  
Colorado School of Mines

***February 2003***

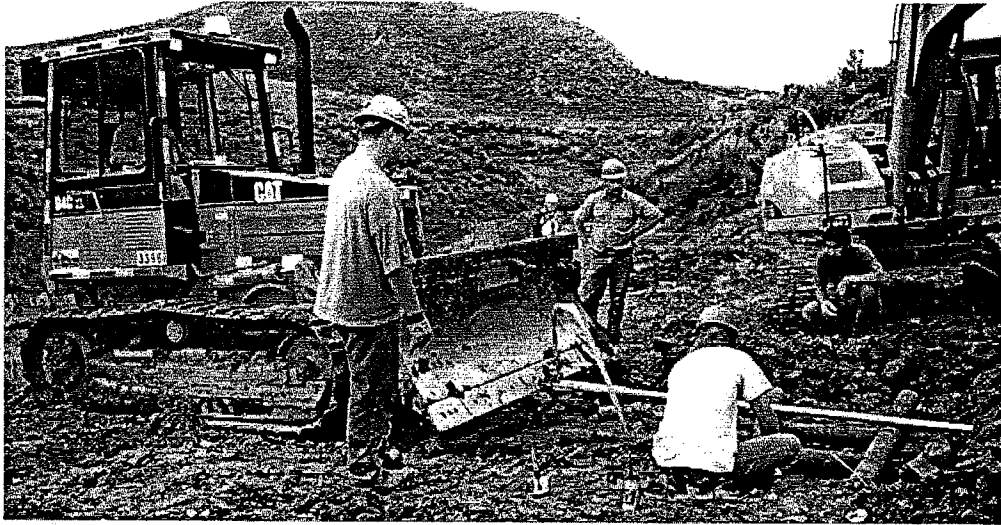
Figure 1. Control of pipe buckling by timber support from underneath.

The most significant installation problem encountered during the early part of the research was the tendency of the drive pipe to bend or buckle during pushing. This tendency has been successfully counteracted by placement of supporting landscape timbers below the pipe (Figure 1), or held in a "V" to support the pipe during driving (Figure 2). It is our conclusion that this problem has been effectively addressed by these methods.

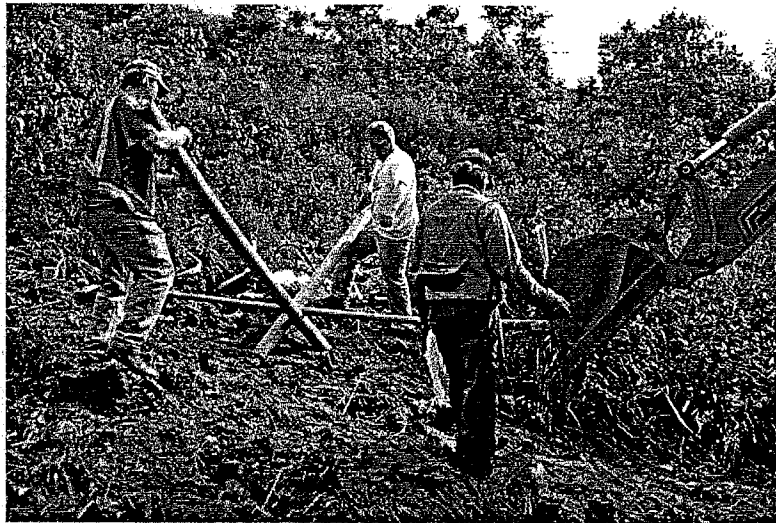
Figure 2. Control of pipe buckling by "V" support.

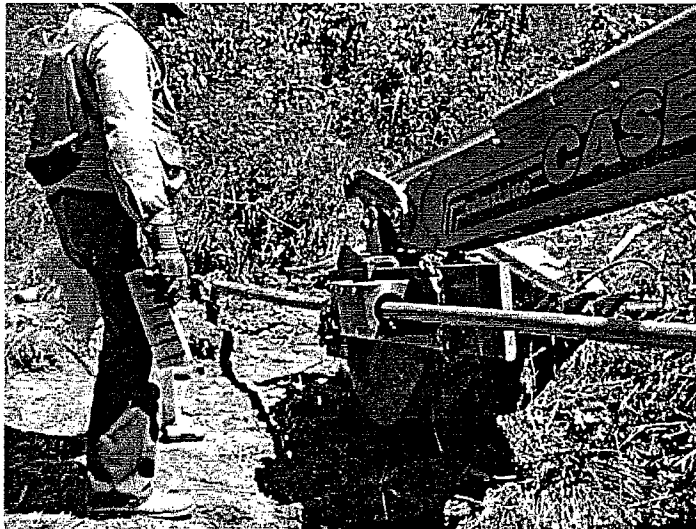
Figure 12. Testing of pipe gripping mechanism using a backhoe.
