Active Heating Infrared Thermography for Detection of Subsurface Bridge Deck Deterioration

Final Report for Highway IDEA Project 101

Prepared by:
Kenneth Maser, Infrasense, Inc., Arlington, MA

November 2004

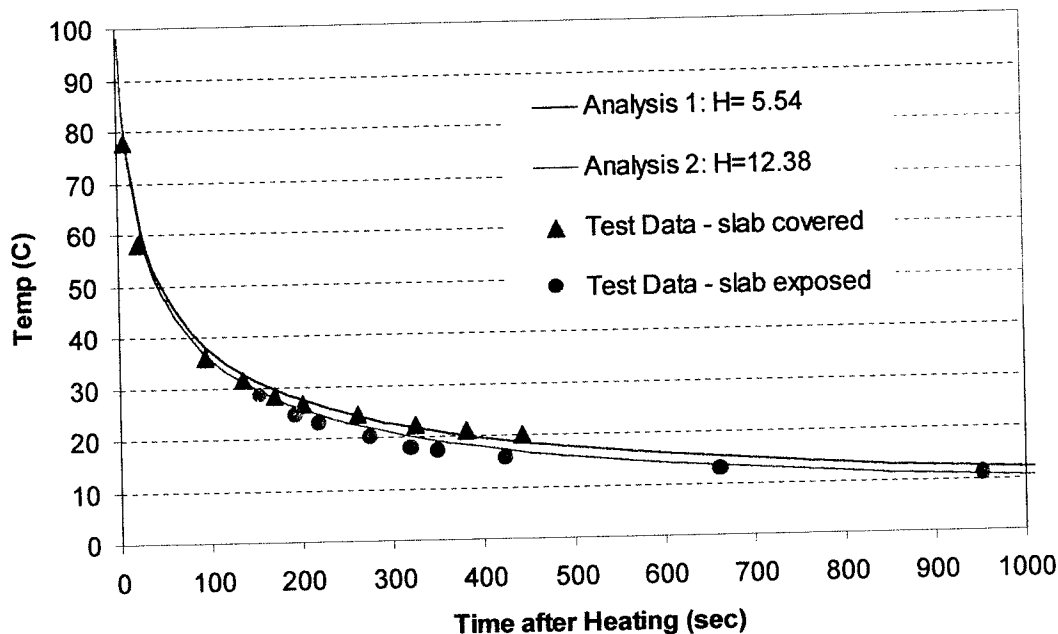
Figure 10 – Model vs. Experiment: Results for 60 Seconds of Heating

A preliminary test of intact concrete was done to check the analytic results. At the Ray-Tech manufacturing facility, the Mini-Tech pavement was used to apply heat for 1 minute on their concrete floor slab. The results of the analysis for two different surface heat transfer coefficients (H) have been plotted along with data from the test (Figure 10). The values for H were selected from a table of values provided by Starnes and Carino (2003). The value of 5.54 appears to be a very good match for the experiment where the slab was covered for a period of time after heating. The higher value of 12.38 appears to be a good match for the experiment where the slab was exposed to the air immediately after heating. These comparisons verify that the model (and the thermal properties used) provides a good representation for the surface temperature vs. time for a slab heated uniformly for a short period.

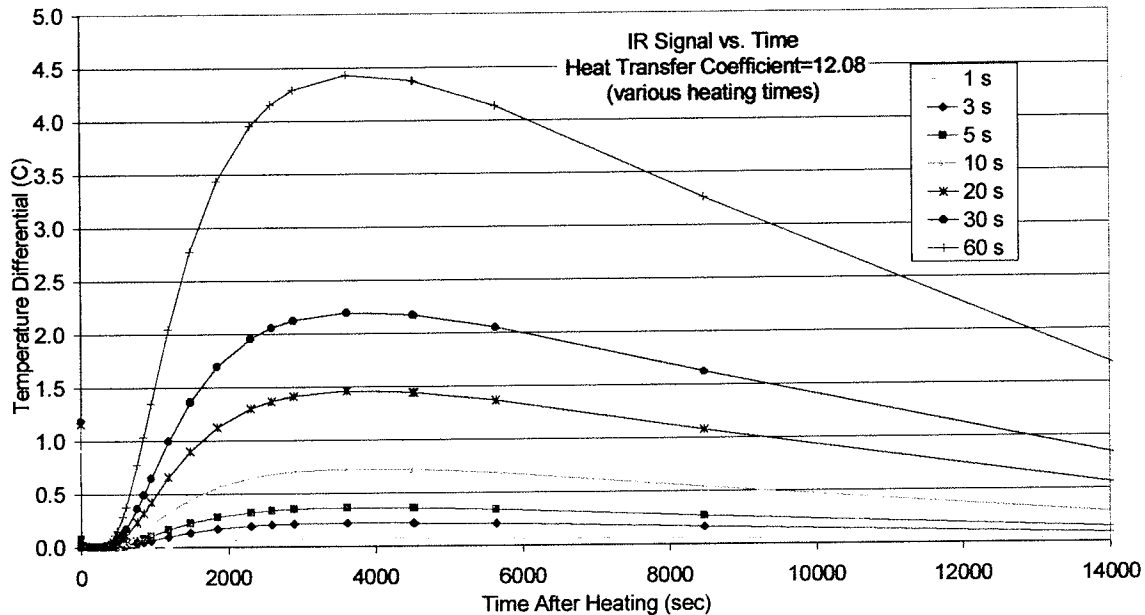
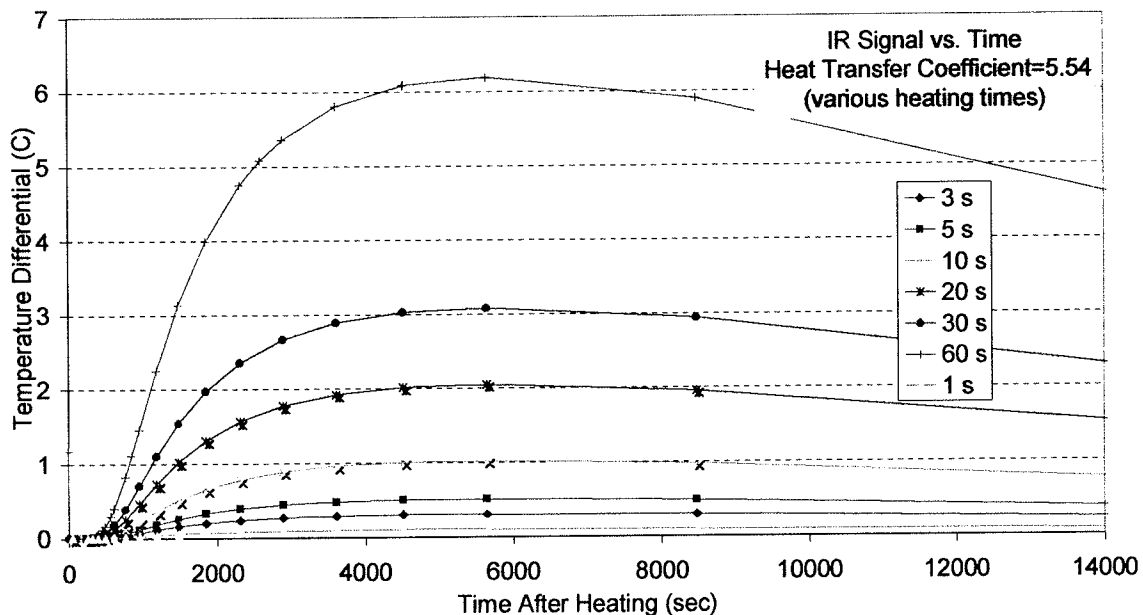
Figure 11 – Temperature Differential vs. Time for Different Heating Times

With this reality check on an intact slab, the analytical work continued to model a delaminated slab. The results of this analysis are presented as a temperature differential vs. time for sound vs. delaminated slabs. The temperature differential results for this calculation are shown in Figure 11. The calculation was conducted for various heating times ranging from 1 to 60 seconds, and for the two different heat transfer coefficients discussed above. Note that the differential rises to a maximum at time, T_{max} , and then slowly tapers off. Times close to T_{max} would represent the best times to conduct the infrared survey.

(a) Results for $H=12.38$

(b) Results for $H=5.54$

The results of Figure 11 reveal a very similar pattern of behavior to the results obtained by previous researchers as described in Section 2. The temperature differential rises after the time of heating to a maximum value, and then tapers off slowly over time. The model results show that the time to reach the maximum temperature differential is approximately 3500 seconds, or almost 1 hour, regardless of the heating time. The maximum value increases with increasing time of heating, as would be expected.

The results of Figure 11 show that that heating times of 1 to 10 seconds produce temperature differentials ranging from 0.1 to 1.0 °C. These short heating times would allow the heaters to move

across the deck at up to 1 ft/sec, and a 300 foot long, 4 lane deck can be surveyed in 1200 seconds, or 20 minutes. Note that the lower value of H (associated with decreasing the surface heat loss) increases the differential and extends the time to the maximum differential. The following section describes laboratory tests conducted to verify the above analytic observations.

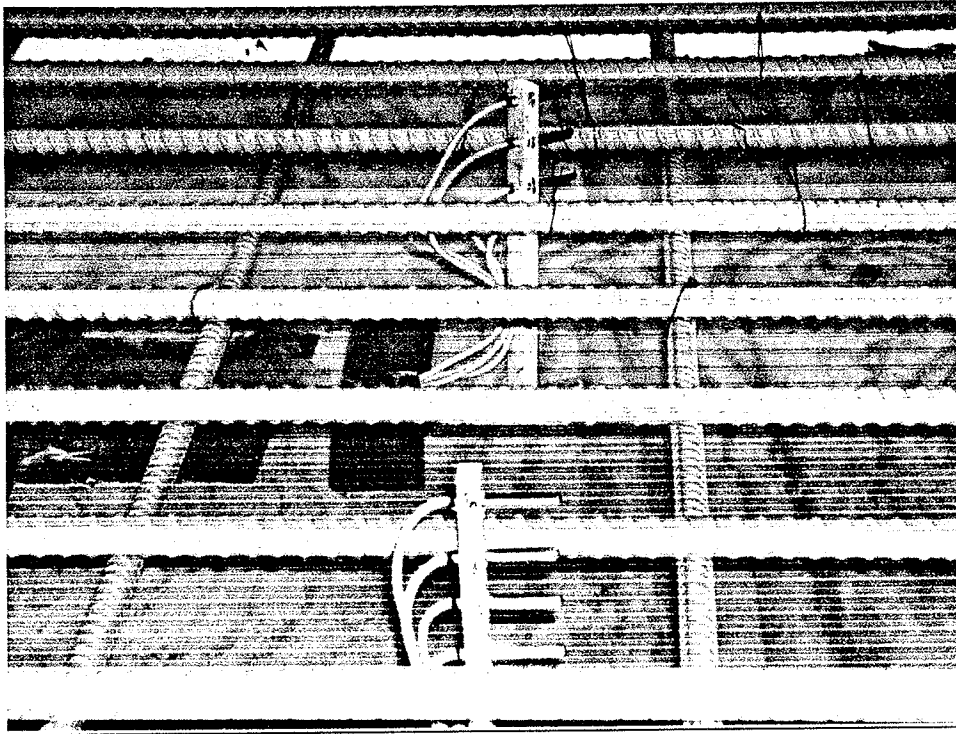
Figure 13 – Thermistor Array for Internal Temperature Monitoring

The slab was instrumented with thermistors with a range of -40 to +212 °F. The thermistors were oriented horizontally so that each thermistor would not experience a thermal gradient. Four thermistors were placed together in a vertical array. One array was placed where the slab was solid (in the center of the slab), and one array was placed at the location of a delamination (Figure 13) approximately 2 inches from its outer boundary.

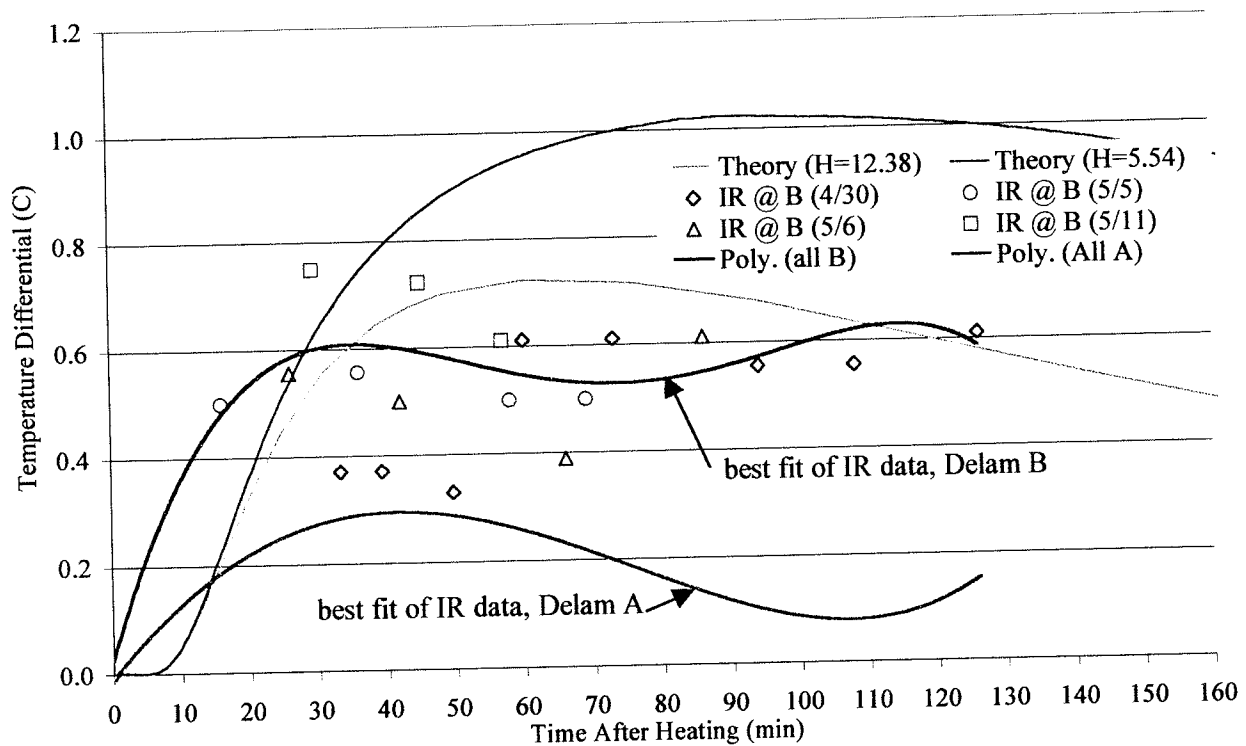
Figure 20 – Infrared Temperature Differentials for All Tests

Figure 20 shows that the temperature differentials measured for delamination A were somewhat smaller than those measured for delamination B. This is unexpected, since A was closer to the surface than B. Most likely there was more heat applied to B due to the configuration of the heating arrangement. The lowest differentials were measured for delamination C. This is expected, since it is the smallest of the three delaminations.

In one of the 5 tests (May 4), the delaminations did not appear in the infrared image. This test was conducted on a windy day. The winds apparently accelerated the heat loss from the slab, and the heat flow into the slab was inadequate to create thermal differentials. Under such conditions the heating time would have to be increased to compensate for the heat loss.

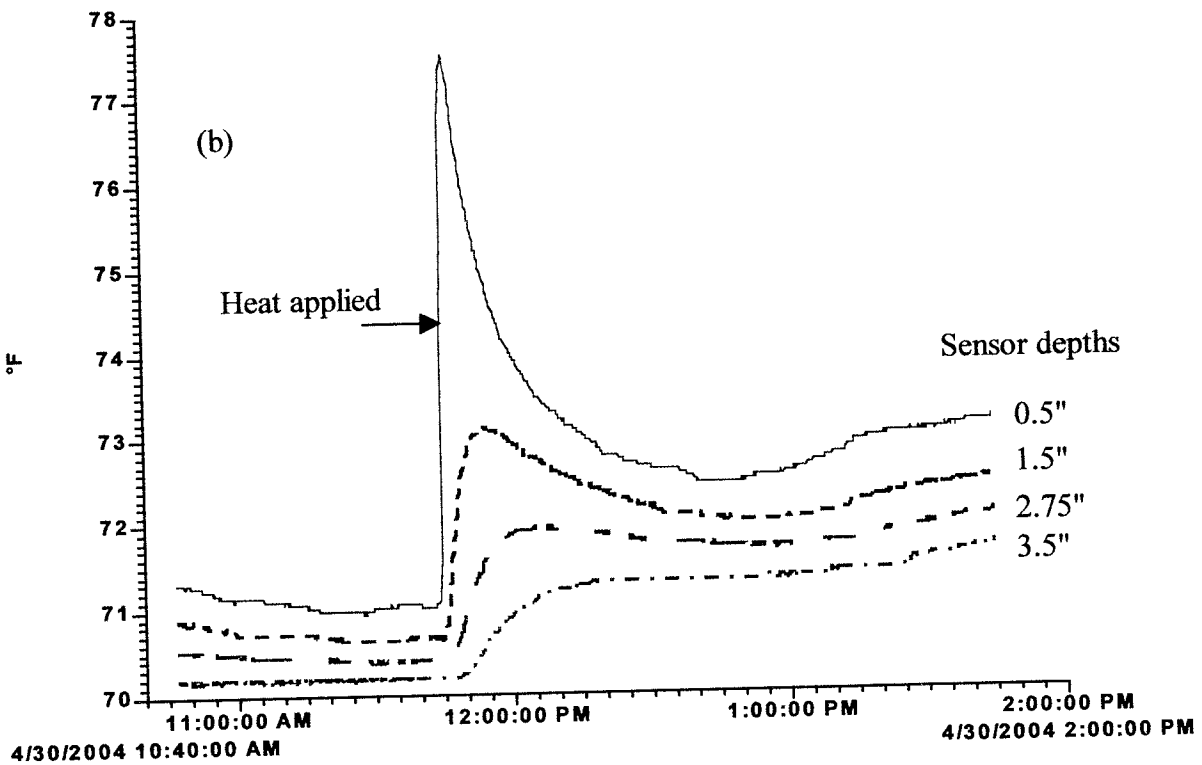
Figure 21 – Temperature Profiles: (a) at Delamination and (b) in Sound Area

The monitoring of the internal temperatures in the slab using thermistors provides insight into the development of the temperature differentials produced by the delamination. Figure 21 shows a sample of the internal temperatures of the slab at the delaminated vs. the sound locations. The effect of the delamination on the temperatures is clear in these graphs. The graphs show that the delamination creates a small temperature discontinuity before heating, which is then magnified after the heating occurs.

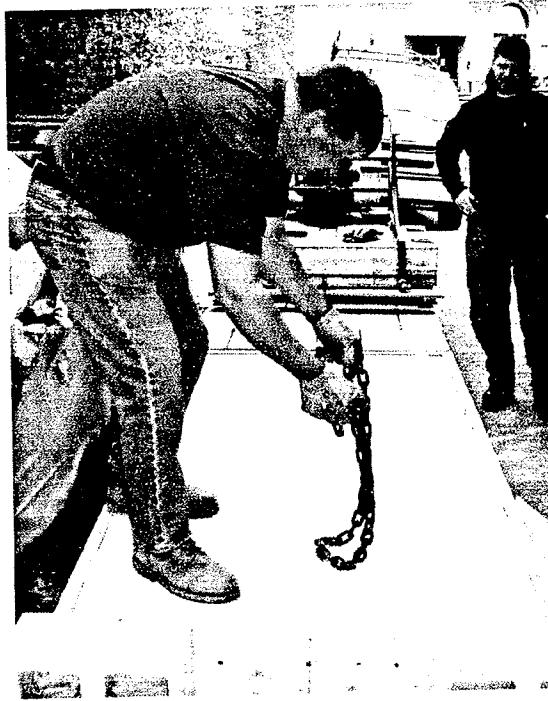
Figure 23 – Chain Drag Survey of Test Slab

The test slab with its carefully fabricated delaminations provided a unique opportunity to evaluate the detection of delamination using conventional sounding methods vs. the infrared method. To carry out this evaluation, arrangements were made with the Massachusetts Highway Department (MHD) to have an experienced Bridge Inspector sound the slab. On May 5, 2004, MHD sent an inspector to the Tufts University Lab to sound the slab. Using a chain, he quickly found the two large delaminations (see Figure 23). He then used a 16 oz. hammer to zero in on the delaminations and reported their estimated size (Table 2).

From these results, it is clear that while sounding detected the larger delaminations, the method underestimated the extent of the delamination and missed the smaller delaminations. It appears that the edge of a delamination does not sound as hollow as the center of the delamination and is below the detection limit for sounding. Delam A, 2 inches below the surface, showed up bigger than

Delam B that was at 2.75 inches. This indicates that the deeper the delamination is more difficult to detect.
