**Cleaning and Recoating Electrified Third Rail
Cover Boards**

Final Report for
Transit IDEA Project 44

Prepared by:
Arun Vohra
Consulting Engineer
Bethesda, MD

July 2008

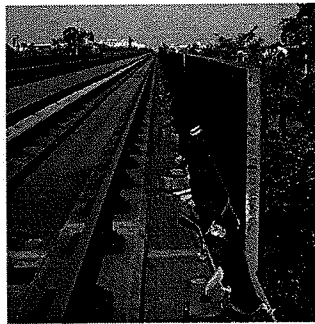
Cover Board blown off along with third rail during Hurricane Wilma, Miami, October 2005

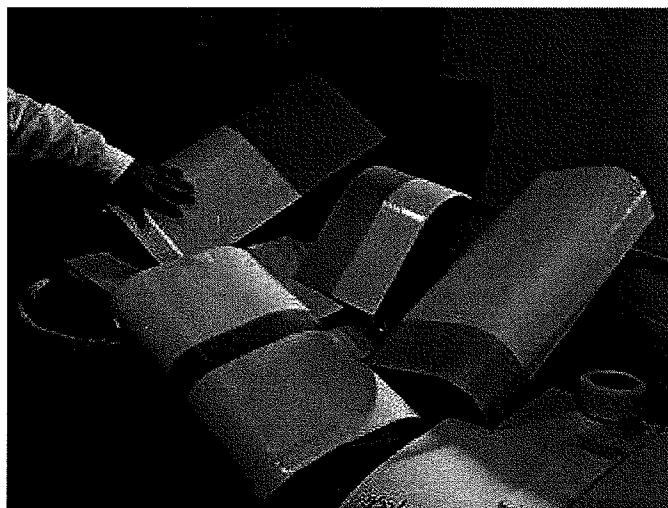
Fig 3. Reinforcing mesh and polyurea coating applied to MDT and BART Cover Boards

For severely weakened cover boards, several mesh reinforcement products were applied to the cover board prior to applying the polyurea spray coat. An 8 inch wide, self adhering fiberglass reinforcement mesh applied to the cover board surface prior to applying the polyurea spray coating appeared to provide the best strength benefit to the cover board.

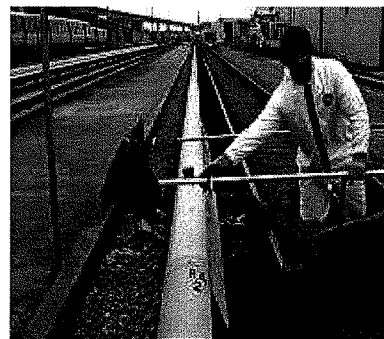
Fig 8. Recoating application from vehicle moving on the track,

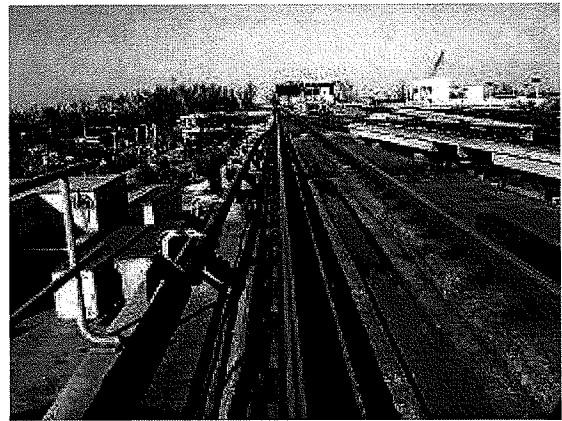
Fig 10. Weakened Cover board blown off by Hurricane Wilma, Miami, Oct 2005

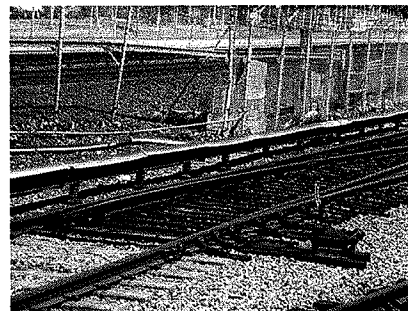
Fig 12. BART Cover Board weakened by sun and wind. 7/21/06

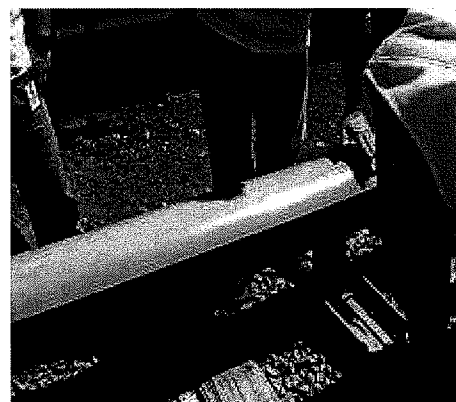
Fig 13. Restored Cover Board with Polyurea spray & reinforcing mesh, BART
