**Cleaning Device for Electrified Third Rail
Insulators**

Final Report for
Transit IDEA Project 36

Prepared by:
Arun Vohra, P.E.
Consulting Engineer
Bethesda, MD

October 2004

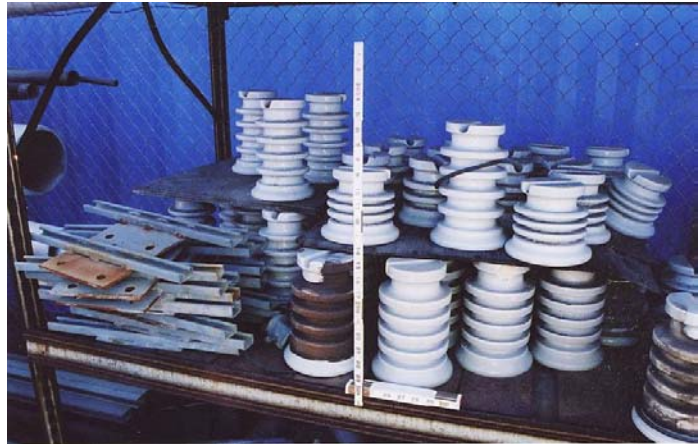
Figure 3. Insulators come in different shapes, sizes and materials. BART 6/03

The power draw is enormous. A fully loaded train accelerating out of a station can draw over 10,000 amps which can contribute to insulator failure. Insulators are made of porcelain, fiberglass or wood and may have different shapes, diameters and heights. Some rail transit systems have more than one type and size of insulator, which makes it harder to design a standard sized cleaning device. The cleaning device may have to be adjustable to accommodate the different insulators sizes.

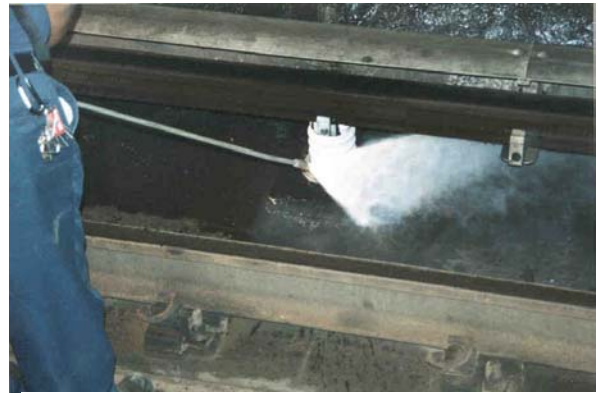
Fig. 8 WMATA hot tap powerwash

WMATA started using a hot tap water pressure washing program for insulators on portions of its system about one year ago. However it takes a long time and uses a fair amount of labor to clean the insulators with this method. A four person crew uses a pressure washer carried on a service vehicle. The service vehicle stops about every 50 feet. The crew walk behind the parked service vehicle using a hand held pressure washing gun connected by a length of hose to the pressure washer. About 500 insulators on a 5000 ft section of track are cleaned in one 3-4 hour cleaning shift. This method cleans a significant portion of the surface dirt. The number of train delay incidents due to insulator failure has significantly decreased. However, the back of the insulators, towards the tunnel wall, cannot be cleaned.

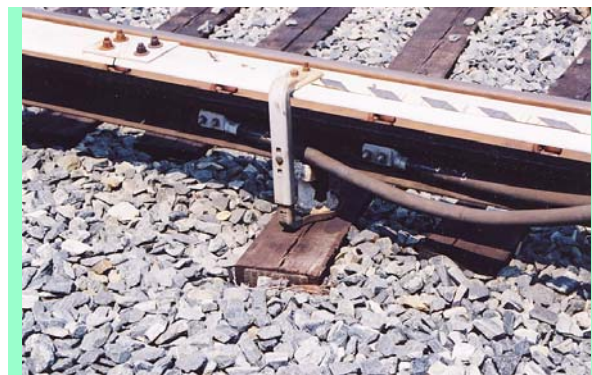
Figure 11. Cable obstruction at insulator.
MTA Baltimore

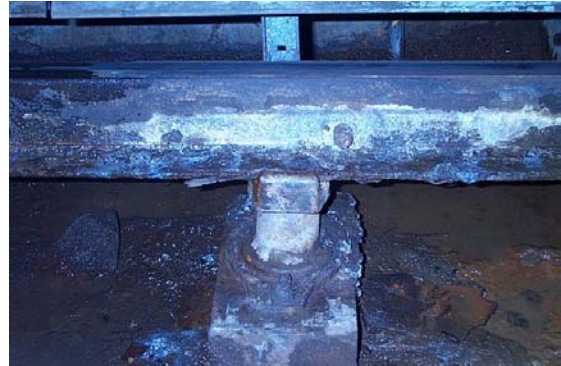
Figure 12 Third rail and metal bracket are corroded. MTA Baltimore

Acid cleaning chemicals were sprayed on the insulators and third rail cover, followed by pressure washing using cold water at 1500 pounds per square inch (psi.) The surfaces were successfully cleaned, but there were significant corrosion problems on steel surfaces that the acid contacted. The acid cleaning has been discontinued. There is no present method for testing the insulator performance. There is no fixed replacement schedule per year. The MTA has problems with dirty insulators similar to WMATA, but on a lesser scale since the system is newer and smaller.

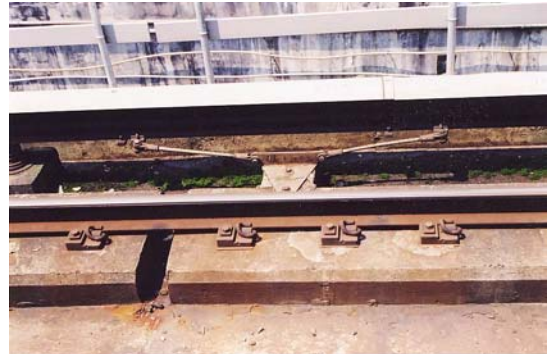
Fig 13. Anchor obstruction near insulator. BART 6/6/03

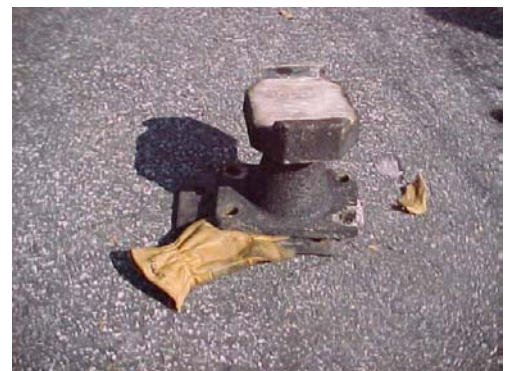
Figure 14. Burnt Insulator MARTA

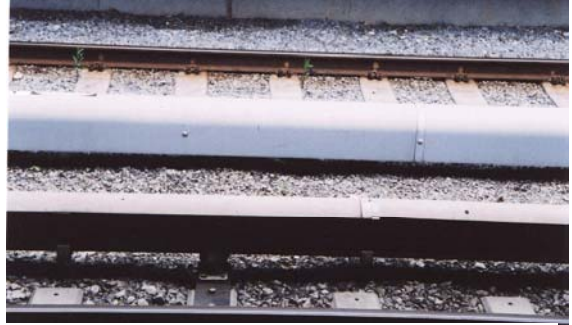
Figure 15. Cover Board restricts access to insulator . MARTA 6/03

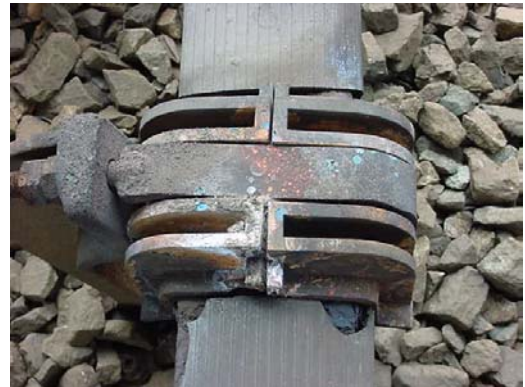
Figure16. Burnt Insulator, SEPTA

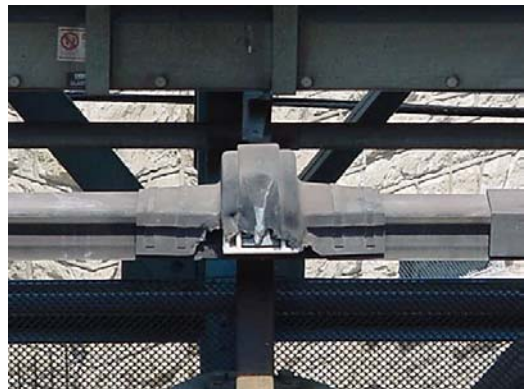
Figure 17. Burnt insulator and cap with under running shoe, SEPTA

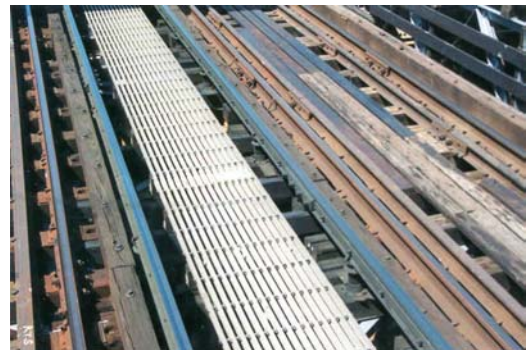
Figure 18. CTA Elevated section with insulator hidden by wood protective rail

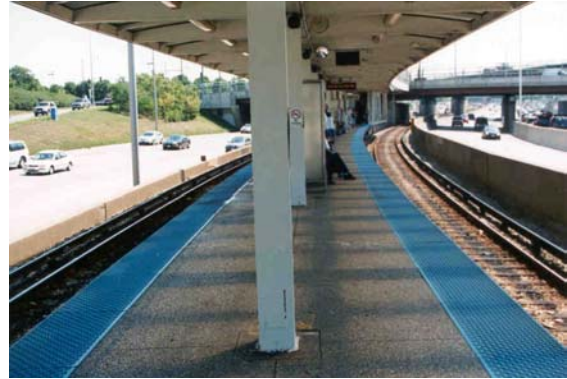
Figure 19. Salted snow thrown by highway snow plows deposits salt on insulators, CTA

Chicago has very cold winters and roads are heavily salted. Moving trains entrain a salt mist and/or salt dust cloud as they enter the tunnels from street level.

Consequently, insulators face heavier corrosion just inside tunnels, as there is no rain to rinse off the salt. Where the track runs adjacent to a highway, snow plows throw snow and salt on the third rail. Insulators are cleaned by hand using cleaning pads to allow train operation.

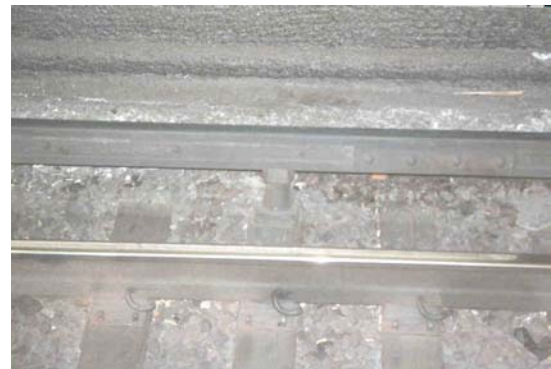
Figure 20. MBTA insulator in tunnel

MBTA has 108 miles of track, of which 14 miles are in tunnels. About 60 miles of track have third rail, the rest use overhead power supply. Insulators are spaced every 10 feet apart, for a total of about 9300 insulators in tunnels and 55,000 insulators outside. Most insulators are about 8 years old and there is no significant failure problem at the present time. Insulators have never been cleaned. Insulator failure on the third rail riser is an issue. Less than 10% of the insulators are made of porcelain, the rest are made of fiberglass. System voltage is 600 DC volts.

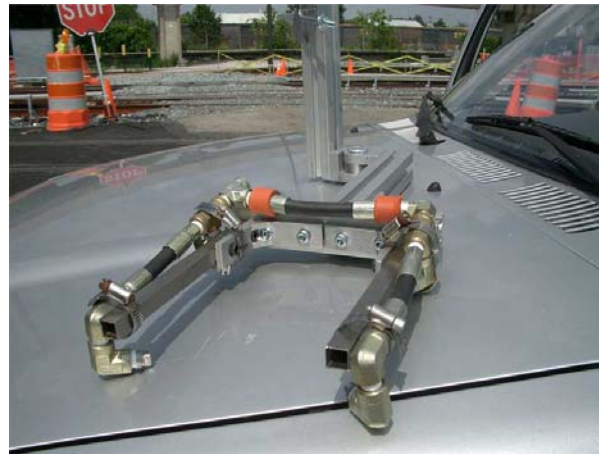
Figure 23. Prototype device showing nozzles

Pressure washing is the recommended cleaning technology. The prototype device was clamped to

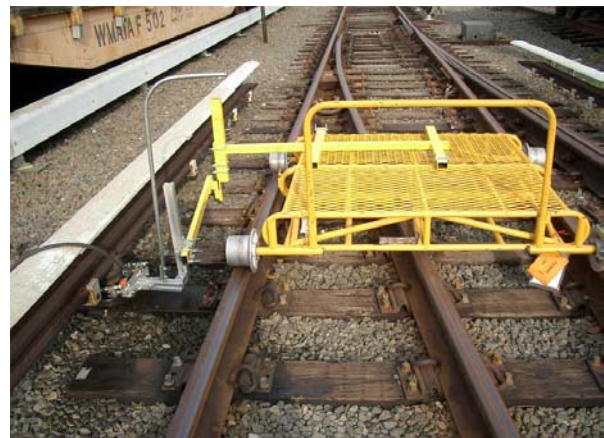
Figure 24. Nolan cart with device, WMATA

a Nolan cart. This type of push cart is available at most transit agencies. As the cart was pushed along the track, the device engaged, rotated around and disengaged the insulator. The spray nozzles cleaned a band all the way around the insulator.

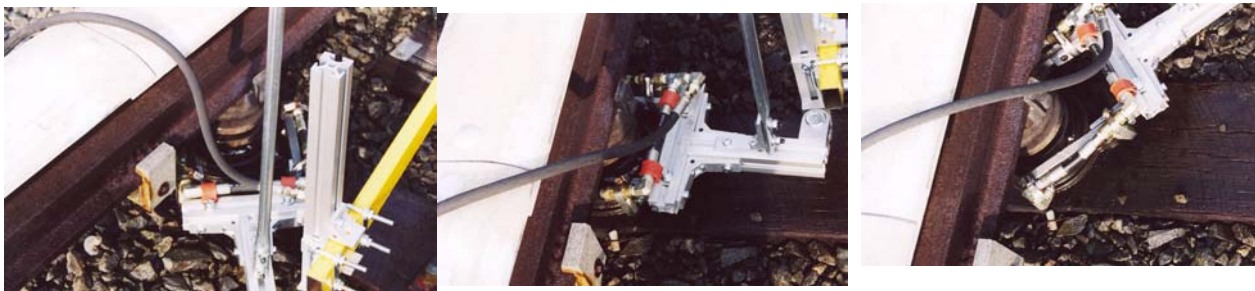
Figure 25. Cleaning device engaging, mid way, and releasing an insulator, WMATA.

The action of the device was smooth and well defined in approaching, the secondary arm rotating the cleaning head around; and releasing the insulator. All four spray nozzles provided cleaning action and cleaned a continuous band around the insulator. The manual control handle allows an operator to precisely allow the U shape head to engage the insulator. The final product would have springs that would cause the cleaning head movement to be automatic with the provision for manual override. The device allows the back side of the insulator to be cleaned

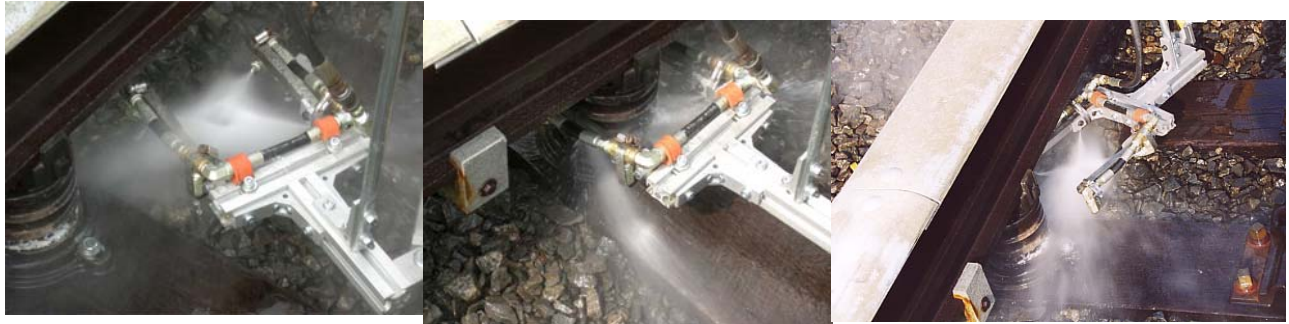
Figure 25. Spray pattern, engaging, mid way, and releasing an insulator, WMATA

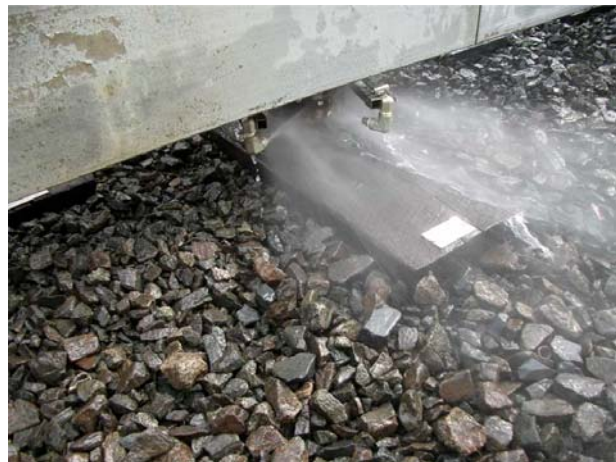
Figure 26. Spray action on back of insulator.
