TRANSPORTATION RESEARCH  
**CIRCULAR**

Number E-C139

**Use of Accelerated  
Pavement Testing to  
Evaluate Maintenance and  
Pavement Preservation  
Treatments**

# **Accelerated Pavement Testing Experiment to Assess the Use of Modified Binders to Limit Reflective Cracking in Thin Asphalt Concrete Overlays**

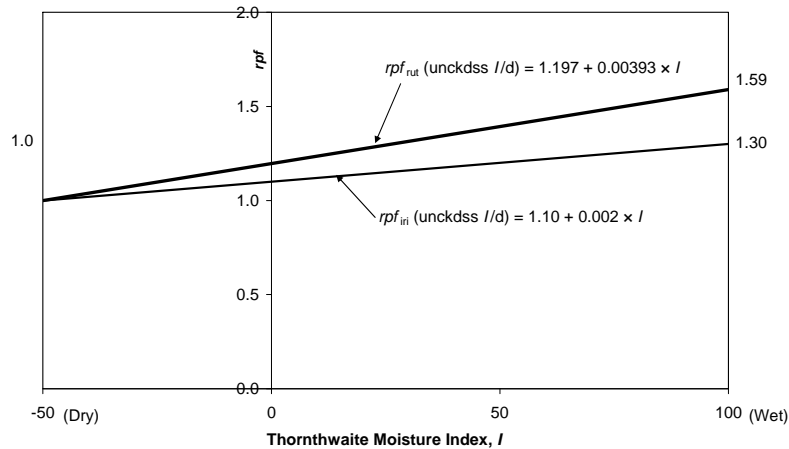
**FIGURE 6 Variation in  $rpf_{\text{rut}} (I/d)$  and  $rpf_{\text{iri}} (I/d)$  with Thornthwaite Moisture Index (uncracked single seals).**

The results in Figure 6 suggest that the variation in the relative performance factors with climate is significant for rutting of the uncracked single seals.

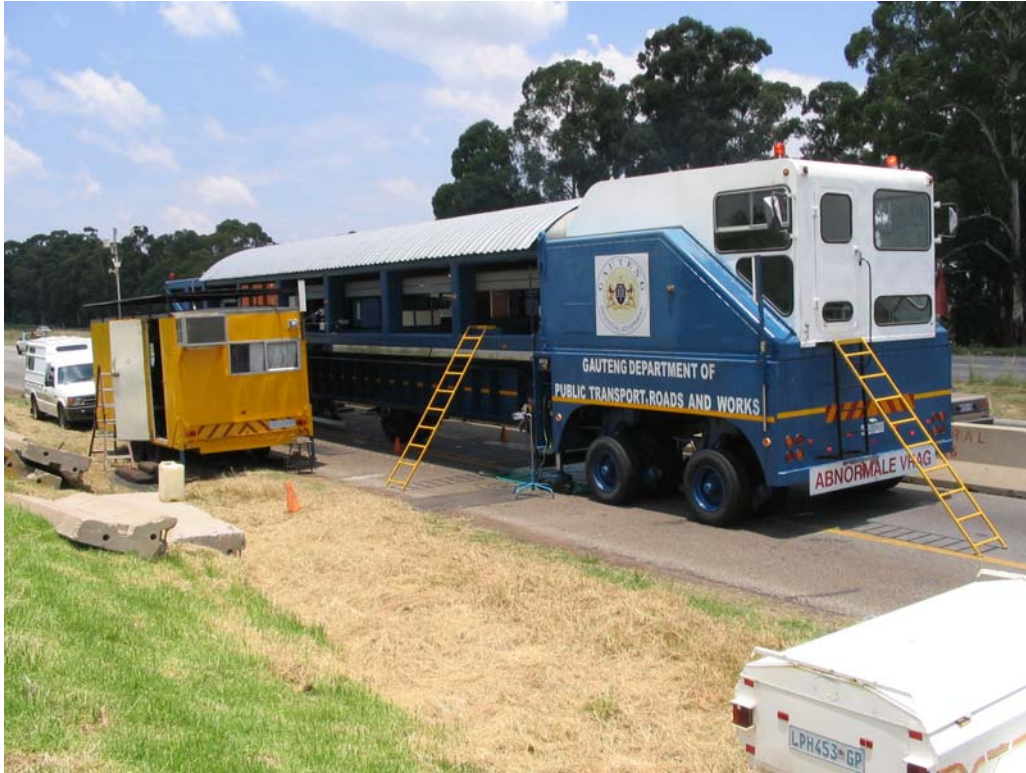
**FIGURE 1 HVS located on a test site.**

In order to provide examples of typical pavement preservation treatment evaluations using APT, a selection of projects where the HVS ([Figure 1](#)) specifically was used in South Africa are provided below. The focus is not on the detail of each of these projects, but merely a summary of the conditions evaluated and the typical outcomes of the evaluation. A host of other examples can also be found in the literature on APT (*1,2,13,14*). Based on this information the protocol for pavement preservation APT presented in the next section has been developed.
