# FRP COMPOSITES FOR REHABILITATION OF HYDRAULIC STRUCTURES

Vijay P.V., P.E., WVU

John D. Clarkson, P.E., US Army Corps of Engineers

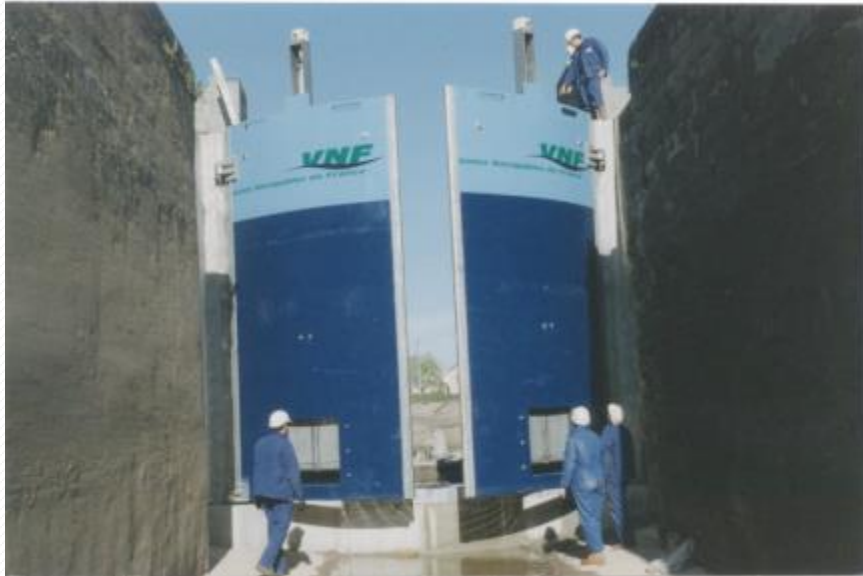
**Golbey Gate Replacement -  
Composite Miter Gates ,  
France**

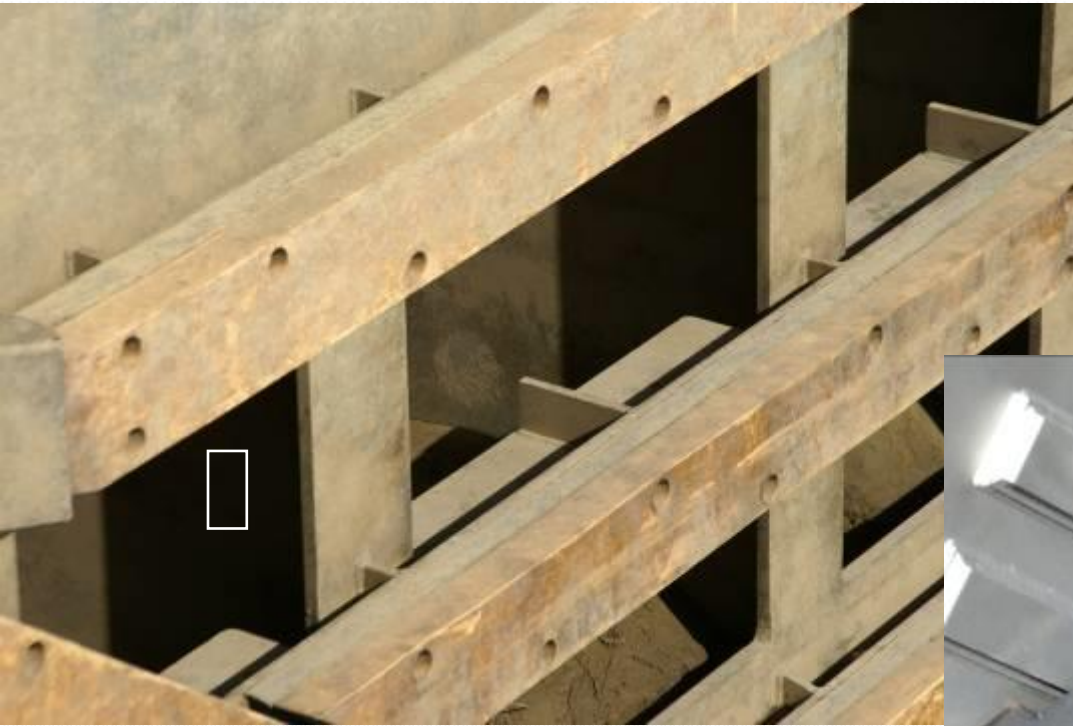
Composite  
Beams in lieu  
of Timber

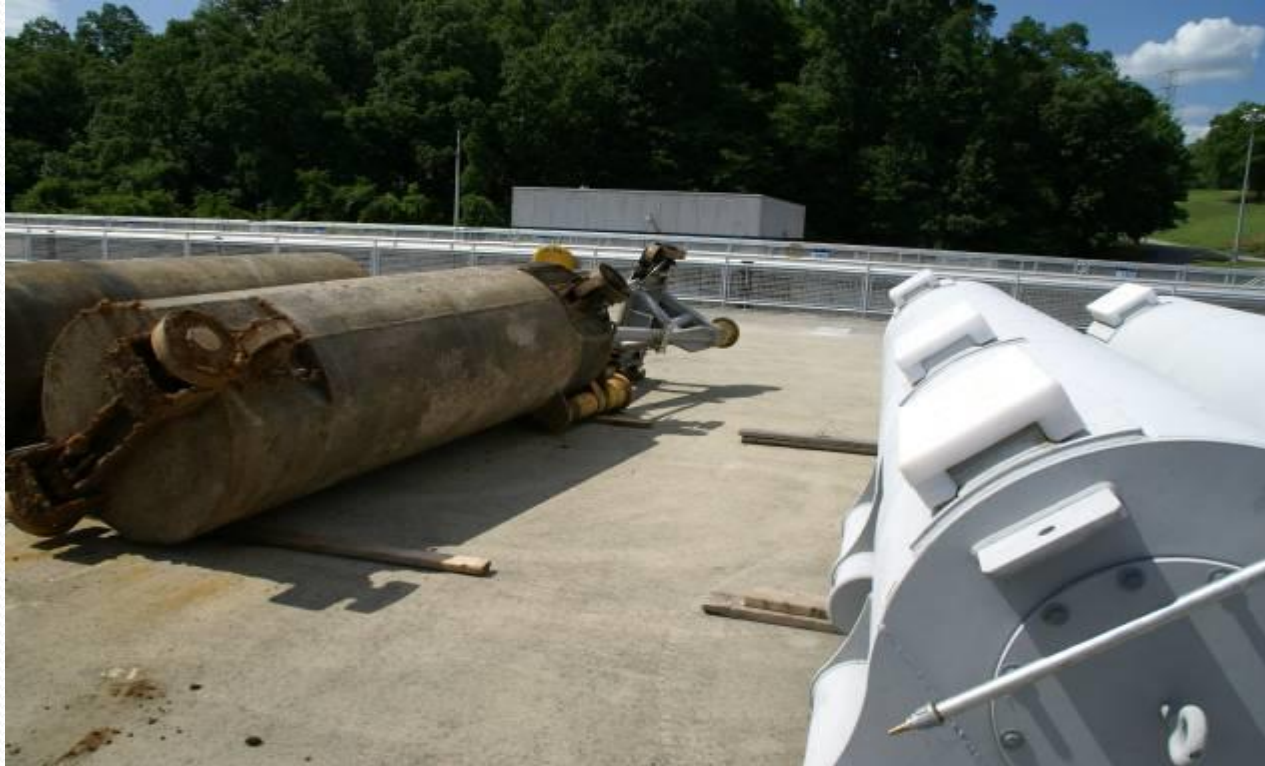
Replacing wheels on floating mooring bits with polymer slides.

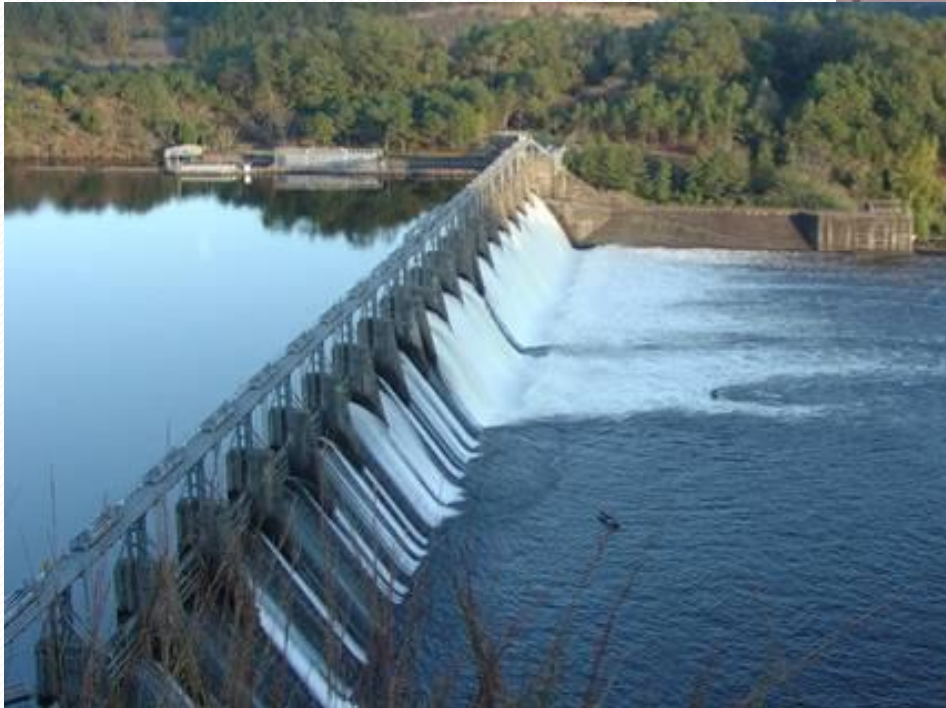
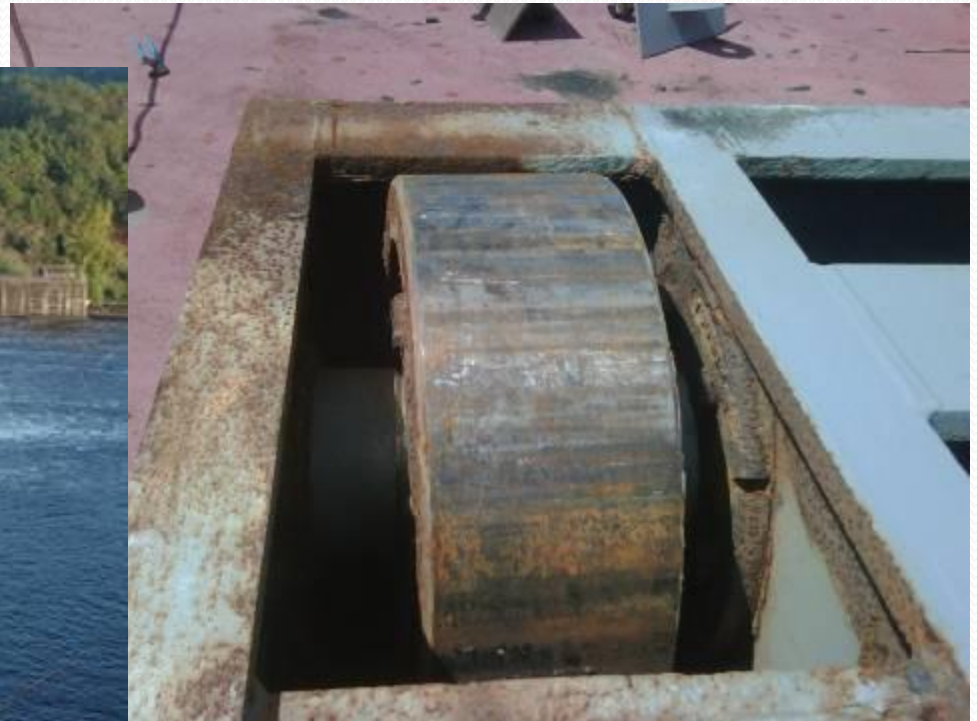
- The reaction rollers ceased up due to corrosion and drag when gate is raised or lowered. Design a repair using polymer composite glides with no moving parts.

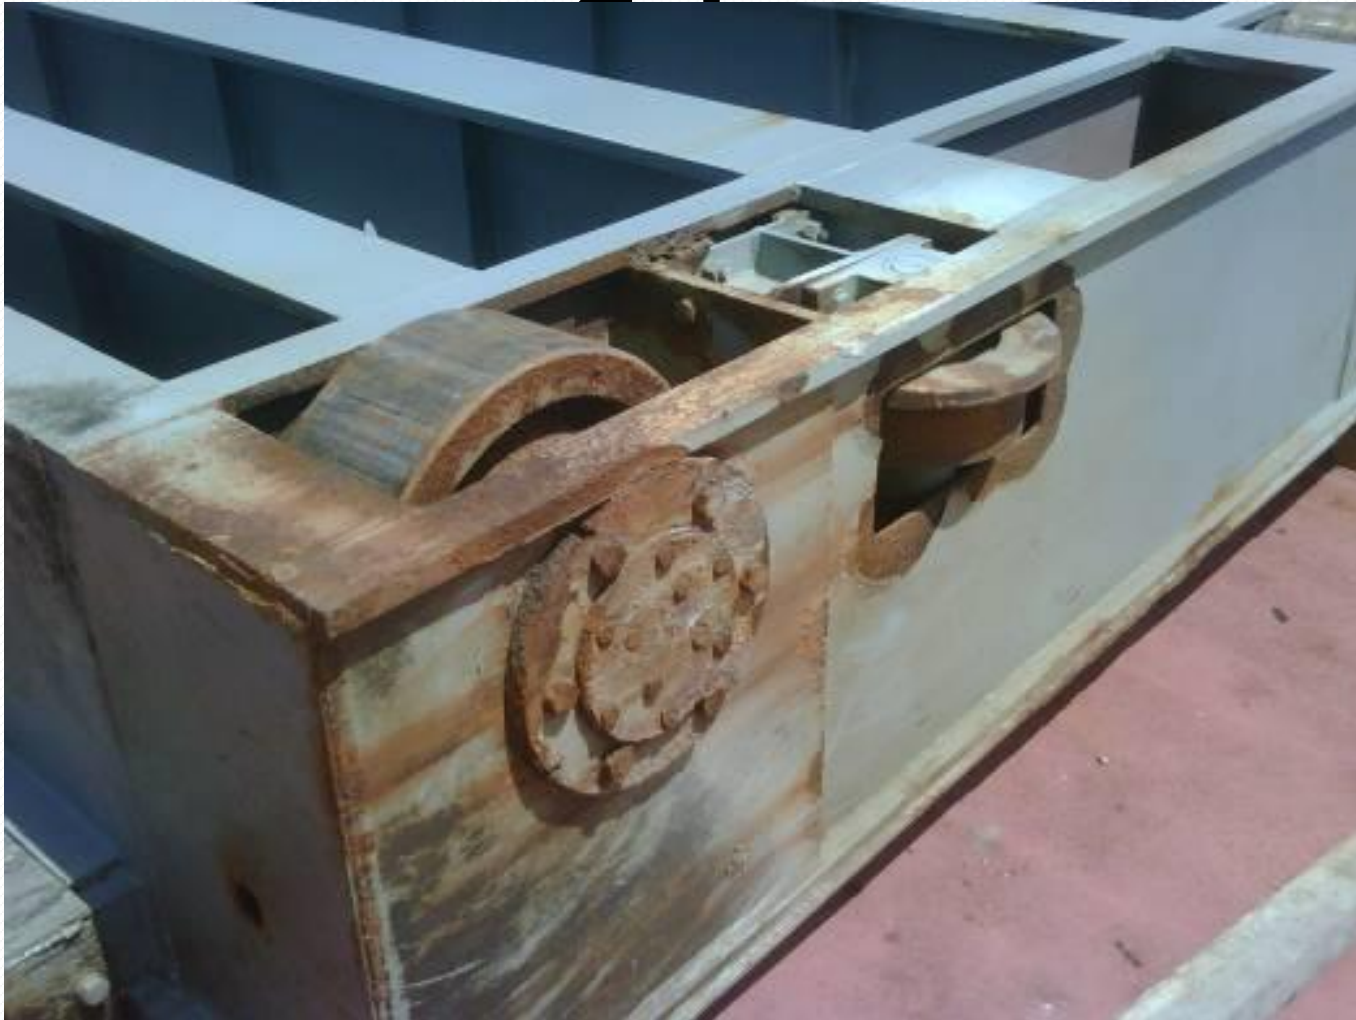
Rollers on lift gates no longer functioning due to corrosion that has caused the bearings to seize up.

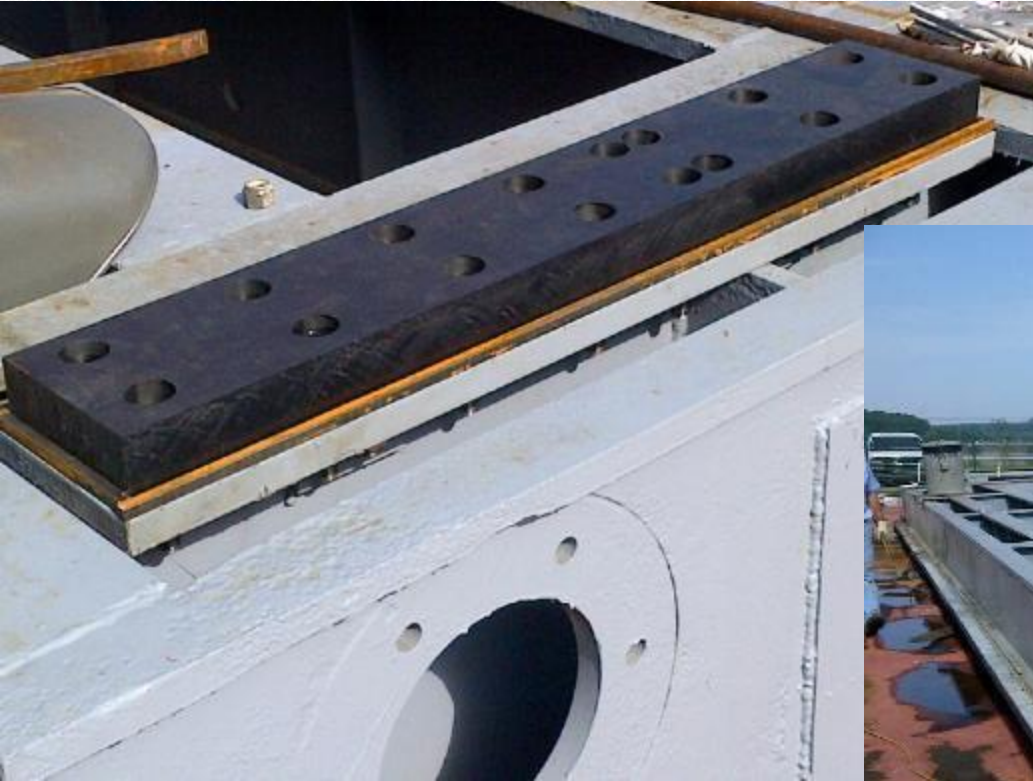
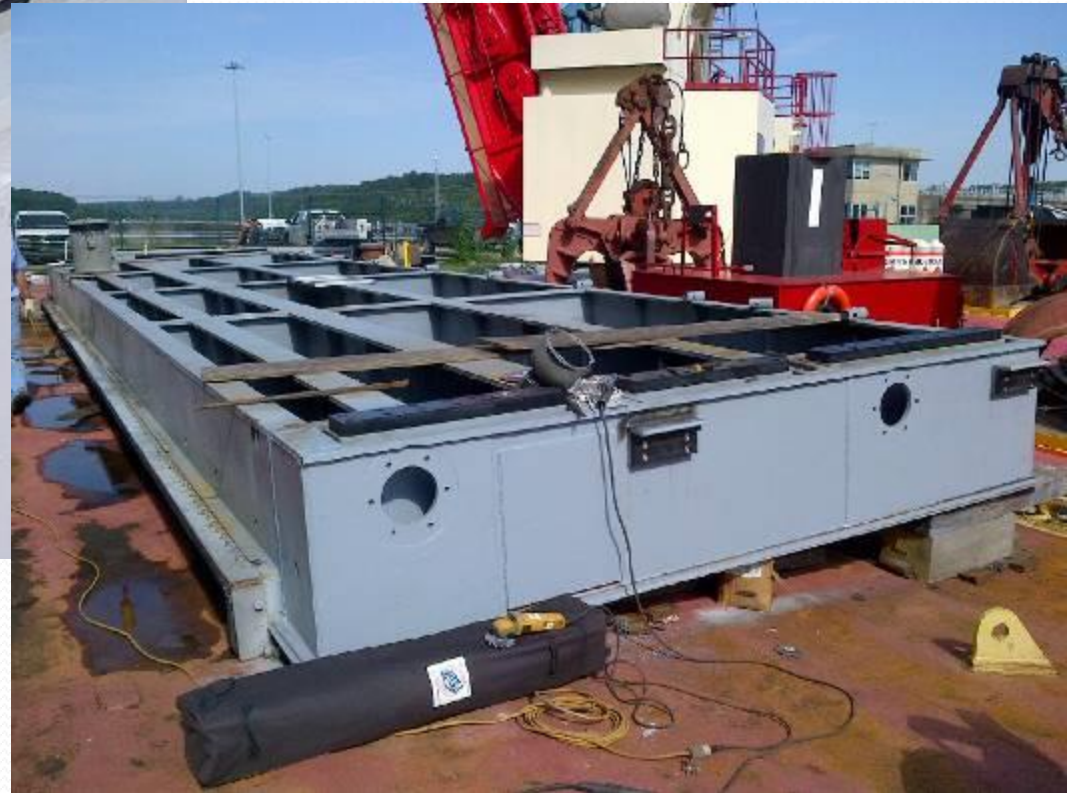
# New pads installed

## No moving parts

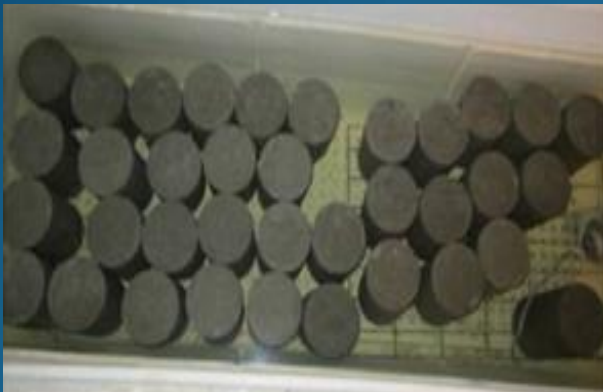
*Concrete cylinders (4"x8")- 36 cylinders*

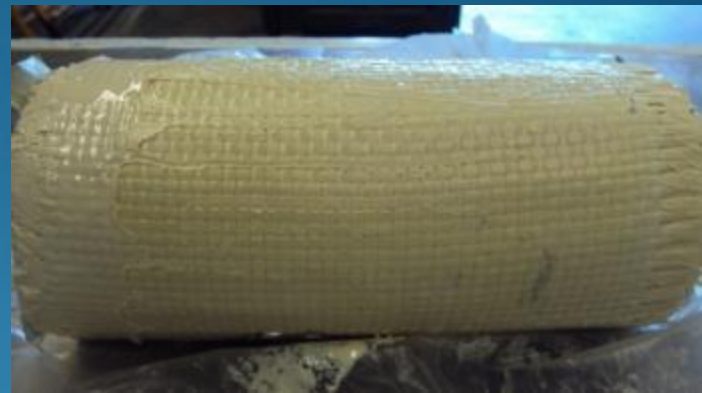
*Resin impregnated & heat resistant Aquawrap 142 °C (288 °F).*

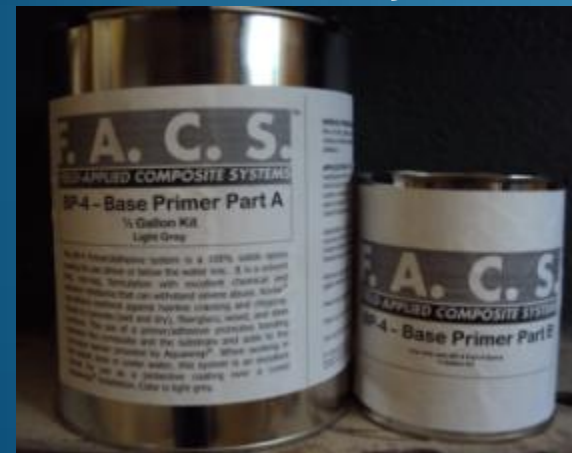
*BP-4 primer*

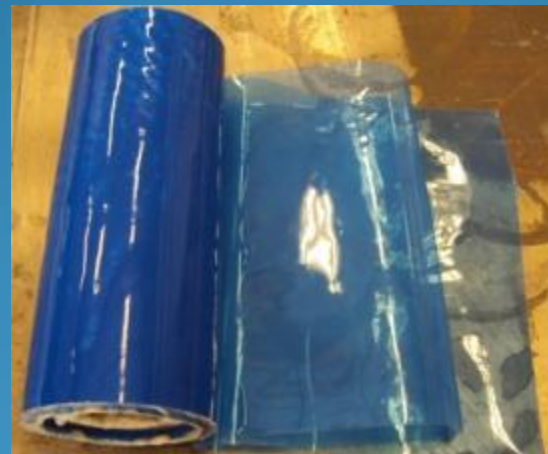
*Stricture banding  
(Compresses & consolidates Aquawrap)*

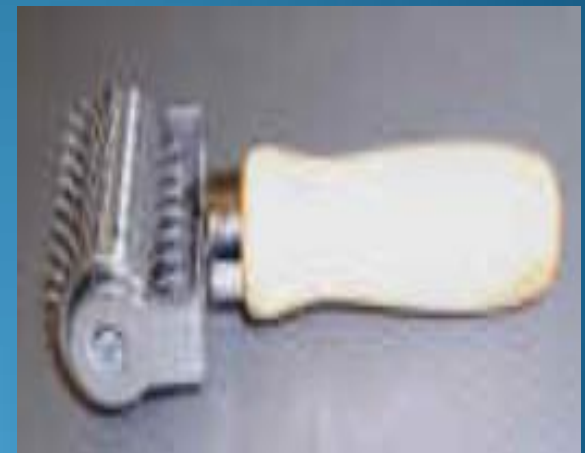
*Perforator tool  
(Releases curing generated gas buildup)*

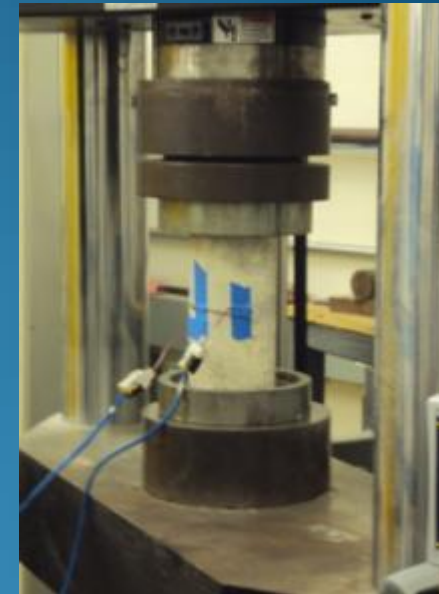
- ❖ Concrete cylinders with & without wrap (4"x8") were tested under axial compression (ASTM C-39).
- ❖ Cylinders were capped on both ends with elastomeric pads to achieve concentric axial loading.

*Compression tests on wrapped cylinder*

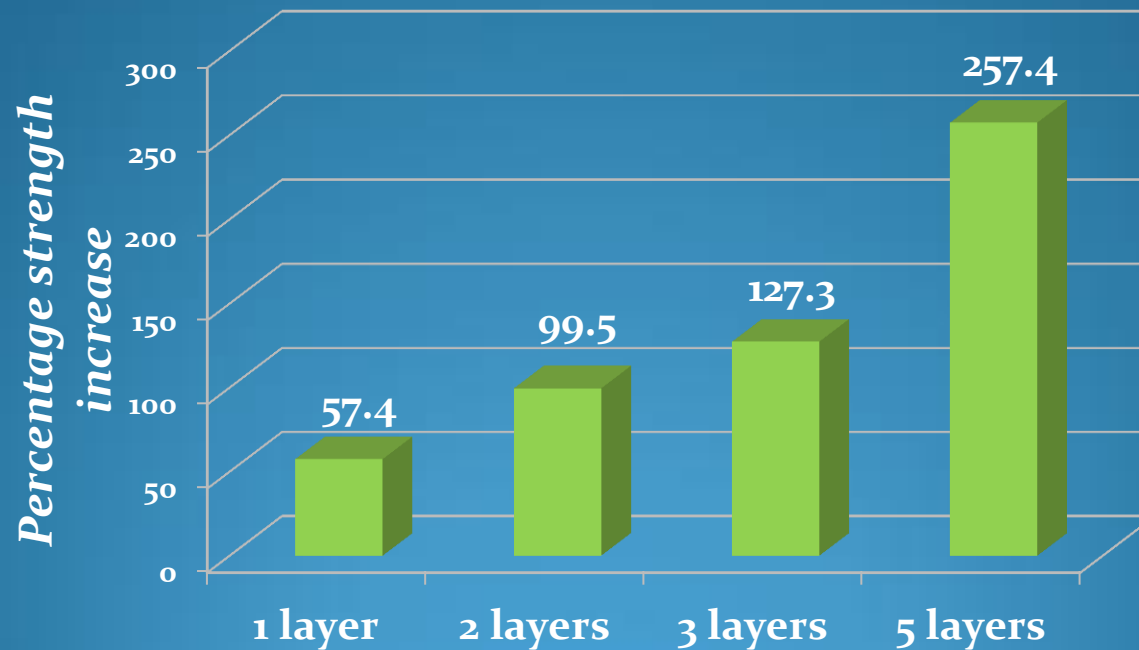
- ❖ Wrapped cylinders with 1, 2, 3 and 5 layers of Aquawrap showed an avg. strength increase of 57.4%, 99.8%, 127.4% and 257.5%, respectively.
- ❖ Average strength increase per layer was noted to be ~50%.

- ❖ Strength increase of ~50% per wrap for concrete cylinders.
- ❖ The Aquawrap materials were found to be in original condition after three months of installation on discharge ports in Chickamauga L&D, TN.
- ❖ Underwater curable composite wrap – easier and more durable than using steel jackets and grout.

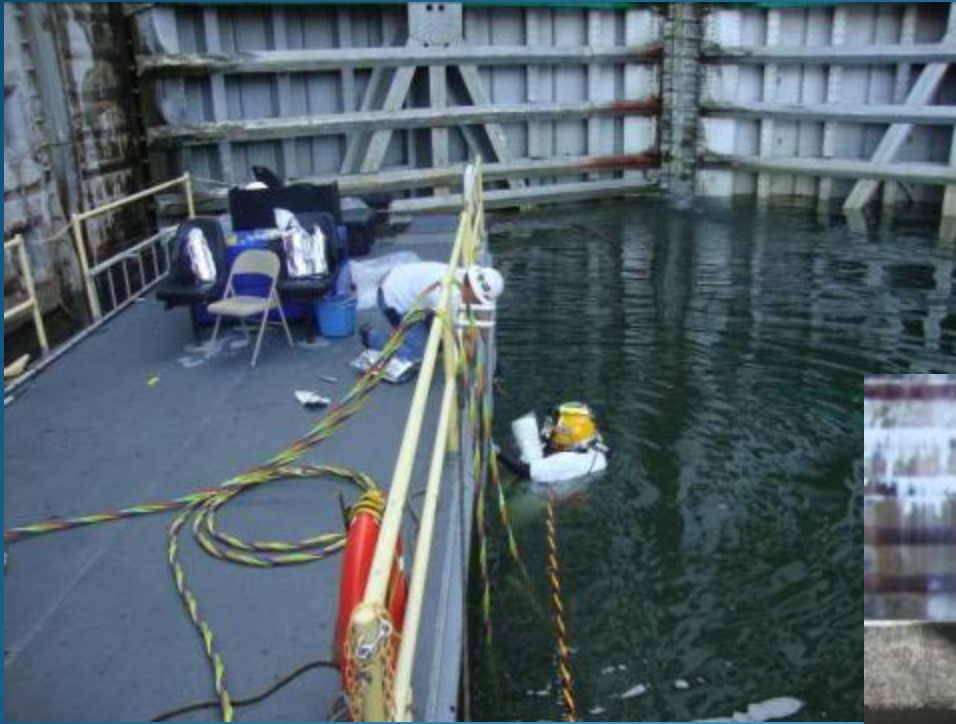
Video monitoring of installation – subsequent diving inspection has shown the composite wrap to look like the day it was installed.

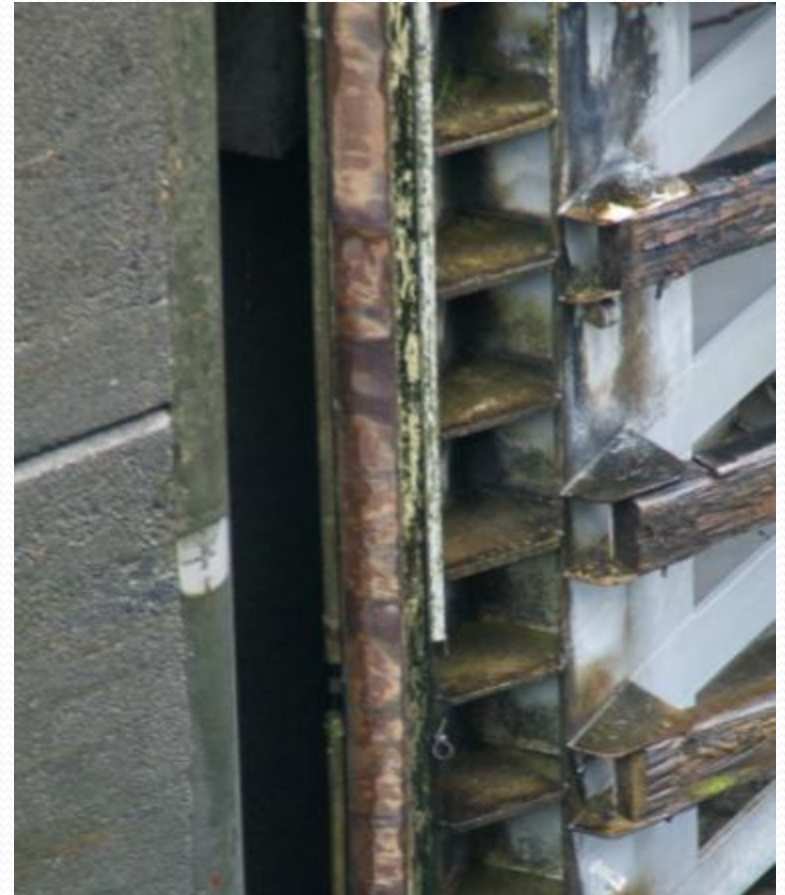
Corroded steel miter blocks.

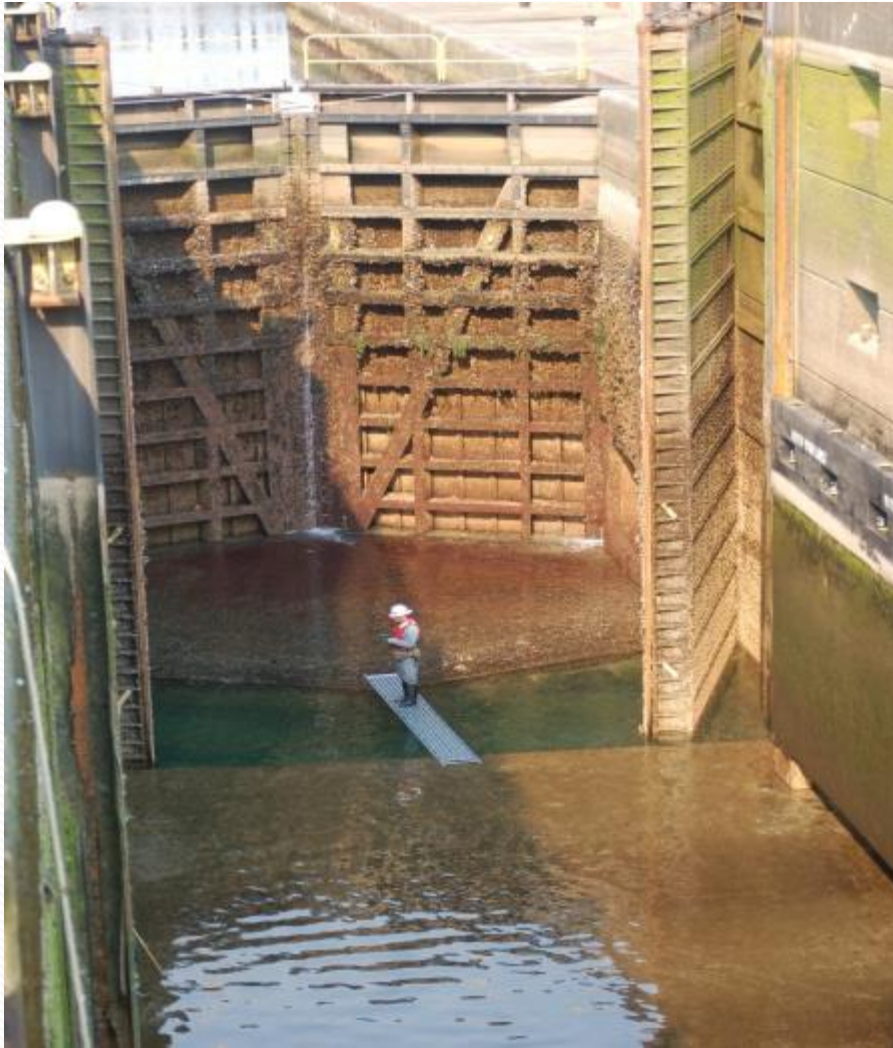
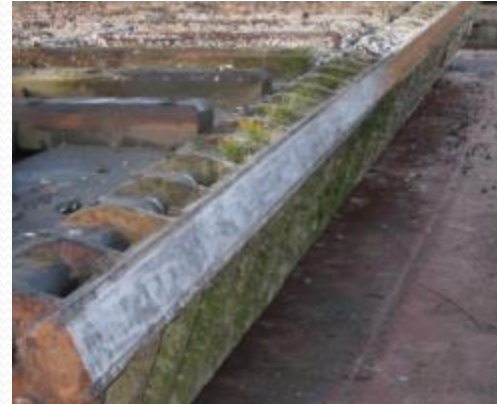
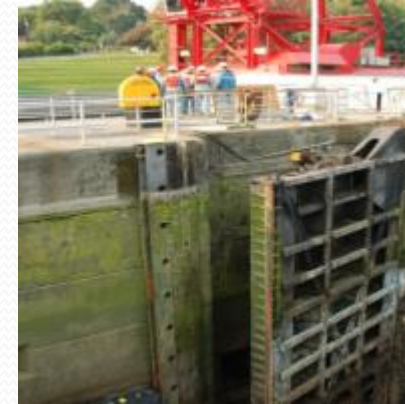
**Miter block required to withstand compressive pressure and 12,000 cycles of operation per year**

**Composites designed to resist hydro-static pressure, water-jet knife, and comp. pressure (70 kips/ft length)**

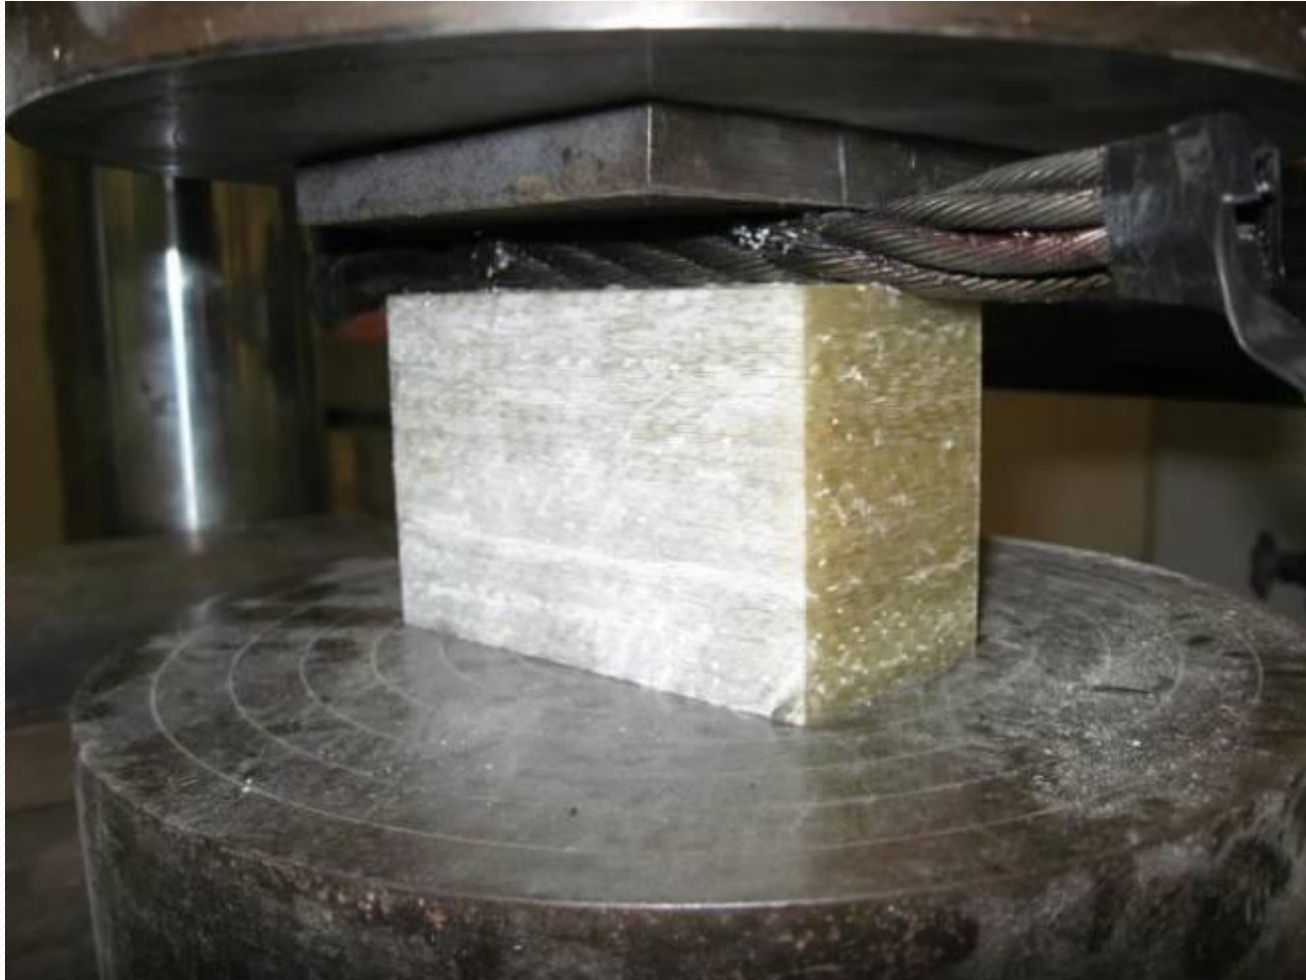
Pinching Behavior with Foreign Object

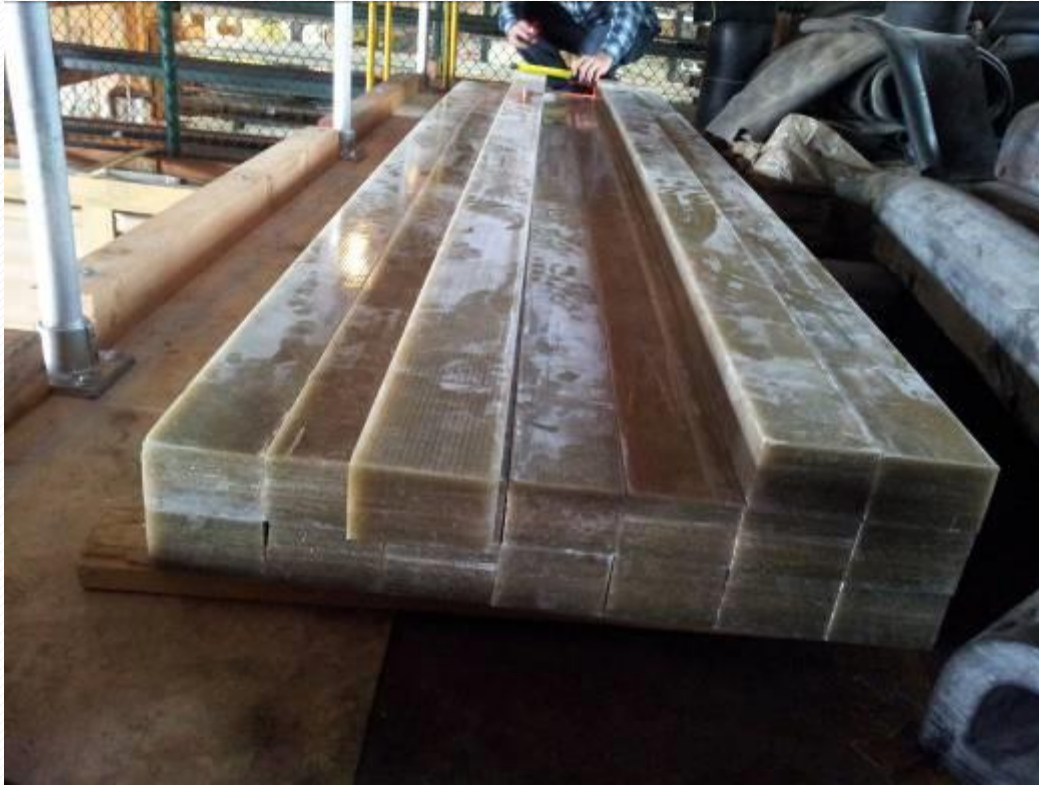
FRP composite miter blocks selected survived 50 ksi that far exceeds the required 1.4 ksi with no cracking after fatigue load in excess of 500,000 cycles. Scheduled for installation during dewatering in October 2014.

- ❖ Solid FRP miter block met strength requirements under both the static and fatigue loads, carrying an average failure stress of 51 ksi (vs. required 1.4 ksi). Additional warping studies are underway. Non-corrosive and better sealing.

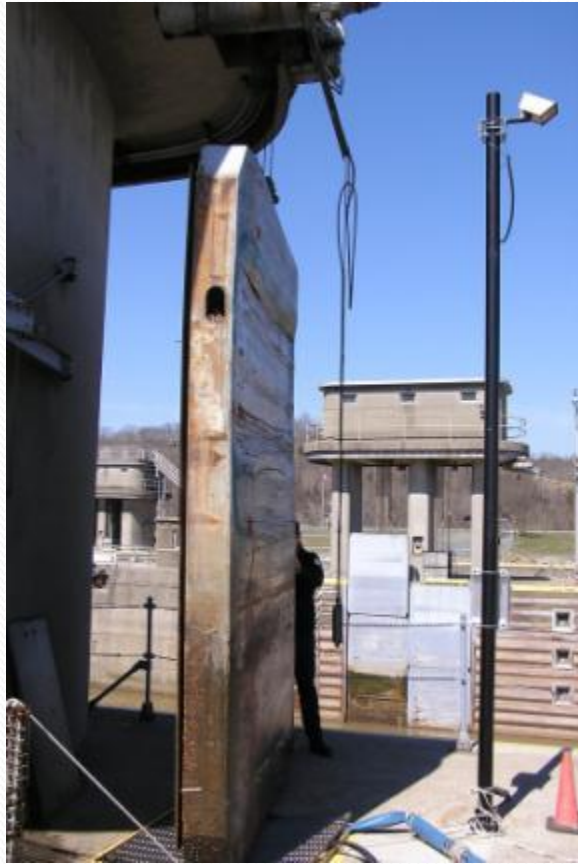
10'x12' steel protection panel with heavy weight & corrosion

Existing panel is requires difficult and extensive welding to fabricate

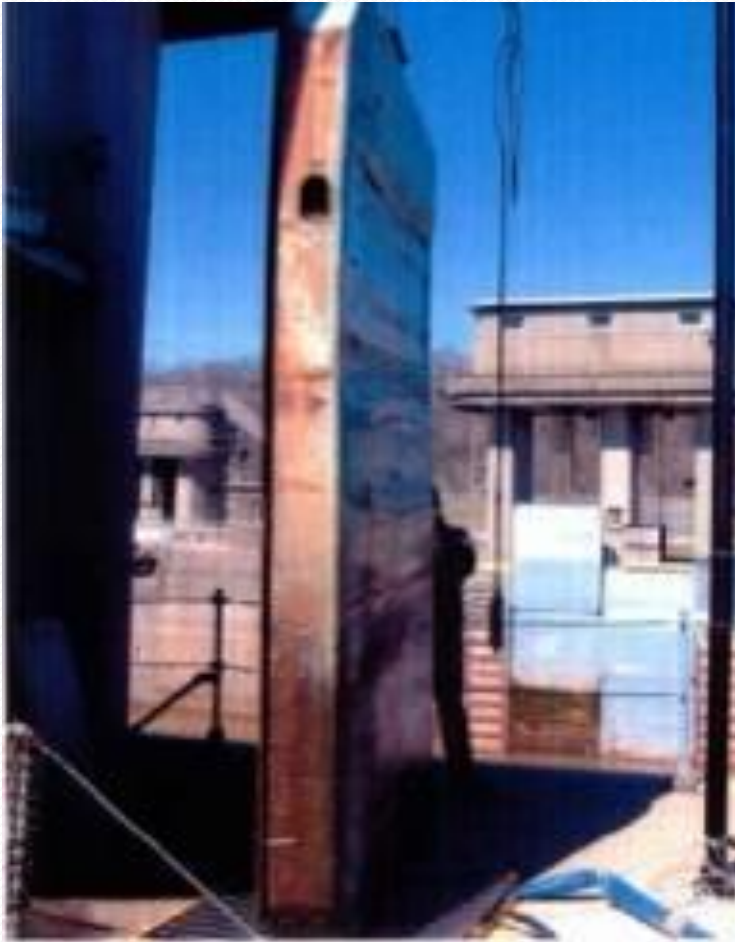
Current steel panels

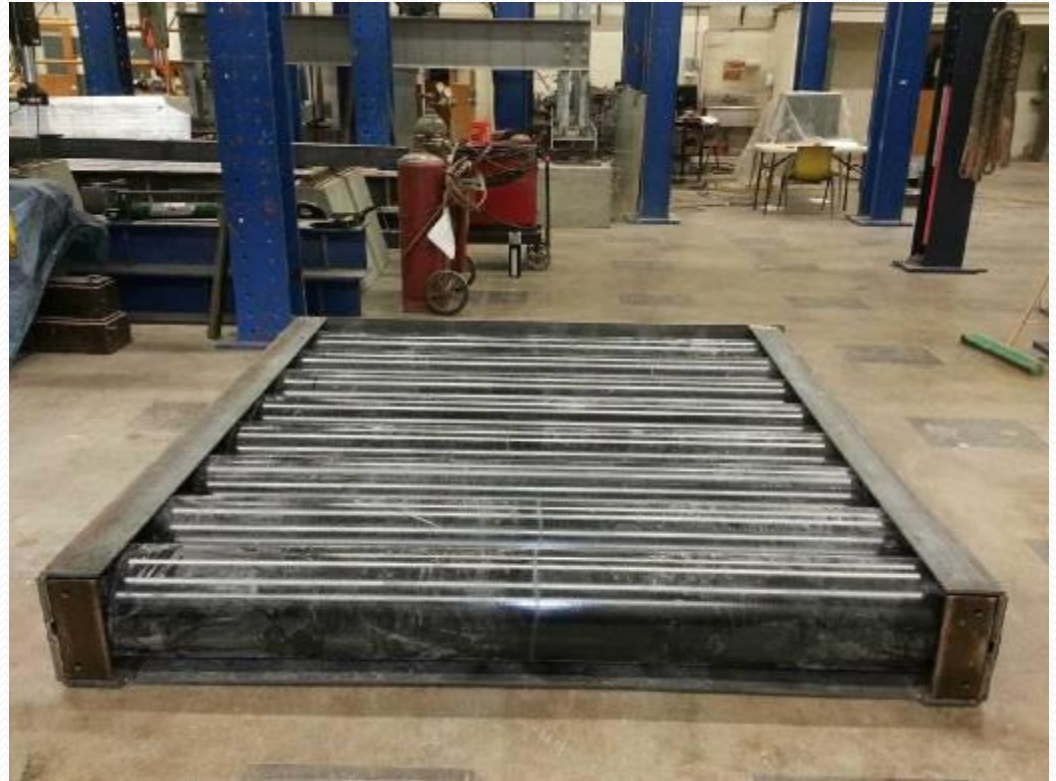
Initial tube and plate design

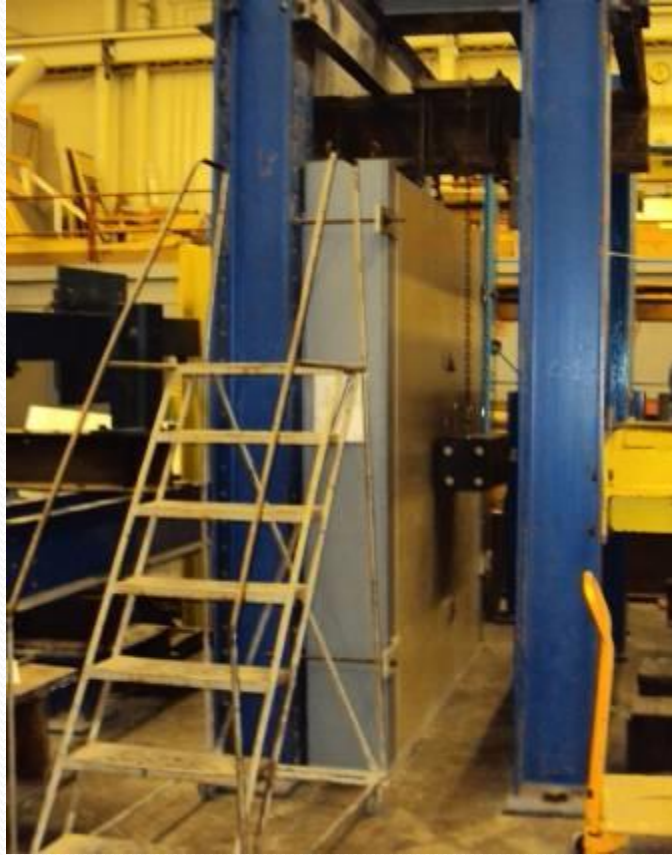
FRP hex sections  
with shear keys

Laboratory testing

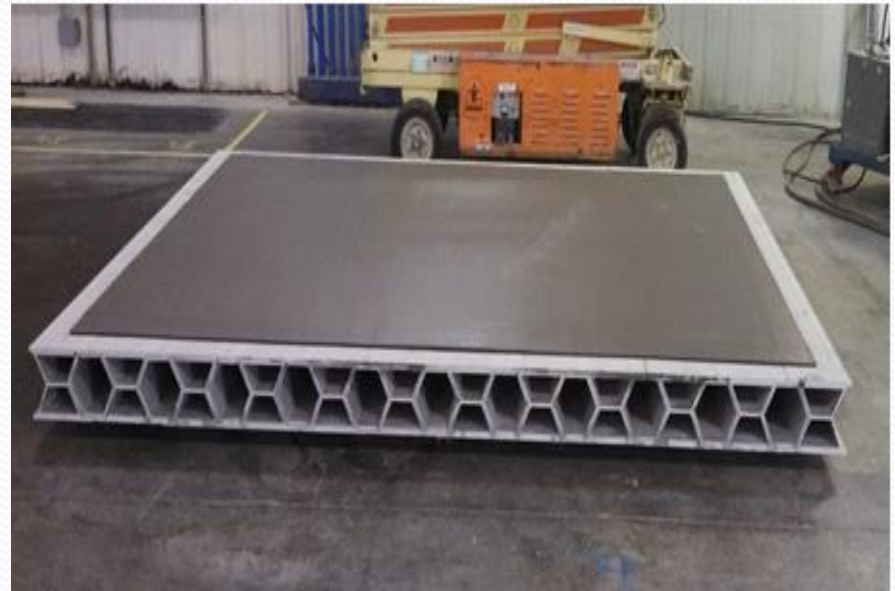
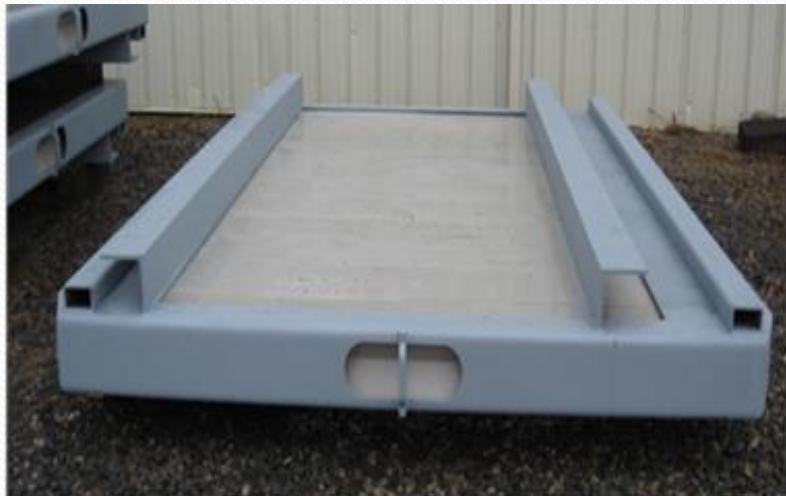
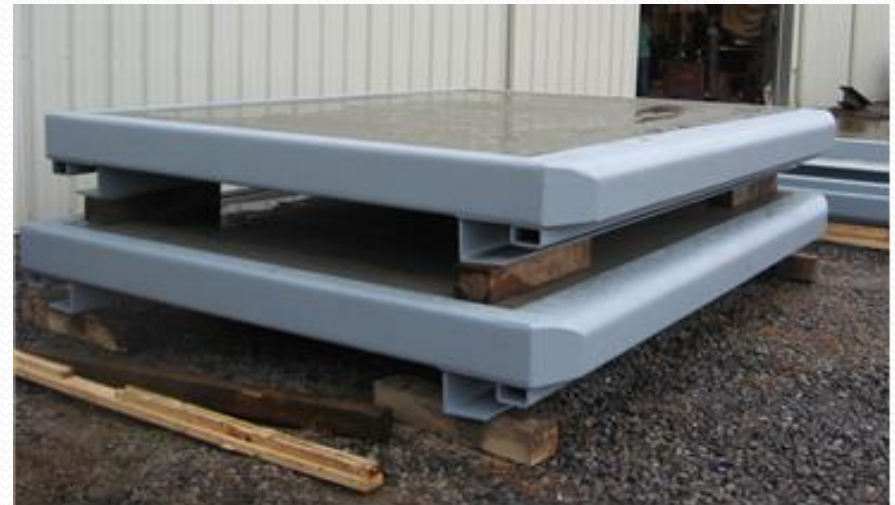
FRP superdeck required an edge steel frame housing.  
Finished panels to be installed Spring of 2014.

Hexagonal FRP superdeck panel system showed excellent energy absorption characteristics. Steel panels costly, heavy, and they corrode – designed using off-the-shelf products.

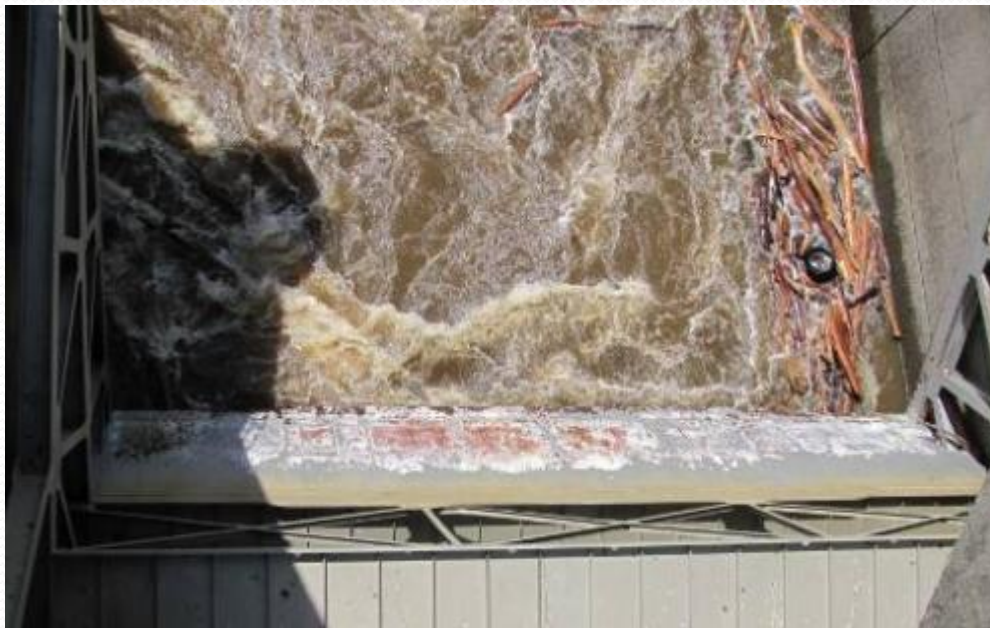
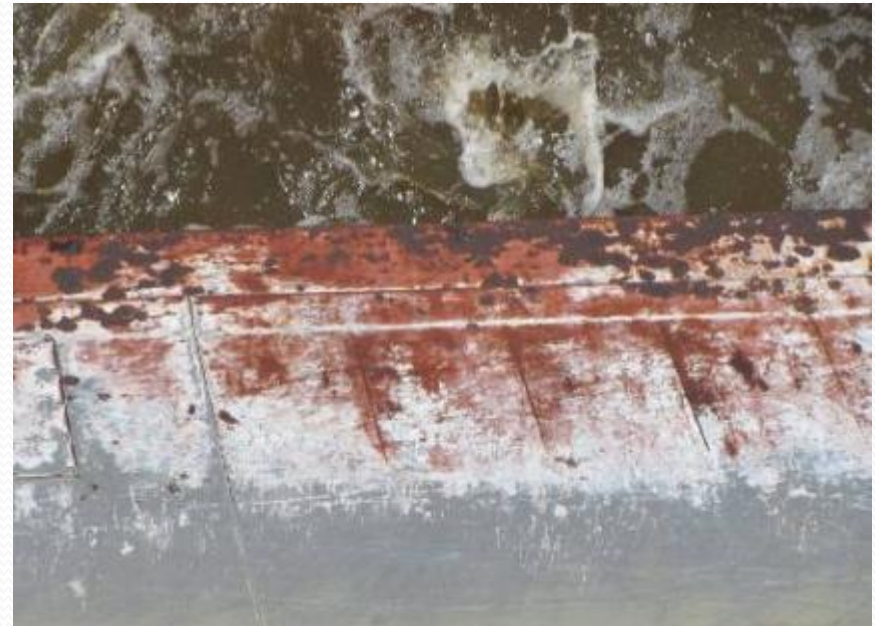
- **Abrasion - Resistant Overlays for Tainter Gates at Heflin Dam, AL.** Swirling debris quickly damages traditionally used vinyl coatings.

Use organic and ceramic composites for overlays

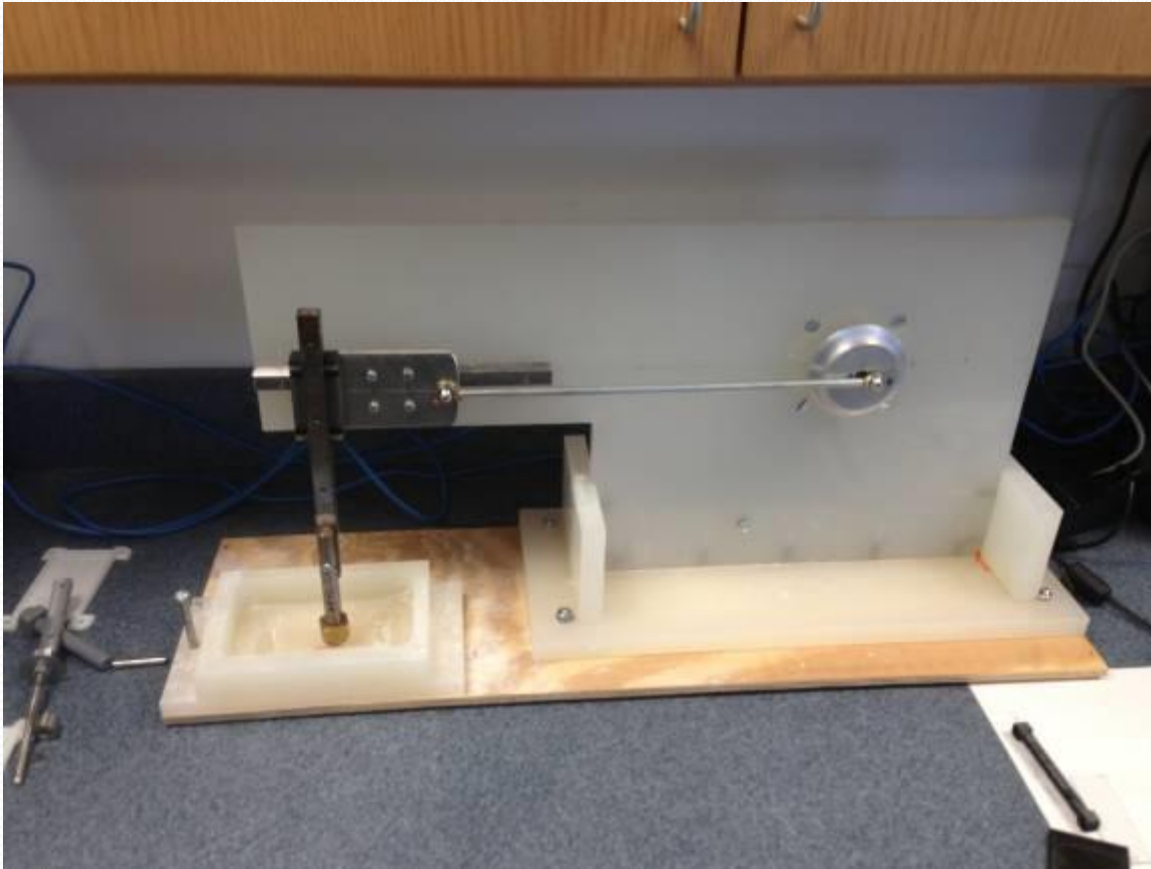
Reciprocating Abrading Steel Ball System (L) with Computerized Control & Profilometer (R) (Note: the tank will accommodate both securing of specimen and conditioning with liquid)

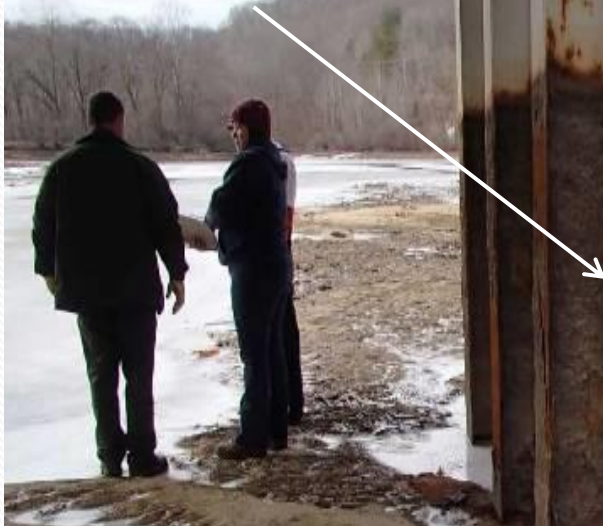
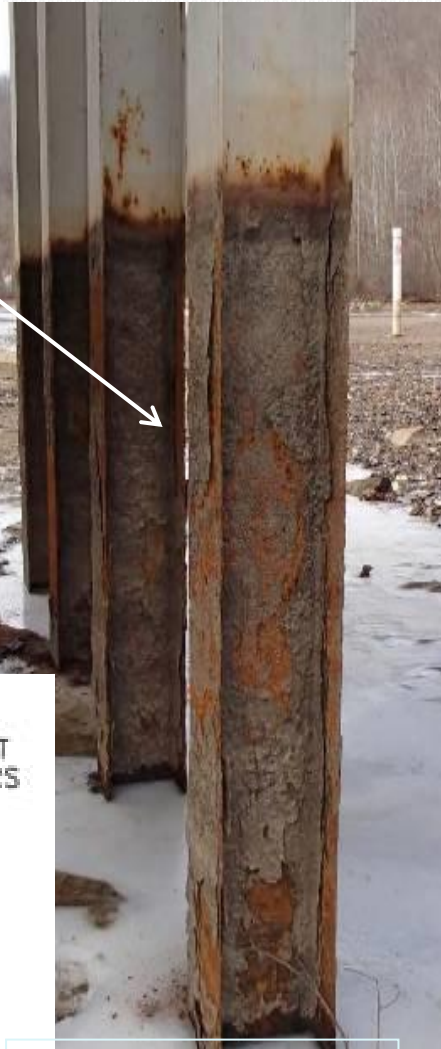
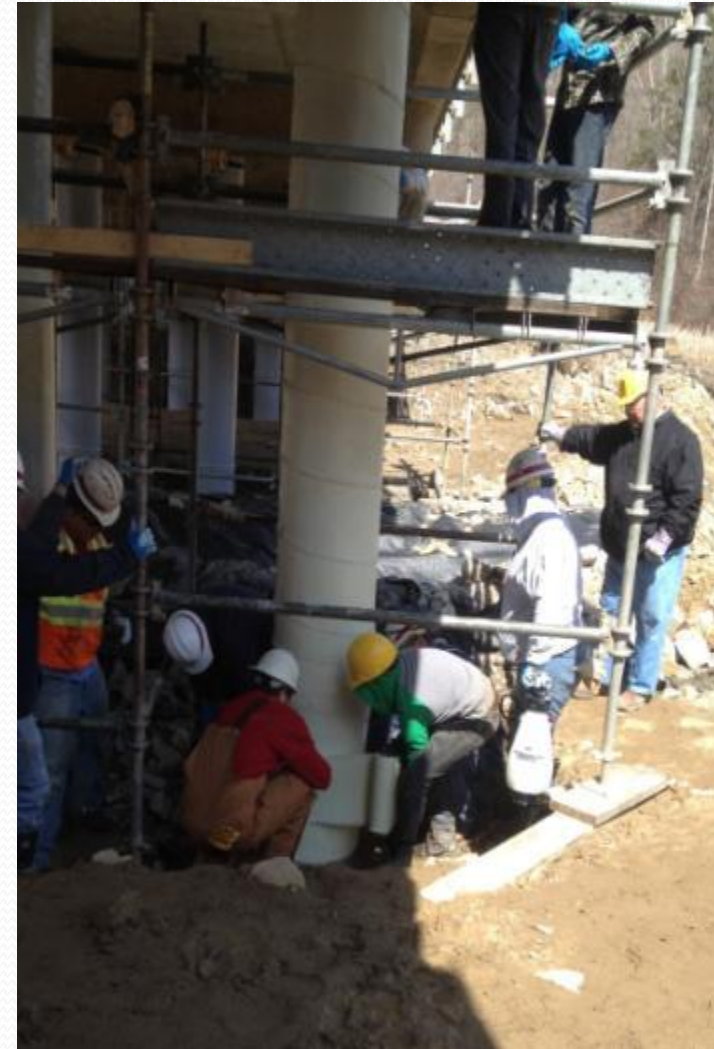
Significant section loss

Repair design

Wrapping the piles with FRP

Conventional fix of welding steel plates only good for 10-15 years. Corroded steel piles were rehabilitated to original load capacity with FRP jackets at 35% of cost using conventional methods.
