# FRP COMPOSITES FOR REHABILITATION OF HYDRAULIC STRUCTURES

Vijay P.V., P.E., WVU

John D. Clarkson, P.E., US Army Corps of Engineers

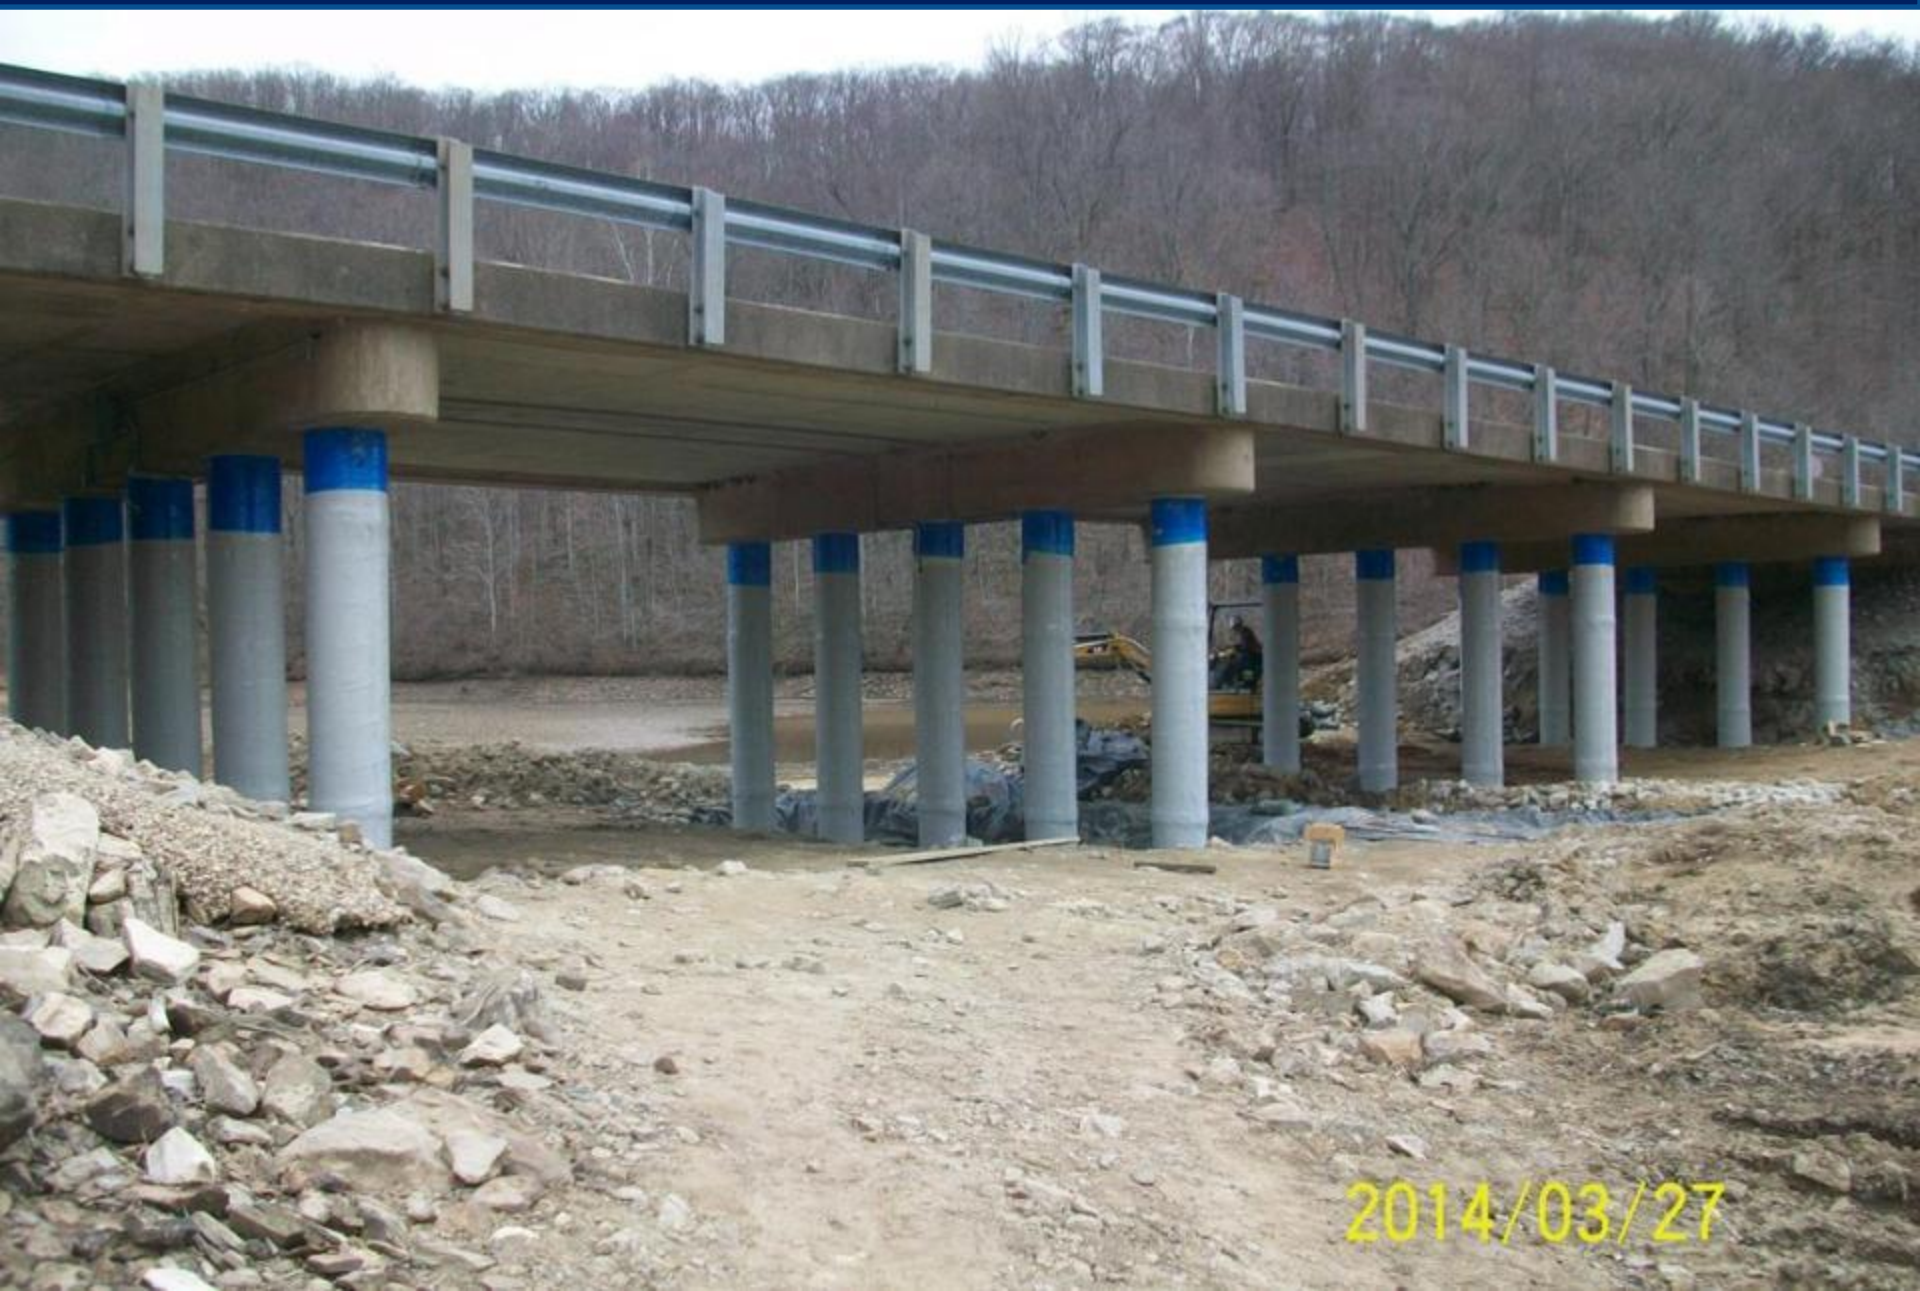
# 5- FRP SHELL AND WRAP WITH SCC FILLING

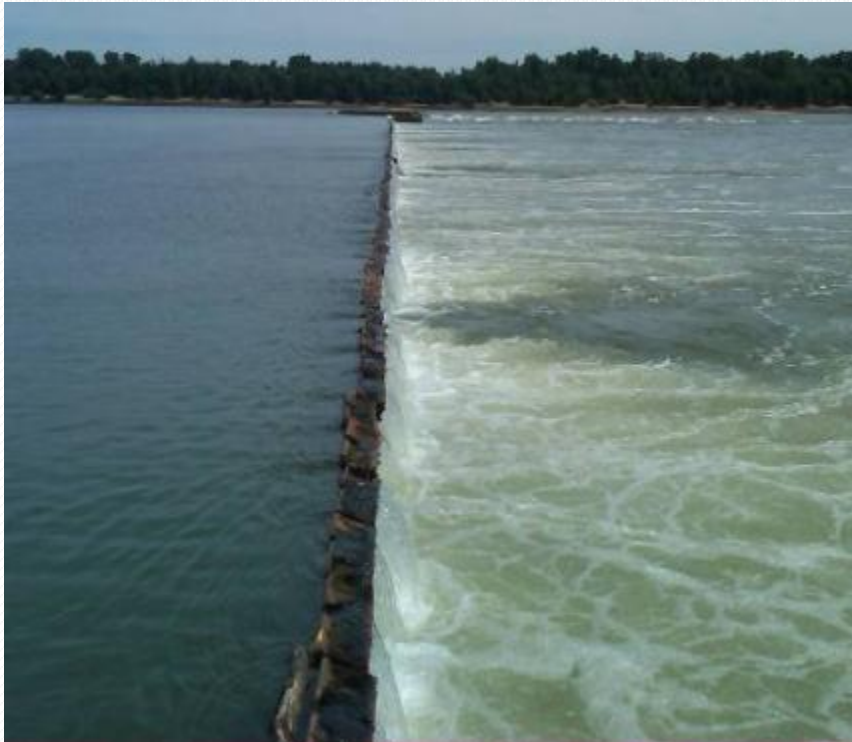
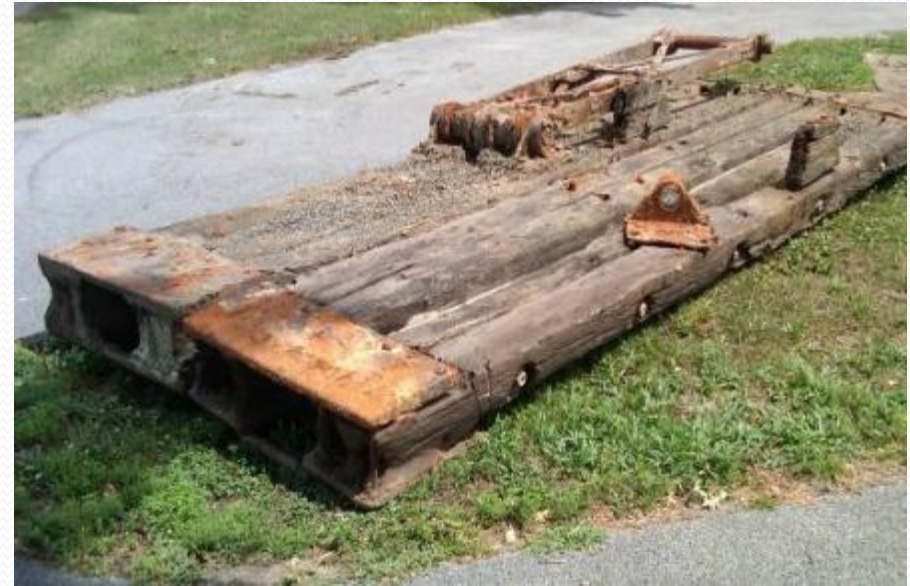
Rapid and severe deterioration in traditional wooden wickets. Replacement is costly.
