TRB Innovative Technologies for a Resilient Marine Transportation System 3rd Biennial Research and Development Conference, June 24-26, 2014, Washington, DC

Rehabilitation of East Lynn Lake Bridge Steel Pile Bents With Composites

Overview of East Lynn Lake Bridge, WV - Steel H-pile Rehab with Composites Project

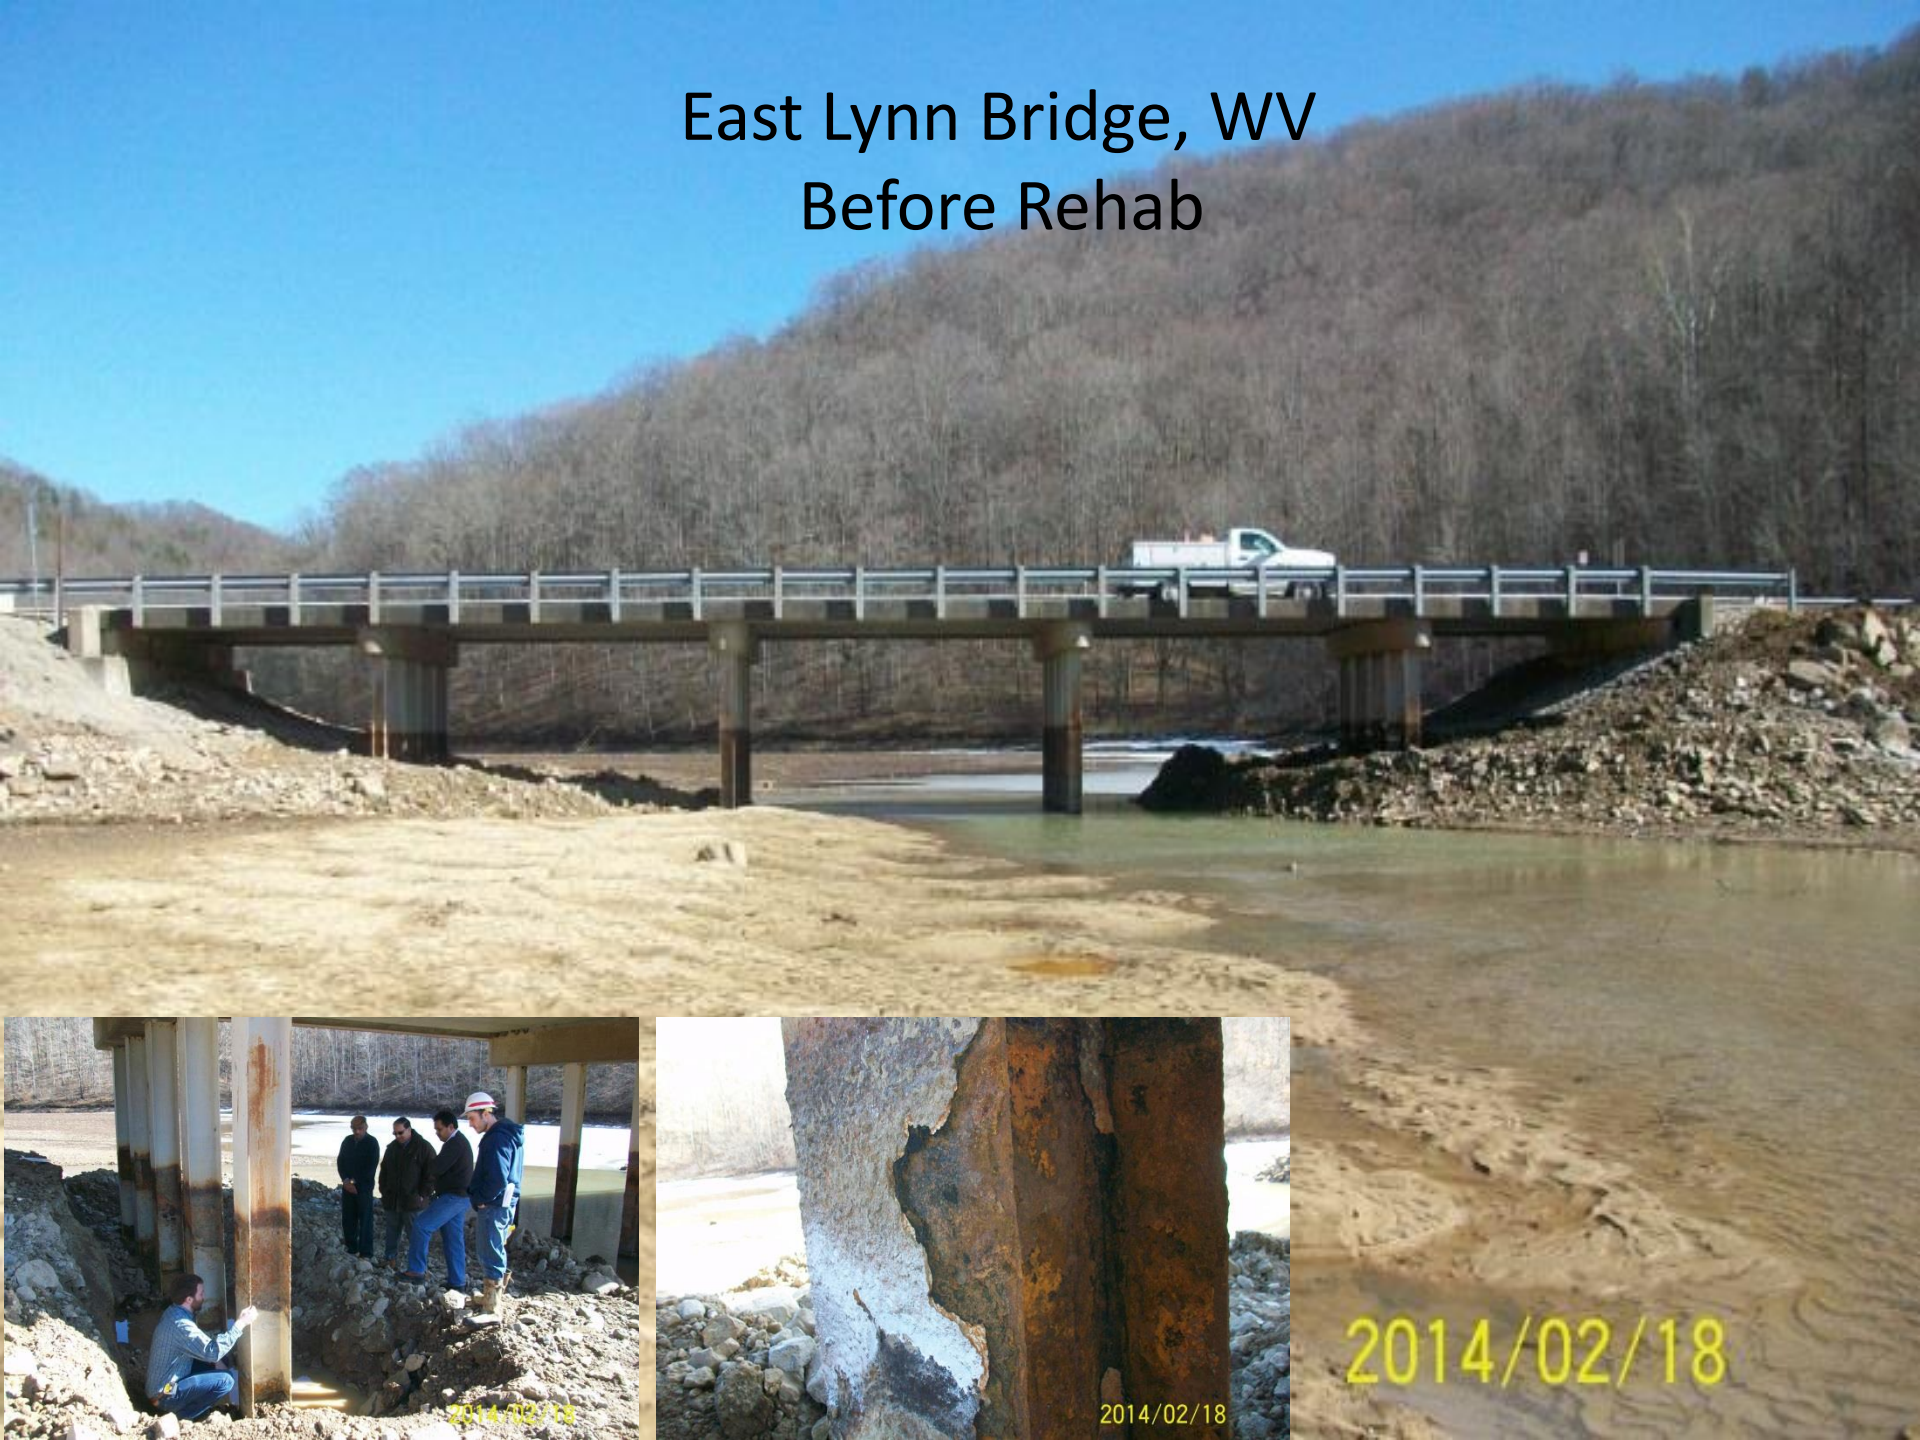
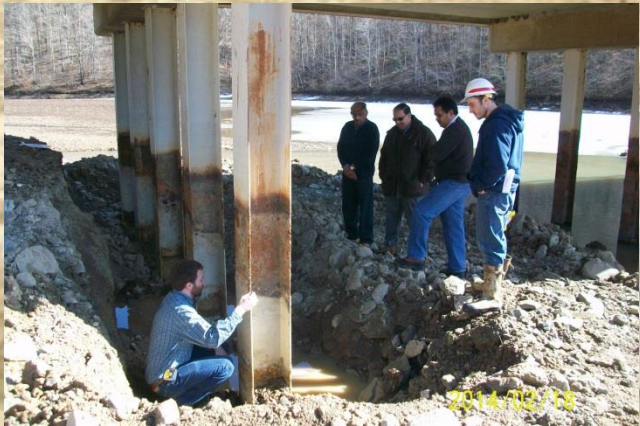
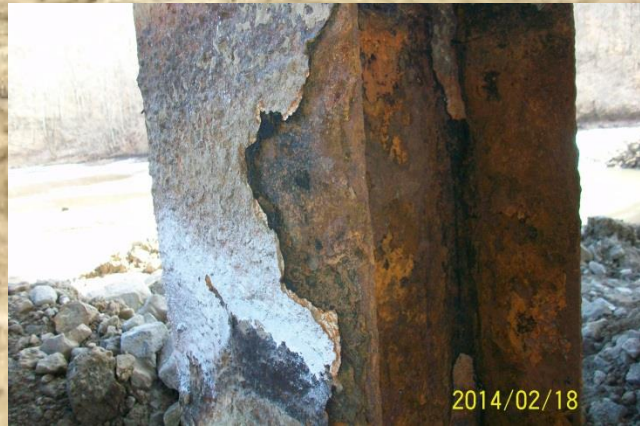
East Lynn Bridge, WV Before Rehab

Corrosion of H-piles resulted in section loss up to **50%**, load rating of **6 tons**, speed reduction to 10 MPH, and one lane closure.

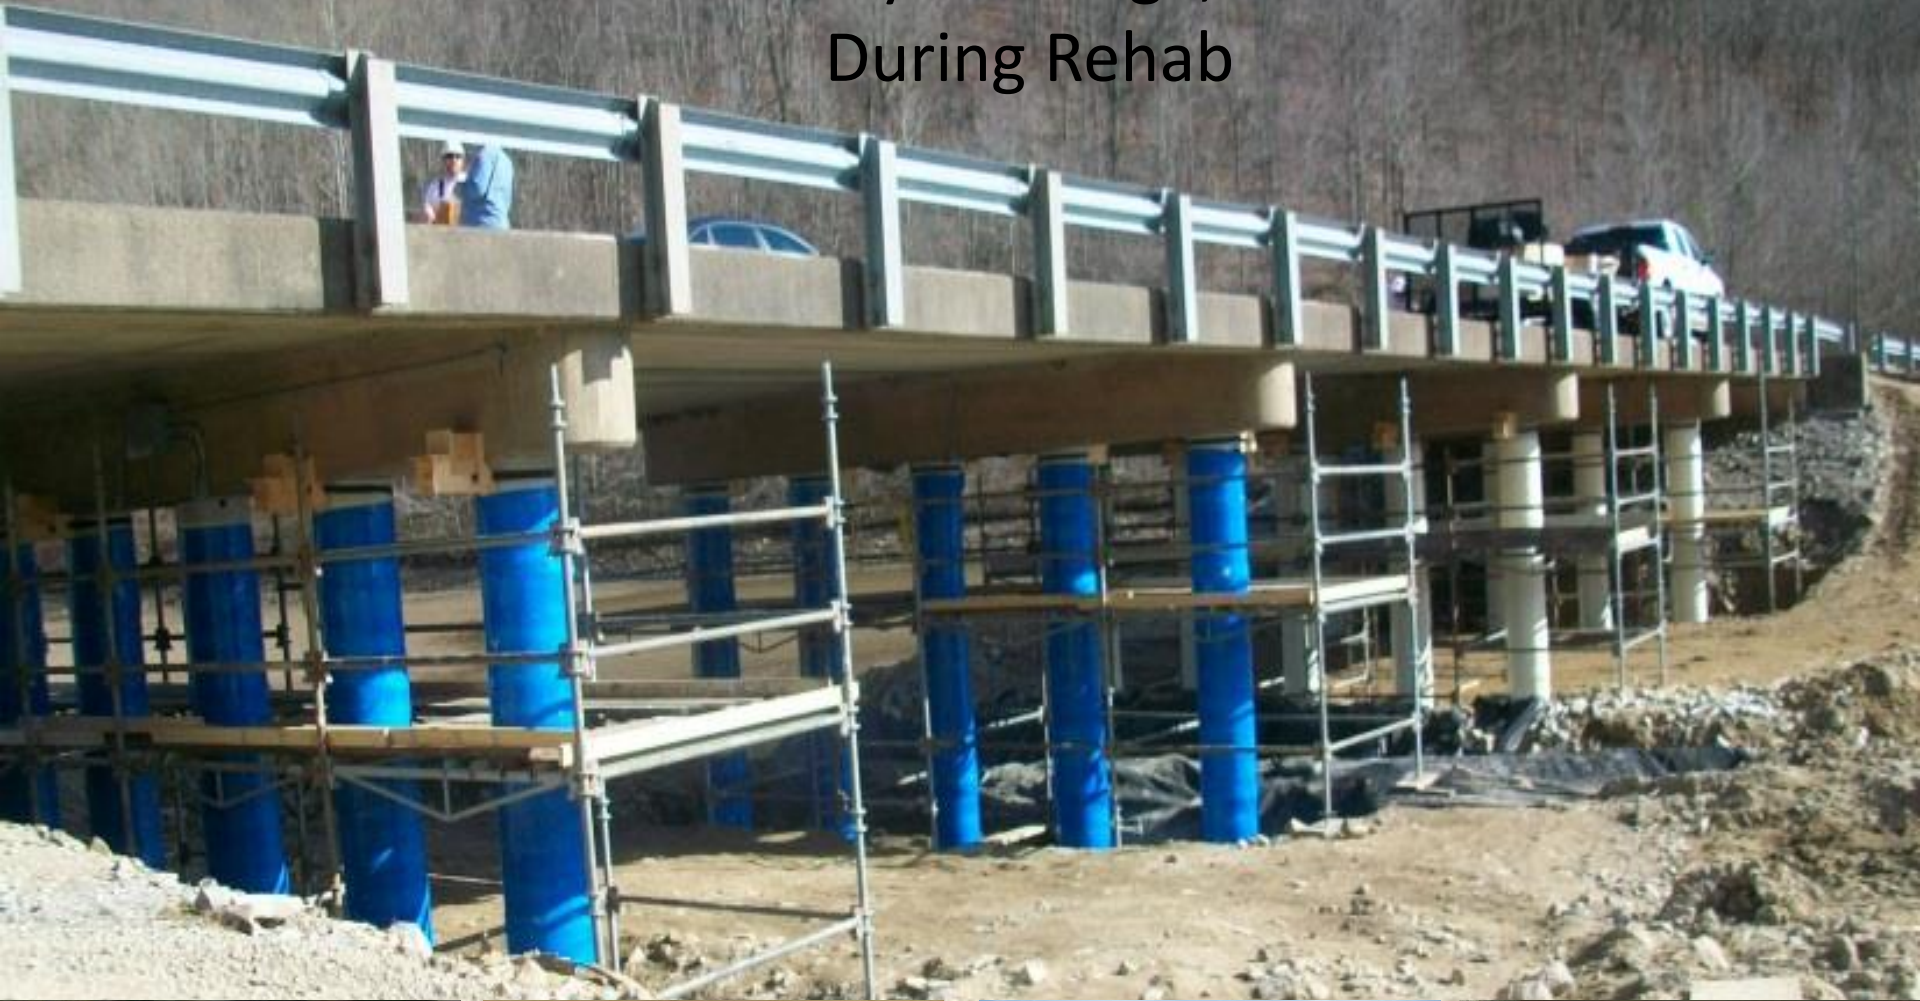
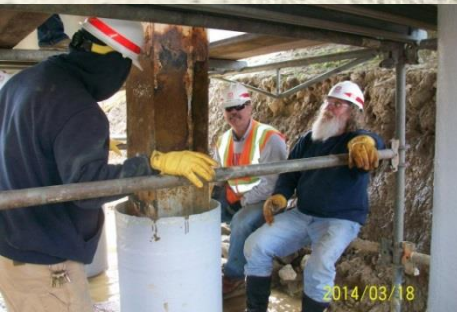
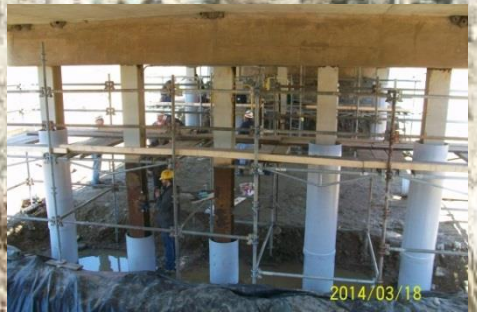
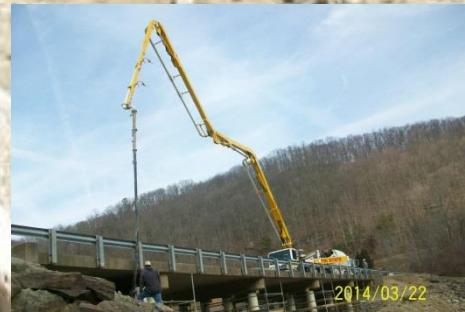
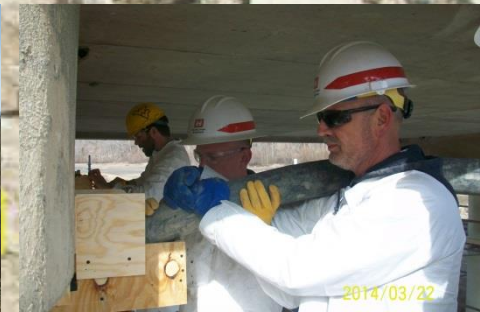
East Lynn Bridge, WV During Rehab

- 1) Polymer concrete as a foundation barrier where FRP shells and SCC concrete rest on;
- 2) Glass fiber reinforced polymer (GFRP) composite shells/jackets of 20" in diameter to enclose steel piles;
- 3) Self-consolidated concrete within the shell surrounding H-piles;
- 4) Glass FRP fabric wrap over FRP shell.

Advanced FRP composite materials were used to bring the bridge back to original design capacity at **25%** of conventional construction cost in **3 weeks**.

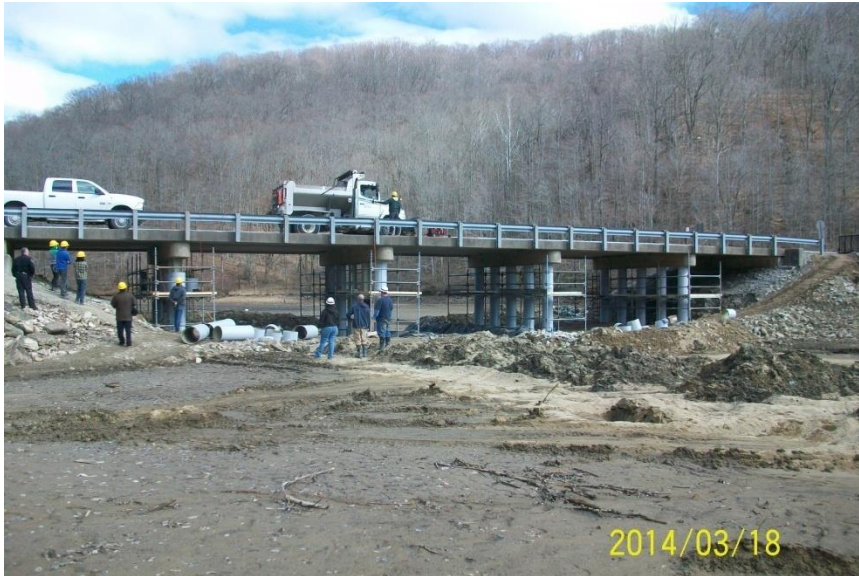
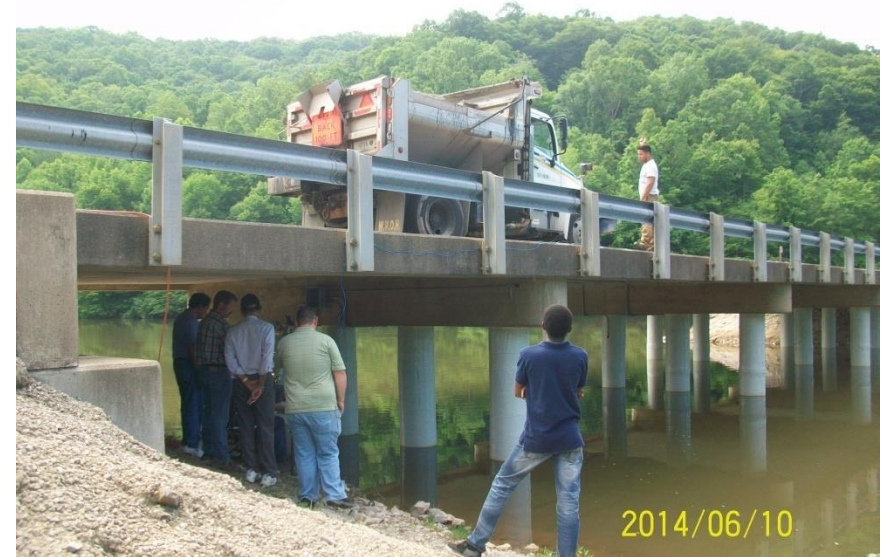
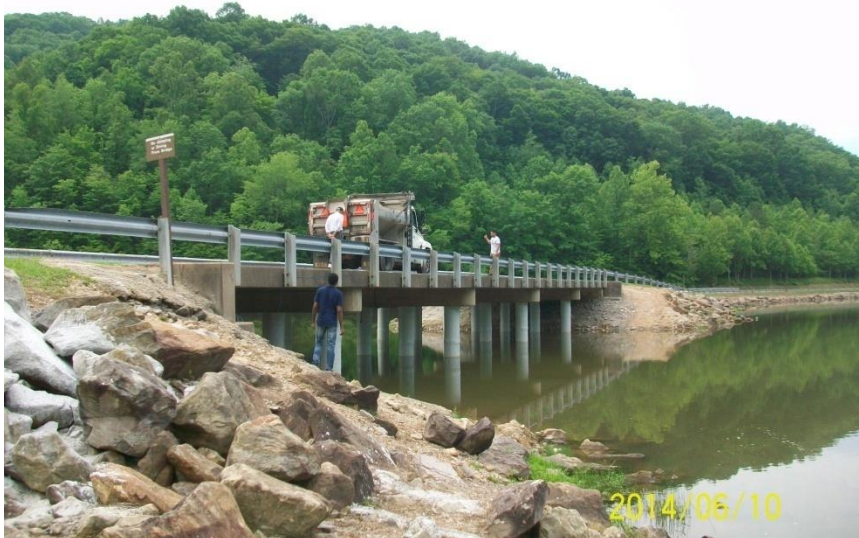
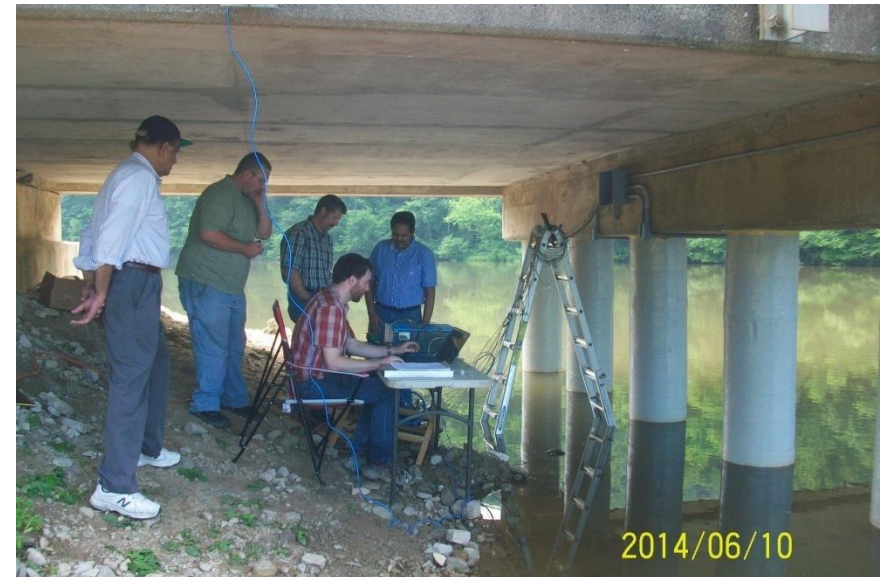
Pre- and Post- Repair Load Testing

- Advanced composites were successfully used to retrofit heavily corroded steel piles and have transformed a deteriorated bridge into a new structure.
- The load tests revealed that the load carrying capacity was enhanced 10 times higher under static loads and 3 times higher under dynamic loads.
- This work demonstrated several composite advantages: 1) design flexibility, 2) innovative, 3) rapid deployment, 4) cost-effective, 5) outstanding performance.
- Composite rehab approach offers great potential for strengthening a wide range of timber, steel, concrete structures and will play an important role in sustaining existing constructed facilities.

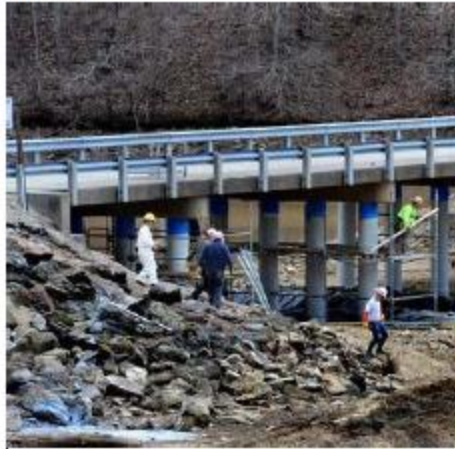
West Virginia University engineering students remove scaffolding f Lynn Lake after its piers were fixed with a WVU-designed repair p

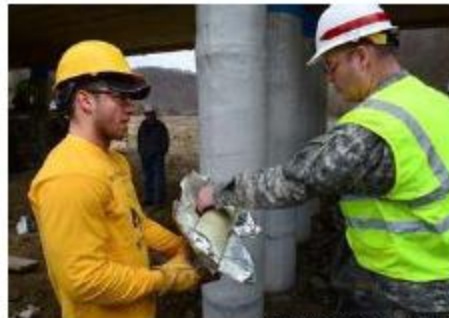
Huntington District Corps of Engineers Col. Leon F. Parrott looks at a roll of composite wrap used on the bridge piers and being held by engineering grad student Luis Perra.
