Impacts of Winter 2015

William McClellan
Assistant General Manager Rail Ops

MBTA Boston, Mass

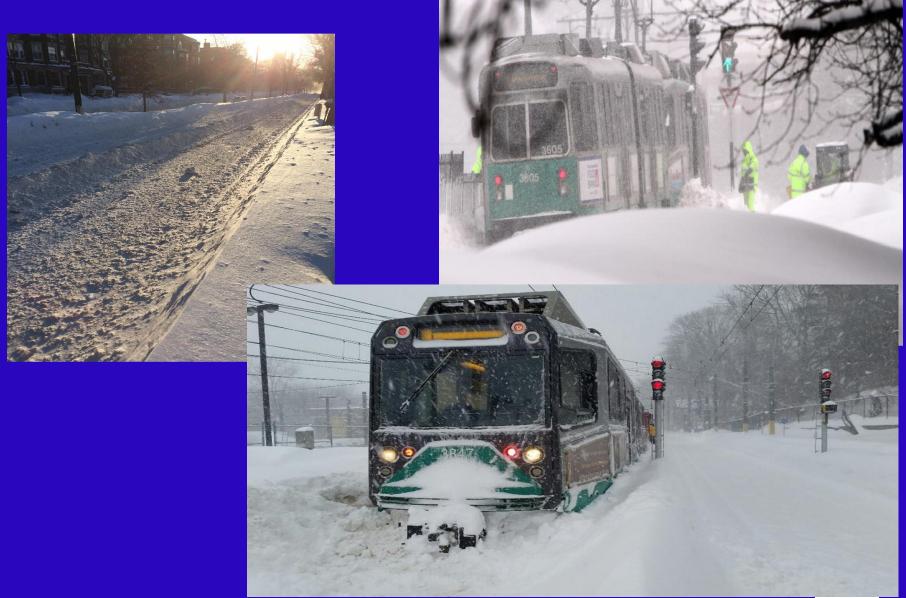
...with severe impacts

- Up to 8" of ice coating rails
- Up to 6' snow drifts along Right of Way
- 2-3 feet of snow
- Significant snow accumulations and bitter cold severely disrupted MBTA operations
 - Interlocking, third rail, switches, crossings affected
 - Extensive traction motor damage and voltage spikes
- Red/Orange/Green Lines and select Bus routes most severely impacted;
 Yards/Garages also heavily impacted

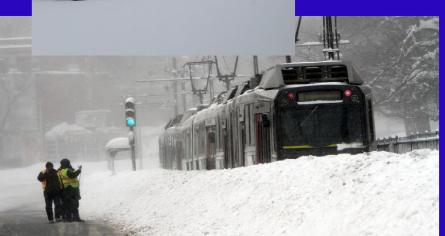
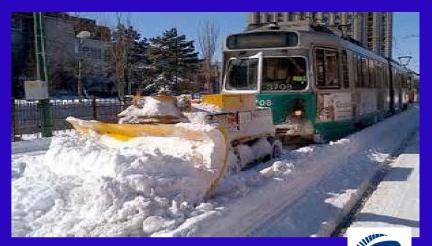
- Due to plowing and the lack of areas to remove the snow, a "BathTub" effect was created on the ROW.
- Ice build up in flange ways and large piles of snow, caused derailments.
- The use of revenue equipment for snow removal, caused damage to the streetcars.

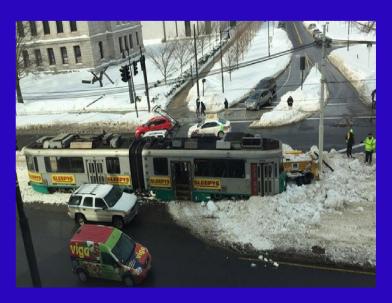
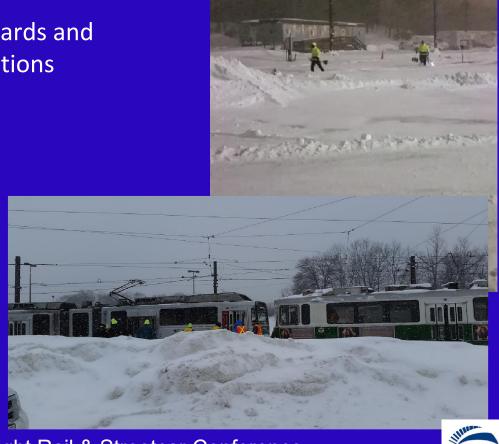
- Disabled trains caused snow and ice build up in the track area
- Inability to remove snow from yards and parking areas, hampered operations

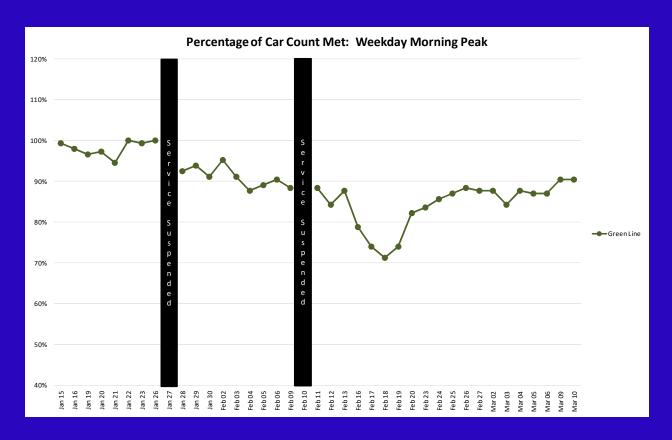
Peak Rail Car Availability

At times, vehicle availability declined to 40%

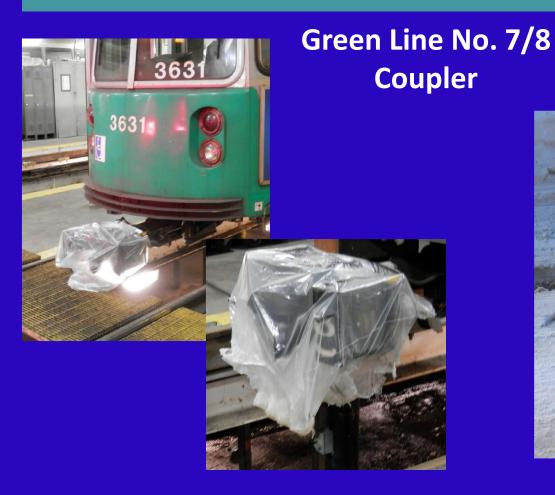
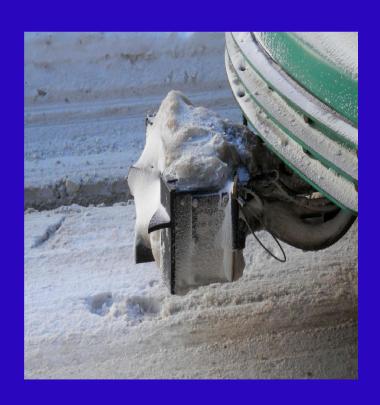
Thyristors Type 7

Melting on Thyristor

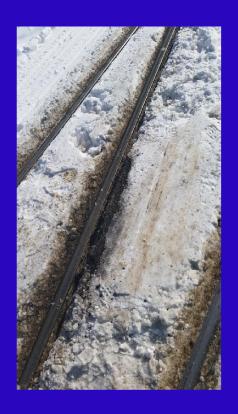
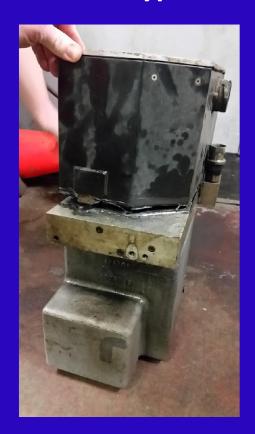
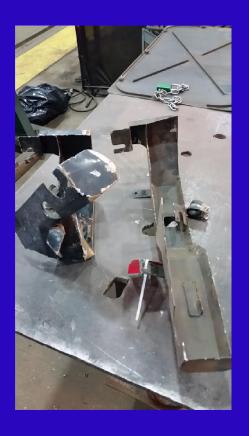
- Clear snow and icepack from Vehicle Components
- HPCU relocation program
