1ST INTERNATIONAL ROADSIDE SAFETY CONFERENCE
SAFER ROADS, SAVING LIVES, SAVING MONEY

Advances in Winter Road Maintenance Practices to Improve Road Side Safety

High Friction Surfacing Treatment, how a 45 year old process has been re-engineered into one of the leading national safety systems deployed by the US highway agencies

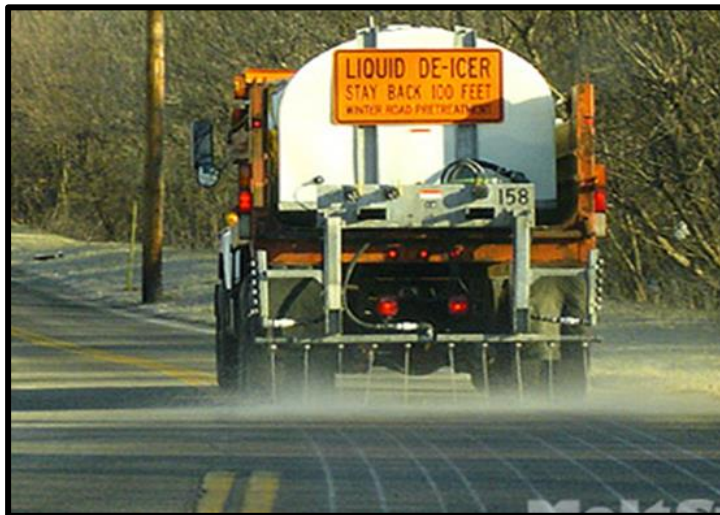
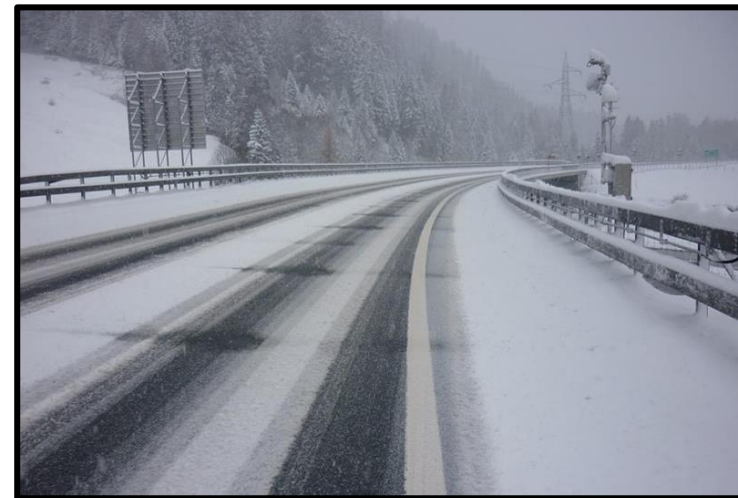
Anti-icing:

- not practical for all winter storms; certain conditions must be present.
- very effective, especially for preventing black ice.
- applied by sprayer trucks up to several days before a snow or ice event.
- Fixed Automated Spray systems (FAST) installed on bridges and overpasses.

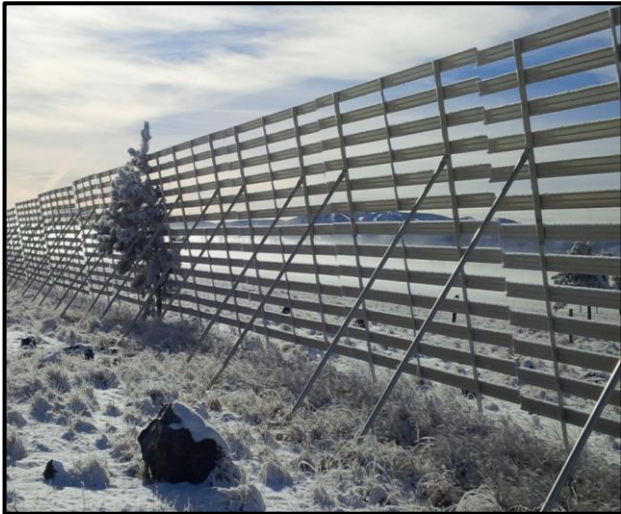
Snow Fencing

- *Anti-icing*---apply liquid materials before storms to prevent bonding.
- *De-icing*---apply rock salt and/or liquid chemicals on snow/ ice.
- *Gritting* ---apply abrasives
- *Plowing*--- mechanical removal of snow and ice
- *Hauling*---remove accumulations of plowed snow
- *Snow fences*--- roadside structures reduce snow drifting.
- *Avalanche sheds*---structures cover mountain road.
- *Closures*---extreme measure.
- *Tire Chains*---mandatory in certain locations

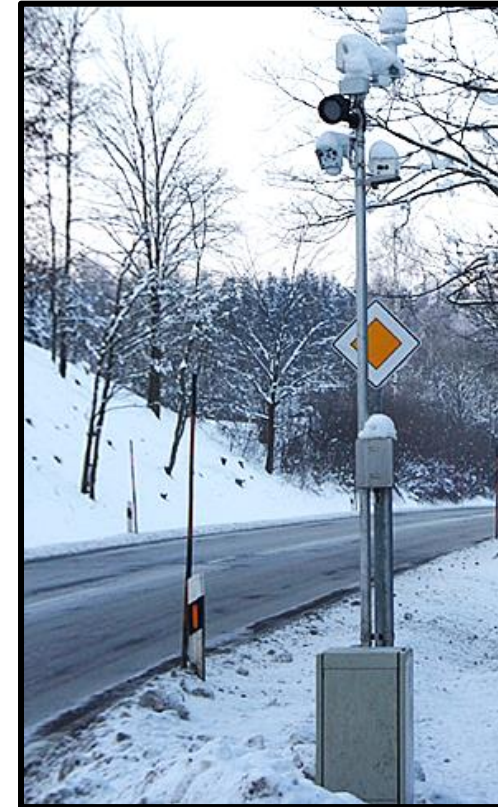
Road Weather Information Systems (RWIS) provide real-time data:

- air temperature,
- amount and type of precipitation,
- visibility,
- dew point,
- relative humidity,
- wind speed and direction,
- pavement temperature,
- subsurface temperature,
- surface condition (dry, wet, frozen),
- pavement salinity and freezing point of the road surface.

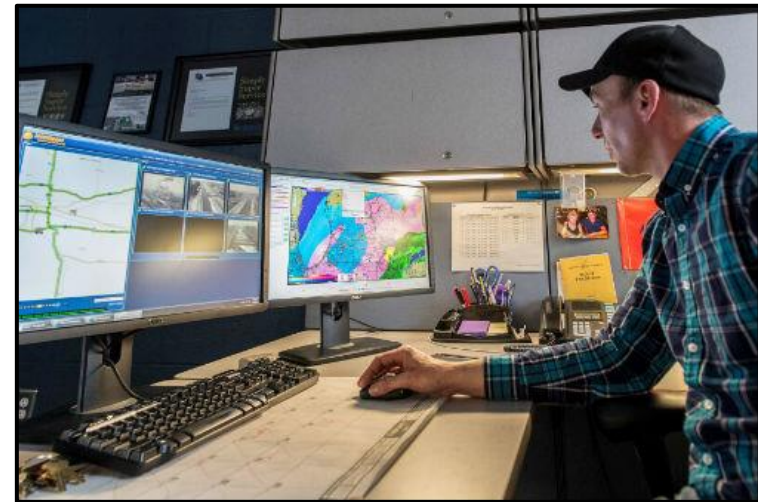
- vehicles equipped with air and pavement surface temperature sensors.
- Some sensors detect surface moisture and salinity.
- Sensors being developed to measure the thickness of ice or snow.
- More plow trucks now equipped with
- AVL (Automatic Vehicle Locator) that report direction, speed, plow position, operation , material application rate.
- Friction sensors in development

Ben Hodges, transportation maintenance supervisor at MDOT's Grand Ledge garage, checks on plow AVL information. Photo courtesy of MDOT.

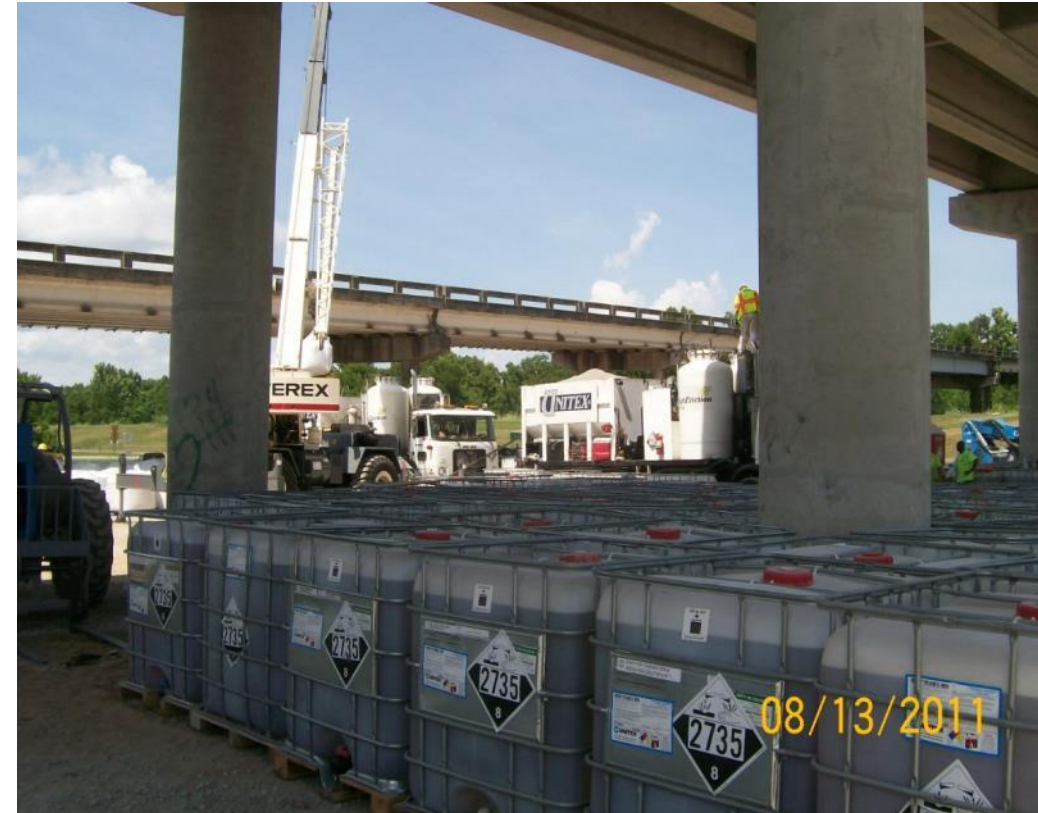
HFST Binder Materials

To form a laminate layer that allows for 75% aggregate embedment depth

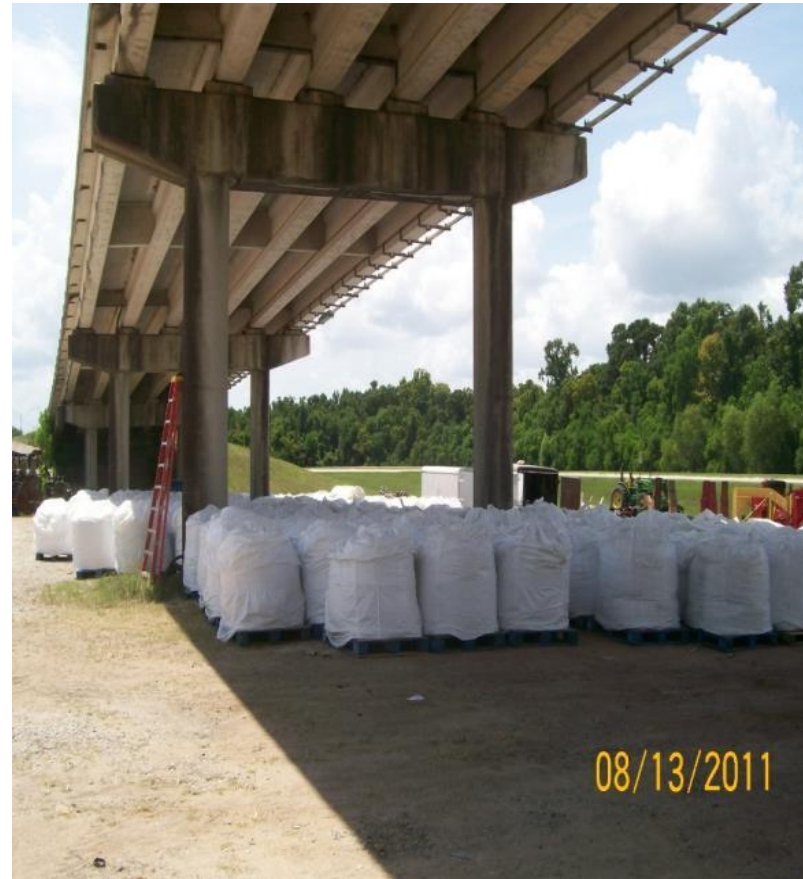
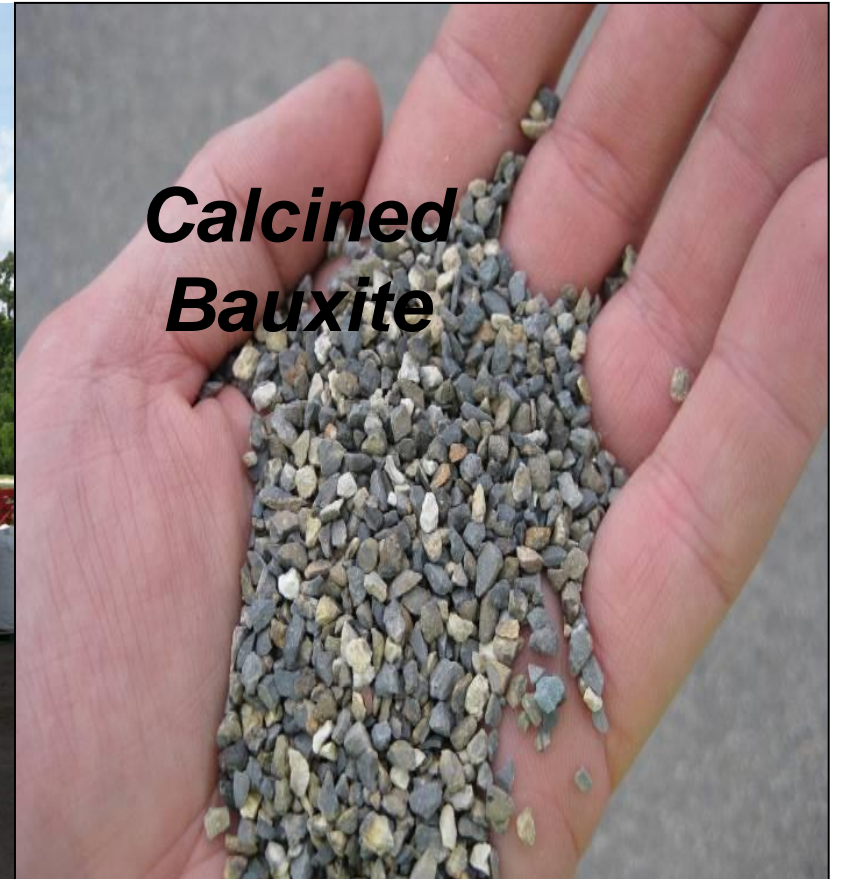
HFST Aggregate

Recommended aggregate is calcined bauxite which provides the highest resistance to polishing

Typically referred to as a 1-3mm aggregate

**Calcined
Bauxite**

- Recommended aggregate is calcined bauxite which provides the highest resistance to polishing.

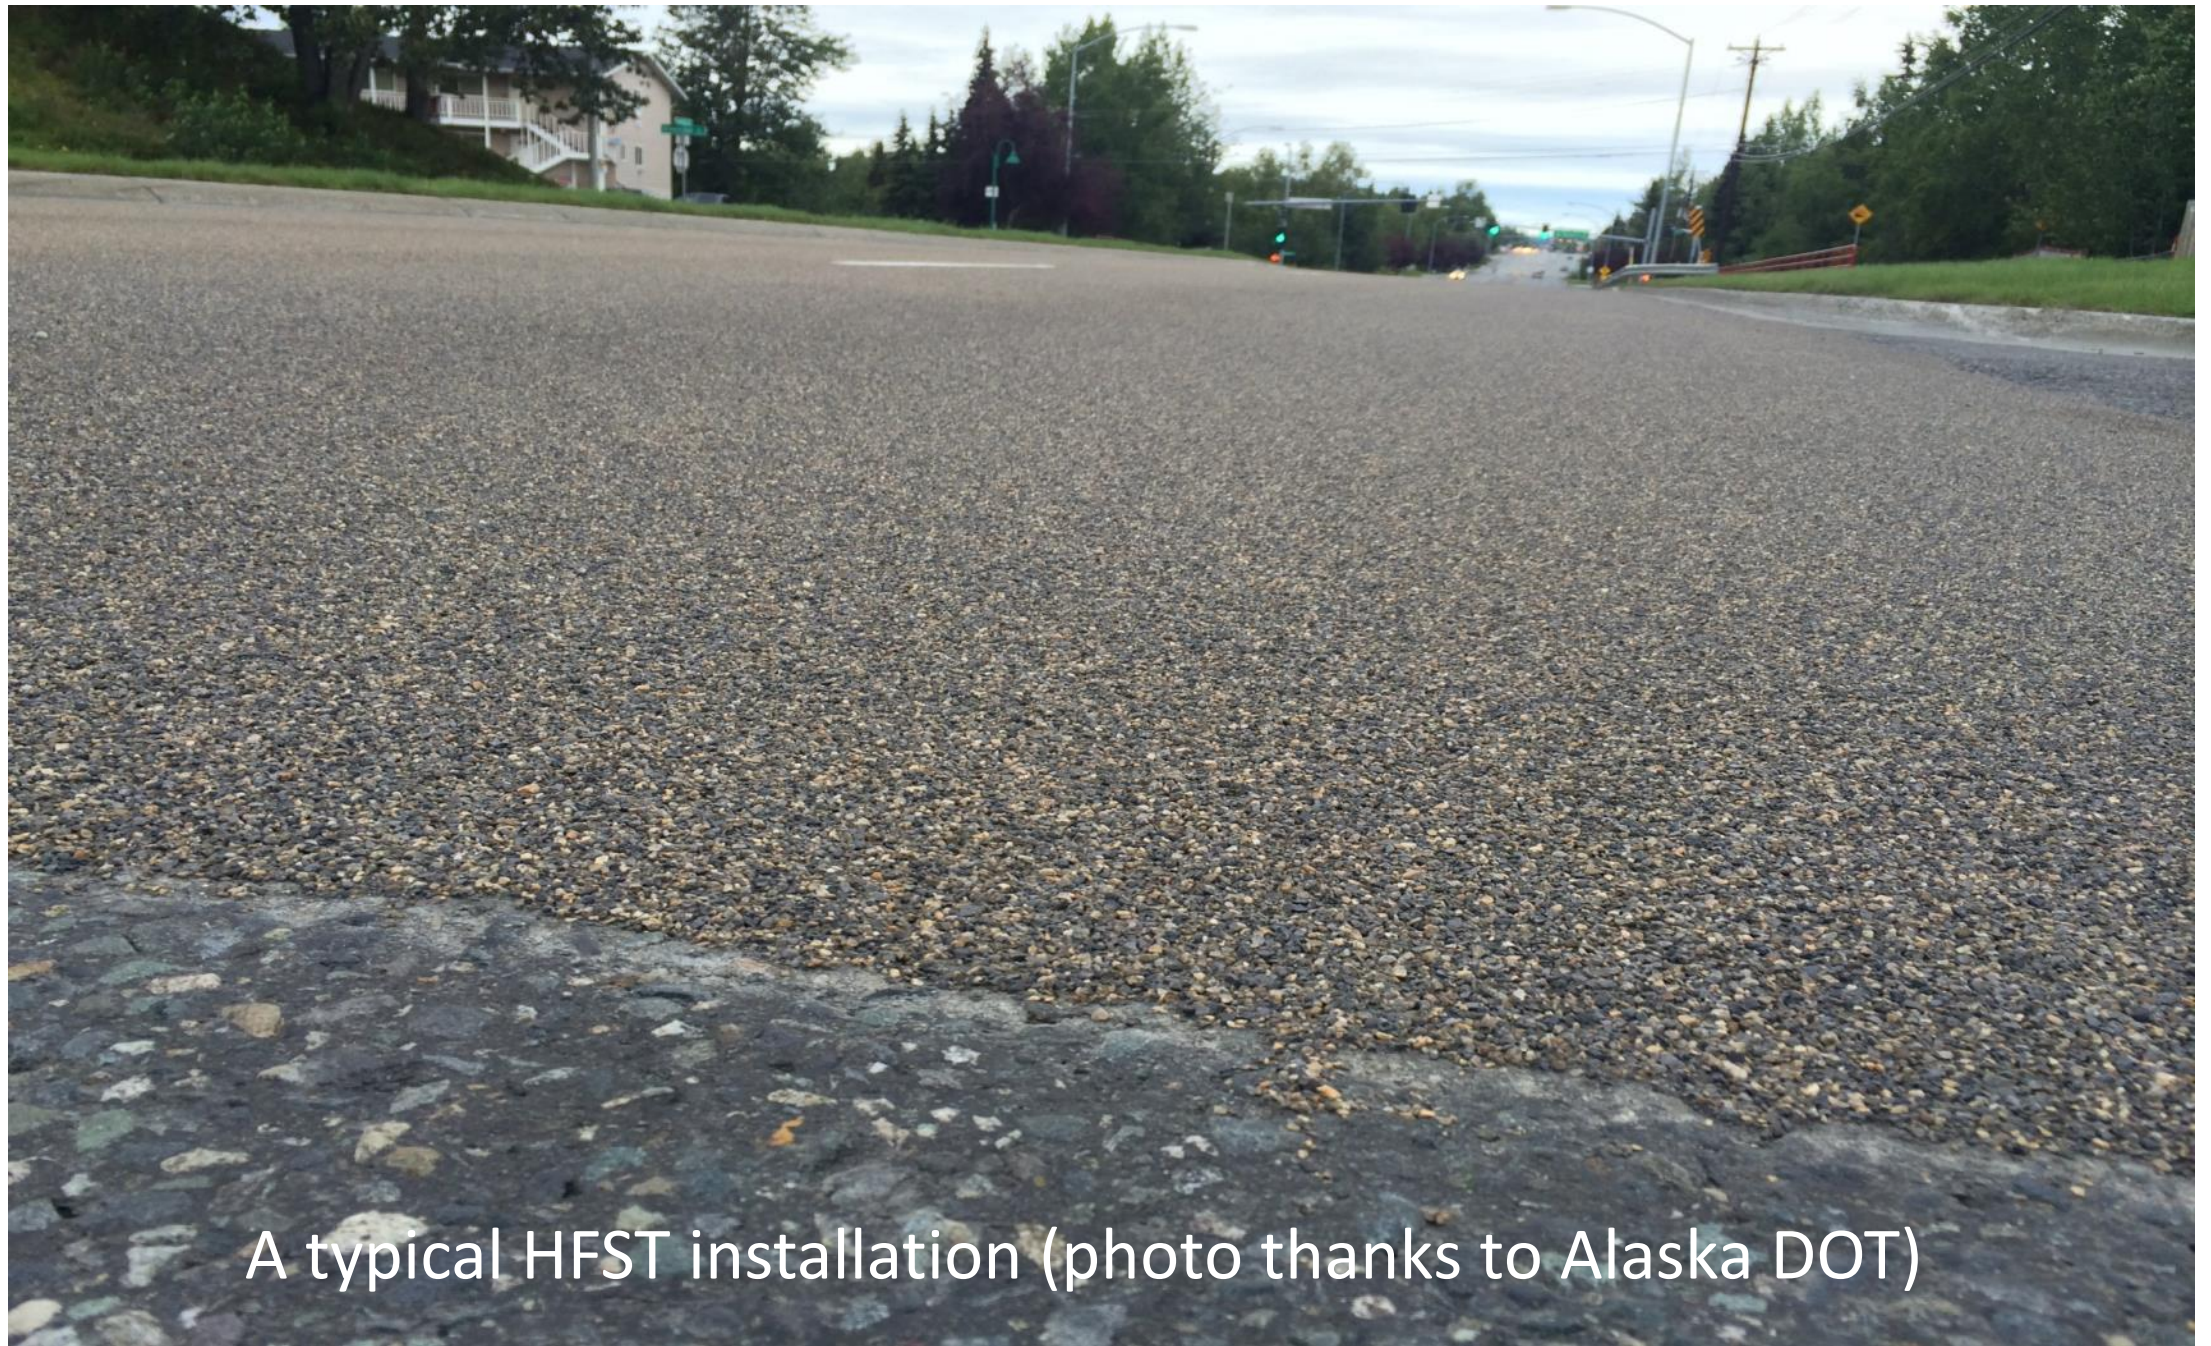
A typical HFST installation (photo thanks to Alaska DOT)

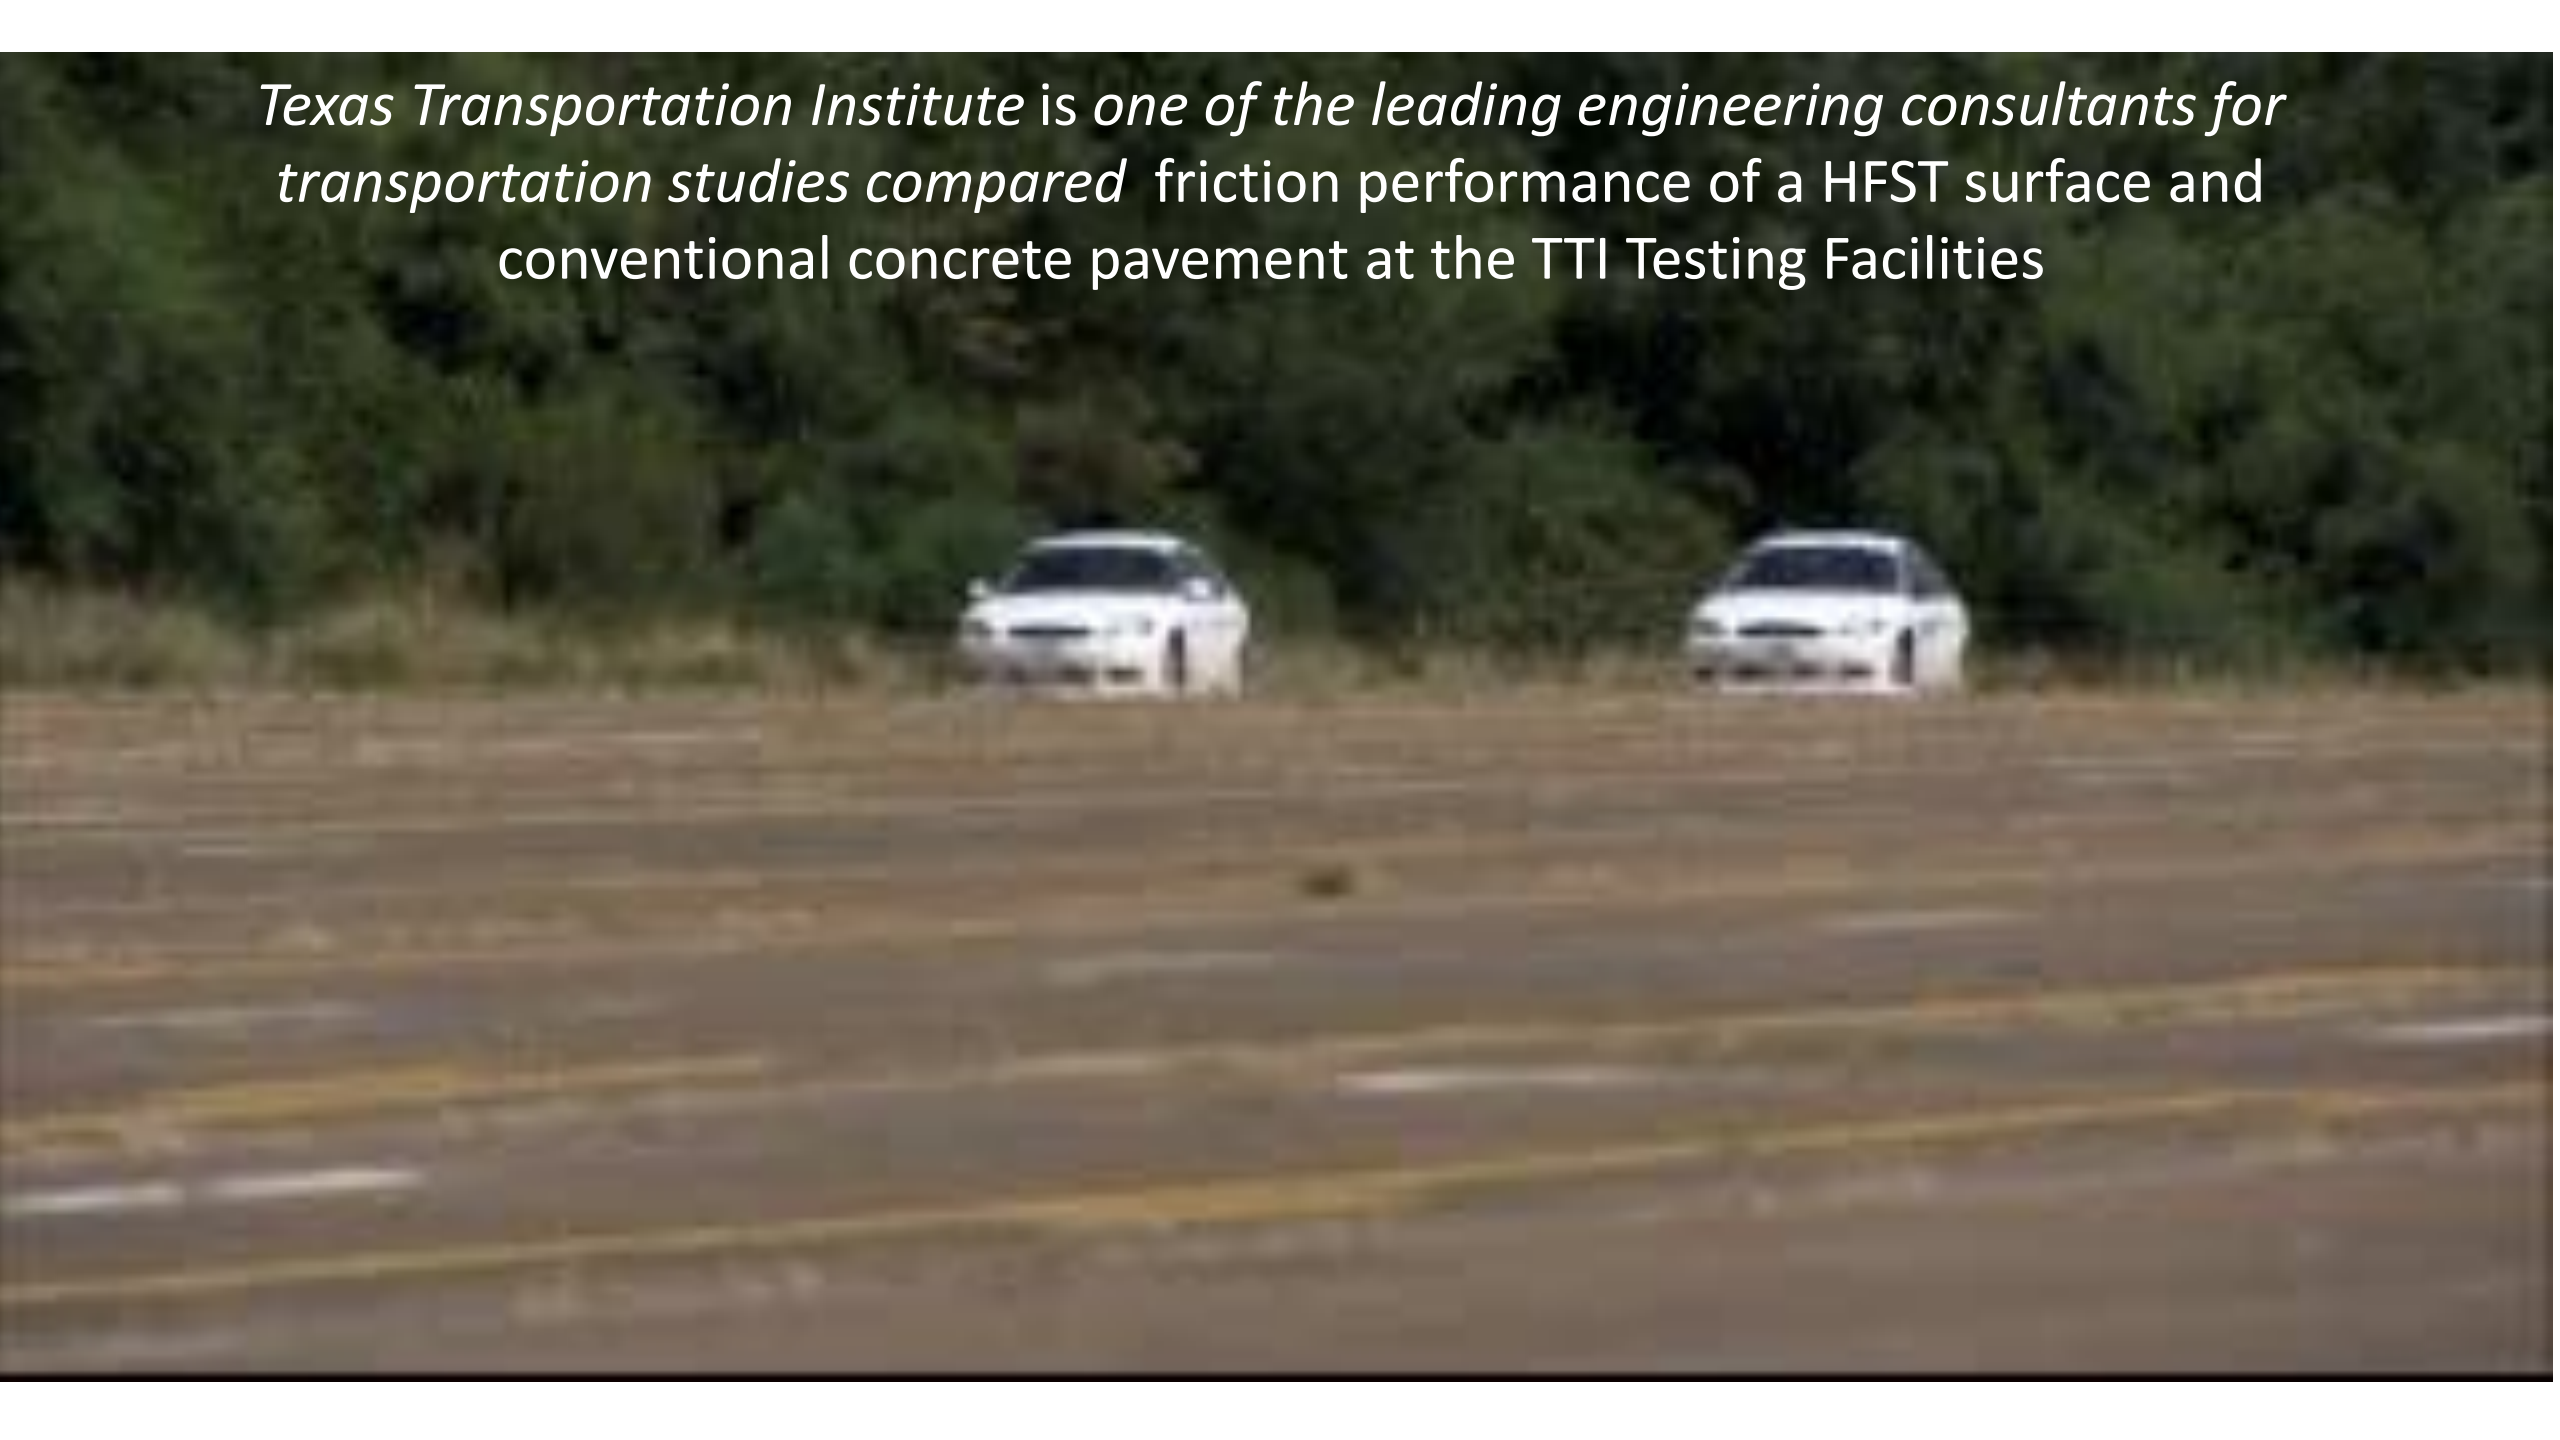
Texas Transportation Institute is one of the leading engineering consultants for transportation studies compared friction performance of a HFST surface and conventional concrete pavement at the TTI Testing Facilities

Skid testing conducted at the TTI test track
College Station, TX

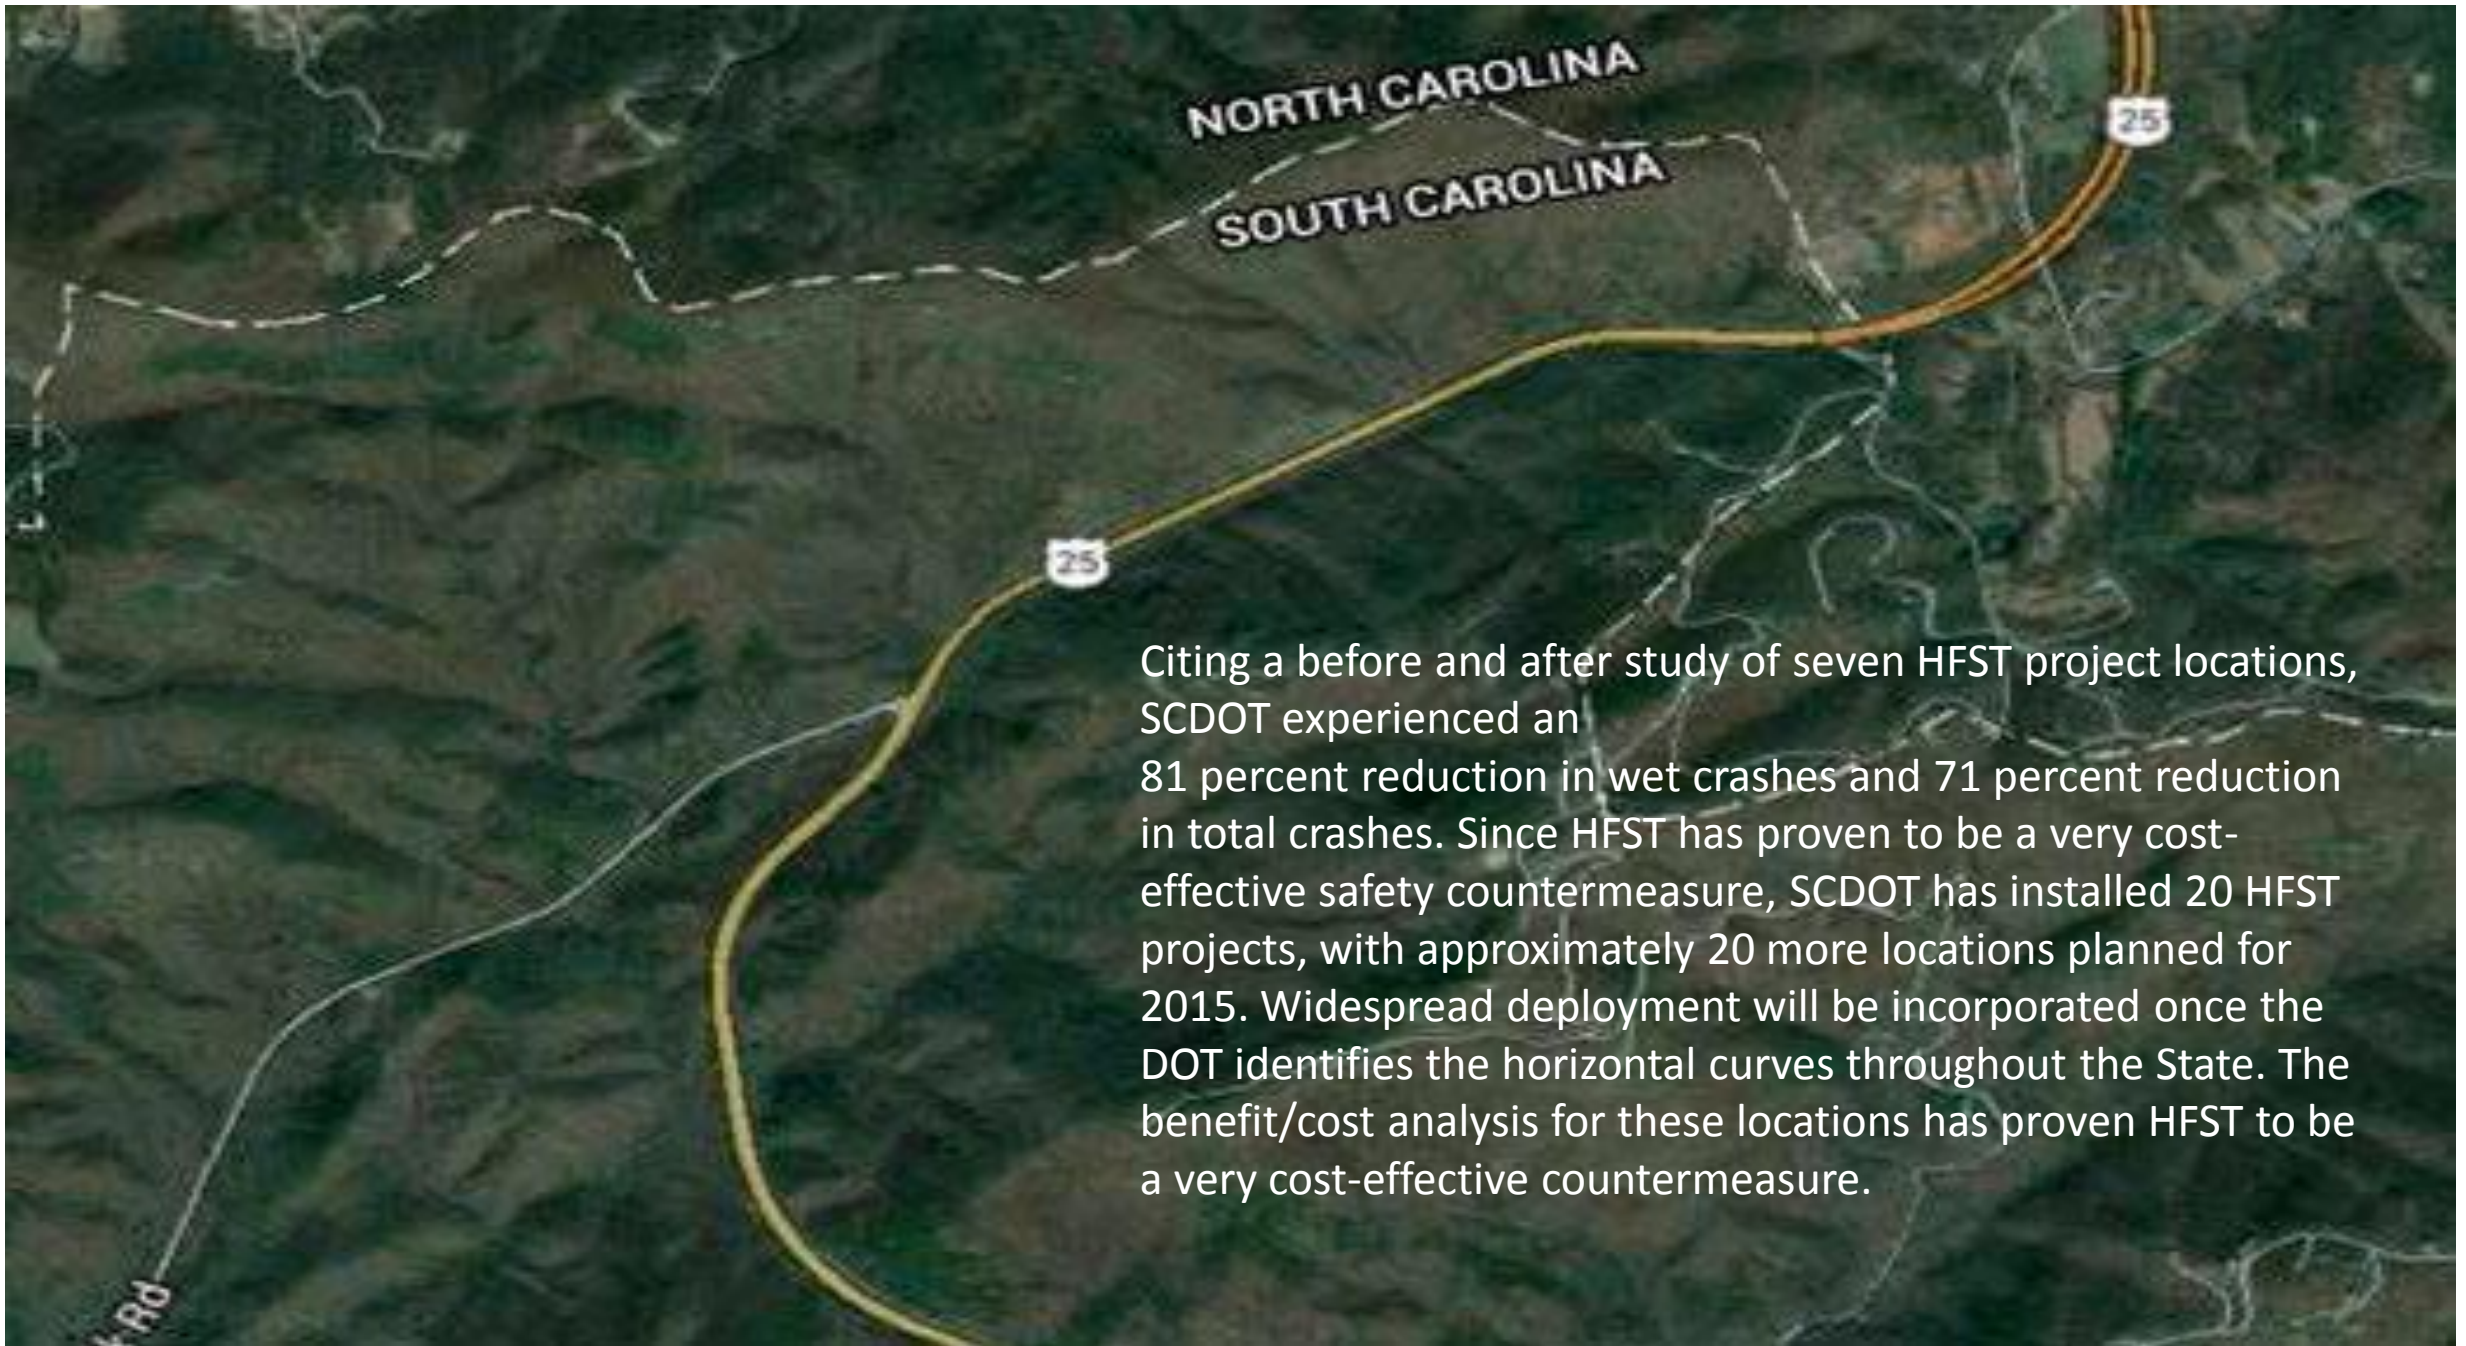
I-85 Northbound On-Ramp from NC-7 (Ozark Ave) – Exit 19

Injury Crash Summary Before After Percent Reduction

Class B injury Crashes 5 0 - 100.0 %

Class C Injury Crashes 20 2 - 90.0 %

Property Damage Only 25 9 - 64.0 %

Overall Summary Results

Total Crashes: - 78 % (reduction)

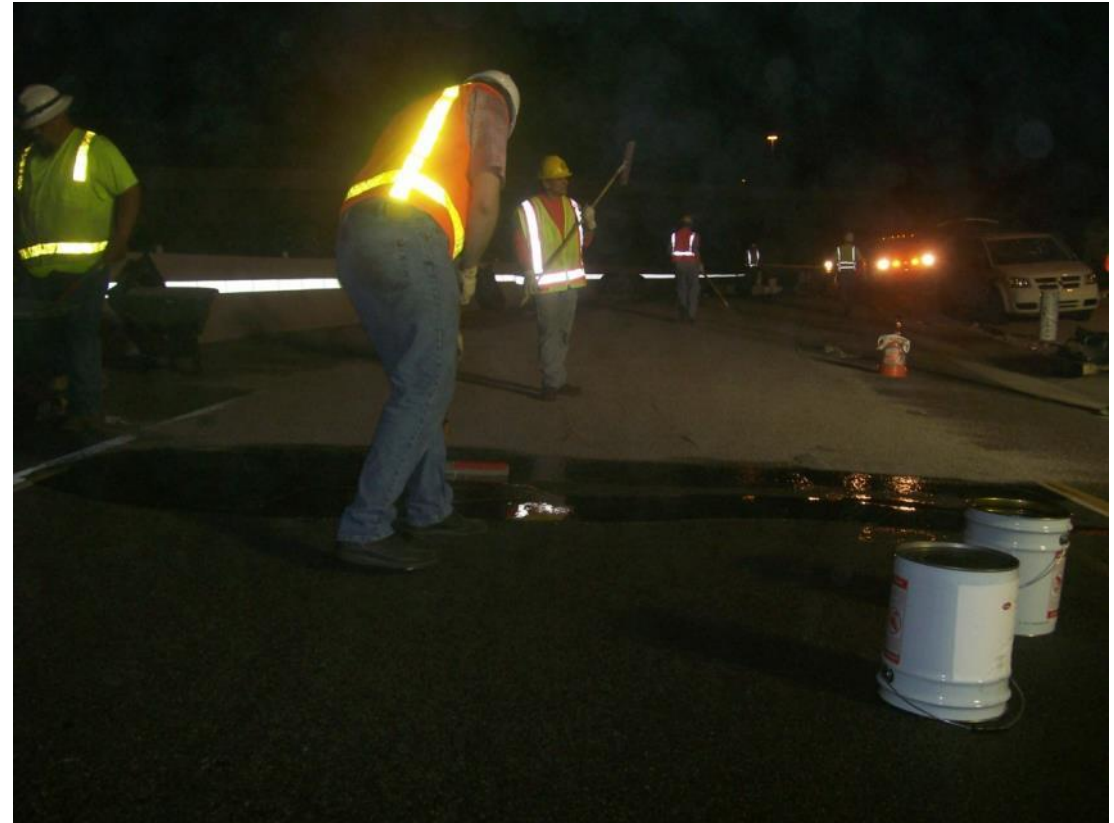
Lessons learned and improvements made / NC DOT

Installed three times because of the variable application method, ramp is on a grade the resin binder thickness couldn't be controlled with manual squeegees. The resin binder ran off the side of the pavement, the aggregate distribution was uneven with bare spots because of not being able to control the aggregate spread rate and identify missed spots working at night

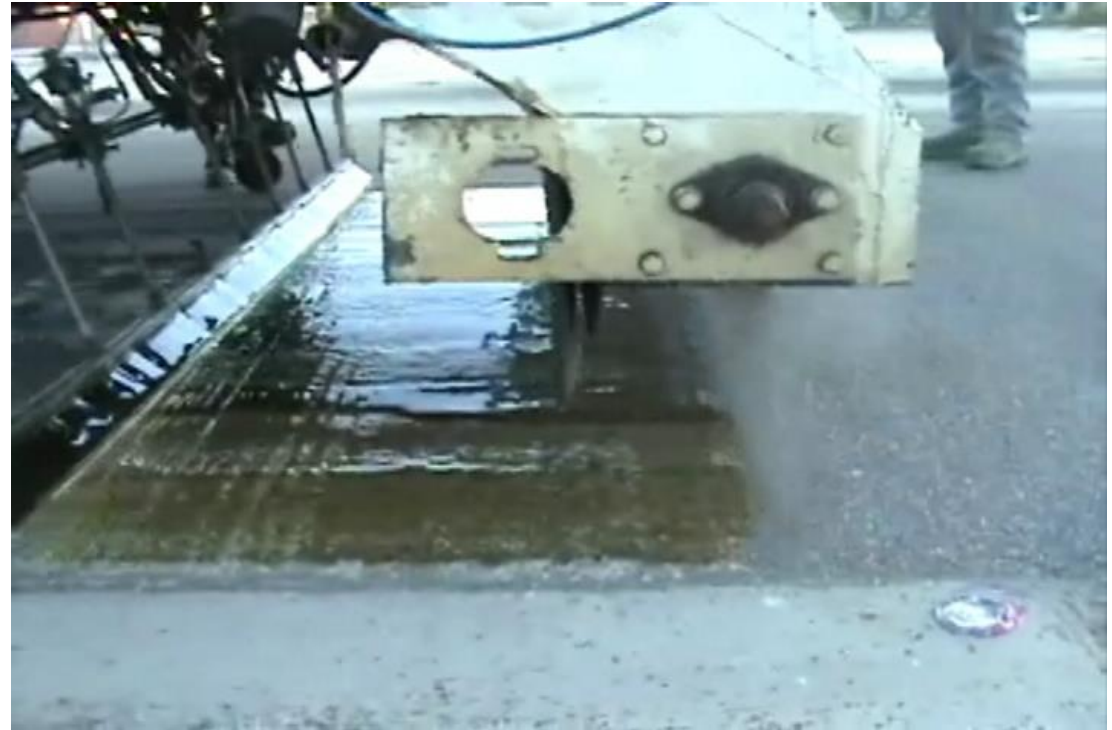
2009 application advancement SC DOT

Automated metering and mixing of the resin binder, self adjusting telescoping application bar with a thickness control device, a creep drive activated aggregate spreader.

A two mile project was completed within the specification tolerances in half of the estimated application time by progressing to an automated application.

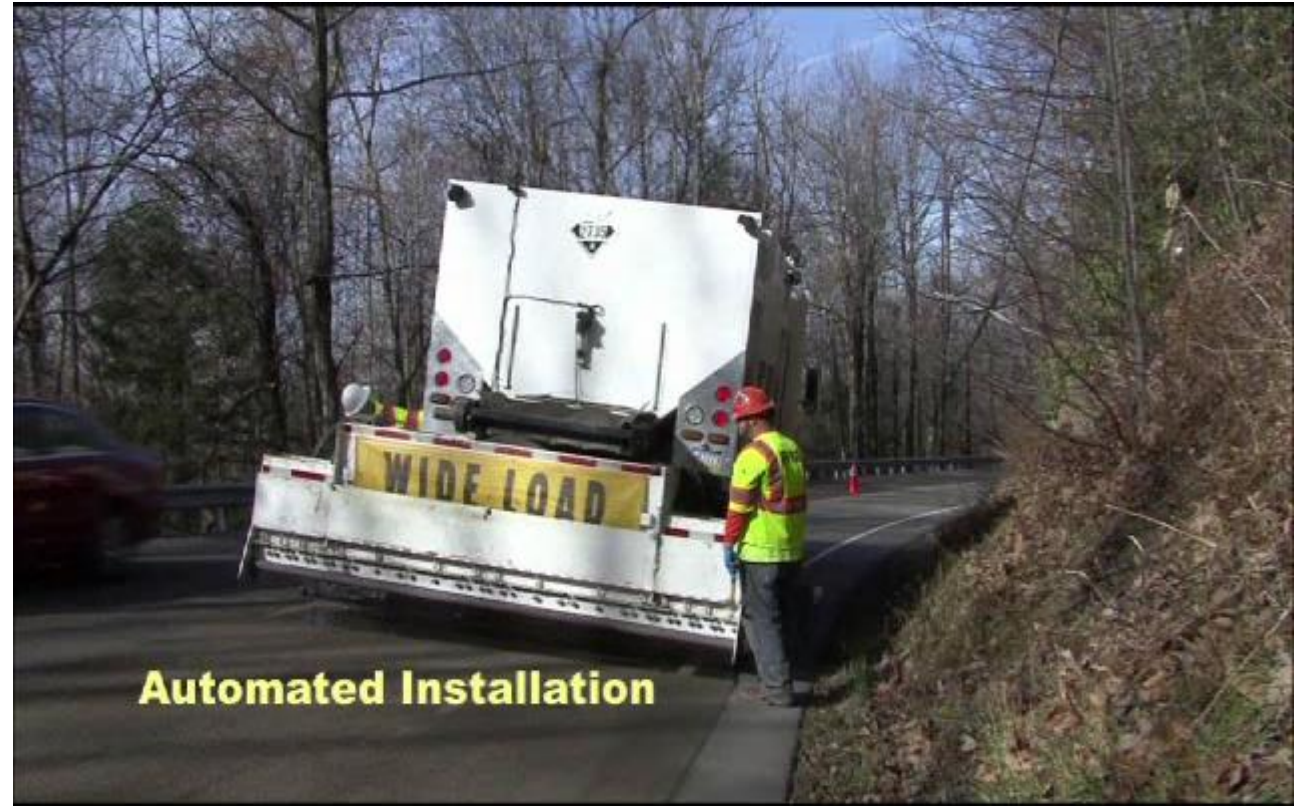
Grade control, long range continuous applications with no breaks for constant quality control.

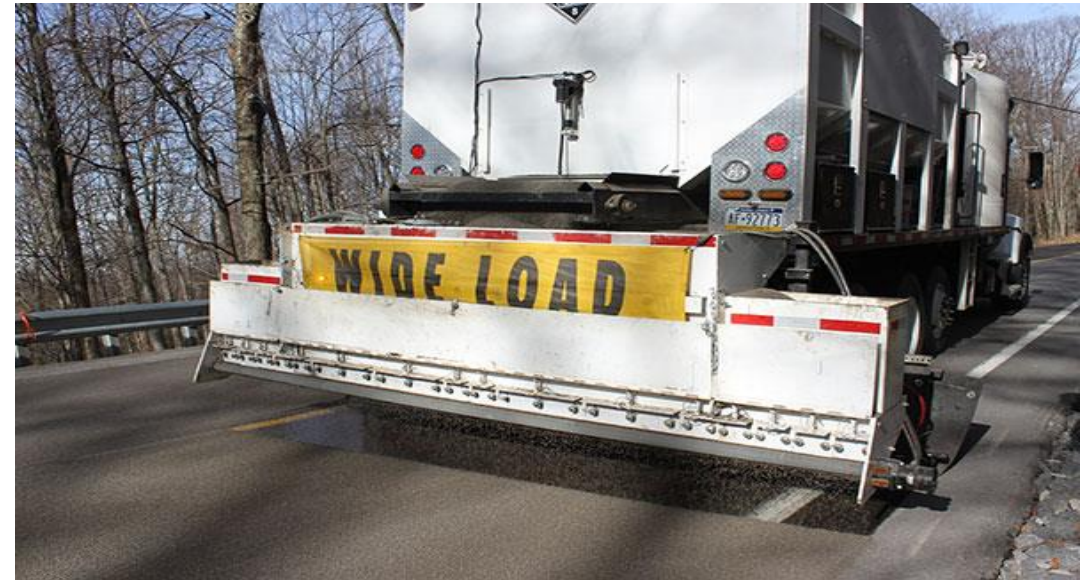
HFST Real-time Reporting System

Real time report generated in truck

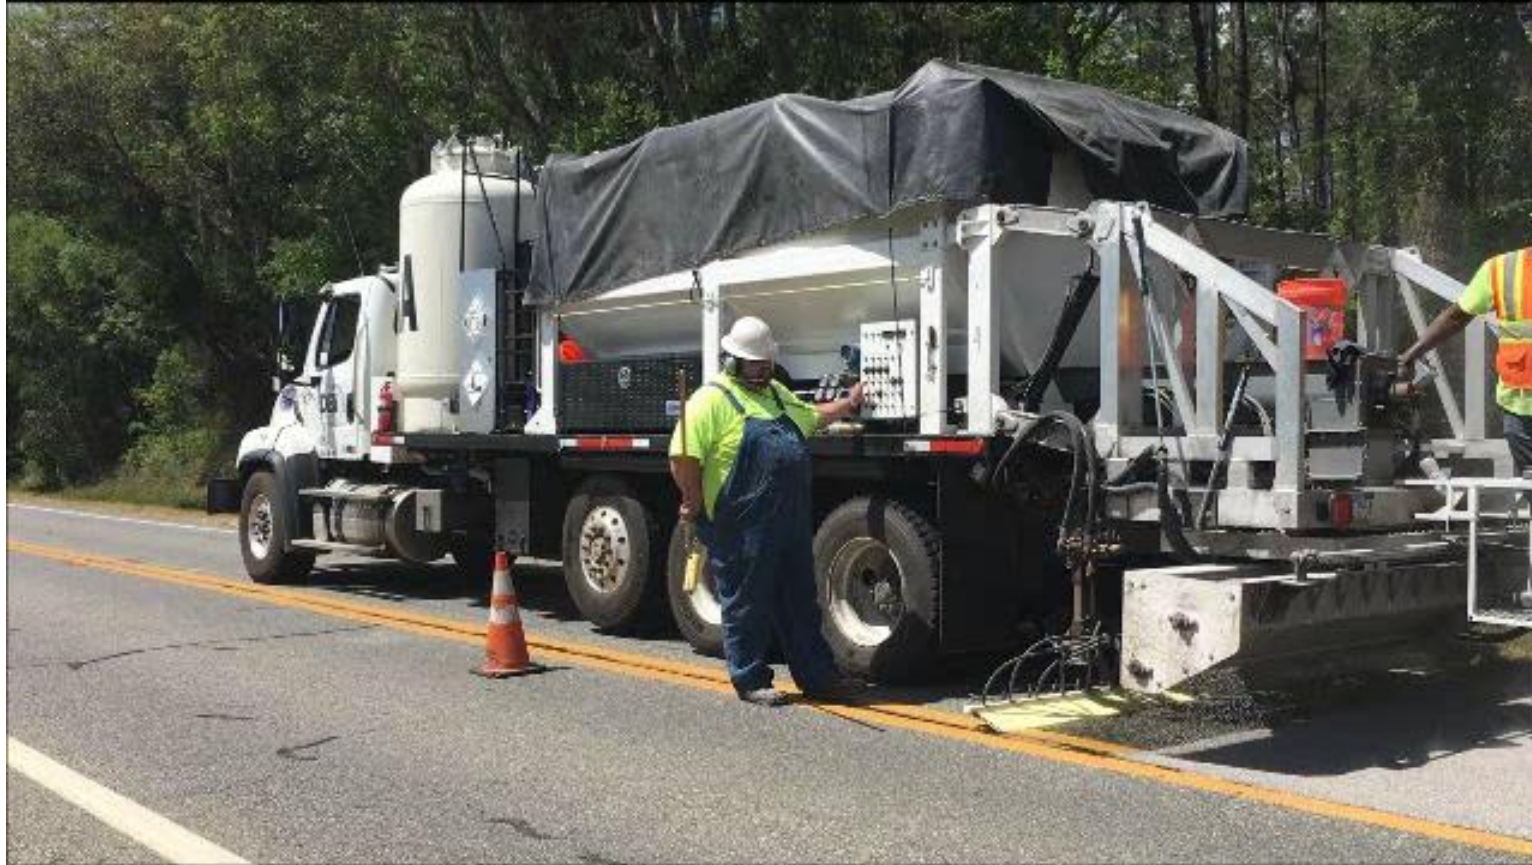
Real-time fleet tracking

Fully automated application truck with “real time” reporting module, four application staff 42,000lbs of bauxite and 1200 gallons of resin binder applying HFST at full lane widths up to the road markings. Application speeds of up to 26 linear feet per minute.

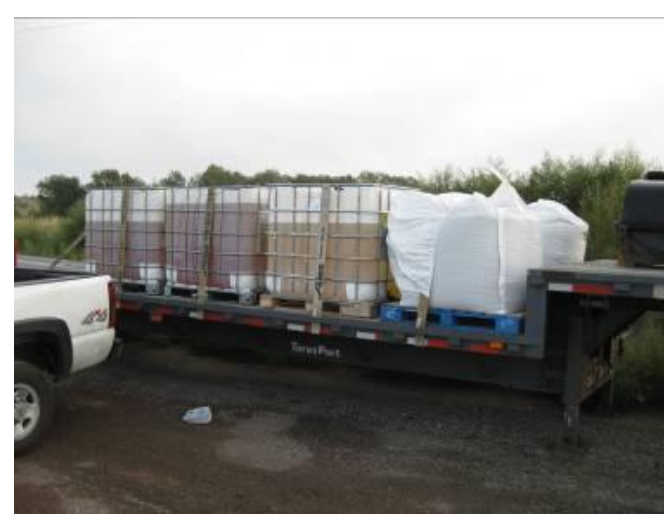
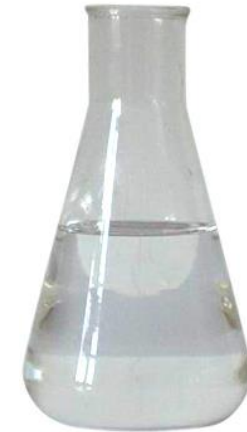
Bonding Agents

Binder	Curing Time	Curing Temp.
• Epoxy-Resin	3 - 4 hours	70+ F
• Rosin-Ester	As soon as it reaches ambient temperature	ambient temp.
• Polyurethane-Resin	2.5 hours	
• Methyl Methacrylate	1.5 hours	<20F to 100+F
• Polyester-Resin	2 hours	<40F to 100+F

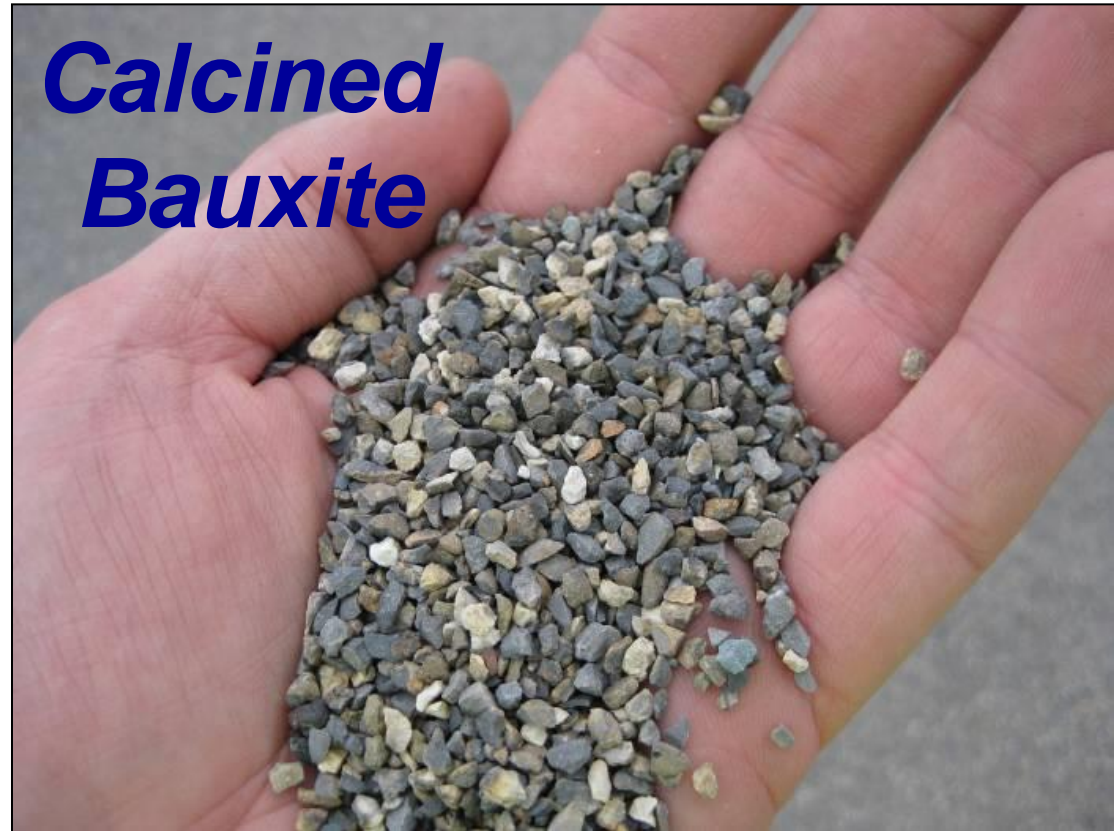
**Typically
referred to
as a 3 mm
aggregate**

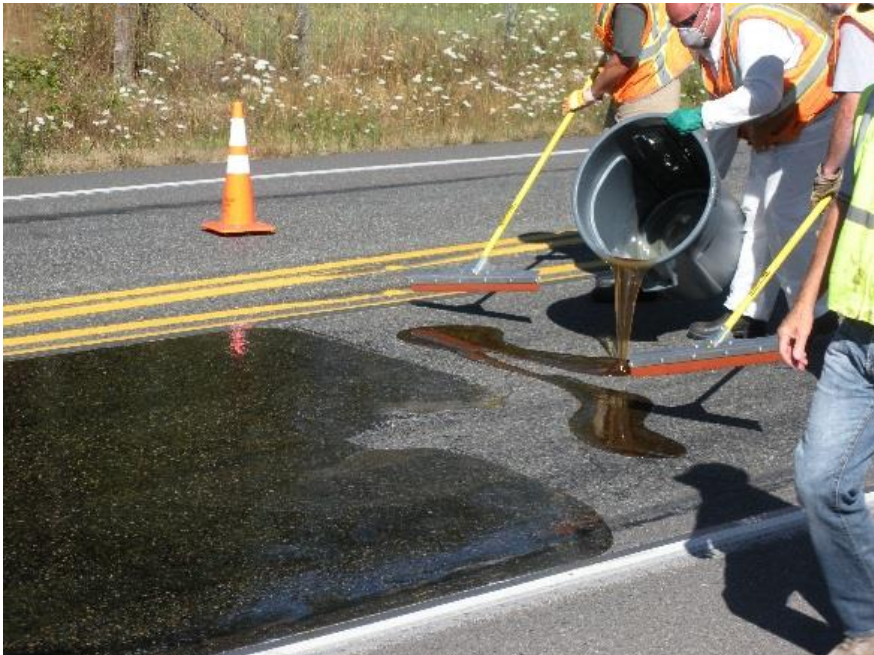
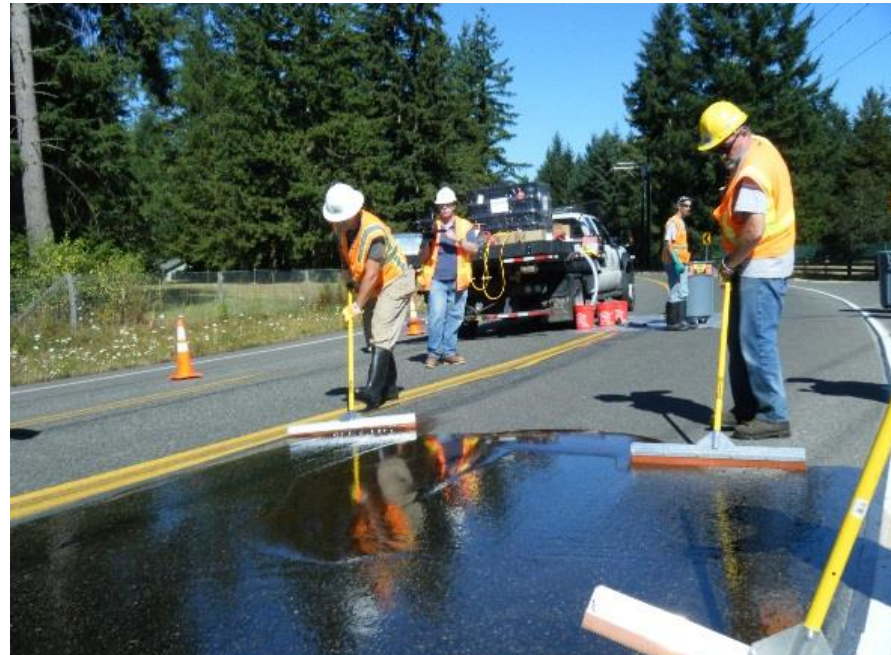
Manual Installation

- **Manual mixing of epoxy material**
- **Manual application of epoxy with squeegee**
- **Hand broadcast and distribution of aggregate**
- **Production rates: 200-1000 SY/hr.**
