1ST INTERNATIONAL ROADSIDE SAFETY CONFERENCE
SAFER ROADS, SAVING LIVES, SAVING MONEY

Advances in Winter Road Maintenance Practices to Improve Road Side Safety

High Friction Surfacing Treatment, how a 45 year old process has been re-engineered into one of the leading national safety systems deployed by the US highway agencies

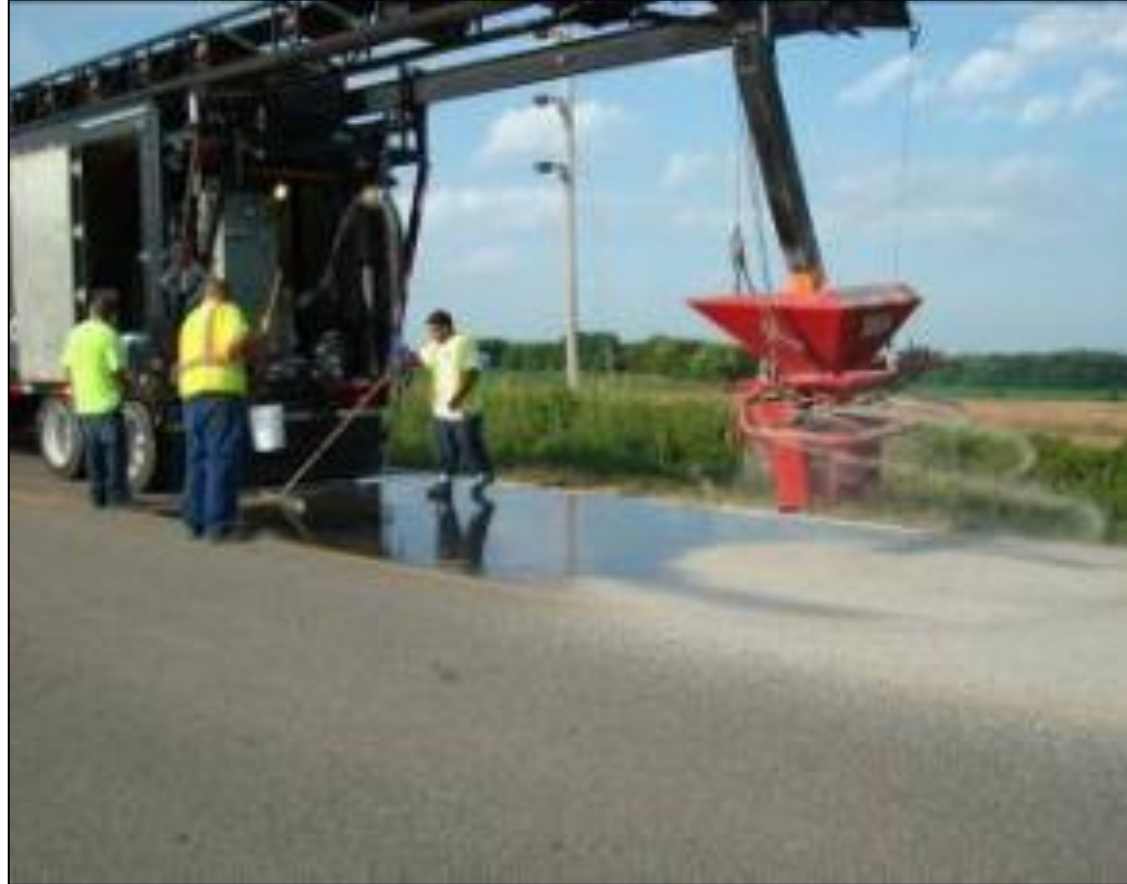
- **Machine mixing of binder**
- **Machine assistance in getting aggregate close to final position**
- **Binder distribution often by pump but total reliance on squeegees to attain binder thickness**
- **Production Rates:
1800 S.Y./hr.**

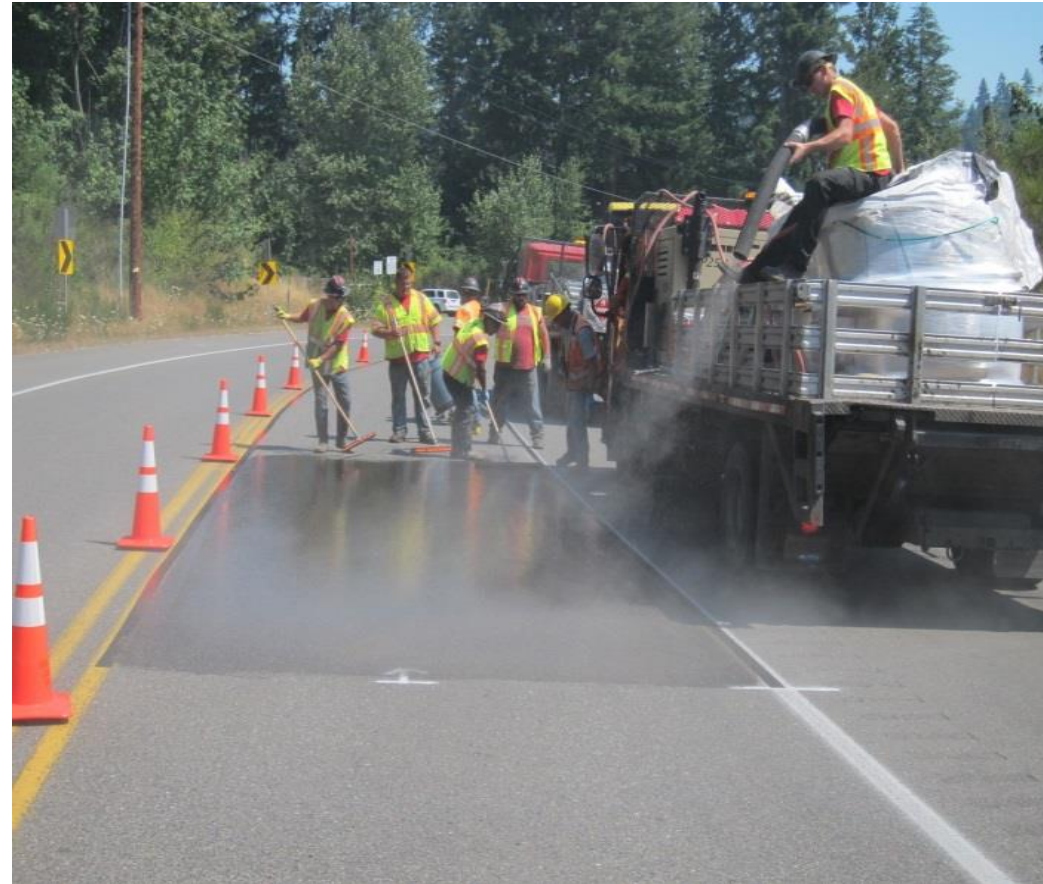
Mechanically Assisted Installation

- **May or may not include machine mixing of binder**
- **Binder distribution may include a pump but total reliance on squeegees to attain binder distribution and thickness**
- **Aggregate is sprayed to final position**
- **Production Rates:
1800 S.Y./hr.**

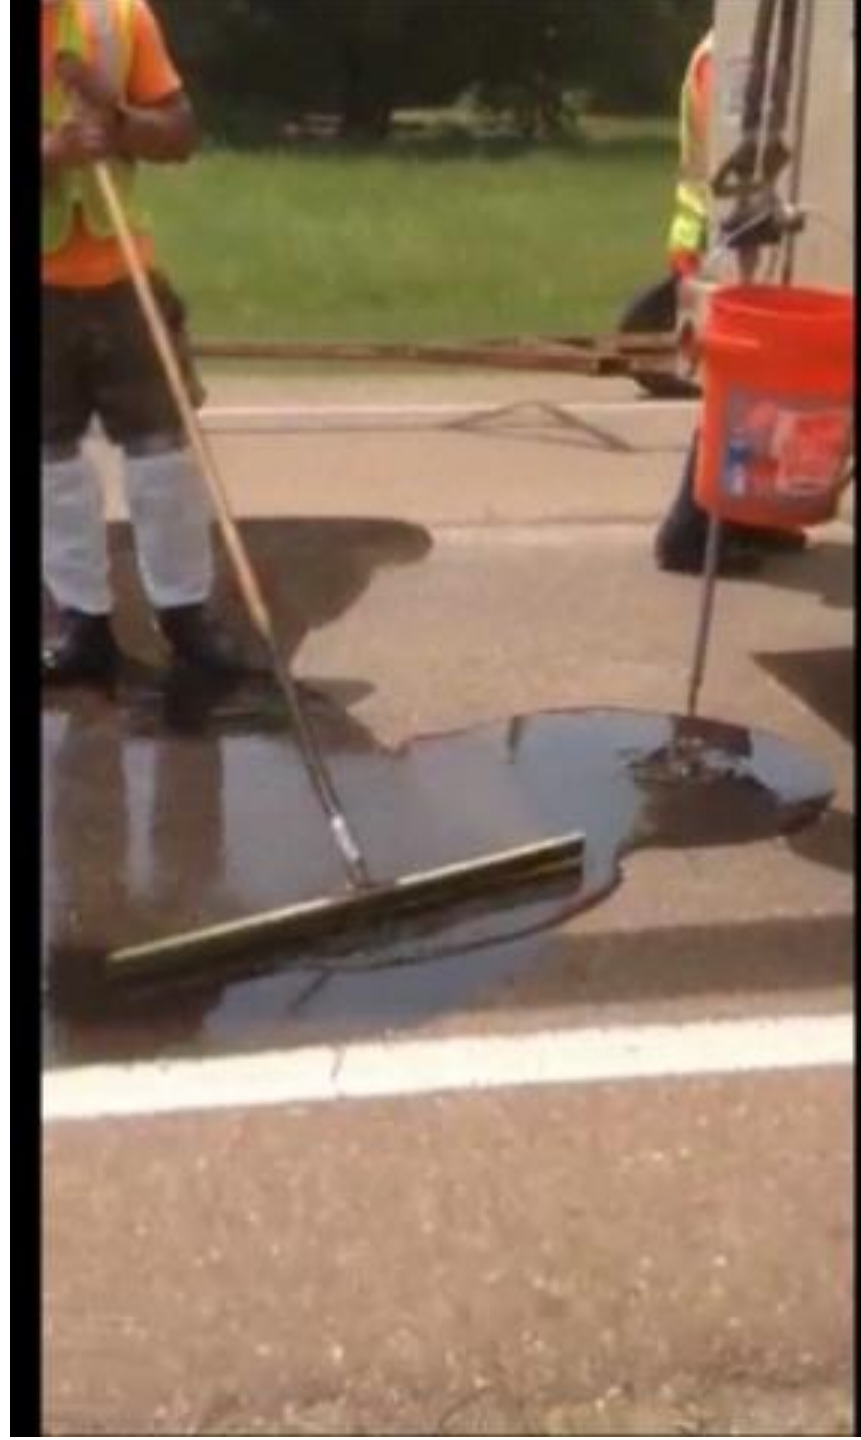
Automated Installation

- Machine mixes binder
- Machine places binder at final location
- Binder depth monitored constantly by machine
- Aggregate is placed by machine at final location within seconds of binder
- Handwork is limited to irregular areas
- Production Rates: 2800 SY/hr.

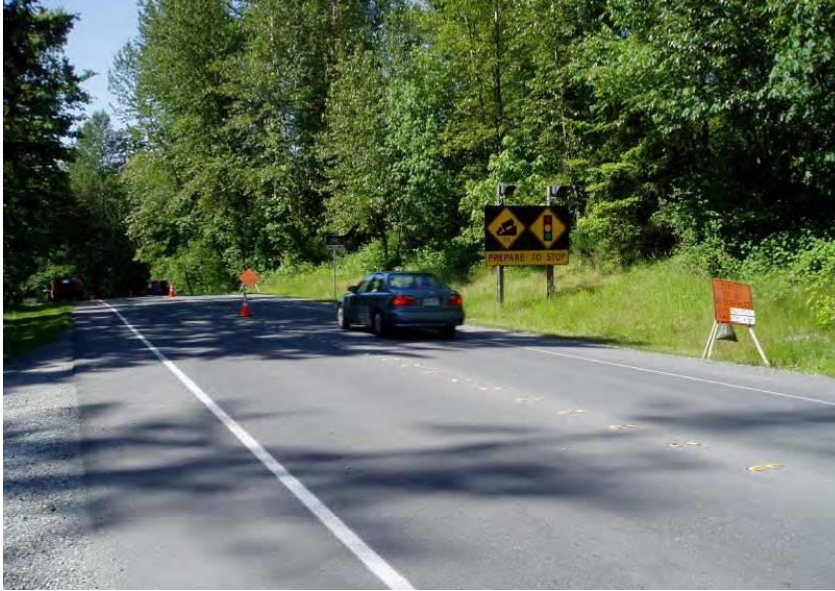
Bellevue, Washington State

- Local Road Project
- 15% downgrade
- Curve with an intersection at the bottom

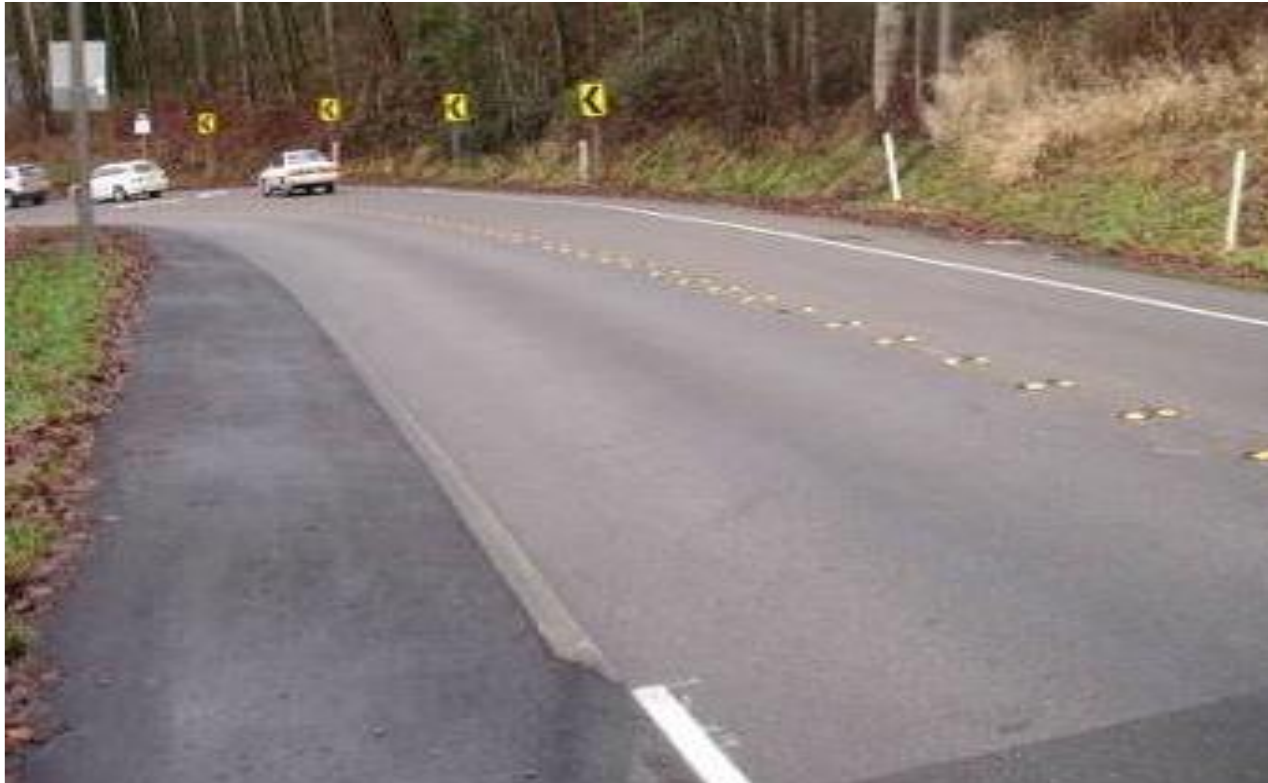
Installed HFST in October 2004

- Install HFST just before the intersection in 2004
- Installation time less than 6 hours

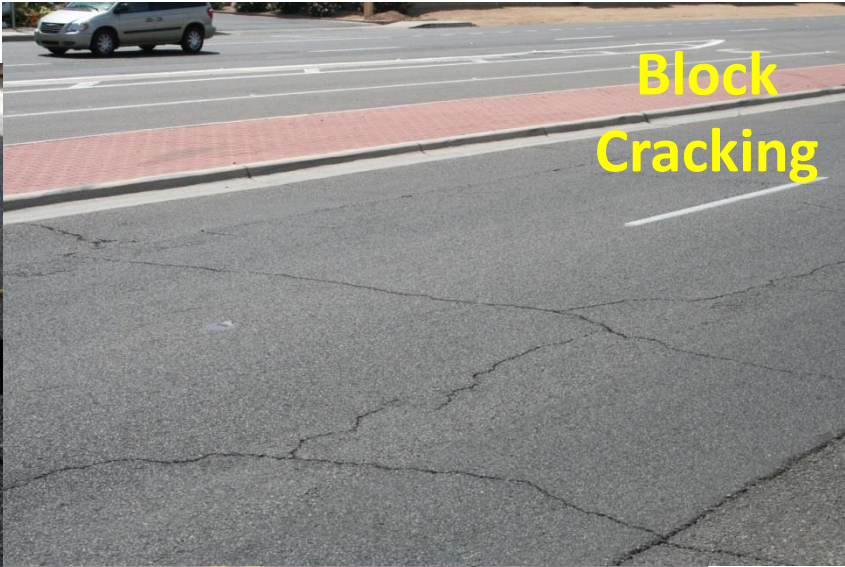
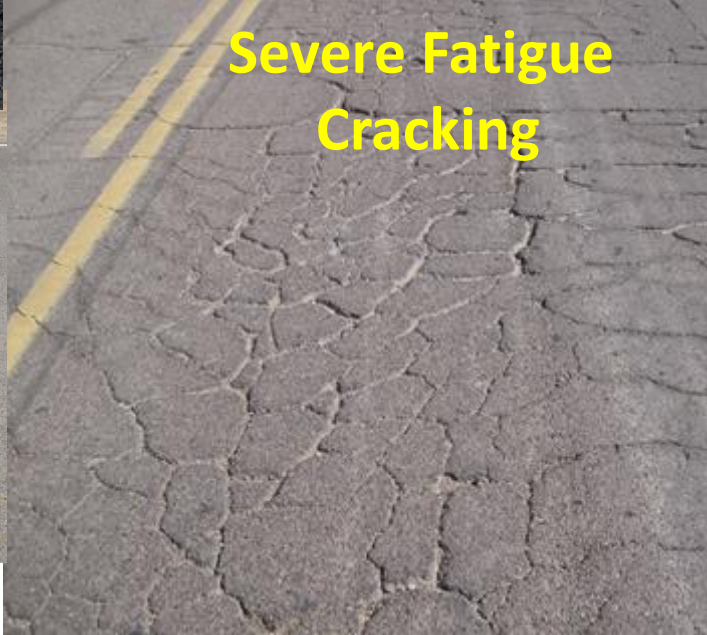
Pavement Distresses

- The most significant issue is existing pavement condition
- We are expecting 10+ years based on accelerated test track results and current project experience
- But it depends on having a good specification and a good installation

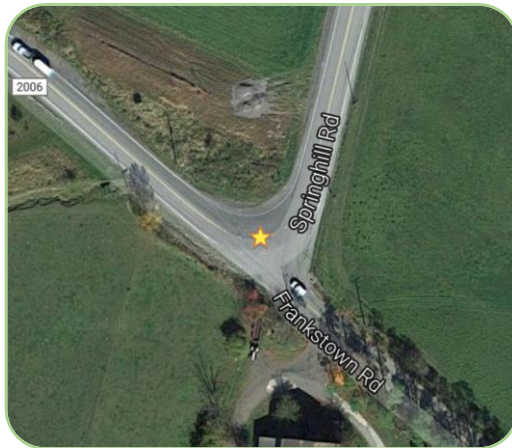
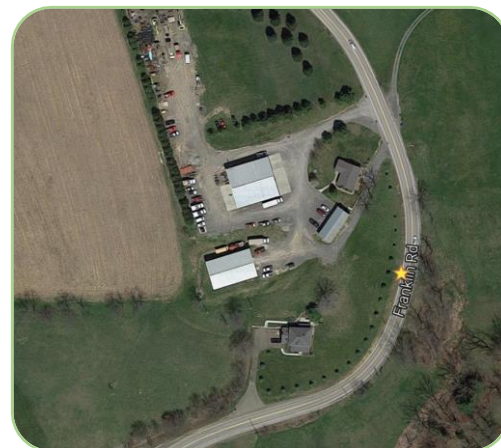
FIGURE 1 Examples of high, medium, and low curvature (from left to right)

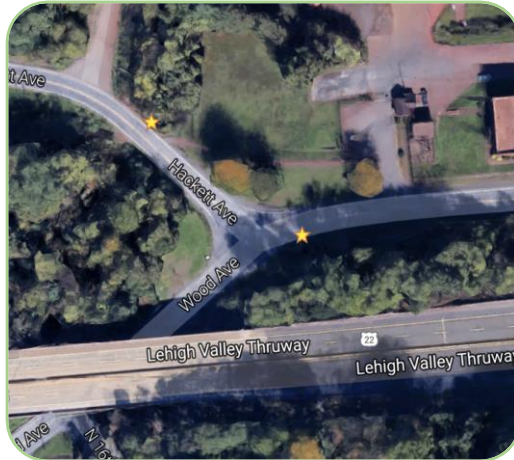
2-Lane
4894 ADT
4% Trucks
Urban
3-Leg Intersection
Tangent
B/C Ratio = 133

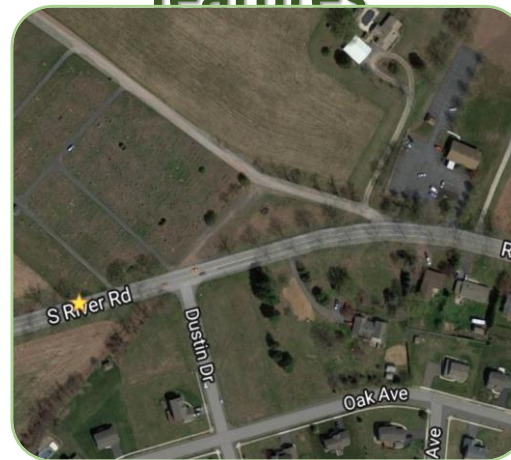
2-Lane
6253 ADT
11% Trucks
Rural
Segment
Horizontal Curve
B/C Ratio = 105

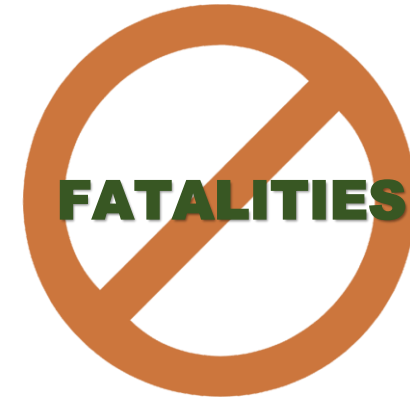
- **Key Findings:**

- More than **70% reduction** in average crashes per year across **all injury categories**
- **100% reduction** in **fatalities**

- **Conclusions:**

- HFSTs are both an **effective** and **economical** means of improving roadway safety.
- In order to receive the greatest safety impact and return on investment, DOTs should first target **horizontal curves** at **intersections** in both an **urban and rural** environments
