**ENGINEERING PROPERTIES AND FIELD PERFORMANCE
OF WARM MIX ASPHALT TECHNOLOGIES**

FINAL REPORT

Prepared for
National Cooperative Highway Research Program
Transportation Research Board
of
The National Academies

February 2014

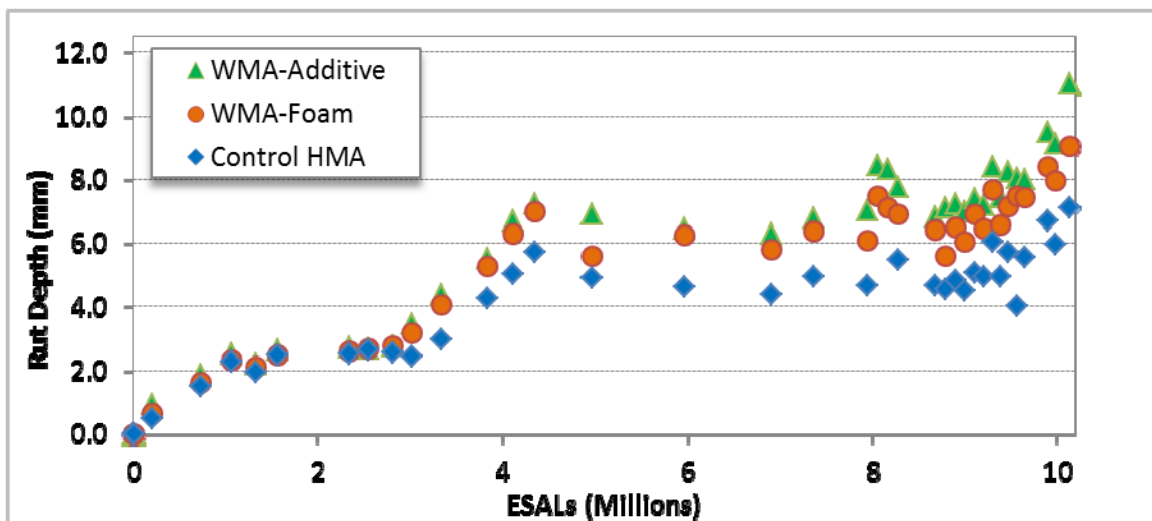
Figure 1 Rutting of the Control HMA and WMA Test Sections in the 4th Cycle of the NCAT Test Track

The control HMA and WMA sections performed very well through the cycle. No cracking was evident, IRI data were steady, texture changes were very small, and rut depths were satisfactory by most agency standards. Figure 1 shows the rutting progression through the 10 million Equivalent Single Axles Load (ESAL) applications over the two-year trafficking period. Although the rut depths for the WMA sections were slightly higher than those for the control section, likely as a result of the softer binders in the WMA sections, the differences are considered acceptable.

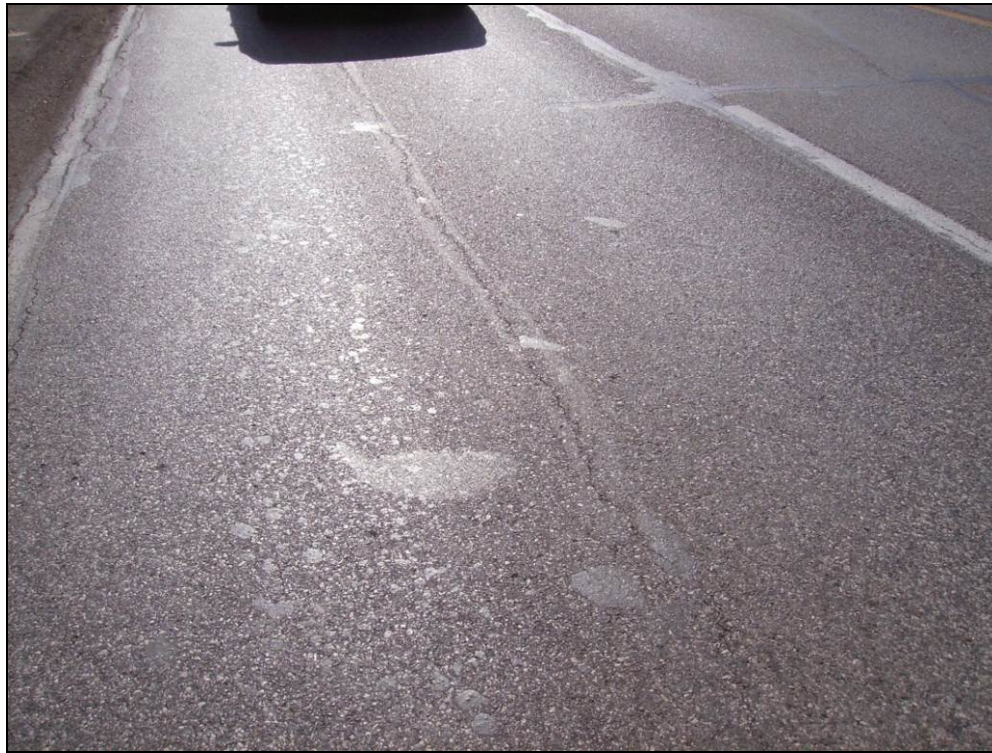
Figure 16 shows an example of the non-wheelpath longitudinal cracking observed in all sections. Figure 17 shows an example of the transverse cracking seen in all sections.

Figure 16 Example of Non-Wheelpath Longitudinal Cracking in St. Louis, MO

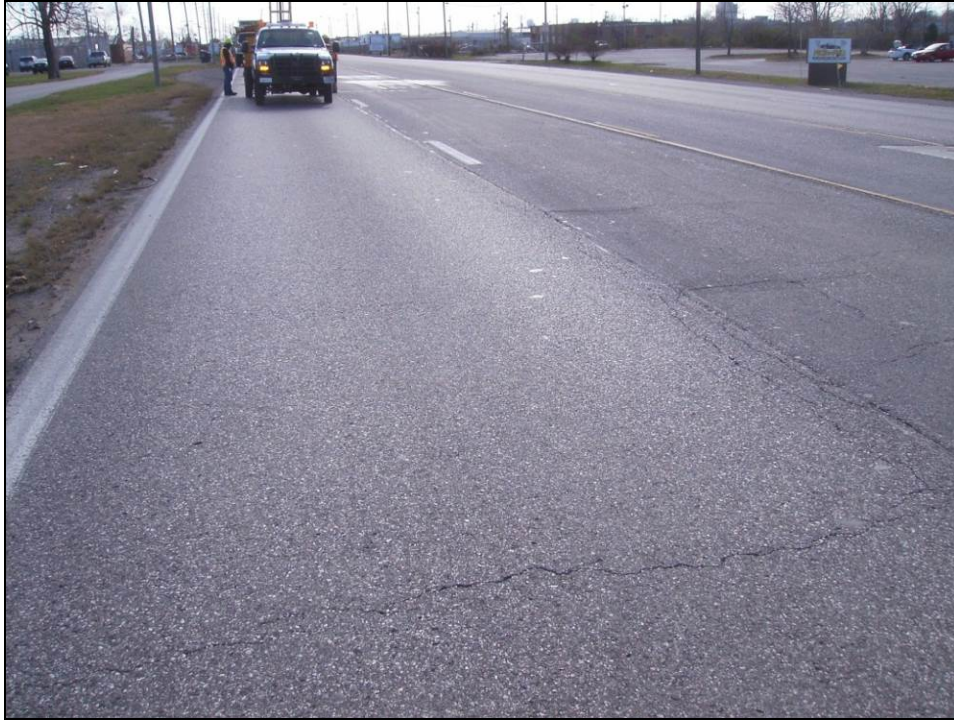
Figure 17 Example of Transverse Cracking in St. Louis, MO

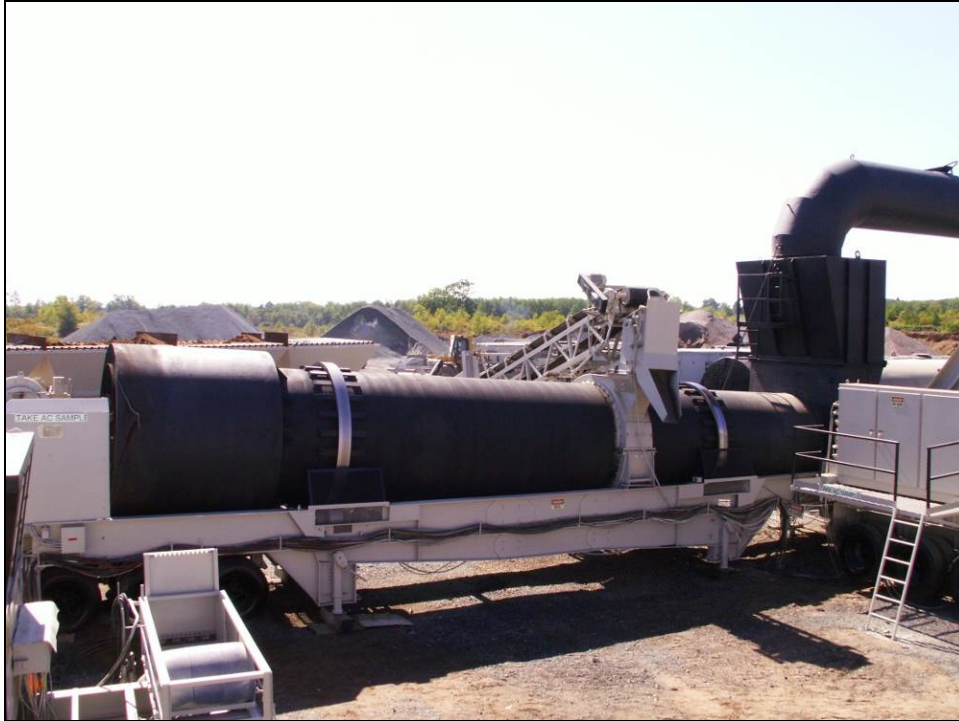
For the WMA mixture, the Sasobit was pre-blended with the base binder at a rate of 1.5 percent by weight of binder. On thousand tons of WMA mix were produced. Mixing temperatures for the control HMA and the WMA were 325°F and 260°F respectively. The asphalt plant used to produce both mixes was located in Spread Eagle, Wisconsin and was a portable, parallel-flow drum plant. The plant incorporated an Adeco drum, Gencor burner, and a Cedar Rapids silo. The burner fuel for the drier was reclaimed oil. A photograph of the plant is shown in Figure 18.

Figure 18 Portable Asphalt Plant used for Iron Mountain, MI Project (19)

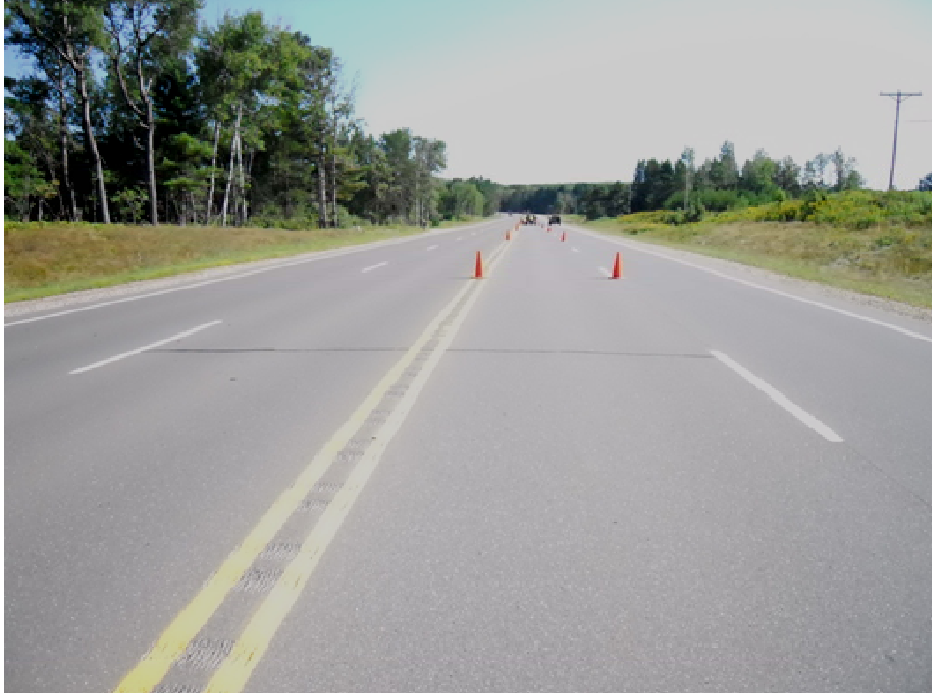
Figure 20 shows the transverse cracking observed in the Sasobit section. It can be seen that this cracking spans across both original middle lanes. The middle-right lane shown in Figure 20 is the WMA mixture, while the middle-left lane is HMA that was not part of this field evaluation. Since this transverse crack goes across both original lanes, it is likely that this is reflective cracking from the underlying concrete.

Figure 20 Transverse Cracking in WMA Section in Iron Mountain, MI

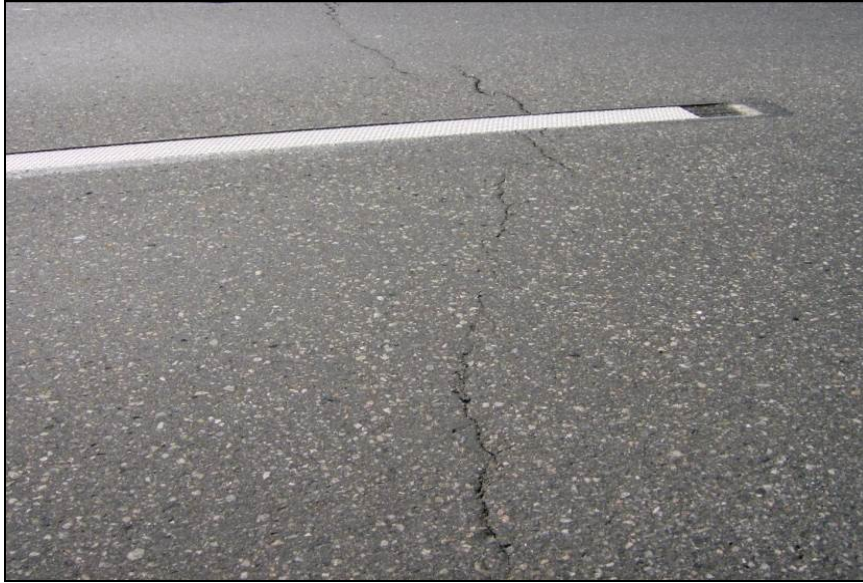
Figure 23 Transverse Cracking in WMA Section in Silverthorne, CO (24)

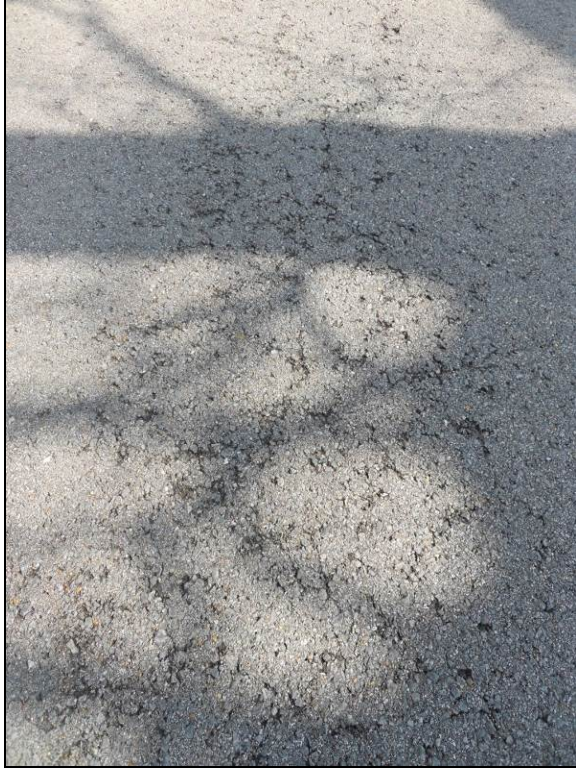
Figure 26 shows an example of the wheelpath longitudinal cracking observed in all mix sections. Figure 27 shows the fatigue cracking observed in the Evotherm section.

Figure 27 Fatigue Cracking in Evotherm Section in Franklin, TN

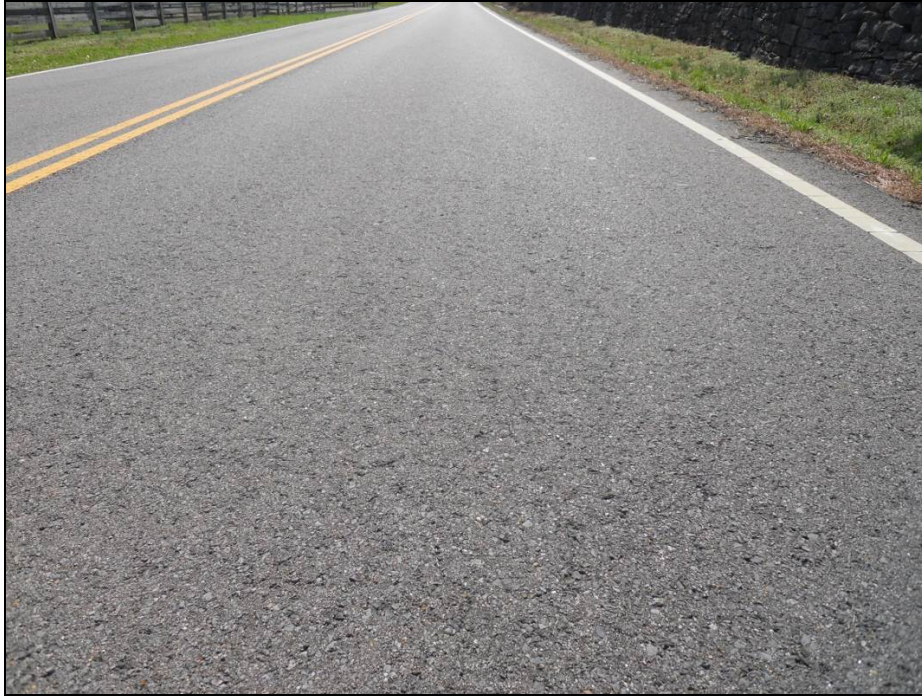
Sand patch tests were conducted at the beginning of each evaluation section in the right wheelpath. The results of the sand patch tests are shown in Table 51. Based on the magnitude of the texture depths, these sections are showing significant raveling. In addition, based on visual observations in the field, all six mix sections had weathered significantly. However, all mixes looked to have experienced the same amount of weathering. Figure 28 shows an example of the surface texture of the mix sections in Franklin, Tennessee.

Figure 28 Example of Surface Texture in Franklin, TN

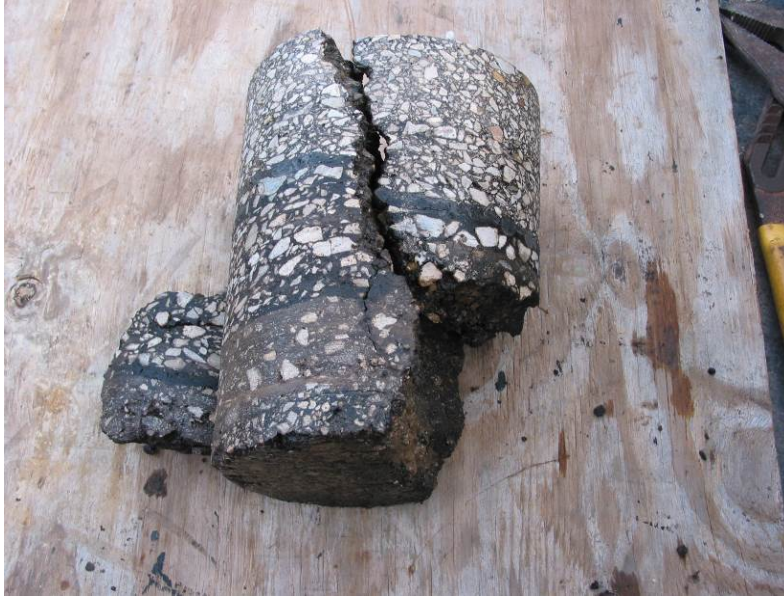
Each evaluation section was carefully inspected for signs of cracking. Both the HMA and WMA sections had small amounts transverse reflective cracking. Cores were taken on some of the cracks to verify that they were reflective cracks as shown in Figure 33. Table 56 shows the total cracking by crack type and severity for both mixes. It can be seen that the amount of low severity cracking in the two different mix sections was comparable. However, the WMA mix sections also had some moderate cracking. Figure 34 show an example of the transverse cracks after 30 months of performance.

Figure 33 Photo Showing Core Taken on a Transverse Crack to demonstrate it was Reflecting from Underlying Pavement Layers

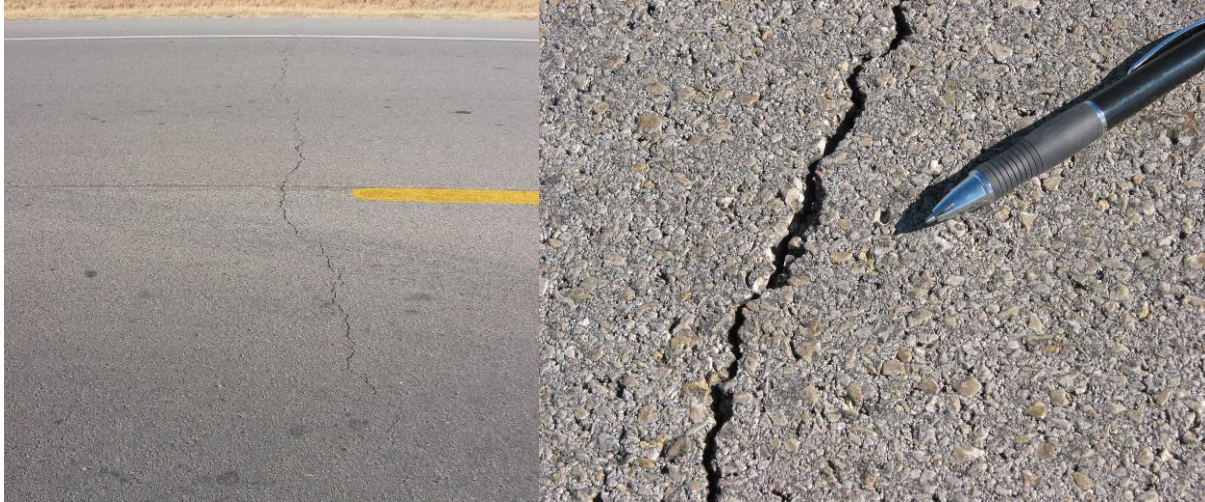
Figure 34 Photos of transverse cracks on the Graham, TX project after 30 months

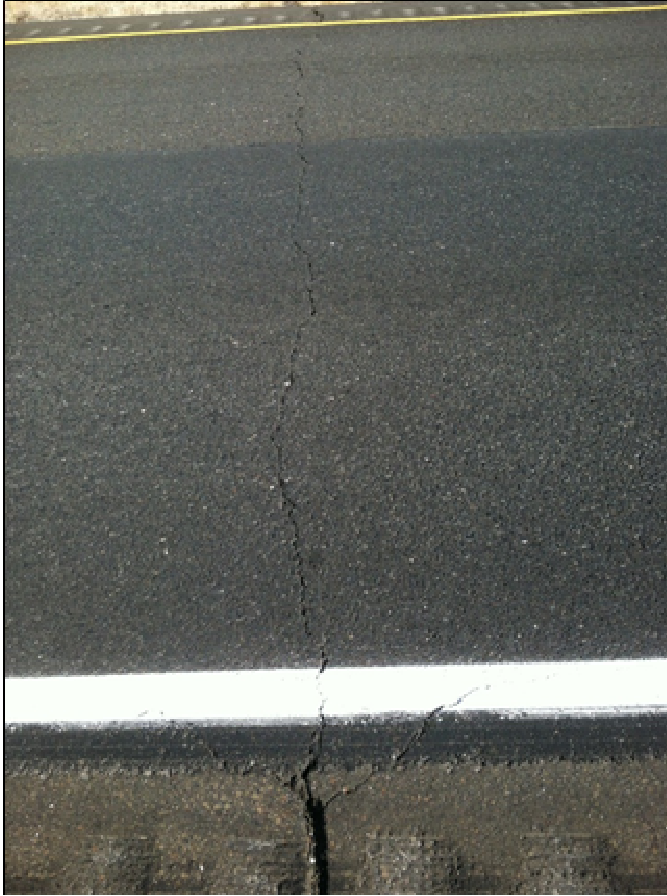
Figure 38 Example of Transverse Cracking in George, WA

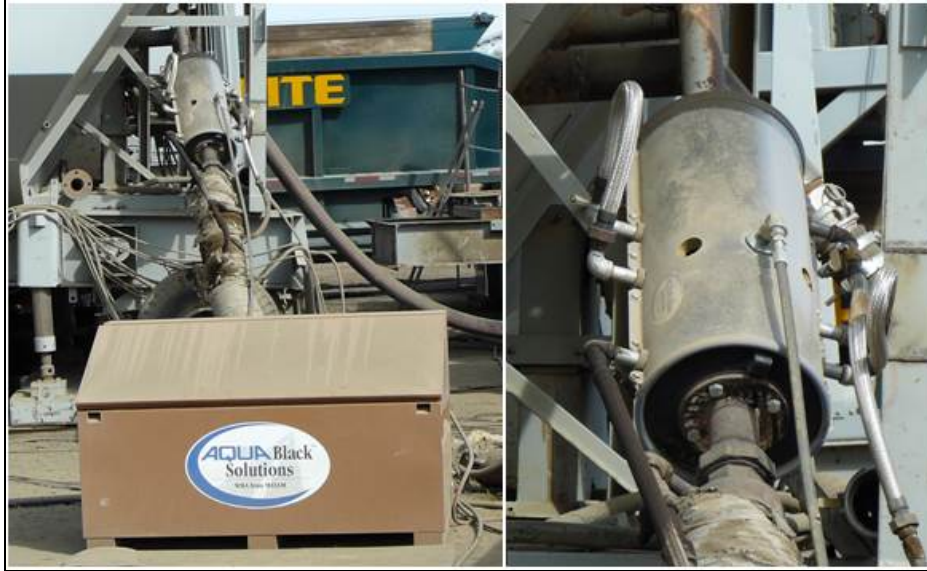
Figure 40 Aquablack WMA System used in Walla Walla, WA

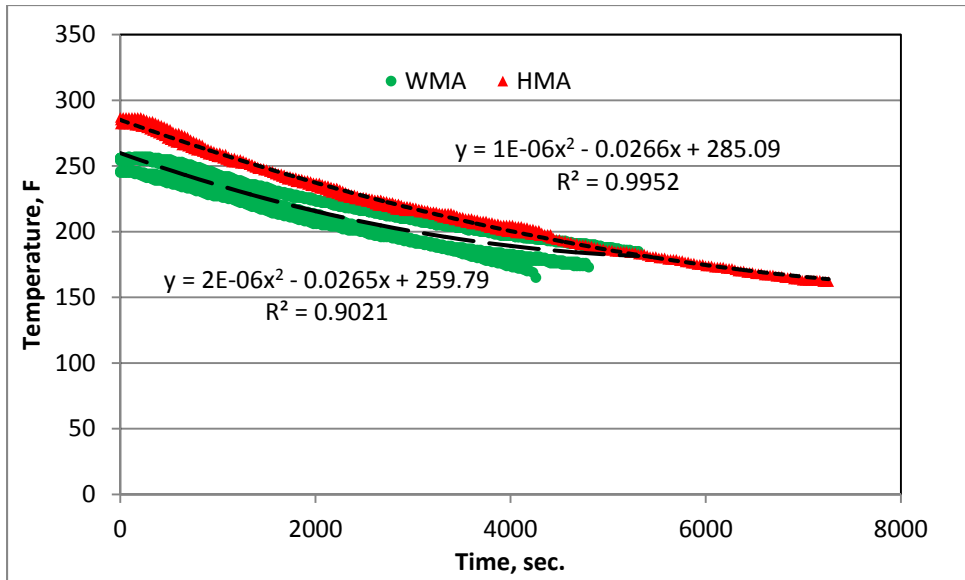
The temperature behind the paver was monitored using temperature probes, which collected temperature data every 30 seconds. Data from the probes were processed to determine the rate at which the mat cooled. Regression was used to fit an equation to the mat temperature and time data collected. Figure 46 shows the regression equations for WMA and HMA. From this analysis, the WMA and HMA mixtures had similar cooling rates.

Figure 46 Mix Cooling Trends in Walla Walla, WA

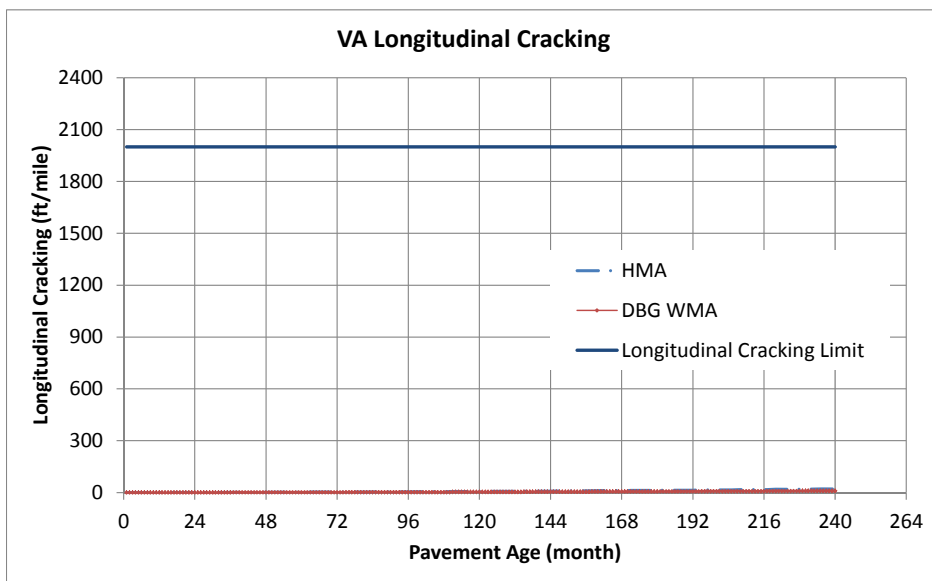
Figure 61 MEPDG Predicted Longitudinal Cracking for I-66, Centreville, VA

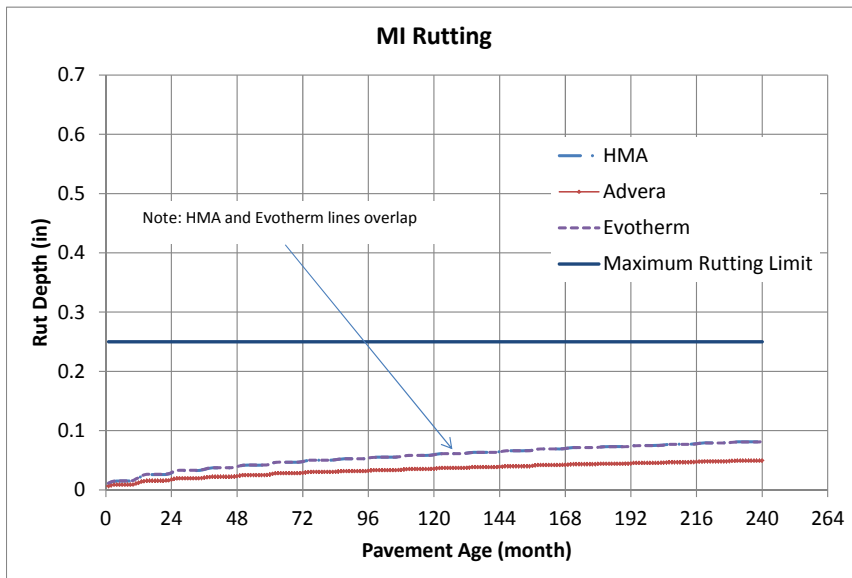
Figure 69 MEPDG Predicted Asphalt Rutting for CR-513 Rapid River, MI

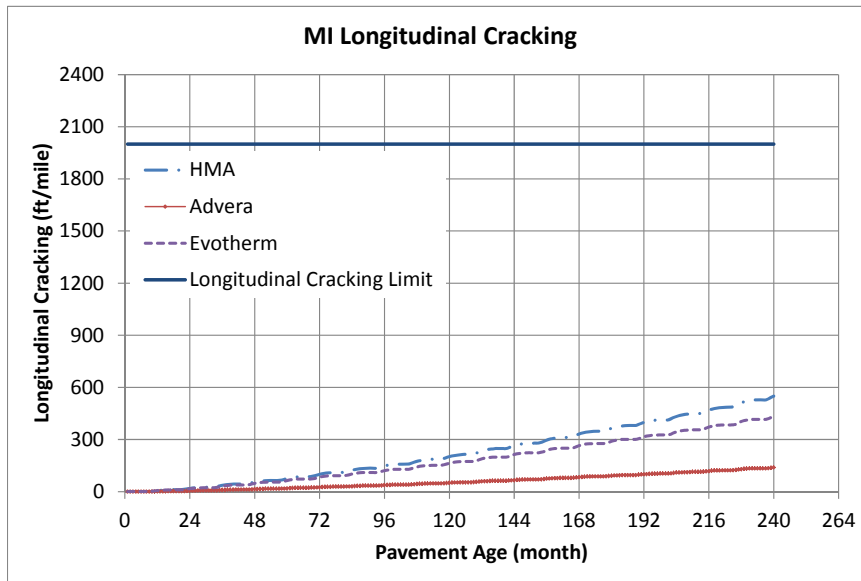
Figure 70 MEPDG Predicted Longitudinal Cracking for CR-513 Rapid River, MI

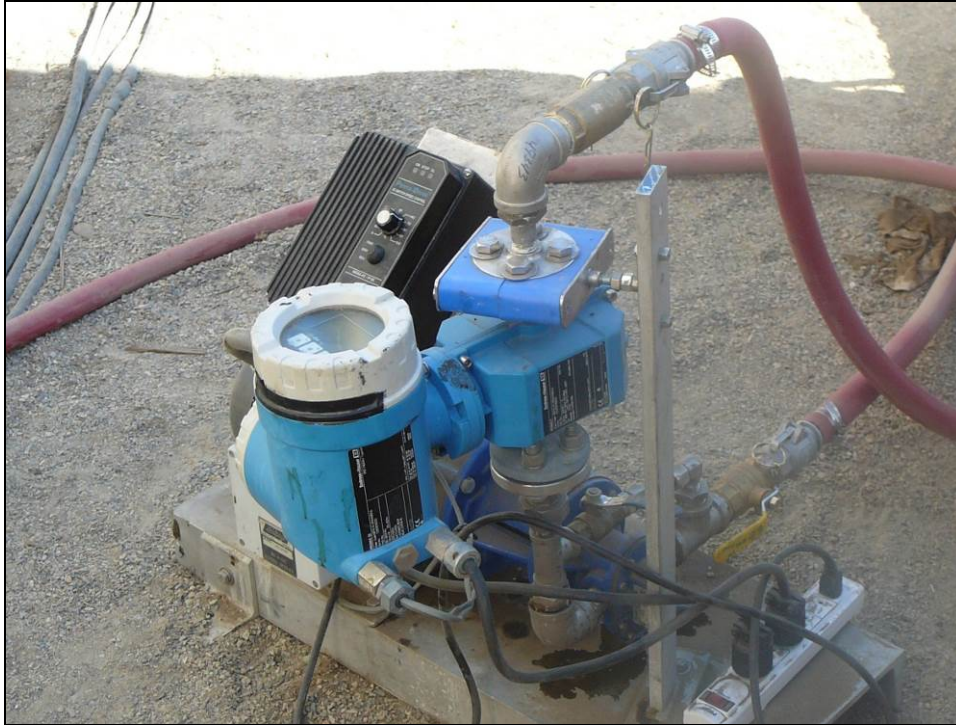
Figure 71 Evotherm DAT Metering System

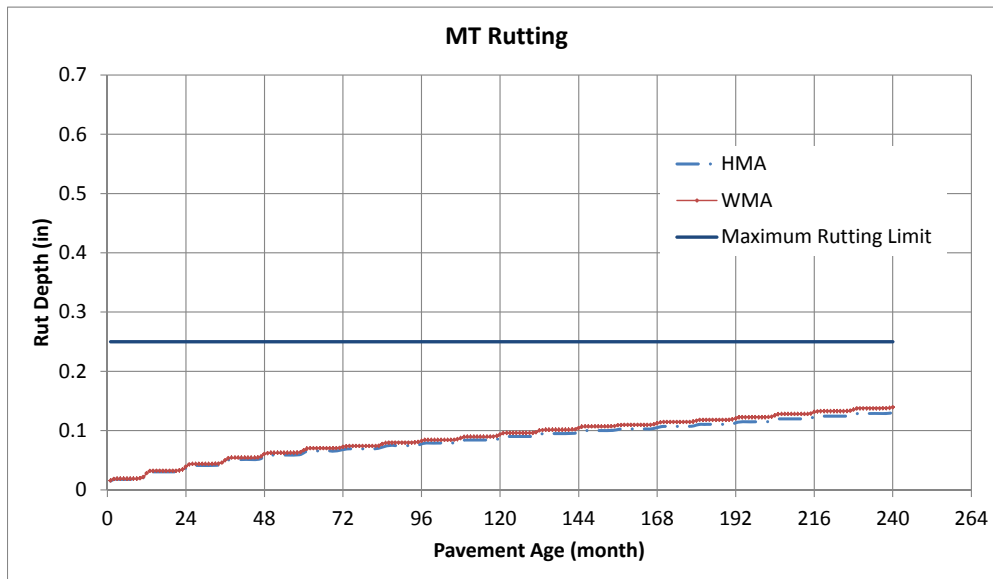
Figure 79 MEPDG Predicted Asphalt Rutting for CR-322 Baker, MT

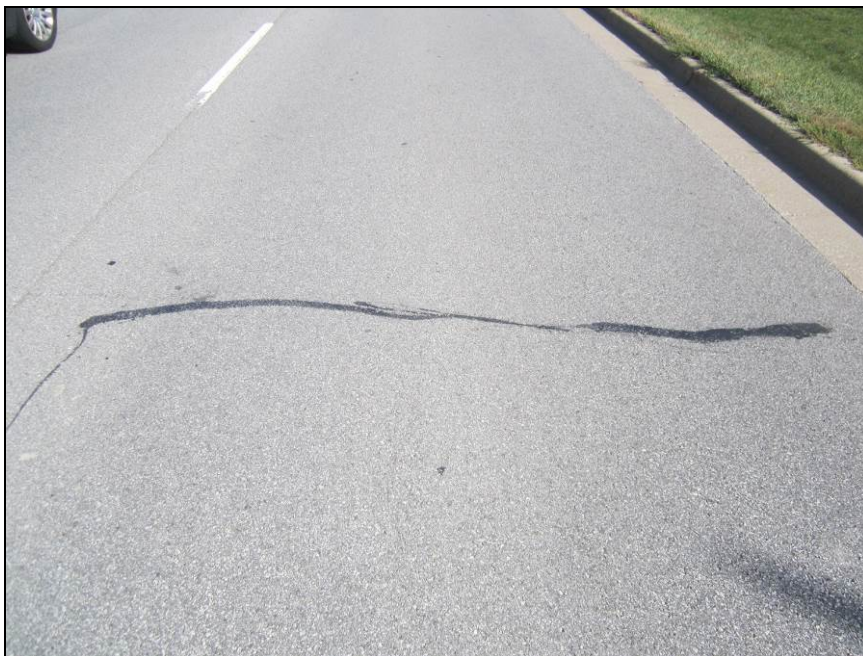
Figure 86 Example of Low-Severity Transverse Crack in Munster, IN

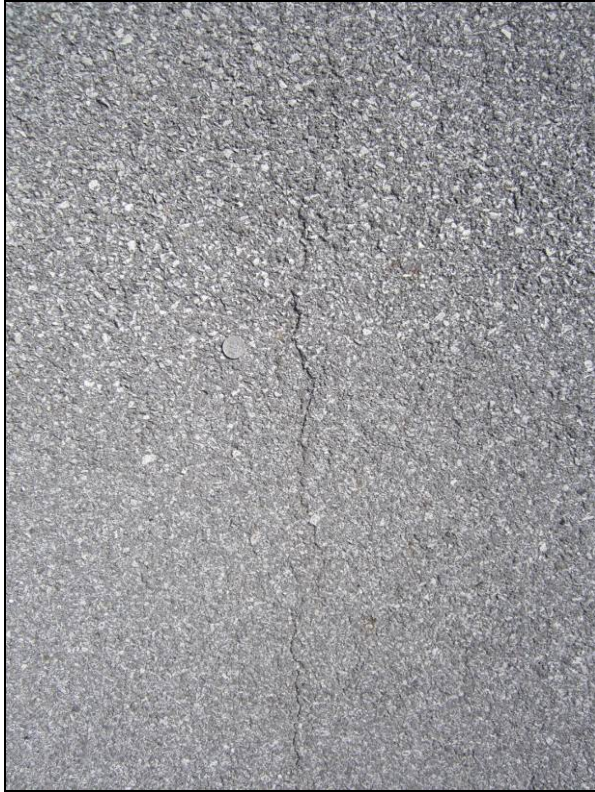
Figure 87 Example of Low-Severity Non-Wheelpath Longitudinal Crack in Munster, IN

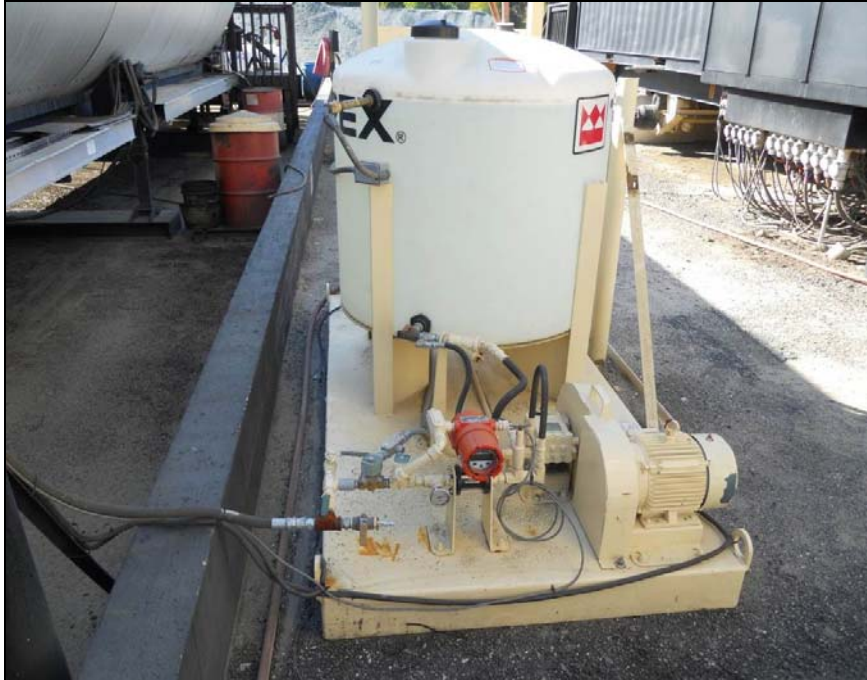
Figure 93 Terex WMA System used in Jefferson Co., FL

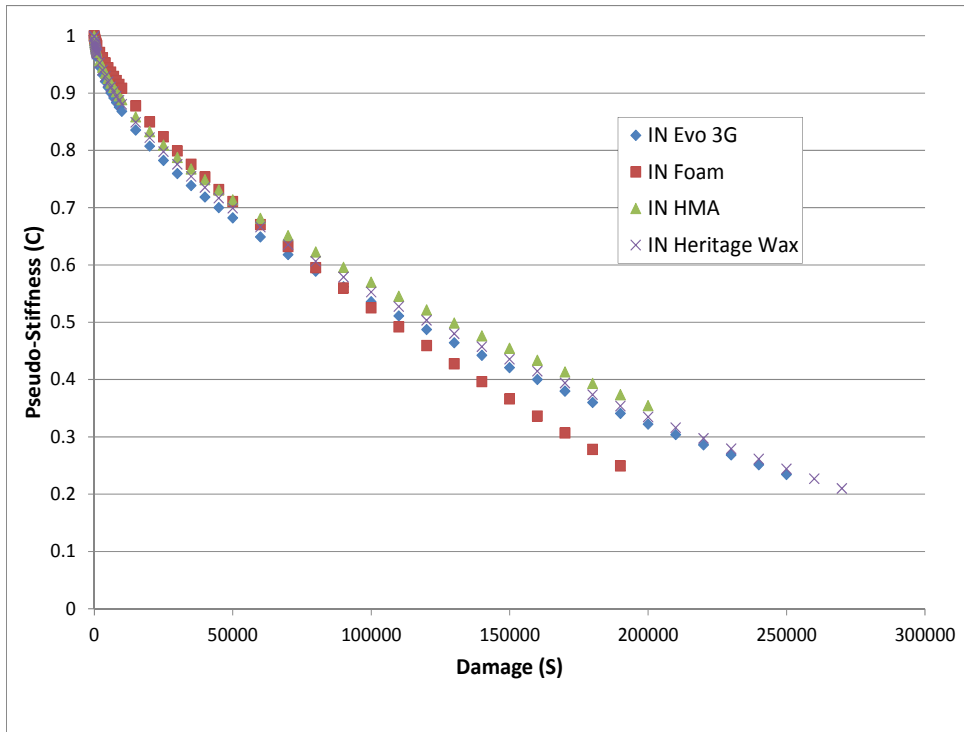
Figure 136 Pseudo-Stiffness (C) versus damage parameter (S) curves for HMA control mix and WMA technologies, Munster, IN project

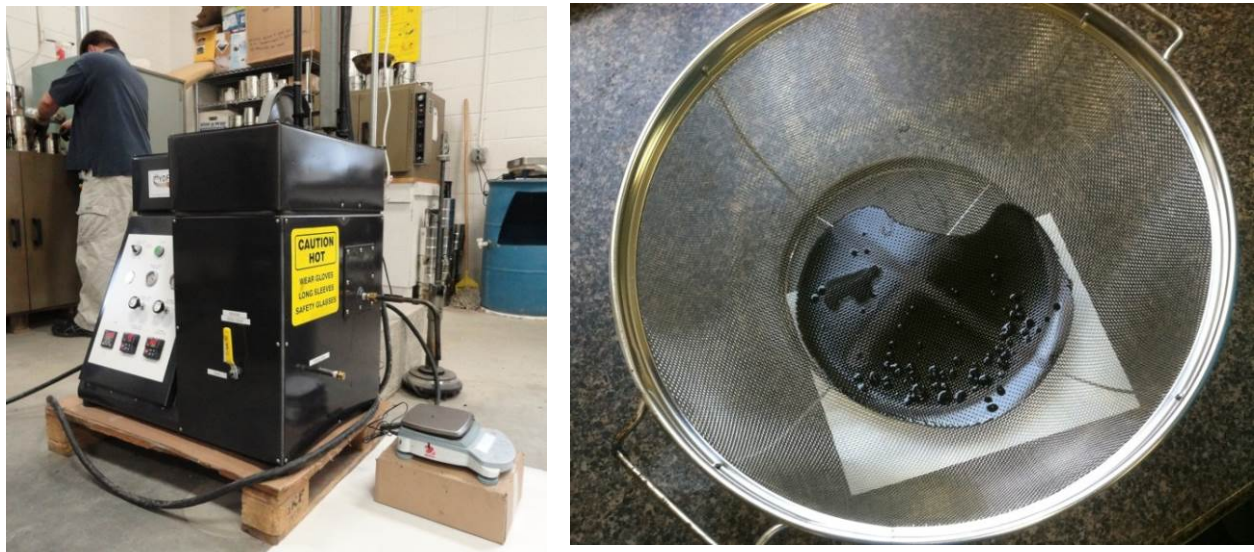
Figure 140 Hydrofoamer (left), polymer strained out of Florida PG 76-22 binder (right)
