NCHRP 25-25/Task 72

CURRENT PRACTICES TO ADDRESS CONSTRUCTION VIBRATION AND POTENTIAL EFFECTS TO HISTORIC BUILDINGS ADJACENT TO TRANSPORTATION PROJECTS

Wilson, Ihrig & Associates, Inc.,
ICF International, and
Simpson, Gumpertz & Heger, Inc.

September 2012

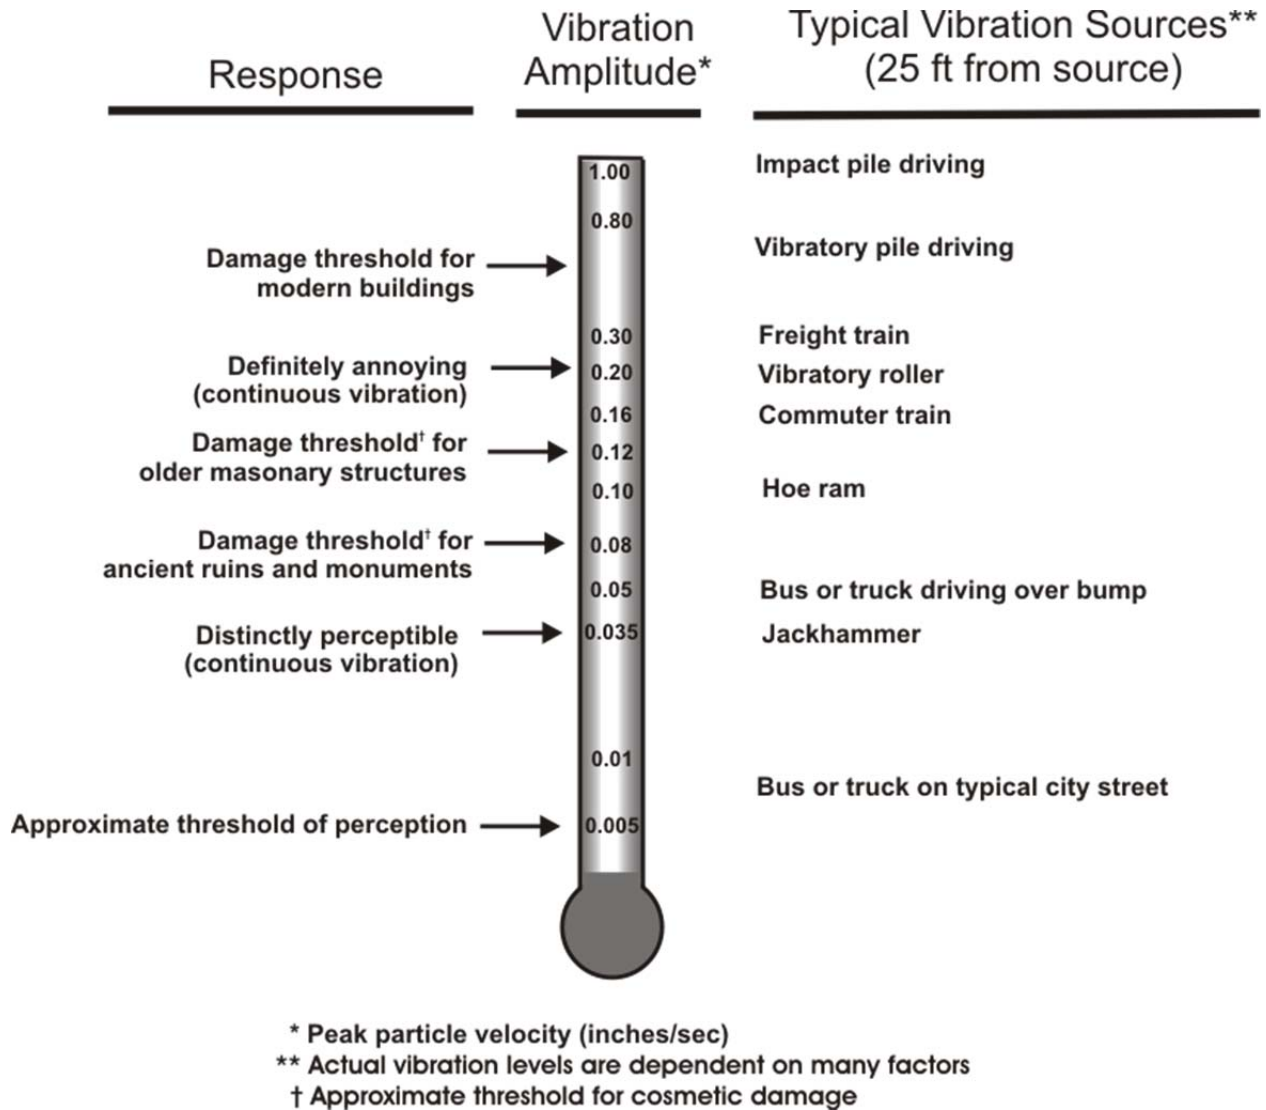
Figure 1 provides a comparison between typical vibration levels at 25 feet from various common sources and the response of humans (annoyance) and the potential for damage to historic buildings. The sensitivity of humans makes them aware of vibration at levels much lower than those that result in damage to most contemporary structures, although older historic buildings can be at risk in the transition range of vibration that is just barely perceptible (0.02 inches/sec) to vibration that most people would find definitely annoying (0.2 inches/sec).

Figure 1. Typical Vibration Amplitudes and Thresholds

Comparing the two sets of data (continuous and transient), it can be seen that there is approximately a factor of eight difference in the sensitivity to the nature of the vibration.

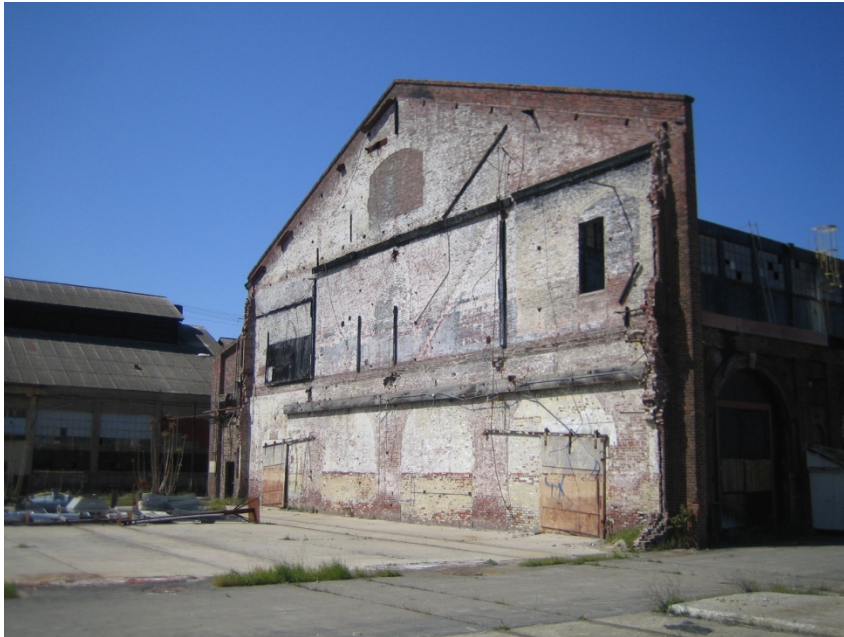
During the project’s design phase, the owner engaged a structural engineer to evaluate the condition of the buildings and the effect of future train vibration. The engineer concluded from a visual review that even though the maximum predicted vibration exceeded the FTA criterion, the vibration was not expected to cause any risk to the existing masonry walls (structural or cosmetic), with the exception of one building (Car Shop), which had a large cantilevered wall (i.e., unsupported laterally). Figure 2 shows the outside of the Car Shop’s unsupported wall.

Figure 2. Car Shop within the Sacramento Railyards Central Shops Historic District

The structural engineer conducted a detailed finite element analysis to evaluate the Car Shop wall and its susceptibility to ground vibration. The vibration consultant made additional vibration measurements for freight and passenger trains and characterized the site-specific soil conditions at the Car Shop. The additional data from measurements were used to refine the predicted vibration levels expected at the base of the cantilevered wall of the Car Shop.

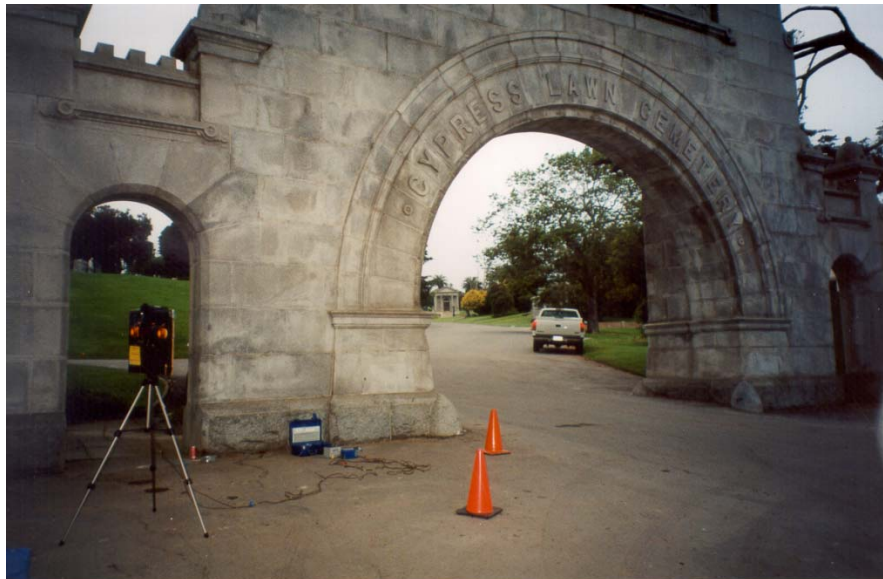
Figure 3 shows the archway and a seismograph used for monitoring vibration. In addition to the seismograph at the base of the archway, there was an alarm system with warning lights (yellow for caution and red for exceedance) and an audible alarm. The warning system provided a direct feedback to the equipment operators when vibration limits were being approached or exceeded and allowed equipment operators to adjust their activity. After an initial learning stage of trial and error, the system became a reasonably successful tool to control vibration.

Figure 3. Cypress Lawn Cemetery Grand Gateway

The implementation of the alarm system was somewhat unusual, but the cost was inconsequential because the seismograph was configured to allow for an alarm. The alarm's main advantage was that it allowed for real-time feedback to the equipment operator, thus increasing the chances of successful compliance with the vibration limit. In general, the response of the equipment operator to having an alarm was positive, and he was able to modify the activity of his equipment to stay within the vibration limits.

Vibration levels measured at the archway during construction of the BART project ranged from 0.09 to 0.12 inches/sec. The higher vibrations occurred during excavation and by movement of a small Caterpillar approximately 15 feet away from the archway. Although these levels were above the limit of 0.08 inches/sec, engineers found no damage to the archway during inspections during and after construction.

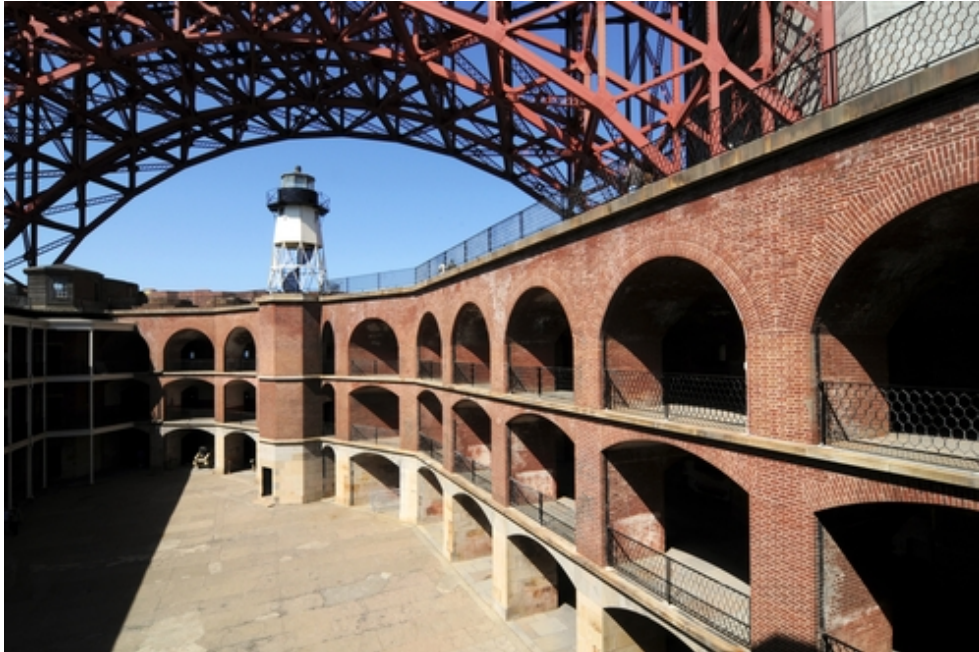
Directly underneath the south end of the bridge is the historic Fort Point a masonry structure built in 1854. Figure 7 shows the inside of Fort Point with the bridge above. The contract specification for the bridge retrofit required vibration to be limited to less than 0.1 inches/sec for continuous activities and 1.0 inches/sec for single-event activities occurring near Fort Point.

Figure 7. Fort Point and Golden Gate Bridge

During Phase 1 remediation, cast-in-drilled-hole (CIDH) piling and pile caps were added around the perimeter of the original bridge foundation pedestals. The interface of new concrete to existing concrete was strengthened with post-tensioning of monostrands, clamping the new footings to the pedestals of the existing foundations. The existing grade beams between the foundation pedestals were also substantially strengthened, and additional grade beams were constructed. After the existing towers supporting the bridge were removed, the second stage of the foundation retrofit proceeded. First, the remaining upper portions of the existing pedestals were demolished. Then, new upper pedestals were constructed and closure pours placed to incorporate these elements into the entire foundation system. The erection of a new tower followed.

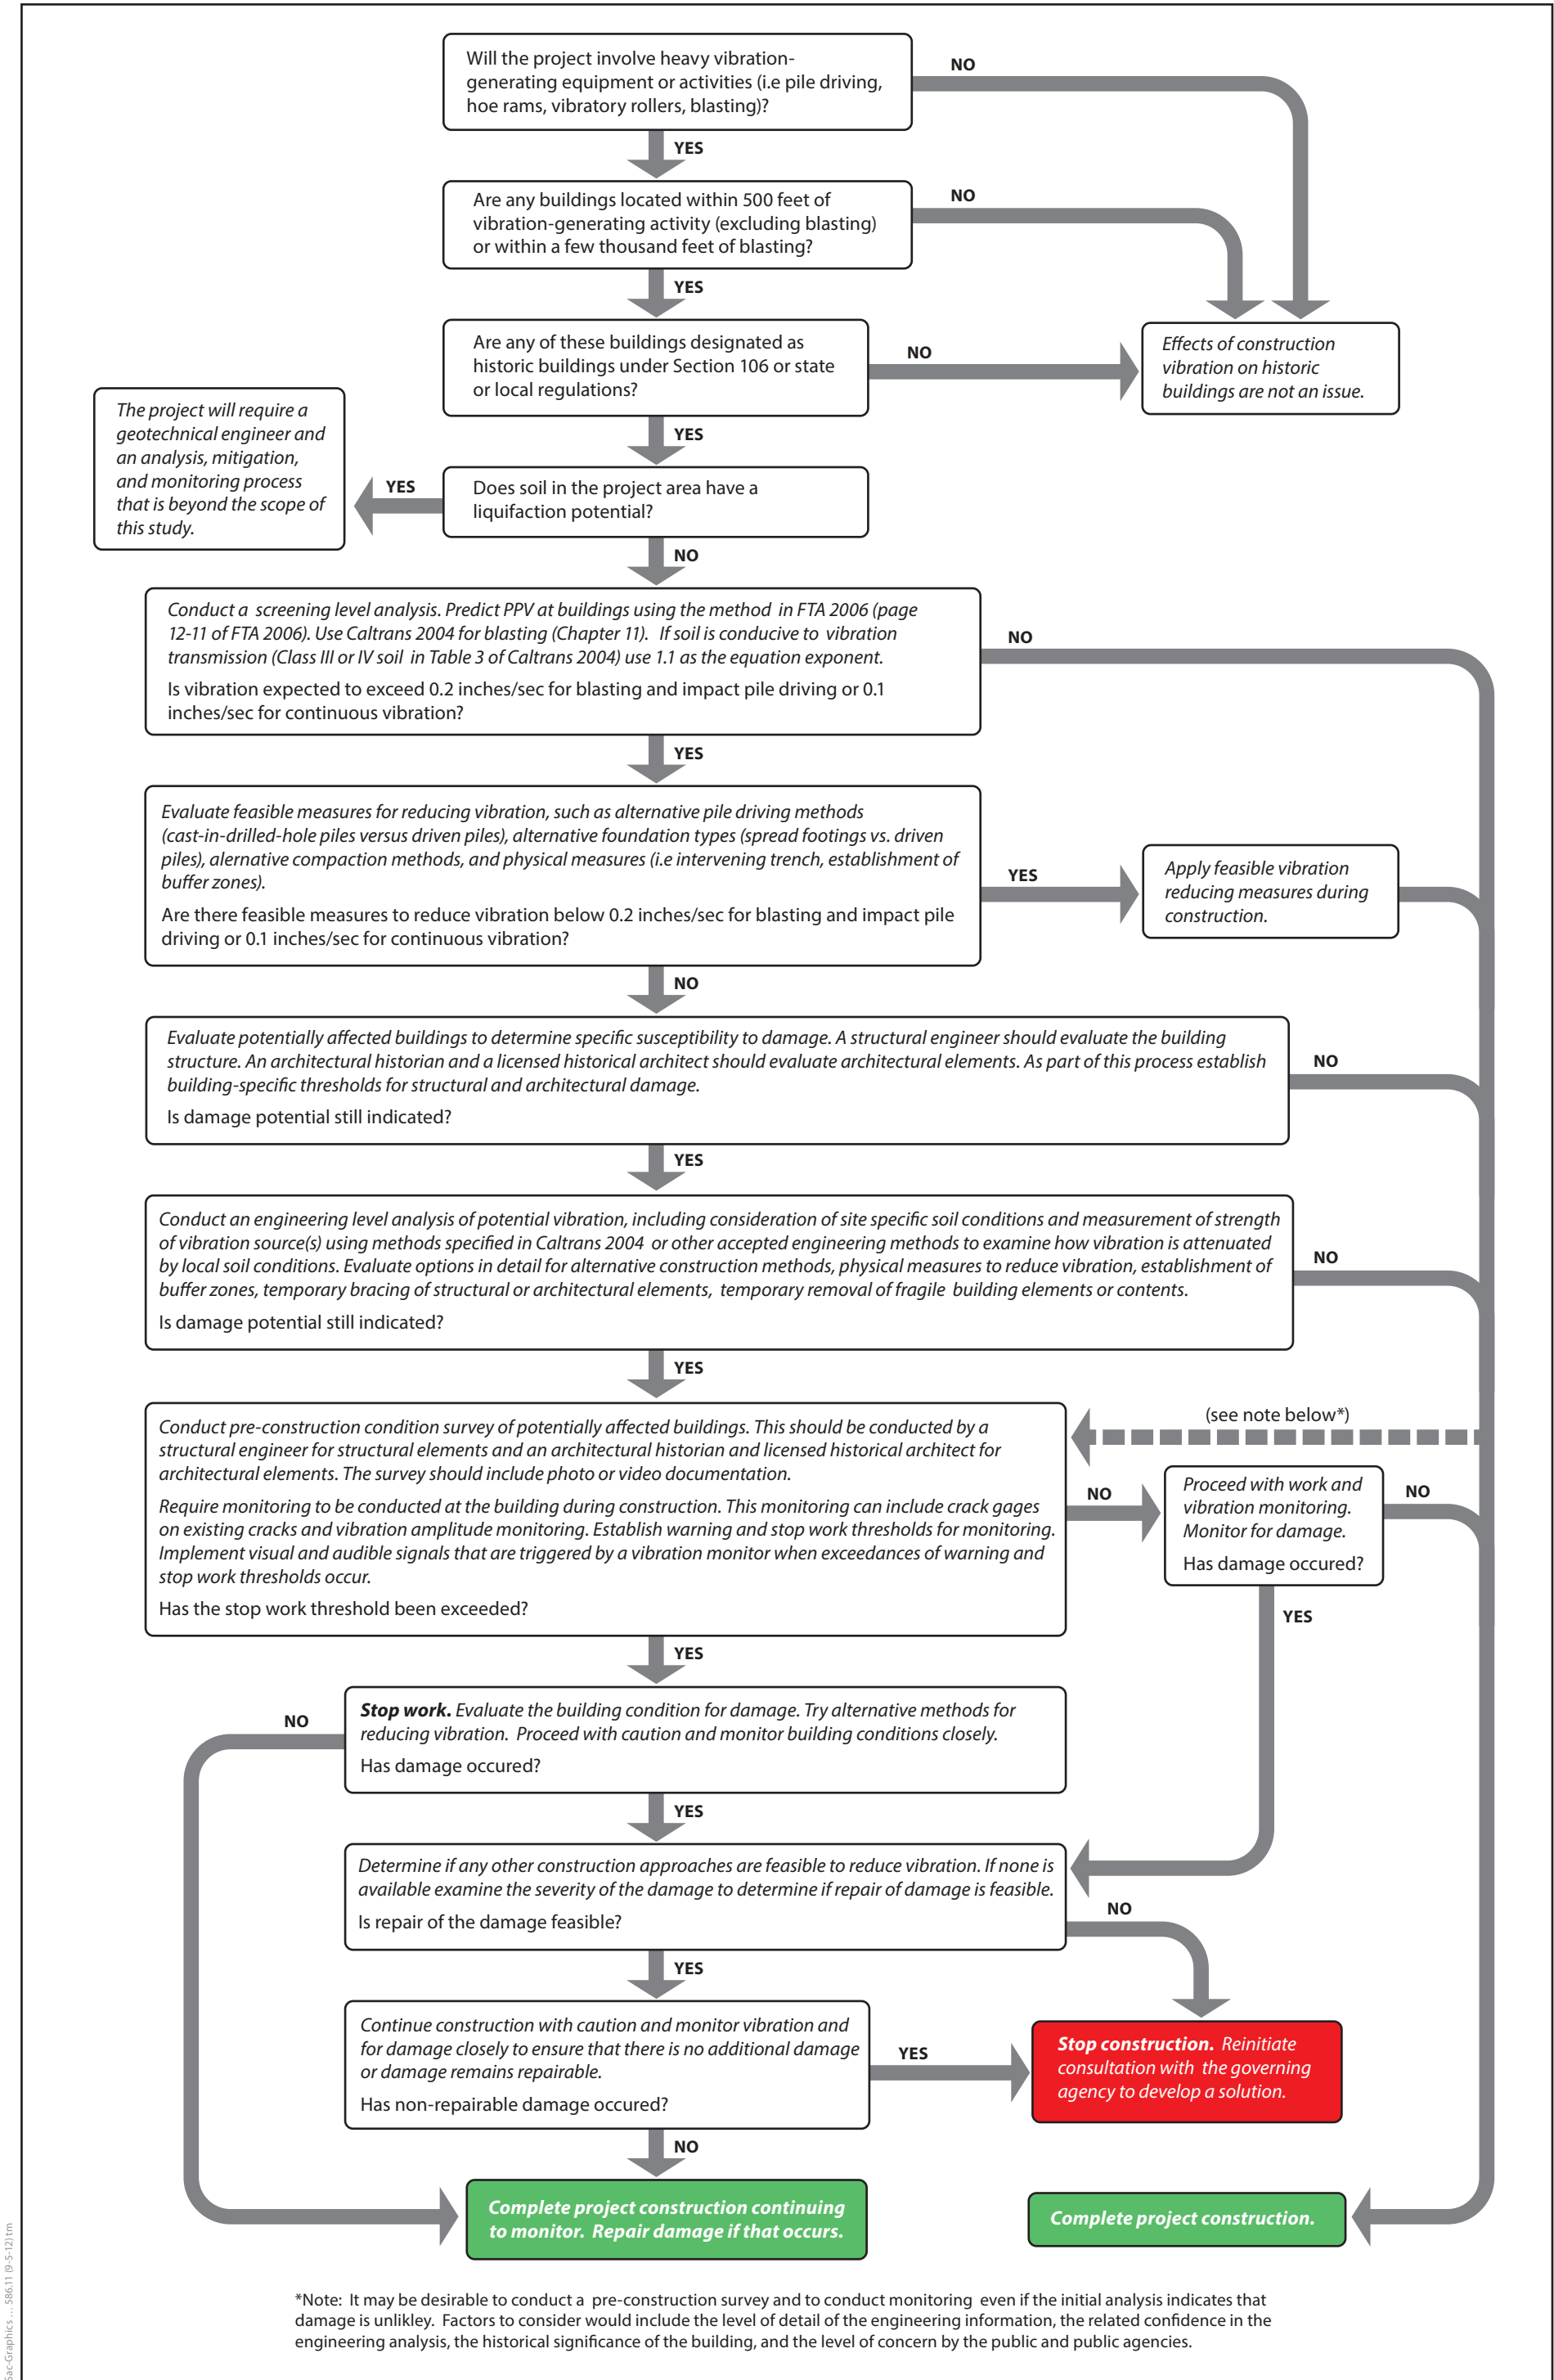
Figure C-1
Flow Chart for Recommended Approach for Addressing Construction Vibration Impacts on Historic Buildings
