## **REPORT 469**

### **Fatigue-Resistant Design of Cantilevered Signal, Sign, and Light Supports**

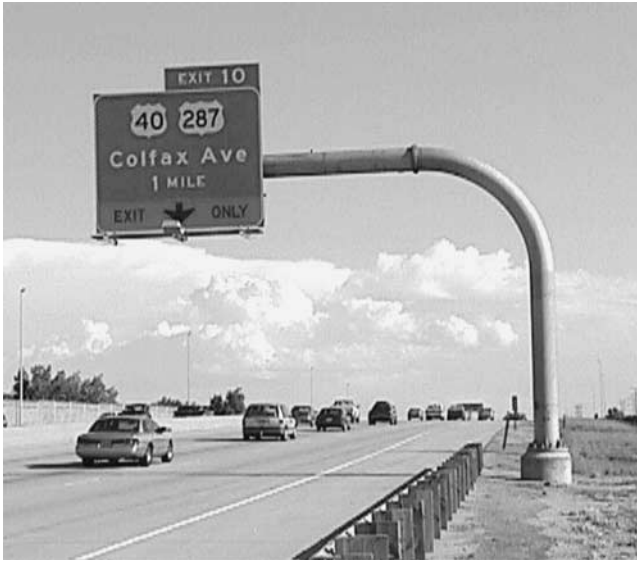
Figure 2-5. At-risk bent monotube sign in foothills of Rocky Mountains.

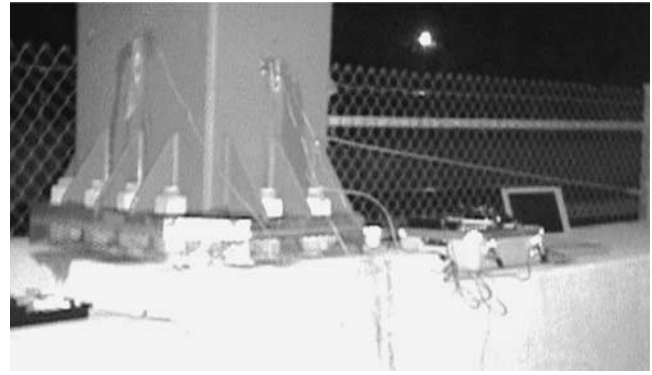
Figure 2-17. Instrumented IDOT Vierendeel VMS post.

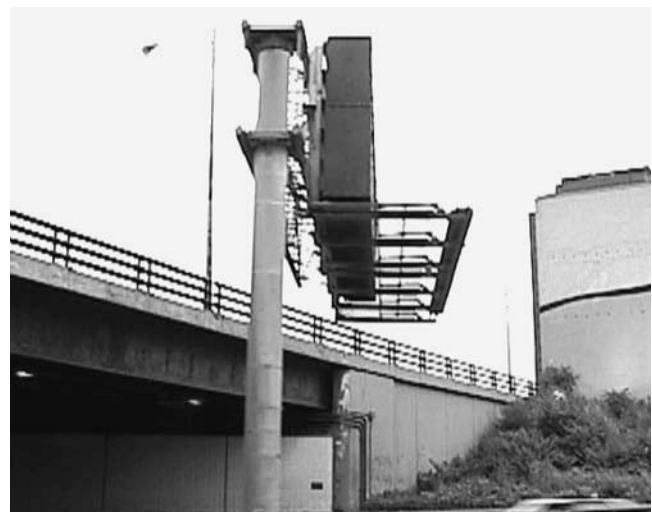
Figure 2-21. Side view of IDOT box-truss VMS structure.

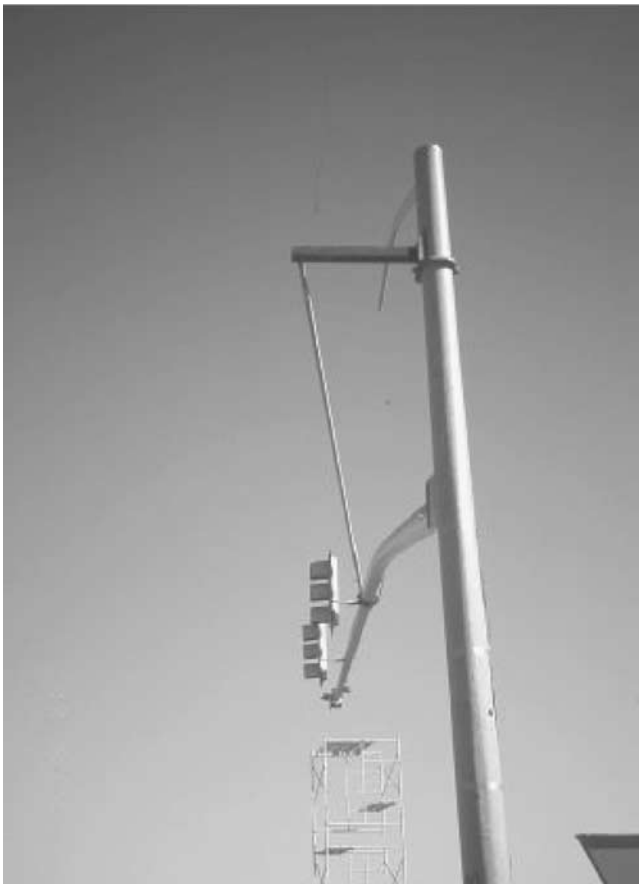
Figure 2-36. University of Wyoming cantilevered strut damper.

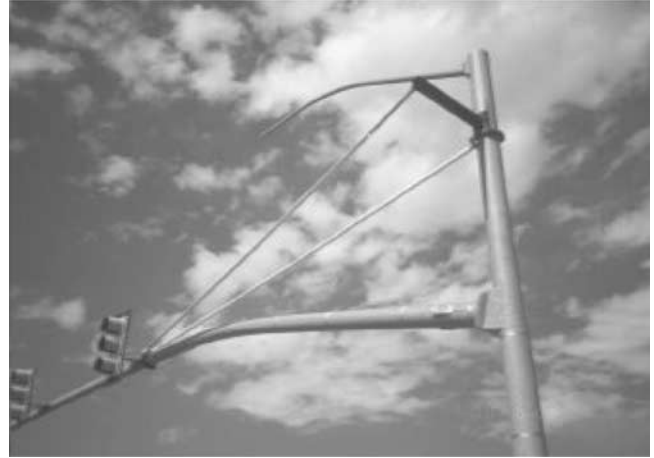
Figure 2-37. University of Wyoming dual-strut damper.

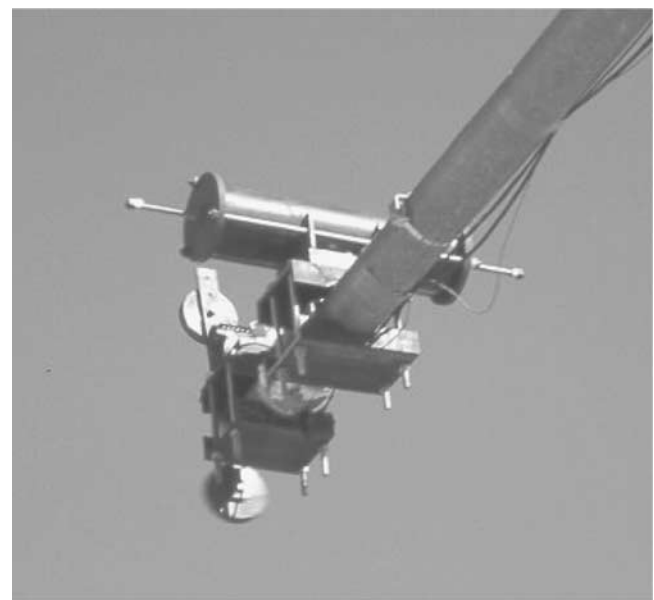
Figure 2-38. University of Wyoming shot-put impact damper.

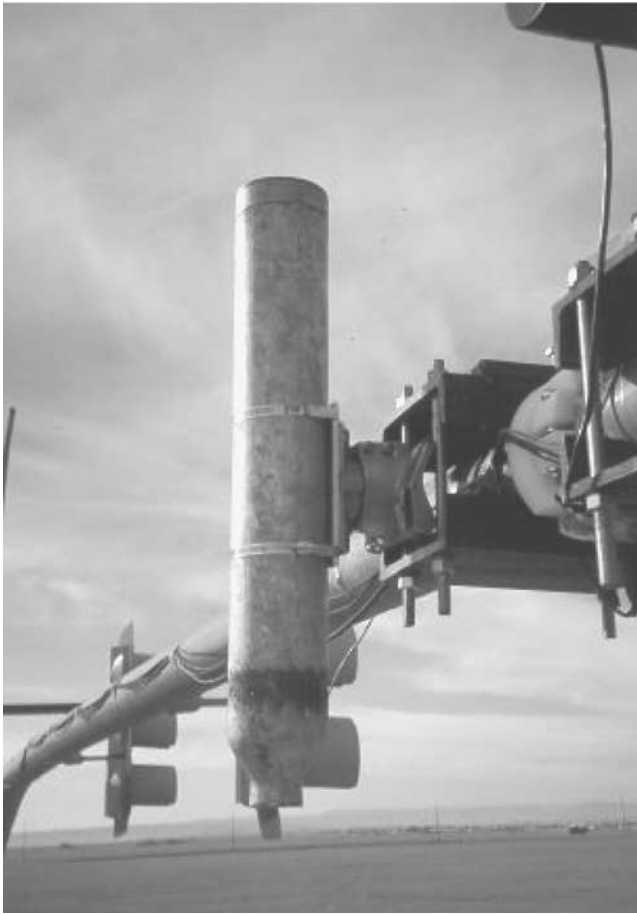
Figure 2-39. University of Florida semituned mass impact damper installed in Wyoming.

The early prototype of the Florida semituned-mass impact damper (102- to 51-mm [4- to 2-in.] taper) was also tested at the University of Wyoming (see Figure 2-39). This damper was the same damper that was tested in the field on the structure near Tampa, Florida (see Section 2.3.4). Again, the device performed fairly well. The in-plane moment was decreased to nearly one-fourth of its original magnitude. The maximum out-of-plane moment was only decreased by a fac-

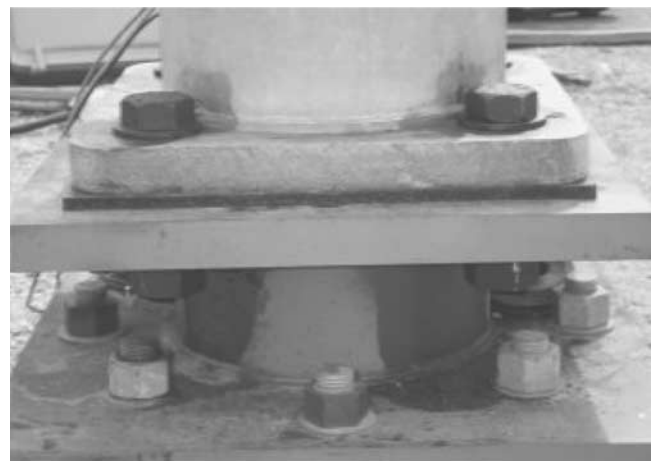
Figure 2-42. University of Wyoming elastomeric pad.

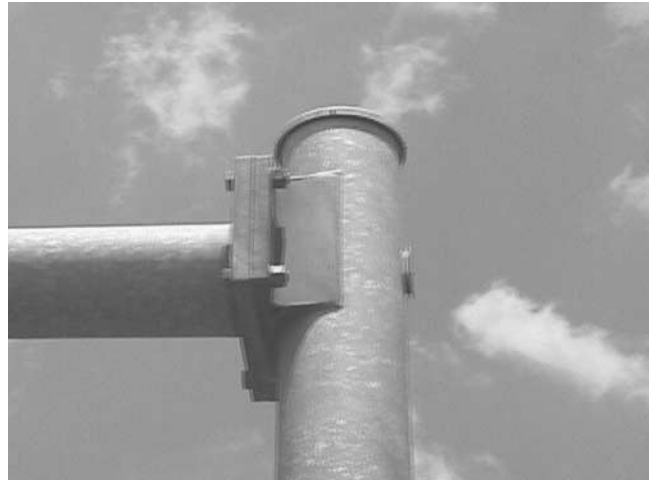
Figure 2-45. Built-up box connection of Tampa structure.

Figures 2-43 and 2-44). The 20.1-m (66-ft) mast arm was attached to the post with a standard built-up box connection (see Figure 2-45). This structure had been reported to exhibit excessive vibration, and it was hoped that the structure (and the dampers that were to be applied to it) could be tested in natural wind conditions. However, winds on the test day rarely exceeded 2 m/s (4.5 mph), which made it necessary to perform pull-down tests in order to examine the effectiveness of the proposed dampers. When a pull-down test is conducted, a rope is first attached to the structure near the tip of the mast arm. Tension is then applied by hand to the rope in harmony with the natural frequency of the structure until the structure is sufficiently excited (see Figure 2-46). The rope is then released, and the structure is allowed to vibrate freely while its response is measured.

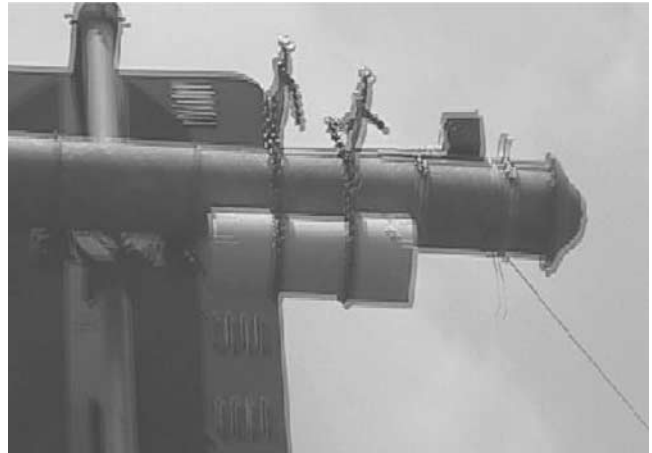
Figure 2-51. PVC-sand damper.

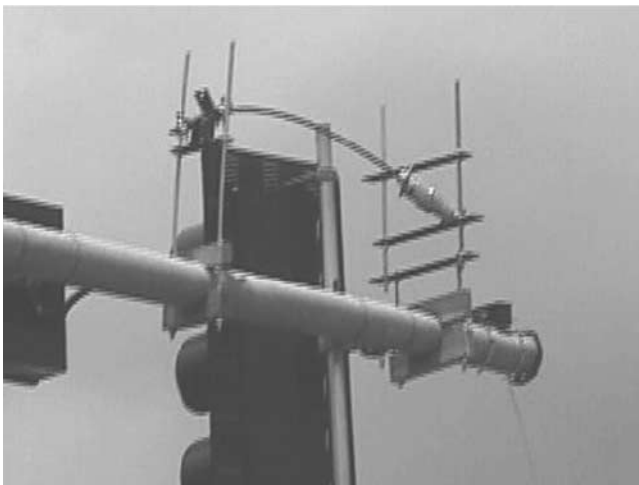
Figure 2-53. University of Wyoming strand damper.

The strand damper developed at the University of Wyoming was tested only three times because of time constraints (see Figure 2-53). As the mast arm oscillated, the mass impacted steel plates mounted above and below the free tip

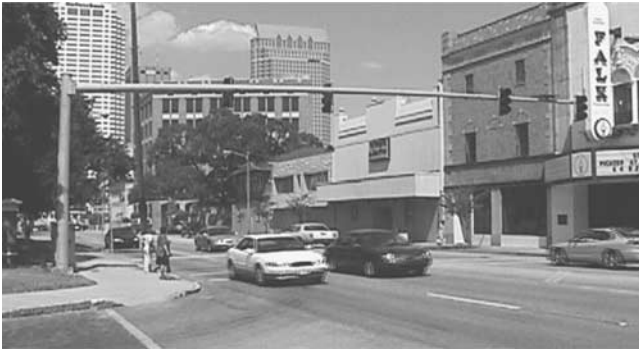
Figure 2-73. At-risk signal structure near University of Tampa.

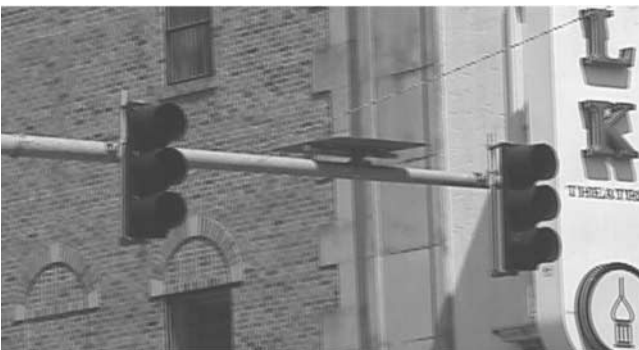
Figure 2-74. Improperly installed damping plate on University of Tampa structure.

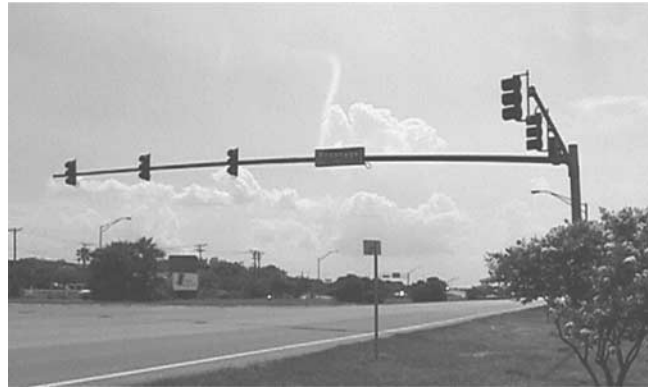
Figure 2-75. At-risk signal structure near Tampa airport.

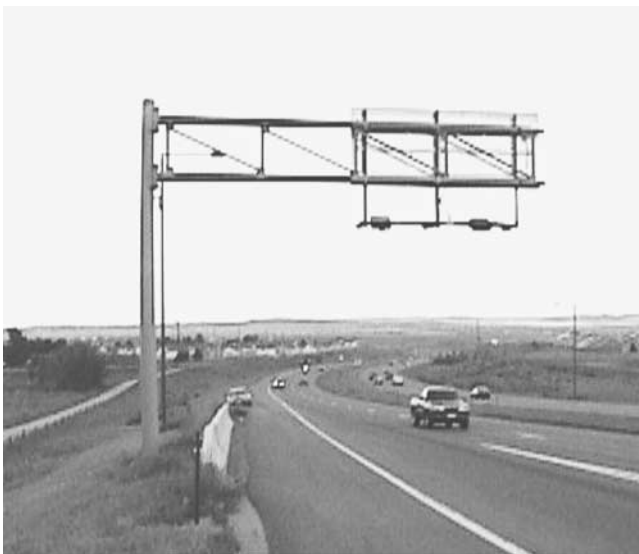
Figure 2-79. At-risk two-chord truss in foothills of Rocky Mountains.

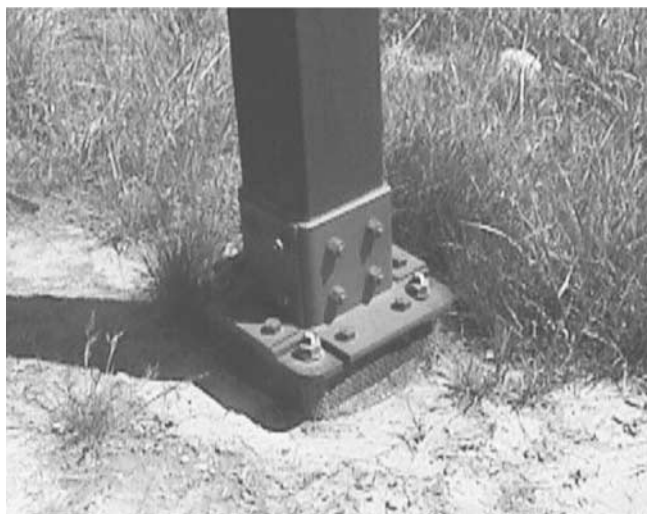
Figure 2-81. Retrofitted luminaire base detail in St. Louis.
