# **COUNTERMEASURES TO PROTECT BRIDGE PIERS FROM SCOUR**

## **REFERENCE DOCUMENT**

**P.F. Lagasse, P.E. Clopper, L.W. Zevenbergen, and L.G. Girard**

December 2006

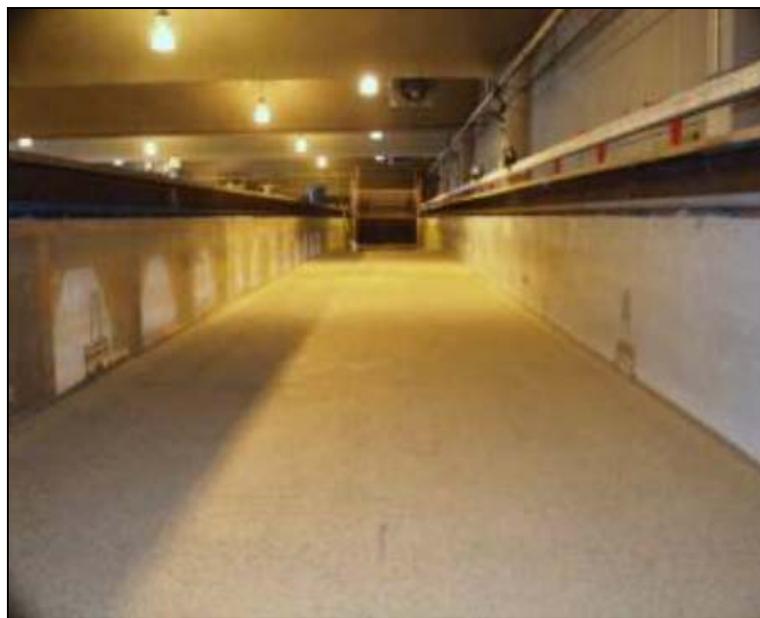
Figure 2.1. Eight foot flume before pier installation.

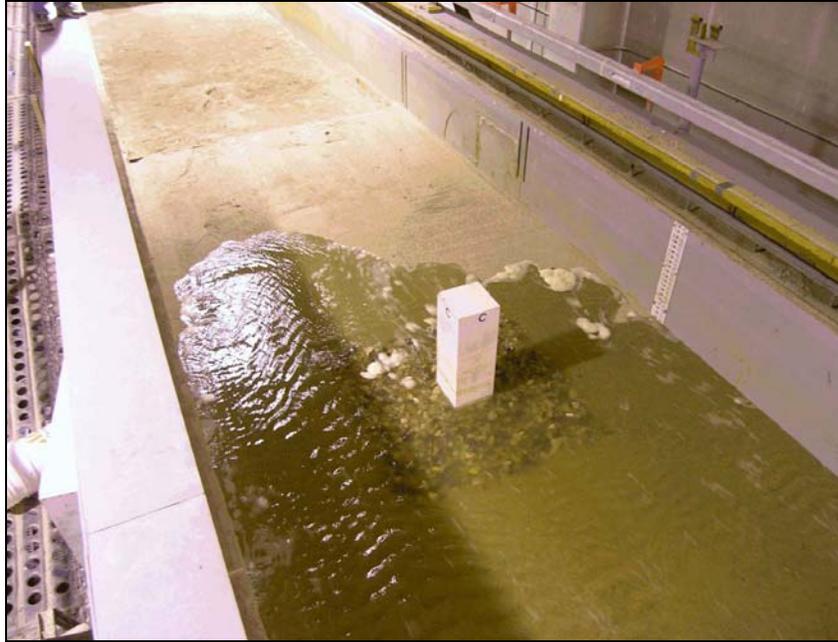
Figure 2.3. Flow being introduced to the flume (looking downstream).

Prior to each test, the tailgate was closed and the flume slowly filled with water until the target flow depth of 30.5 cm (1 ft) was established. Flow was introduced very slowly to ensure no local scour occurred during start-up. During the slow filling process, air was allowed to escape from the sand bed. **Figure 2.3** shows Pier C as flow was introduced to the testing flume.

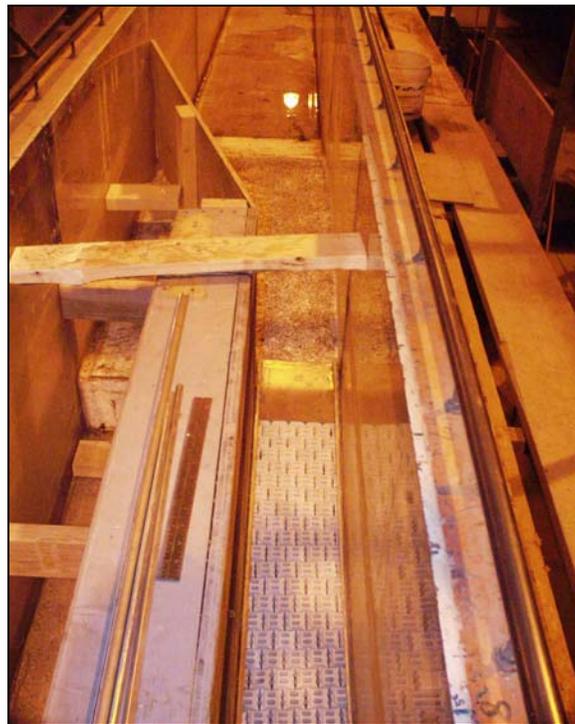
Figure 2.8. Two foot flume after ACB modification.

Several alterations to the 2-foot flume were required for ACB testing. First, two ramps spanning the width of the flume were installed to raise the bed elevation to accommodate a sand bed and ACB installation. A 3.7-meter (12-foot) wall was installed 19 cm (0.62 ft) from the left flume wall to create the testing channel. On both the downstream and upstream ramps, a wall with a 1V:4H slope was installed to create a smooth transition from the 61 cm (2 ft) channel to the 19 cm (0.62 ft) testing channel. Sand was placed and compacted to the level of the ramp between the 3.7-meter (12-foot) wall and the left flume wall. A nonwoven geotextile filter was installed on top of the sand and attached to the sidewalls. ACBs were installed on top of the geotextile filter layer. Aluminum flashing was installed along the sidewalls over the edge blocks to prevent water from channeling down between the flume wall and the block system. **Figure 2.8** shows the 2-foot flume after ACB modifications.

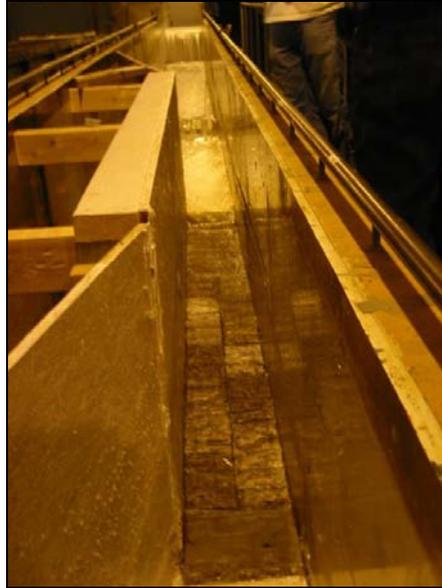
Figure 2.9. Two foot flume after modification for gabion mattresses testing.

Adaptations to the 2-foot flume were required for gabion mattress testing. First, two ramps spanning the width of the flume were installed to raise the bed elevation to accommodate a sand bed and gabion mattresses installation. A 1.8 meter (6 feet) wall was installed 20.3 cm (8 in) from the left flume wall to create the test channel. On both the upstream and downstream ramps, a wall with a 1V:4H slope was installed to create a smooth transition from the 2-foot flume width to the 8-inch wide test section. Sand was placed and compacted to 1.3 cm (0.5 in) below the level of the ramp between the 6-foot wall and the left flume wall. A nonwoven geotextile filter was installed on top of the sand and attached to the sidewalls. Gabions mattresses were installed on top of the geotextile filter layer. Aluminum flashing was installed along the sidewalls over the edge of the gabion mattresses to prevent water from channeling down between the flume wall and the gabion system. **Figure 2.9** is a photograph of the 2-foot flume after the above modifications.

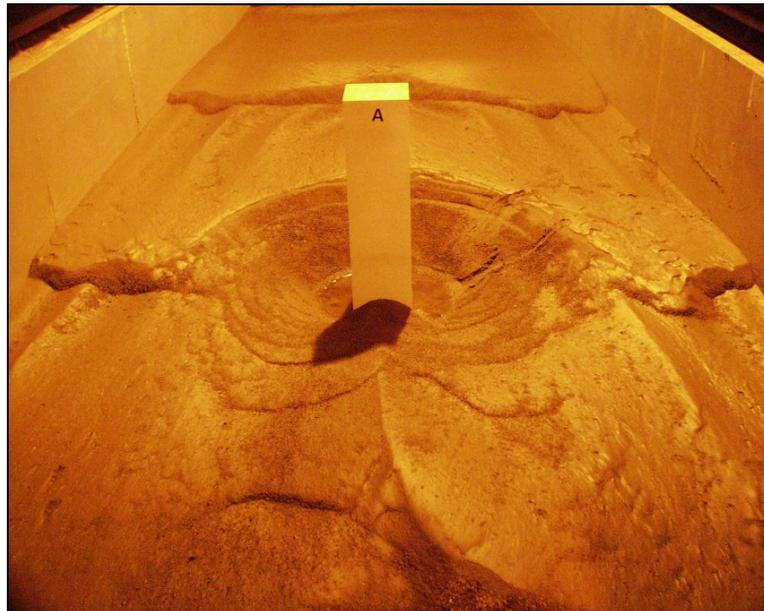
Figure 3.2. Looking upstream at Pier A after completion of Test 1b.

Tests 1 and 2 provided data for an unprotected square pier, under clear-water and live-bed conditions, respectively. Test 1 was a control test and had no protection around the piers, allowing for determination of scour under both clear-water and live-bed conditions. **Figure 3.2** shows Pier A after completion of Test 1b. Test 2 was a control test and had no protection around the piers, allowing for determination of scour under sediment feed conditions. Test 2 was run for a sufficient duration (8 hours) to permit bed forms to migrate through the system.

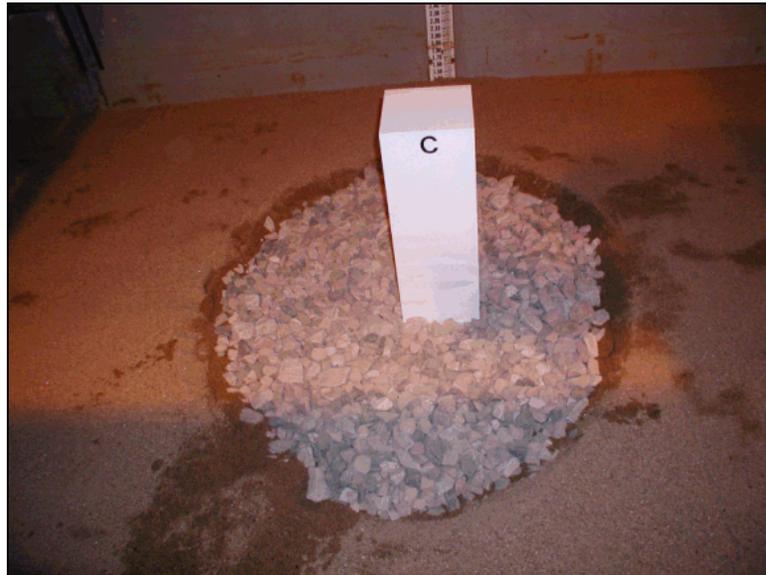
Figure 4.4. Pier C after riprap installation.

Pier C installation consisted of an ellipse-like form specific to the scour hole shape that resulted from Test 1. Riprap installed on the left and right sides was 65 cm (2.125 ft) from the pier face. The extent of the riprap upstream was 40 cm (1.32 ft) from the front of the pier face and the downstream extent of the riprap was 65 cm (2.125 ft) from the pier face. Riprap was installed 10-cm (4 in) deep. **Figure 4.4** shows Pier C after installation, prior to flow initialization. **Figure 4.5** shows Pier C after completion of Test 3b.

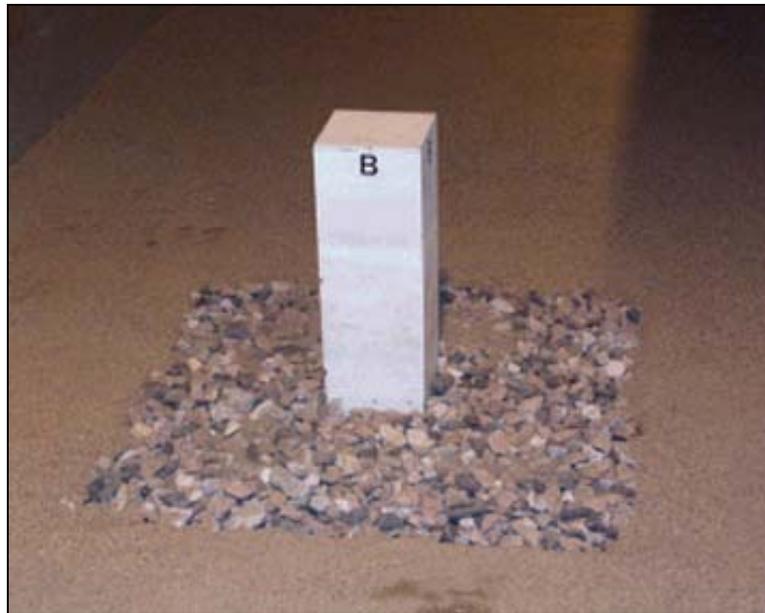
Figure 4.6. Pier B prior to Test 4a.

In Test 4a and Test 4b, the pier scour countermeasure designs were identical, though velocity was varied between the tests. Velocity for Test 4a was  $2.5V_c$ ; velocity for Test 4b was  $3.0V_c$ . Mean diameter of the riprap was 30 mm (1.2 in) on both piers for each test. For riprap installation design for Test 4a and Test 4b, Pier B was similar to the design for Test 3, Pier A. On Pier B, the design per HEC-23 was installed with 10.2 cm (4 in) vertical sidewalls and a 40.6 cm (16 in) horizontal extension from the pier face was maintained, a geotextile filter was added that extended two-thirds of the distance from pier face to the edge of the riprap. Pier C for Tests 4a and 4b incorporated a variation on the HEC-23 configuration with 10.2 cm (4 in) vertical sidewalls, a horizontal riprap extension of 30.5 cm (12 in), and included the addition of a geotextile filter that extended two-thirds of the distance from pier face to the edge of the riprap. No countermeasure was installed on Pier A. **Figure 4.6** shows Pier B, after installation in preparation for Test 4a. **Figure 4.7** shows Pier B after completion of Test 4b, Pier C is visible in the background.

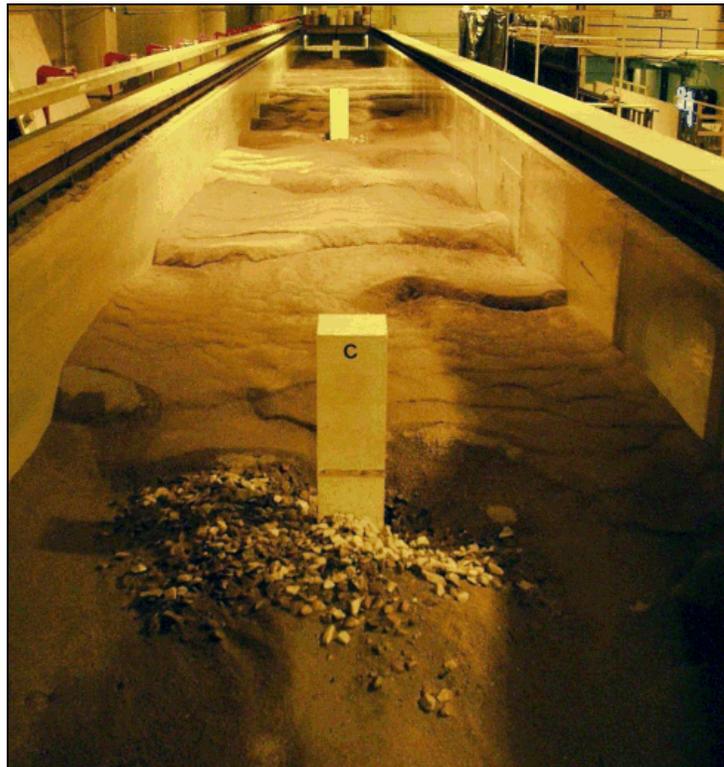
Figure 4.8. Pier C after Test 4c looking upstream.

Test 4c examined sensitivity of the system performance on depth of the riprap layer. Riprap on Pier B extended horizontally 30.5 cm (12 in) with a depth of 15.2 cm (6 in). A geotextile filter extended two-thirds the distance from the pier face to the perimeter of the riprap. Pier C consisted of the same riprap installation design as Pier B, Tests 4a and 4b, except a granular filter layer was utilized in place of the geotextile filter material. Mean grain size diameter of the granular filter on Pier C was 9.7 mm (0.38 in). Thickness of the granular filter layer was 3.9 cm (1.53 in), or four times the mean diameter of the filter material. Horizontal extension of the granular filter layer was two-thirds the distance from the pier face to the edge of the riprap. No countermeasure was installed on Pier A. **Figure 4.8** shows Pier C after Test 4c.

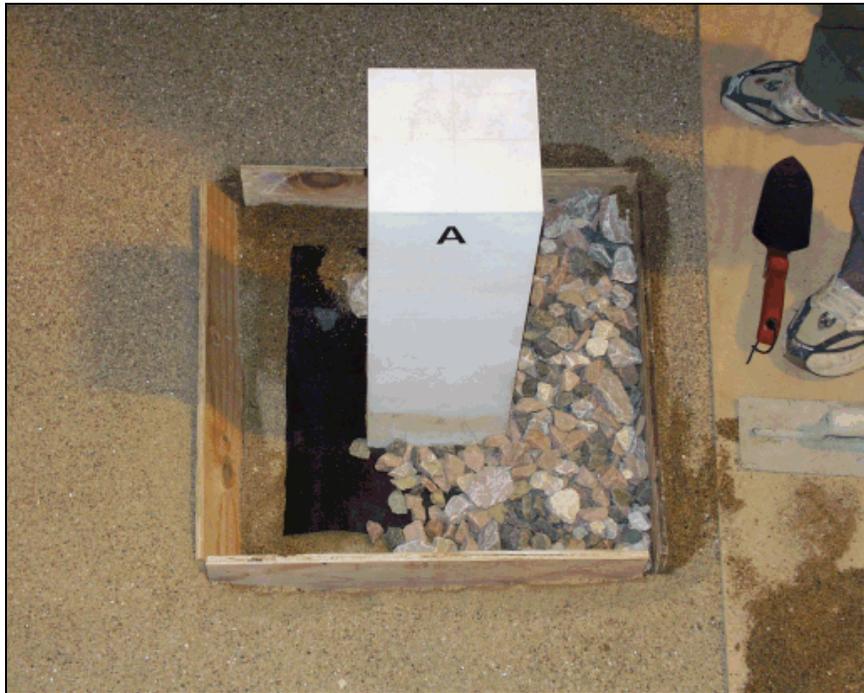
Figure 4.12. Pier A, riprap installation prior to Test 7.

Test 7 examined the sensitivity of system performance to areal coverage of the riprap layer and a geotextile filter layer as presented in HEC-23. Mean diameter of the riprap used in Test 7 was 30 mm (1.2 in) and the depth of riprap was 10.2 cm (4 in) for all riprap layouts. A geotextile filter extended two-thirds the distance from the pier face to the perimeter of the riprap on all piers. On Pier A, the riprap extended one pier width, or 20.3 cm (8 in), on all sides of the pier. On Pier B, the riprap extended 1.5 times the pier diameter, or 30.5 cm (12 in), on all sides of the pier. On Pier C, the riprap extended two times the diameter of the pier, or 40.6 cm (16 in), on all sides of the pier. The photograph in **Figure 4.12** was taken during the installation process as riprap was being placed over the geotextile filter.

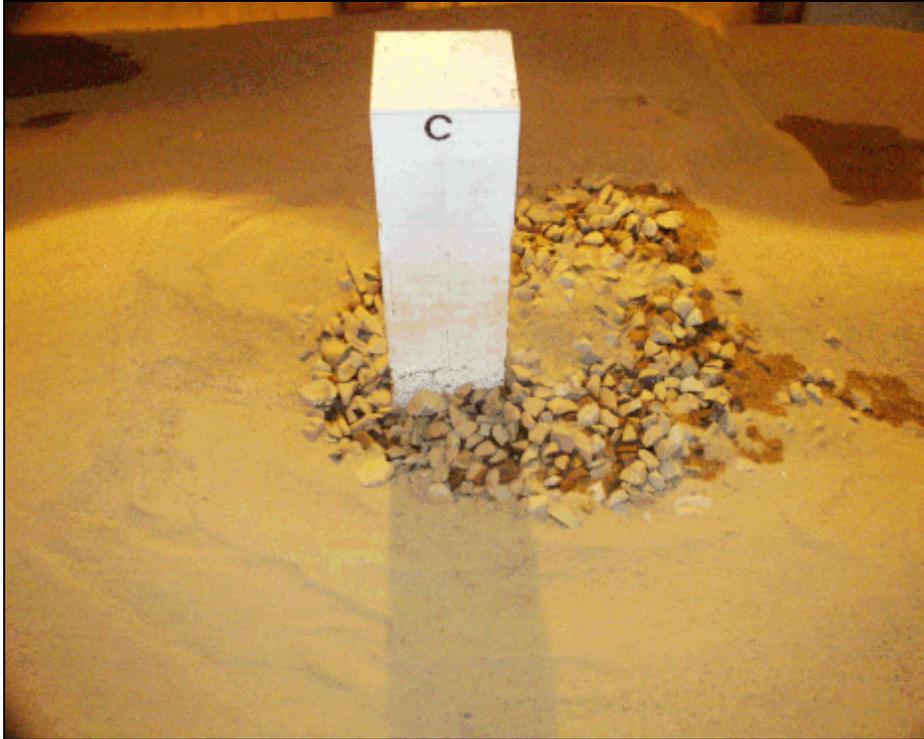
Test 9 was performed to quantify the effect of extended duration in a live-bed system on the riprap configurations of Test 6. After completion of Test 6a and collection of applicable data, testing of the existing bed conditions and pier scour countermeasures resumed for another eight hours. **Figure 4.14** shows Pier C after completion of Test 9.

Figure 4.14. Pier C after Test 9 (flow is from left to right).

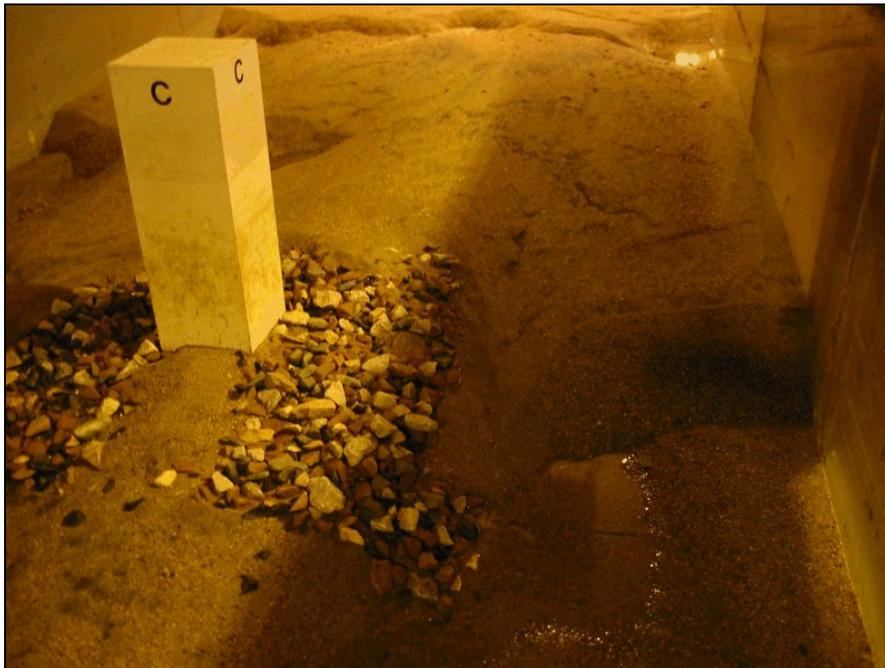
Test 11 (third installation) Pier C, re-examined the pier scour countermeasure design of Test 5, Pier B. Vertical sidewalls were 10.2 cm (4 in) and riprap extended horizontally 40.6 cm (16 in) from the pier face, a geotextile filter extended two-thirds of the distance from pier face to the edge of the riprap. Mean diameter of the riprap was 30 mm (1.2 in). Pier scour countermeasure designs for Piers A and B are described in the following section. A photograph of Pier C after the pier was exposed to  $2V_c$  conditions for 5 hours during extended Test 11b-3 is presented in **Figure 4.15**.

Figure 4.15. Pier C after extended run of Test 11b-3 looking upstream.

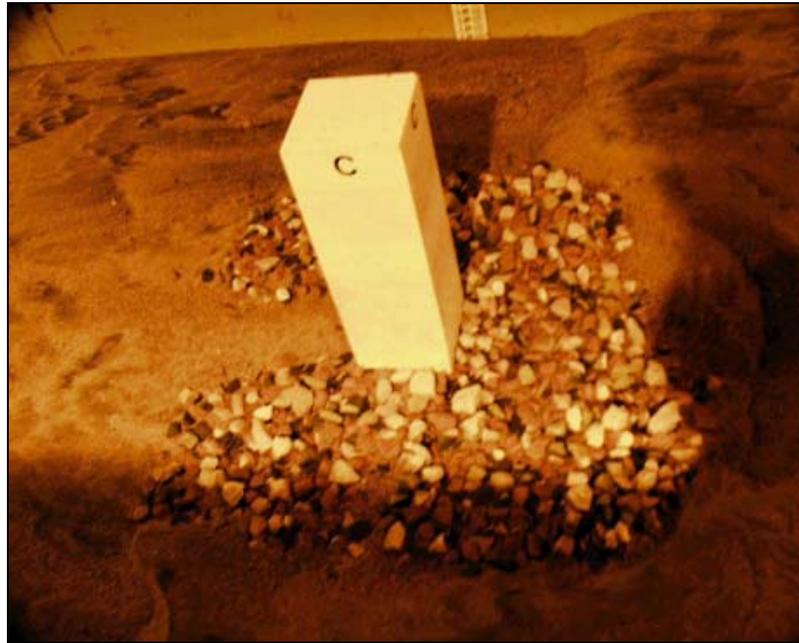
Test 12, Pier C, re-examined the pier scour countermeasure design of Test 3, Pier A. Riprap extended horizontally 40.6 cm (16 in) from each side of the pier in a 10-cm (4 in) deep square. Mean diameter of the riprap was 30 mm (1.2 in). A photograph of Pier C after Test 12b is presented in **Figure 4.16**. Pier scour countermeasure designs for Piers A and B are described later, as they used materials other than loose riprap.

Figure 4.16. Pier C after Test 12b (flow from right to left in photo).

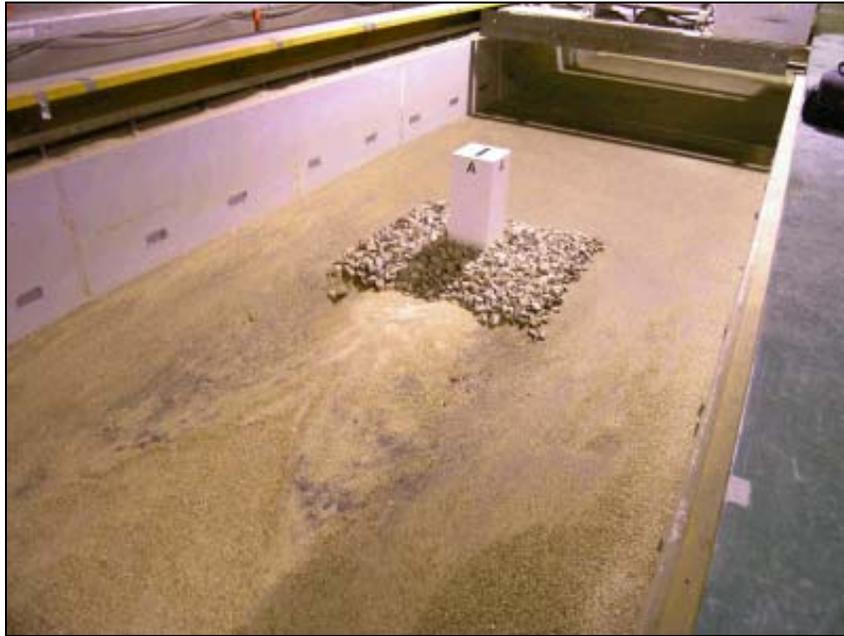
Figure 4.19. Looking upstream at Pier A after Test C16a.

Test C16 documented system performance as a function of the height of mounding riprap at a pier. Riprap extent on Pier A was 41 cm (16 in) on all sides. At the pier, the riprap was stacked to a height of  $4 d_{50}$ , or 12 cm (4.8 in) and sloped to a peripheral height of  $1 d_{50}$ , or 30 mm (1.2 in). No filter was installed. **Figure 4.18** is the construction installation schematic for Pier A. **Figure 4.19** shows Pier A after completion of Test C16a. **Figure 4.20** shows Pier A after completion of Test C16b-2.

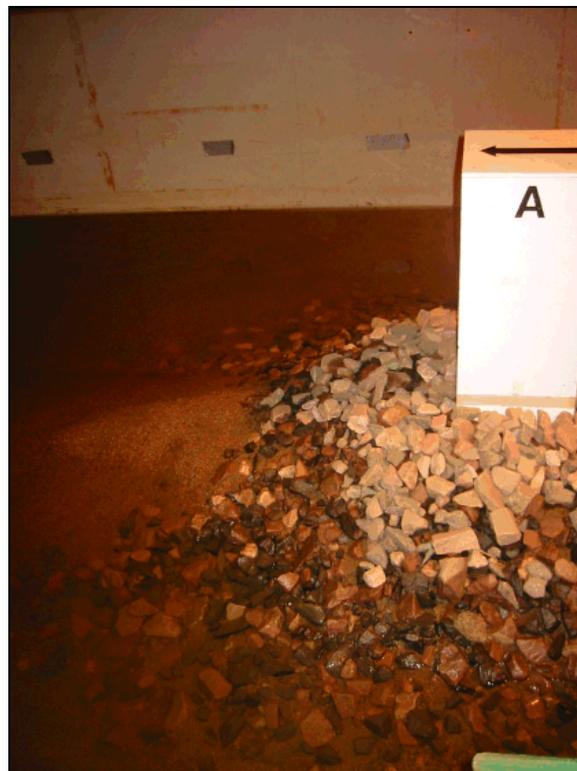
Figure 4.20. Pier A after Test C16b-2 (flow is from right to left).

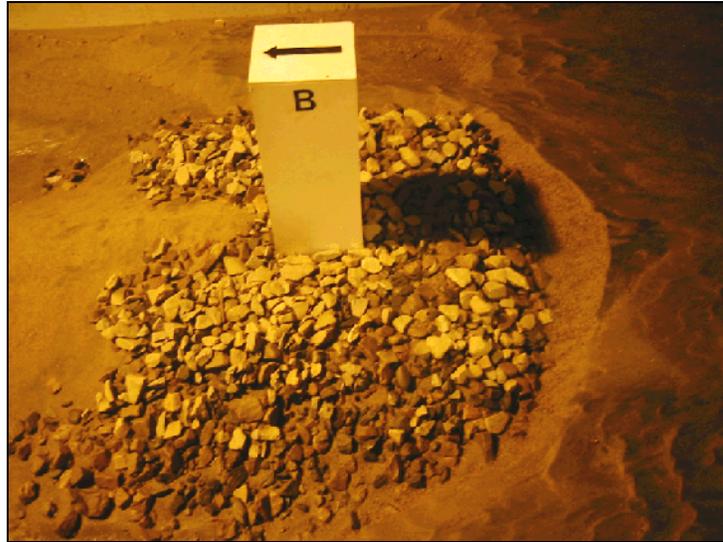
Figure 4.21. Pier B after Test C16b-1 (flow is from right to left).

The riprap layout on Pier B was 41 cm (16 in) on all sides and 2.5  $d_{50}$  or 7.5 cm (3.0 in) deep across the entire installation. No filter was installed. **Figure 4.21** shows Pier B after completion of Test C16b-1.

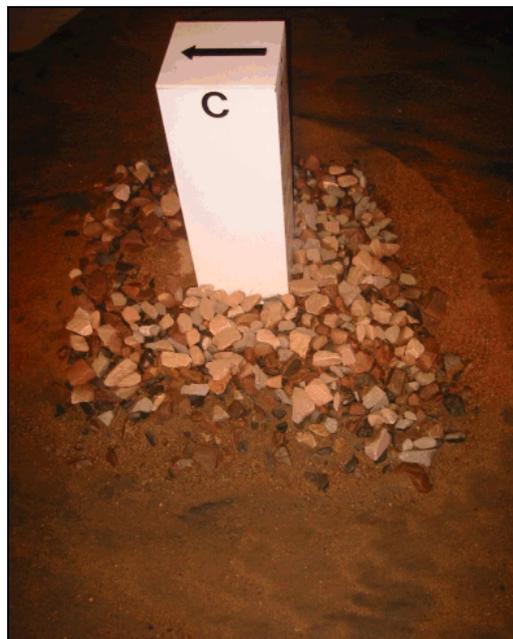
Figure 4.22. Pier C after Test C16b-1 (flow is from right to left).

Pier C was used as a control. The area around the pier was excavated 10 cm (4 in) deep and 30.5 cm (12 in) laterally in all directions. A geotextile filter extending two-thirds the distance from the pier face to the perimeter was installed. **Figure 4.22** shows Pier C after Test C16b-1.

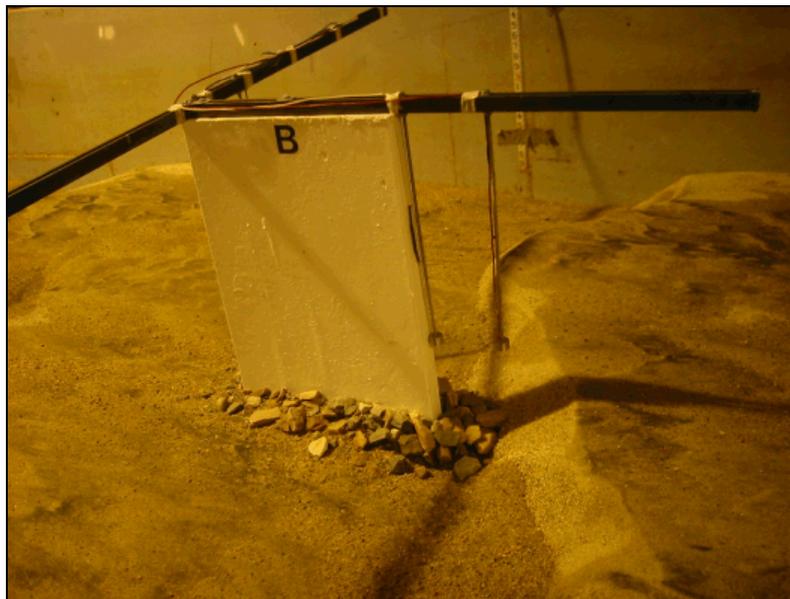
Test C12 protection was designed per HEC-23 guidelines; riprap extended horizontally 10.2 cm (4 in) from each side of the pier, or two times the width of the pier. Mean diameter of the riprap used in Test C12 was 30 mm (1.2 in) and the depth of riprap was 10.2 cm (4 in) for all riprap layouts. A geotextile filter extended two-thirds the distance from the pier face to the perimeter of the riprap on all piers. A photograph of Pier B after the pier was exposed to  $2V_{crit}$  conditions for 2 hours during Test C12b is presented in **Figure 4.23**. **Figure 4.24** shows Pier C after being exposed to  $2V_{crit}$  conditions for 2 hours during Test C12b.

Figure 4.23. Pier B ( $0^\circ$  skew) after Test C12b (flow is from right to left).

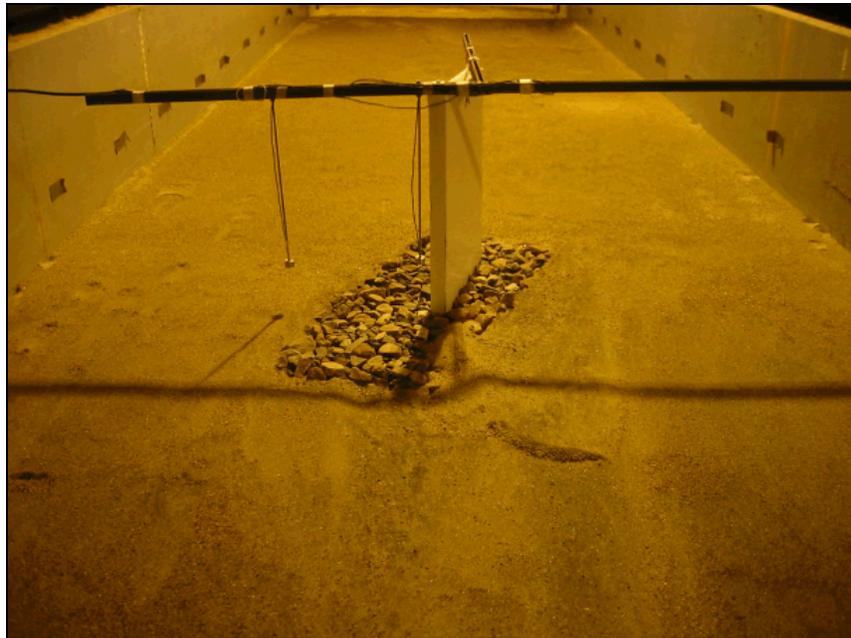
Figure 4.25. Pier A (15° skew) after Test C14a looking upstream.

Test C14 involved examination the performance of riprap placed to the full extent of the unprotected scour hole that develops under conditions corresponding to the design approach velocity. The layout for Test C14 was determined from the mapped extent of the scoured zone resulting from Test C10. Median diameter of the riprap on all three piers in Test C14 was 30 mm (1.2 in). A geotextile filter extended two-thirds the distance from the pier face to the perimeter of the riprap on all piers. **Figure 4.25** shows Pier A after Test C14a. **Figure 4.26** shows the same pier after completion of Test C14b, where flow velocity was  $2.0 V_{crit}$ .

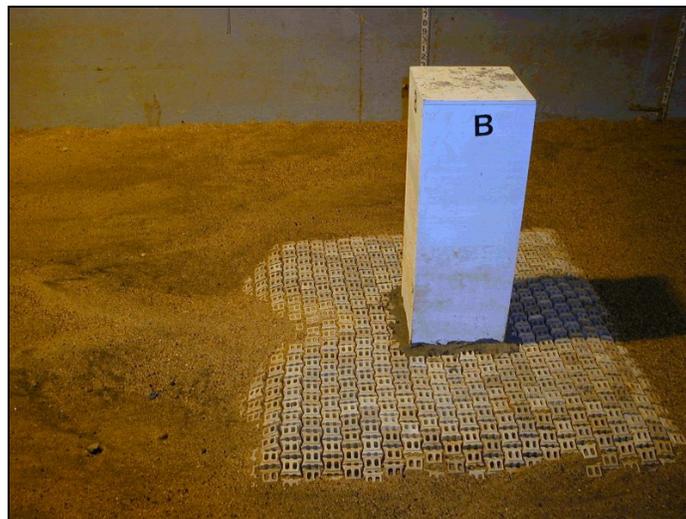
Figure 5.2. Pier B, after Test 11a1 (flow from right to left in photo).

Due to a limited number of miniature blocks available, Test 11 was completed in three separate test runs. One ACB countermeasure configuration was examined at Pier B for each test run of Test 11. Test 11-first installation, Pier B, incorporated a horizontal ACB extension of 40.6 cm (16 in) from pier face to the edge of the installment, a turndown detail around the entire boundary with a radius of curvature of 25.4 cm (10 in), ending in a depth of 10.2 cm (4 in) at the perimeter. Sand was filled over the blocks to create a finished elevation flush with the initial bed level. No scour protection was installed on Piers A and C. **Figure 5.2** shows Pier B after Test 11-a1. Note the stability of the ACBs and the exposure of the edge turndowns.

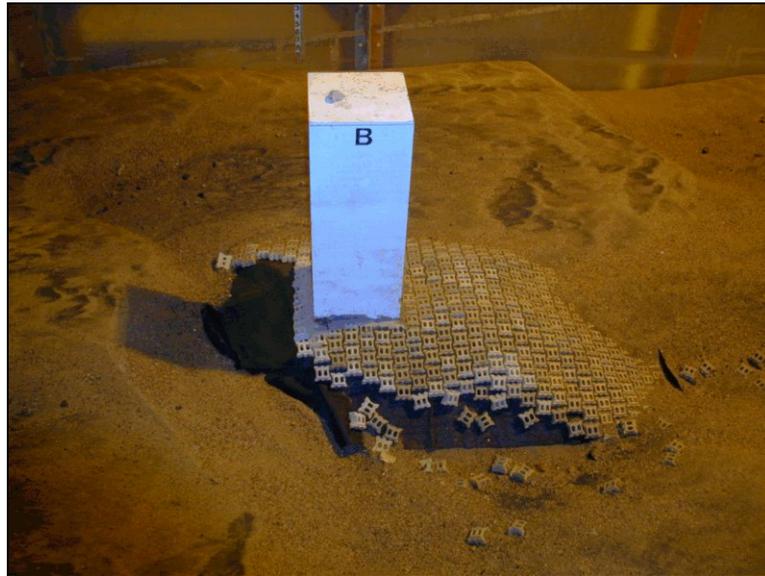
Figure 5.3. Pier B after Test 11b2-extended (flow from left to right in photo).

Test 11 (second installation) Pier B, included a transverse riprap distance of 30.5 cm (12 in) from pier face to the edge of the blocks on the downstream side of the installation. The turnout detail on Test 11-second installation was continuous at a 3H:1V slope from the pier face on the upstream and sides of the pier. The turnout detail from the edge of the transverse portion in the downstream integrated a 4H:1V slope for a horizontal extension of 40.6 cm (16 in). Depth of the turnout at the perimeter of the installation was 10.2 cm (4 in). Sand was filled over the blocks to create a finished elevation flush with the initial bed level. No scour protection was installed on Piers A and C. After the Test 11-second installation,  $2V_c$  run was complete and all data collected, an extended duration run was completed at  $2V_c$ . **Figure 5.3** shows Pier B after the extended run. Note loss of blocks upstream and on the right side of the pier.

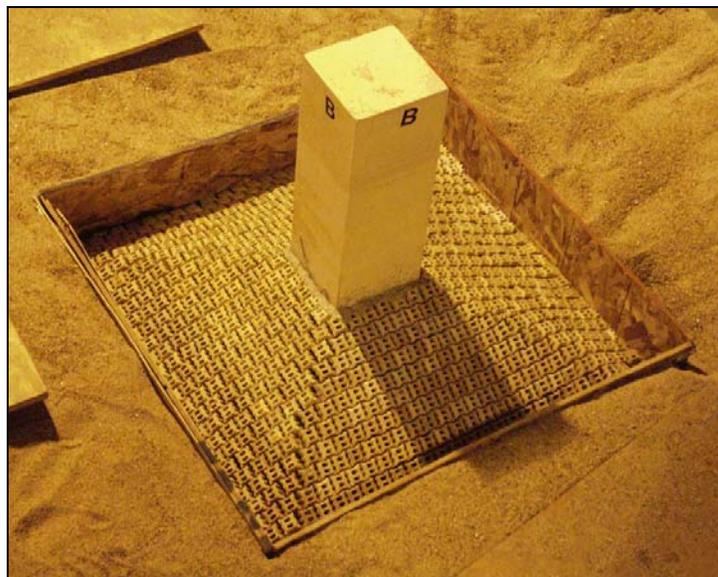
Figure 5.4. Pier B, Test 11 (third installation) before leveling the bed.

Test 11 (third installation) Pier B, incorporated a turndown detail of a 3H:1V slope, extending from the pier face, 5.1 cm (2 in) below the ambient bed surface to a depth of 18.5 cm (7.3 in) at the perimeter. ACBs extended horizontally for 40.6 cm (16 in). Sand was filled over the blocks to create a finished elevation flush with the initial bed level. **Figure 5.4** shows Pier B before the sand be was leveled. No scour protection was installed on Pier A. Test 11, Pier C incorporated the previously mentioned riprap configuration.

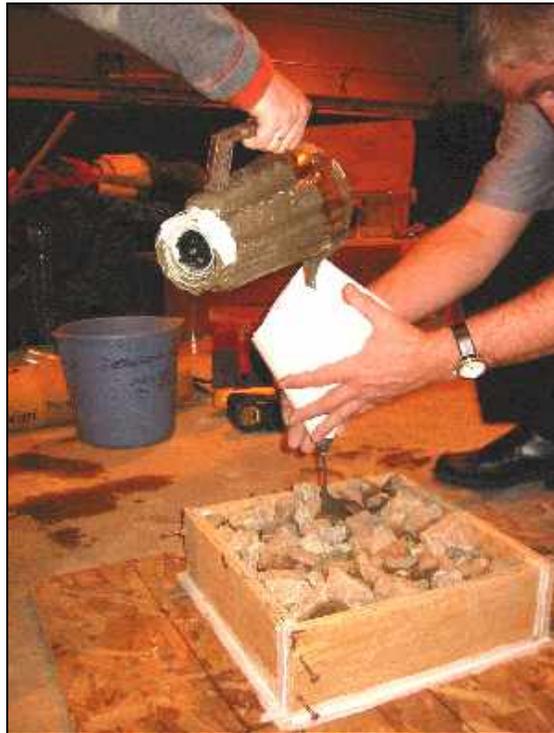
Figure 6.1. Test pour of grout.

For the partially grouted riprap installations, various grout mix designs were developed and constructed "in the dry" using  $d_{50}$  riprap sizes of 14.7 mm (0.58 in), 25.4 mm (1 in), and 30 mm (1.2 in). Consistency of the cementitious grout mix was determined by trial and error. The initial mix design was based on pumpable fine aggregate concrete mix used in the construction of grout-filled mattresses. Test pours were performed for all three riprap sizes. **Figure 6.1** shows a test pour with the 30 mm riprap.

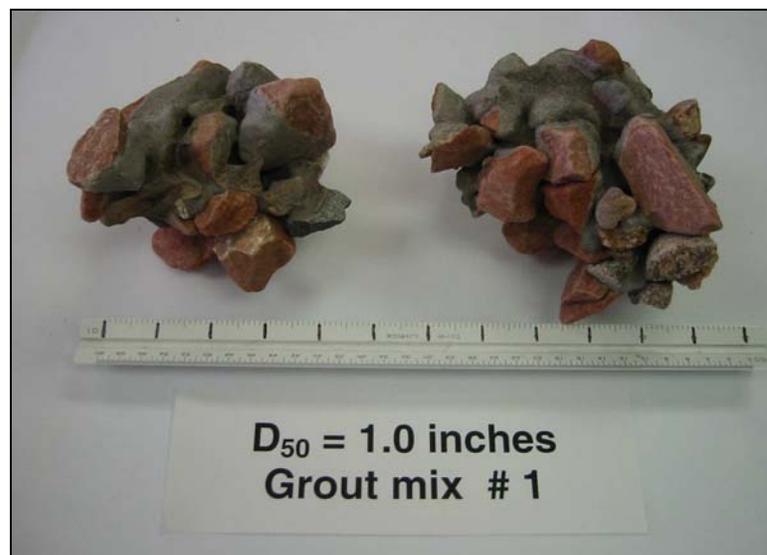
Figure 6.2. Conglomerates produced by partial grouting of riprap.

For testing, riprap was installed around a pier and then a measured volume of grout was hand poured into "spots" on the riprap in a stagger patter. The target fill value of between 15 to 40% of the original void space volume was maintained for all installations tested (see BAW 1990). Conglomerate-like elements in the riprap were produced using the spot-by-spot grouting procedure. **Figure 6.2** shows the conglomerates produced during a test pour. For additional information on the partially grouted riprap concept, see Lagasse et al. 2006b.

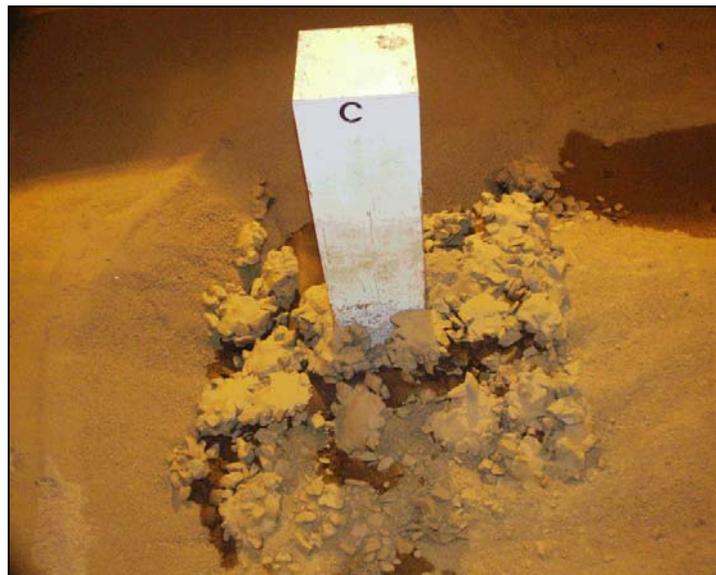
Figure 6.3. Pier C after completion of Test 14 (flow is left to right in photo).

The horizontal extent of riprap on Test 14, Pier C was one and a half times the pier width, or 40.6 cm (16 in), on all sides with a 10.2 cm (4 in) depth. A geotextile filter extended two-thirds the length of the riprap.  $D_{50}$  of the riprap was 25.4 mm (1 in). Approximately 80 ml of grout were poured in each spot and approximately 40 spots were poured. A photograph of Pier C after completion of Test 14 is presented in **Figure 6.3**. (No countermeasure was installed on Pier A. Pier B incorporated the previously described ACB installation.)

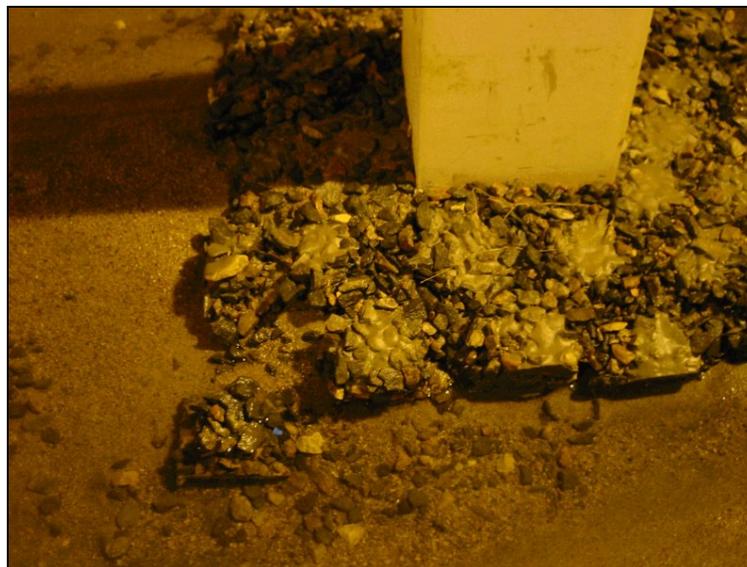
Figure 6.6. Pier A after Test 17a (flow is right to left in photo).

Test 17 was performed to examine reduction of the riprap layout extent due to the effect of partial grouting. All pier designs utilized riprap ( $d_{50} = 14.7$  mm) with a layer thickness of 5.1 cm (2 in). A geotextile filter extended two-thirds the length of the riprap on all pier setups. Approximately 65 ml of grout were poured in each spot. On Pier A, the riprap extended 20.3 cm (8 in) on all sides and was level with the bed. Roughly 32 spots were poured. On Pier B, the riprap extended 20.3 cm (8 in) and was on a one 4H:1V slope. Top of the riprap at the perimeter was 5.1 cm (2 in) below the ambient bed layer. Roughly 26 spots were poured. The riprap on Pier C extended 30.5 cm (12 in) from pier face on a 4H:1V slope. Top of the riprap at the perimeter was 7.6 cm (3 in) below the ambient bed layer. Roughly 54 spots were poured. On Piers B and C, after installation of the riprap and grout spots, sand was filled in over the riprap and leveled. **Figure 6.6** shows Pier A after Test 17a was completed.

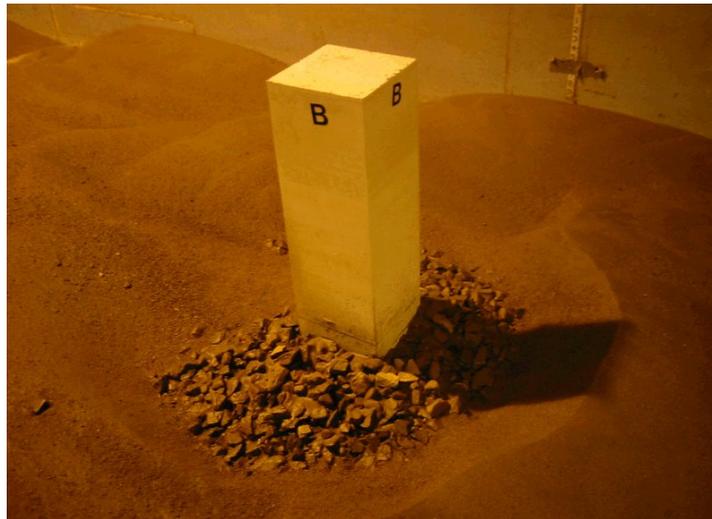
Figure 6.7. Pier B after Test 18 (flow from right to left in photo).

Riprap installation for Test 18, Pier B included a turndown detail on a 2H:1V slope of a 7.6 (3 in) riprap layer. Horizontal extension of the riprap was 40.6 cm (16 in); top of the riprap was level with the ambient bed surface at the pier face and 20.3 cm (8 in) below the bed surface at the perimeter.  $D_{50}$  of the riprap was 25.4 mm (1 in). A geotextile filter extended two-thirds the length of the riprap. Grout spots were staggered in a 10.2 cm (4 in) by 10.2 cm (4 in) grid pattern. Approximately 80 ml of grout were poured in each spot and roughly 60 spots were poured. After installation of the riprap and grout spots, sand was filled in over the riprap and leveled. **Figure 6.7** shows Pier B after completion of Test 18. (No countermeasure was installed at Pier A. Pier C incorporated the previously described ACB installation).

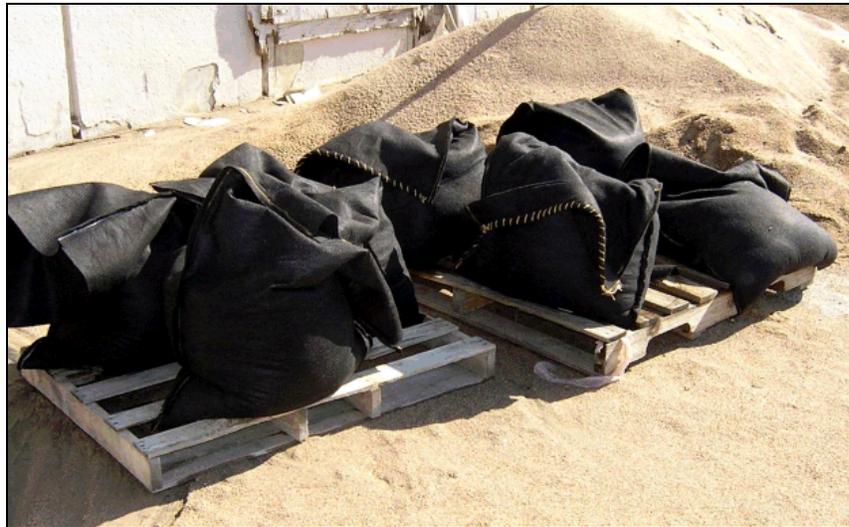
Figure 6.8. Geocontainers before installation around the pier.

Geocontainers. Sand filled geotextile containers were constructed using a geotextile fabric with the characteristics presented in **Table 6.4**. The geotextile containers measured 1.2 m x 0.5 m x 0.1 m (4 ft x 1.5 ft x 0.33 ft) with a typical volume of .06 m<sup>3</sup> (2 ft<sup>3</sup>). Approximately 100 kg (220 lbs) of sand was placed in each bag. Commercial concrete sand meeting appropriate filter criteria was used to fill the geotextile bags. **Figure 6.8** shows the geotextile containers before being placed around the pier.

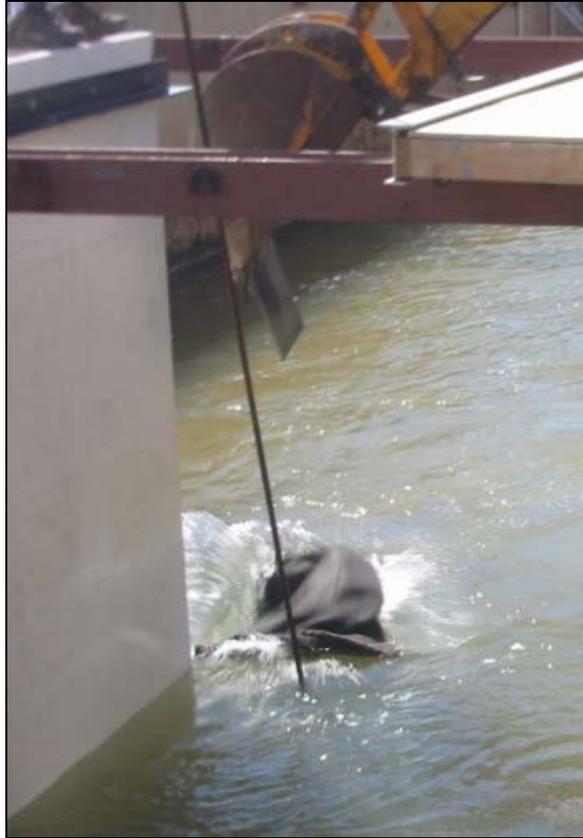
Figure 6.13. Installation of geotextile containers looking downstream, pier is on the left.

An approach flow of 0.3 m (1 ft) deep at approximately 0.5 m/s (1.5 ft/s) was established. A total of 32 geotextile containers were placed around the pier by dropping from a height of about 1.5 m (5 feet) above the water surface. Installation was facilitated by a backhoe fitted with a special grapple attached to the bucket, which enabled the backhoe to pick up the geotextile container, position around the pier to a specified location, and release the container. **Figure 6.13** is a photograph of a geotextile container being dropped near the pier; note the grapple plate attachment to the backhoe. **Figure 6.14** shows the geotextile containers after installation in approximately 0.3 m (1 foot) of flowing water.

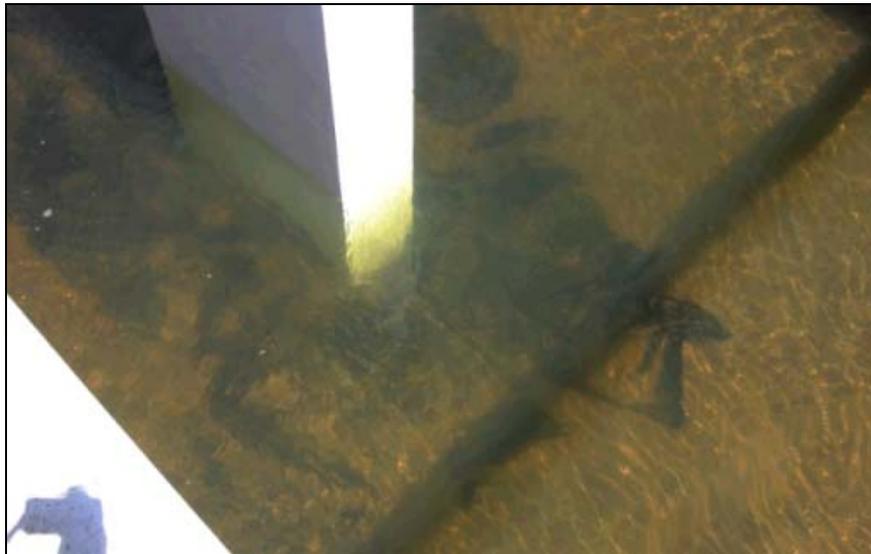
Figure 6.14. Geotextile containers after installation, flow is from upper left lower right.

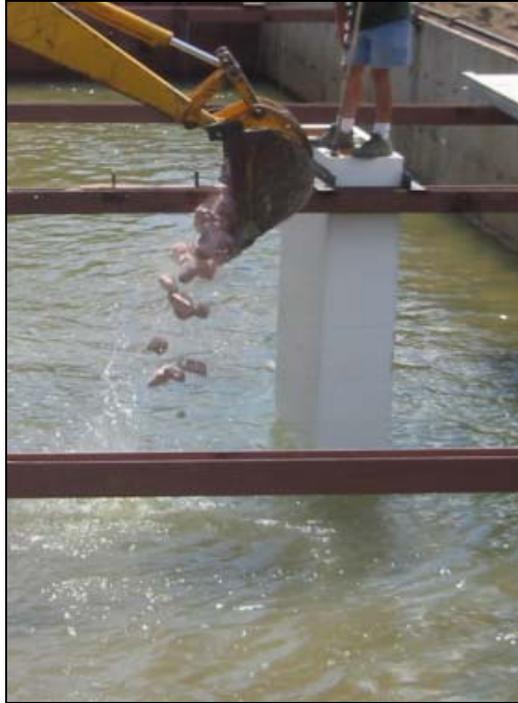
Figure 6.15. Installation of riprap around pier, looking downstream.

Next, riprap was positioned on top of the geotextile containers using the backhoe with the grapple removed. **Figure 6.15** shows riprap being dropped near the pier and **Figure 6.16** shows the riprap after installation.

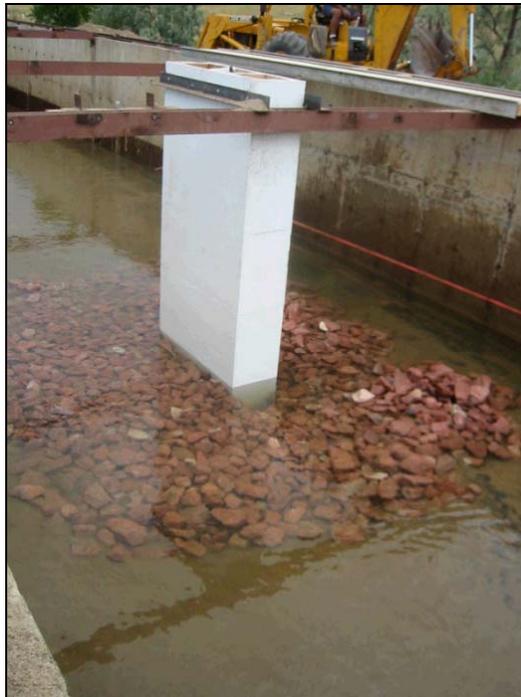
Figure 6.16. Riprap prior to grouting, looking downstream.

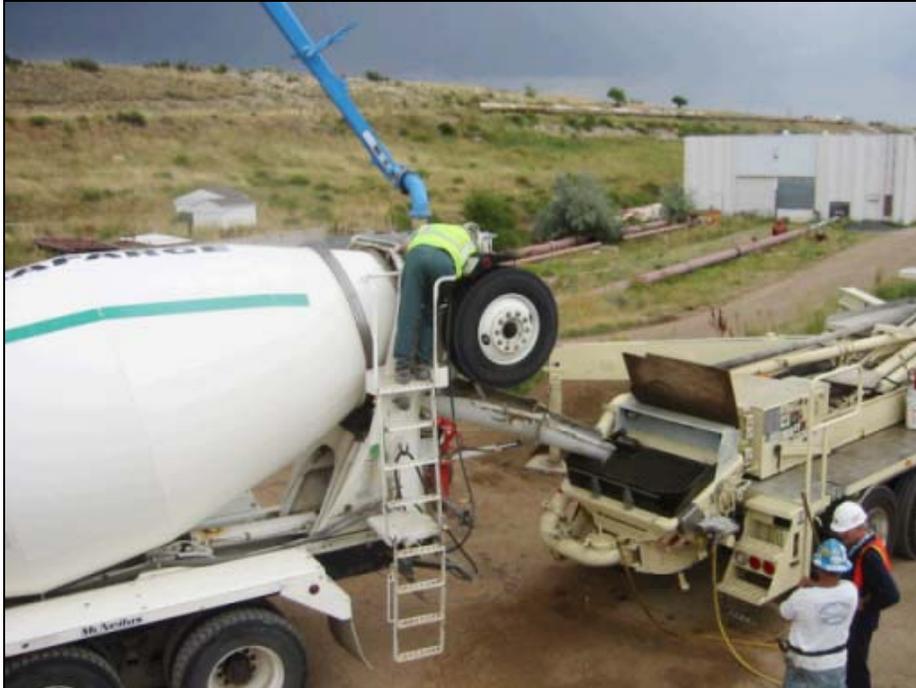
Figure 6.18. Concrete mixer truck and pump truck with boom.

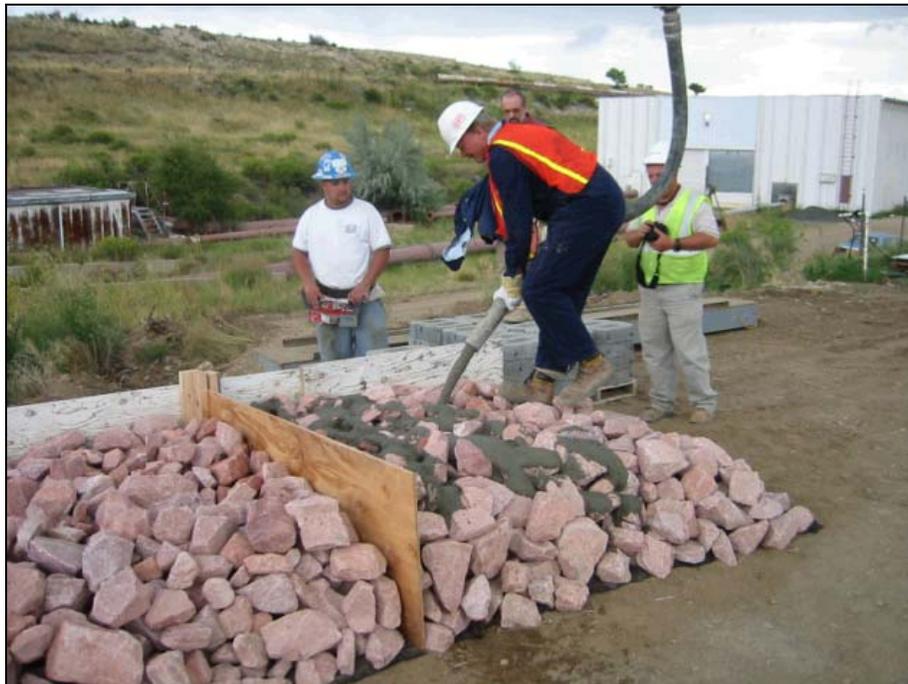
**Grouting Procedure:** Prior to underwater application of the grout in the flume, a preliminary grout application was performed in the dry on a pile of riprap about 0.5 m (1.5 feet) thick. The trial application was performed to determine if the equipment could supply and control the grout pumping rate as needed for the underwater installation conditions. Grout was dispensed from a flexible hose attached to a boom on a concrete pump truck. Grout was supplied to the pump truck from a standard concrete mixer truck, as shown in **Figure 6.18**. **Figure 6.19** shows the preliminary trial grout application in the dry. **Figure 6.20** shows the surface of the riprap after partial grouting, and **Figure 6.21** shows the interior of the dry riprap pile after several exterior stones had been removed to display penetration of the grout. Note in Figures 6.20 and 6.21 how the grout bridges between riprap stones forming larger conglomerate particles. In Figure 6.21, note that less than 50% of the total void space has been filled with grout. The preliminary application confirmed that the equipment acquired for the underwater partial grout application was satisfactory.

Figure 6.19. Preliminary trial grout application in the dry.

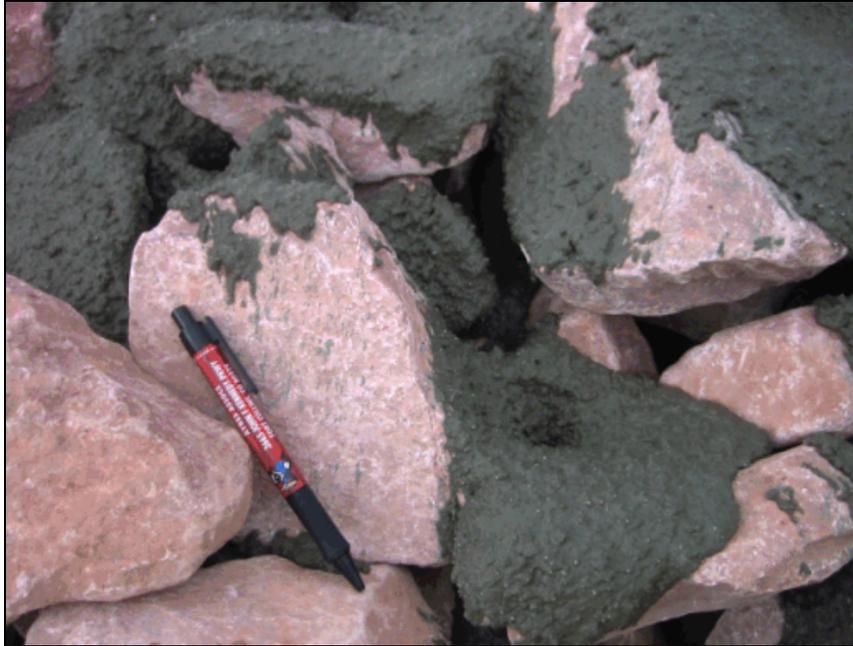
Figure 6.20. Surface of the riprap after partial grouting.

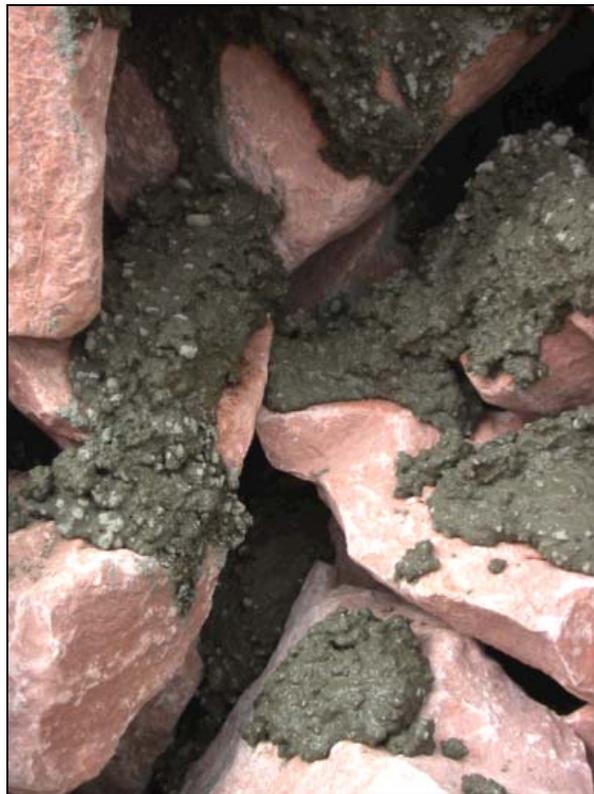
Figure 6.21. Interior of the dry riprap pile (some surface rocks removed).
