# **COUNTERMEASURES TO PROTECT BRIDGE PIERS FROM SCOUR**

## **REFERENCE DOCUMENT**

**P.F. Lagasse, P.E. Clopper, L.W. Zevenbergen, and L.G. Girard**

December 2006

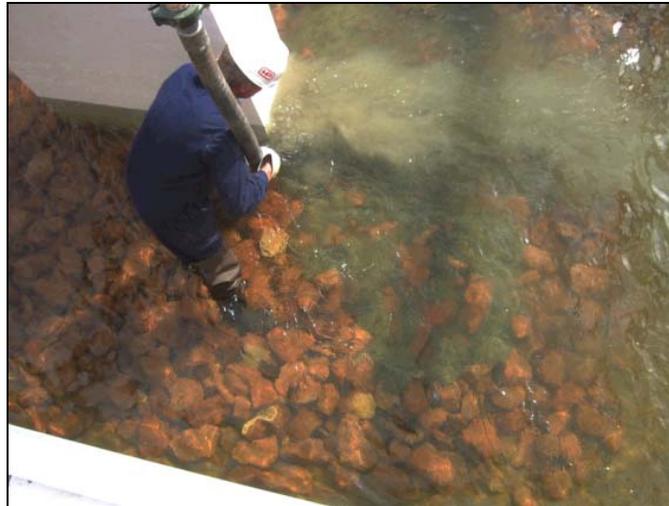
Grout placement in the flume was performed by an experienced underwater grout installation specialist from Germany. The specialist was located in the flume and placed the grout directly on the riprap in 0.3 m (1 ft) of water with a velocity of 0.3 m/s (1 ft/s), as illustrated in **Figure 6.22**.

Figure 6.22. Underwater partial grouting of riprap, flow is from left to right.

Application of grout on the riprap lasted approximately 20 minutes. Approximately  $1.1 \text{ m}^3$  ( $1.4 \text{ yd}^3$ ) of grout was placed, resulting in an application of  $56 \text{ liters/m}^2$  ( $1.6 \text{ ft}^3/\text{yd}^2$ ). Typical grout application rates in German practice are  $60 \text{ liters/m}^2$ , so this test was representative of standard practice for this countermeasure type.

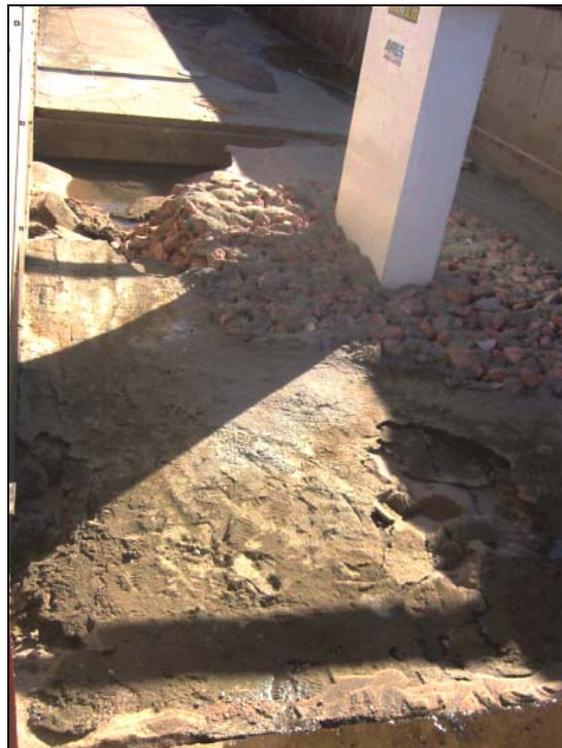
Figure 6.29. After Test C1-high velocity test looking downstream, note damage to the soil cement and scour at the downstream left corner. Partially grouted riprap remained intact.

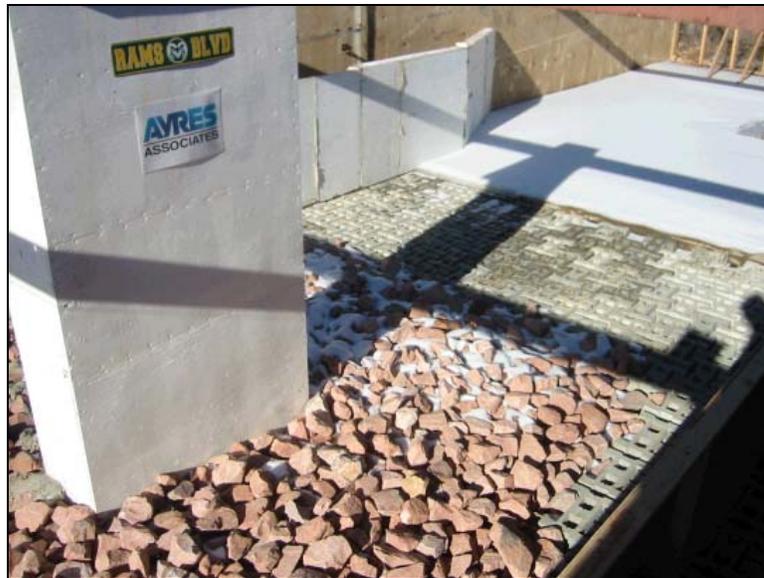
Temporary walls were installed to reduce cross sectional area of the flow and increase velocity in the test section. Walls were installed 0.46 m (1.5 feet) from the existing flume walls, transitioning the section from 6 m (20 feet) to 4.6 m (15 feet). **Figure 6.30** shows the test section after the modifications were completed.

Figure 6.30. Loose riprap, ACB, and contraction wall installation looking upstream (note loose riprap on the near side of the pier and partially grouted riprap on the far side).

Test C20 was a comparison test between loose riprap and partially grouted riprap. To facilitate a comparison of the performance of loose riprap to partially grouted riprap, all riprap and grout were removed from the left side of the pier and replaced with loose riprap of the same gradation and  $d_{50}$  after completion of Test C1 as described in Section 6.2.5. Because the soil cement in Test C1 proved to be inadequate to stabilize the area around the partially grouted riprap, it was completely removed from the bed, exposing the underlying sand bed 10 cm (4 in) lower than the surrounding flume floor and top surface of the riprap. A geotextile fabric, with the hydraulic and physical characteristics presented in Table 6.4, was installed over the exposed sand portion of the test section. Four-inch thick articulating concrete blocks (ACBs) were installed on the geotextile fabric adjacent to the riprap. The ACBs were intended to prevent degradation of the bed in the test section as well as facilitate a smooth transition from the flume floor to the test section.

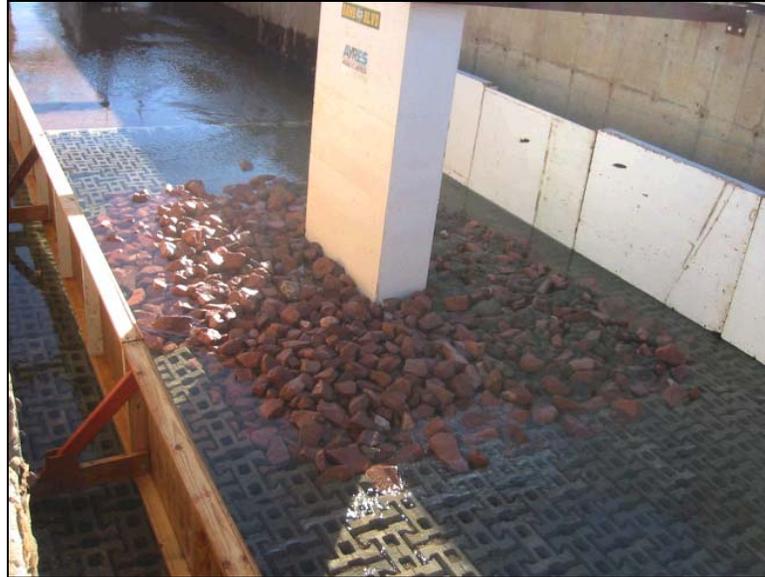
The high velocity comparison test was completed in two steps. In the first step, the maximum flow rate during Test C20 was  $5.6 \text{ m}^3/\text{s}$  (198 cfs). Discharge was steadily increased until approach velocity reached a maximum of  $1.8 \text{ m/s}$  ( $6.0 \text{ ft/s}$ ) at full flow capacity of the flume. The test ran for 1 hour, with no movement of the loose rock. After this trial run, the flume was shut down and modifications to the inlet structure were made to achieve higher velocities at the pier. **Figure 6.31** shows the installation after the trial run.

Figure 6.31. After completion of the first step of Test C2, looking downstream.

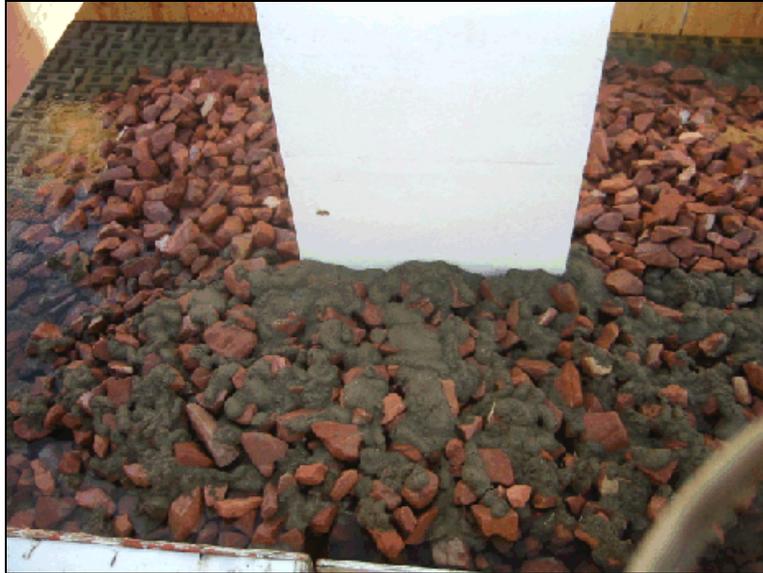
The second step of the test ran for 2 hours, during which time the discharge was again steadily increased to the full flow capacity. At maximum discharge, the approach velocity upstream of the pier reached a maximum of 1.95 m/s (6.4 ft/s). At the higher flows, the loose riprap began to displace. **Figure 6.32** shows the loose riprap side of the installation after completion of the second half of the high velocity comparison test. Note the scour hole on the near side of the pier and the displaced riprap behind and downstream of the pier compared to the previous figure. The partially grouted side of the riprap installation can be seen in this figure, and remained essentially undisturbed. **Figure 6.33** shows the partially grouted side of the installation after the end of this test.

Figure 6.33. Partially grouted riprap after completion of Test C20, flow from left to right.

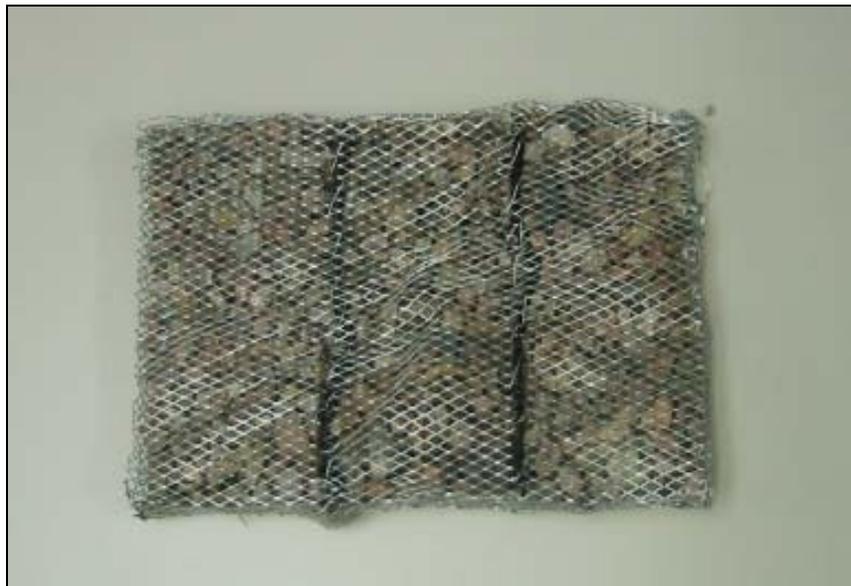
The material selected for use was a  $d_{50} = 5.8$  mm rock from a local source. A grain size distribution graph for the gabion stone is presented in **Figure 7.1**. **Figure 7.2** shows a typical gabion mattress used in the testing program.

Figure 7.2. Typical gabion mattress with wire mesh and three compartments filled with stone.

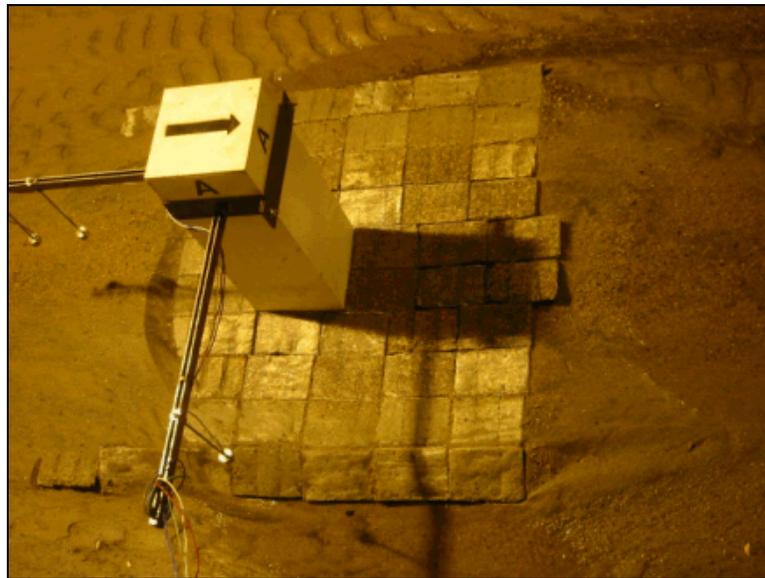
On Pier A, the upstream and downstream extent of the gabion mattress was 46 cm (18 in) and the lateral extent was 40 cm (16 in). **Figure 7.3** shows Pier A after completion of Test C3b. On Pier B, the upstream and downstream extent of the gabion mattresses was 31 cm (12 in) and the lateral extent was 31 cm (12 in). On Pier C, the upstream and downstream extent of the gabion mattress was 31 cm (12 in) and the lateral extent was 20 cm (8 in).

Figure 7.3. Pier A after Test C3b (flow is from left to right).

The objective of Test C3 was to document and quantify the unconnected gabion mattresses system's performance as a function of areal coverage. All spatial arrangements for Test C3 included a geotextile filter extending from the pier face to the perimeter of the gabion mattresses. On all piers, the gabion mattresses were installed so the tops of the gabions were level with the ambient bed surface.

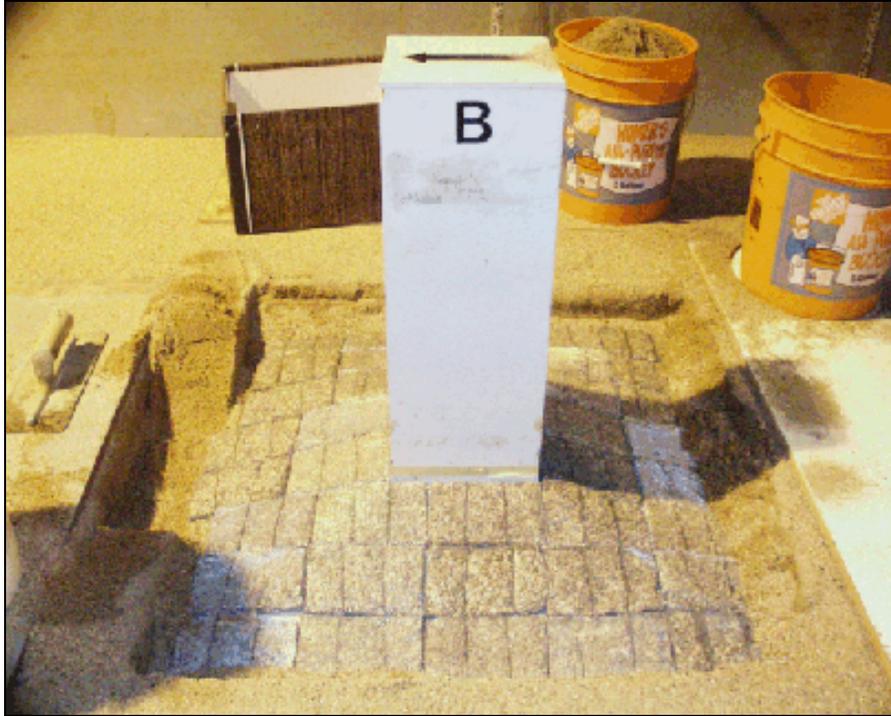
Pier B incorporated a turndown detail of 4H:1V, extending from ambient bed level at the pier face to a depth of 7.6 cm (3 in) at the perimeter. Gabion mattresses extended horizontally for 30.5 cm (12 in). A geotextile filter extended the full length of the gabions. Sand was filled over the gabion mattresses to create a finished elevation flush with the initial bed level.

**Figure 7.4** shows Pier B before the sand bed was leveled. **Figure 7.5** shows Pier B after Test C4b was completed.

Figure 7.4. Pier B, Test C4 before leveling of the bed.

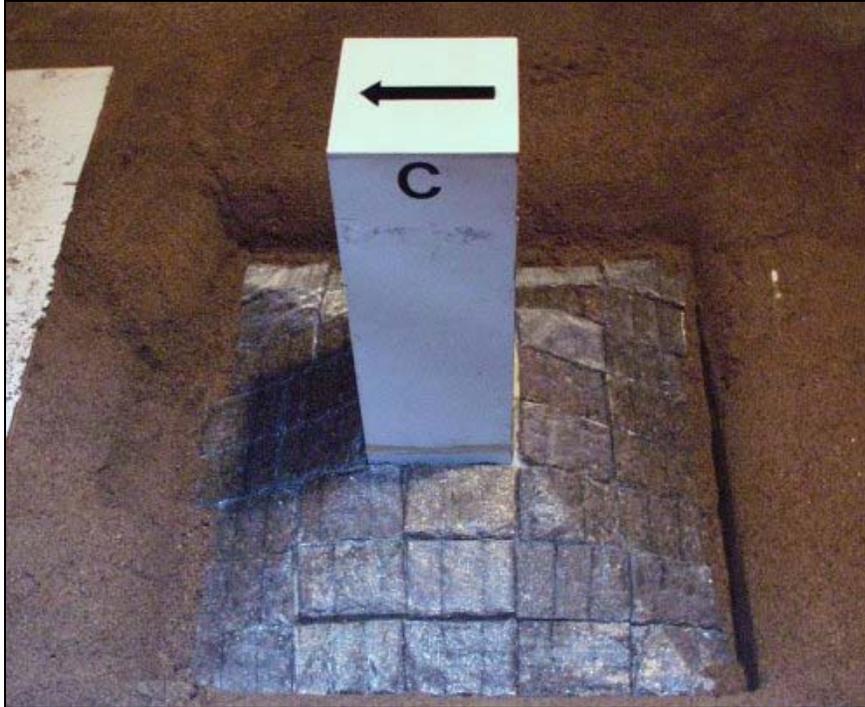
Pier C incorporated a turndown detail of 2H:1V, extending from ambient bed level at the pier face to a depth of 15 cm (6 in) at the perimeter. The Pier C installation was identical to Pier C, Test C4, except the geotextile extended only two-thirds the length of the gabions. Sand was filled over the gabion mattresses to create a finished elevation flush with the initial bed level. **Figure 7.6** is a schematic of Pier C, Test C5. **Figure 7.7** shows Pier C before the sand was filled in and **Figure 7.8** shows Pier C after completion of Test C5b.

Figure 7.7. Pier C before leveling of the bed, Test C5.

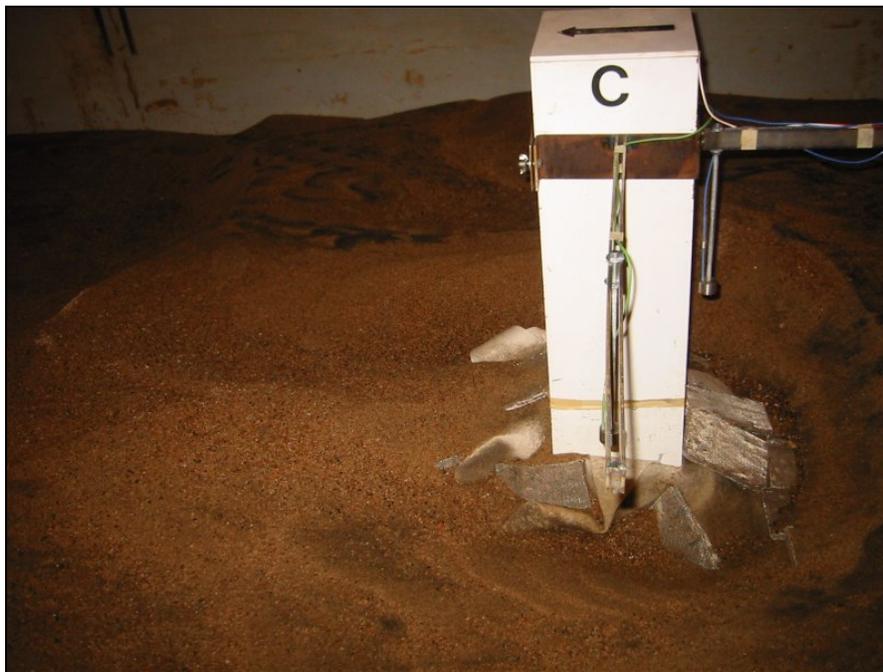
Figure 7.8. Pier C after Test C5b (flow is from right to left).

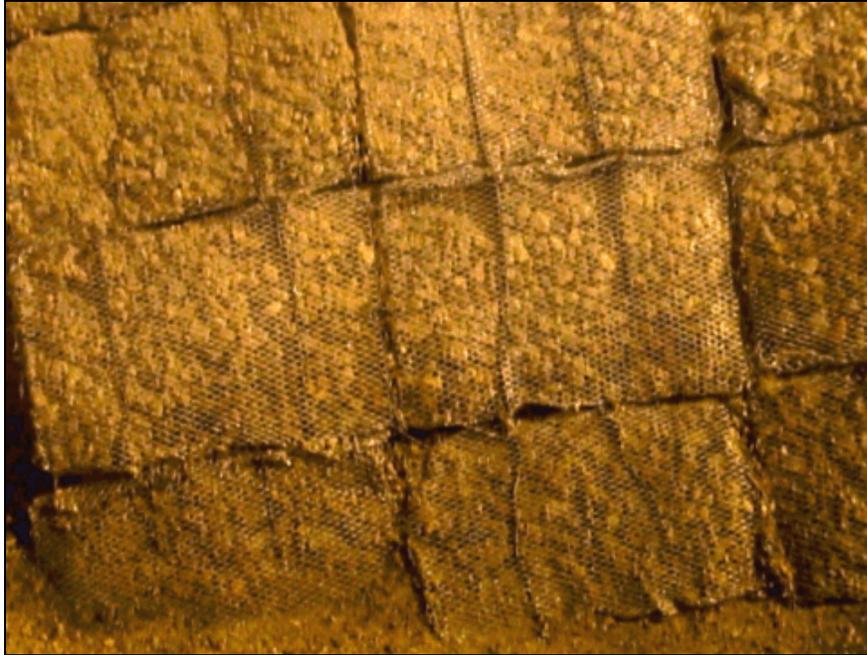
Test C19 was performed to investigate performance of a **connected** gabion mattress system. Installations on each pier were identical to Test C5. The gabions were sewn together on the top abutting selvages at 5 cm (2 in) intervals. Pier A included a horizontal gabion mattress extension of 15 cm (6 in) with a turndown detail around the entire perimeter ending in a depth of 8 cm (3 in). A geotextile filter extended the full length of the gabions. Sand was filled over the turned down blocks to create a finished elevation flush with the initial bed level. **Figure 7.9** shows Pier A after Test C19b. A close up of the gabion mattresses surrounding Pier A after Test C19b is shown in **Figure 7.10**; note in Figure 7.10 the shifting of the stone fill in the compartments and the strain of the wire mesh and connectors.

Figure 7.10. Gabion mattresses on Pier A after Text C19b.

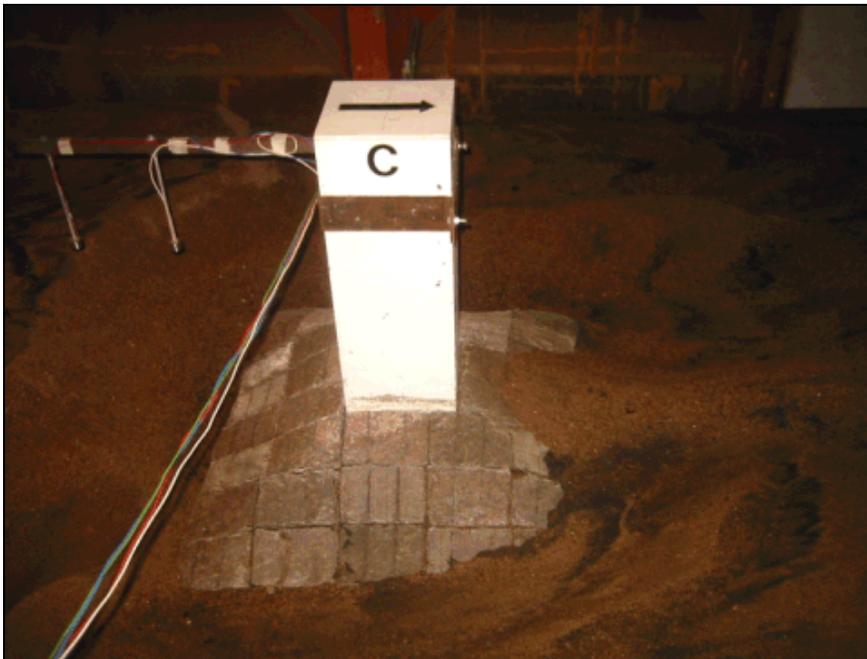
Pier C incorporated a turndown detail of 2H:1V, extending from ambient bed level at the pier face to a depth of 15 cm (6 in) at the perimeter. The geotextile extended two-thirds the length of the gabions. Sand was filled over the gabion mattresses to create a finished elevation flush with the initial bed level. **Figure 7.11** is a photograph of Pier C after completion of Test C19b.

Figure 7.11. Pier C after Test C19b (flow is from left to right).

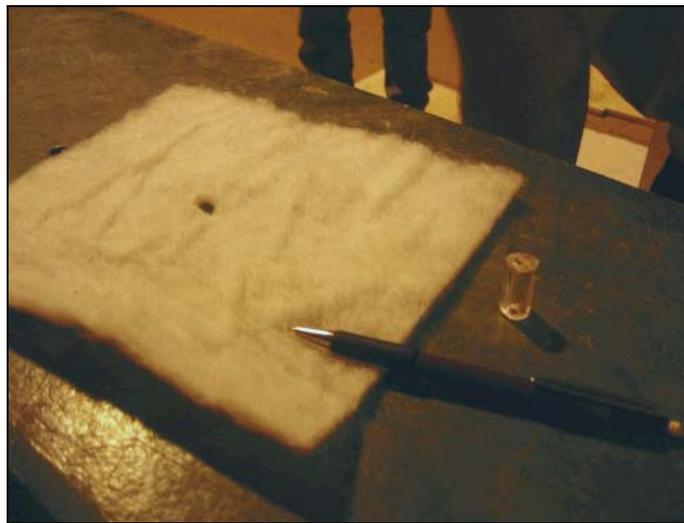
The performance of both rigid and flexible grout-filled mattresses was simulated by this testing program. Modeling of a rigid fabric formed concrete mattress was accomplished by soaking a synthetic batting, typically used in quilting, in a cement rich concrete grout. Mats were cut to fit the installation design; typically, a mattress was 20 by 30 cm (8 by 12 inches). The grout-filled mats were placed in the wet on top of a geotextile filter around each pier. Relief of pore water pressure from beneath the mat was allowed through weep holes cut into the center of each mat and at corners where two mats joined. **Figure 8.1** shows the grout mat batting before being filled with grout, note the weep hole cut in the center. **Figure 8.2** shows a rigid grout-filled mat being placed, with the grout still wet, around a pier.

Figure 8.1. Grout-filled mat before being filled with grout.

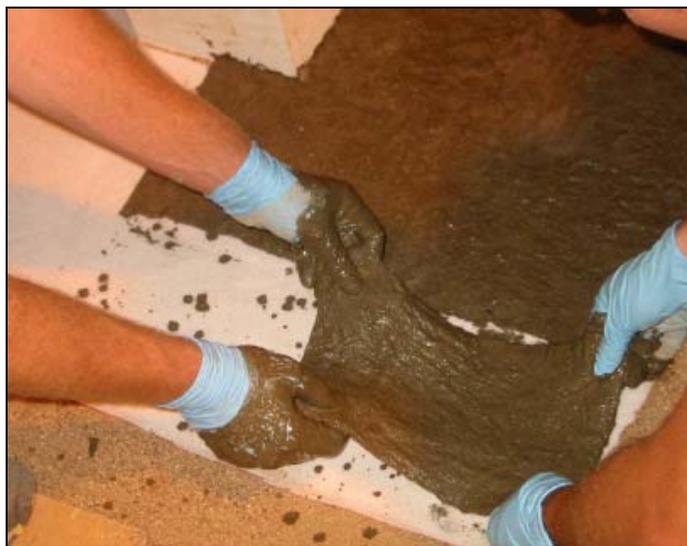
Figure 8.2. Placement of grout-filled mat.

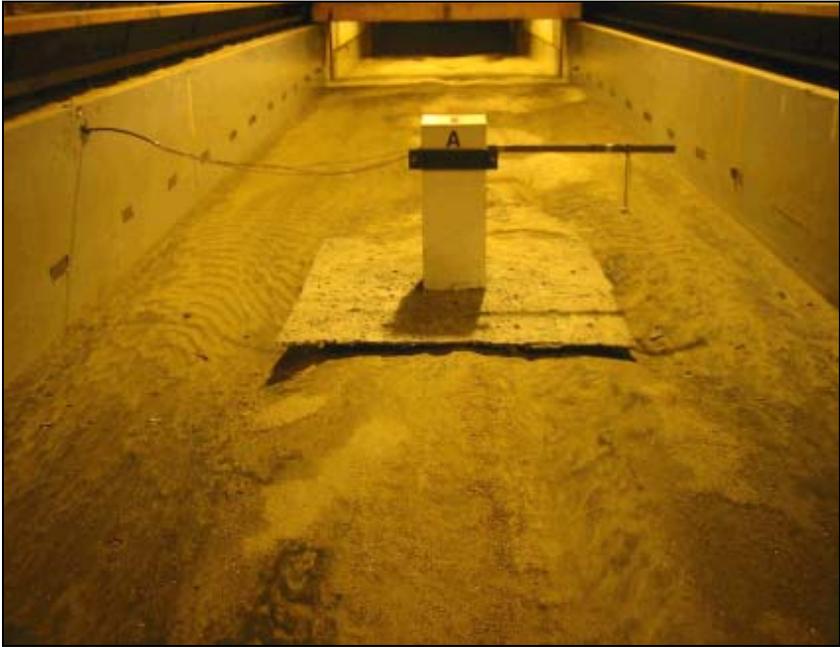
On Pier A, the upstream and downstream extent of the grout mats was 46 cm (18 in) and the lateral extent was 40 cm (16 in). **Figure 8.4** is a schematic of the grout-filled mattress installation on Pier A for Tests C7. **Figure 8.5** shows Pier A after completion of Test C7b. On Pier B, the upstream and downstream extent of the grout mats was 31 cm (12 in) and the lateral extent was 20 cm (8 in). On Pier C, the upstream and downstream extent of the grout mats was 31 cm (12 in) and the lateral extent was 40 cm (16 in). **Figures 8.6 and 8.7** present photographs of Pier C after completion of Test C7b.

Figure 8.5. Pier A after Test C7b, looking upstream.

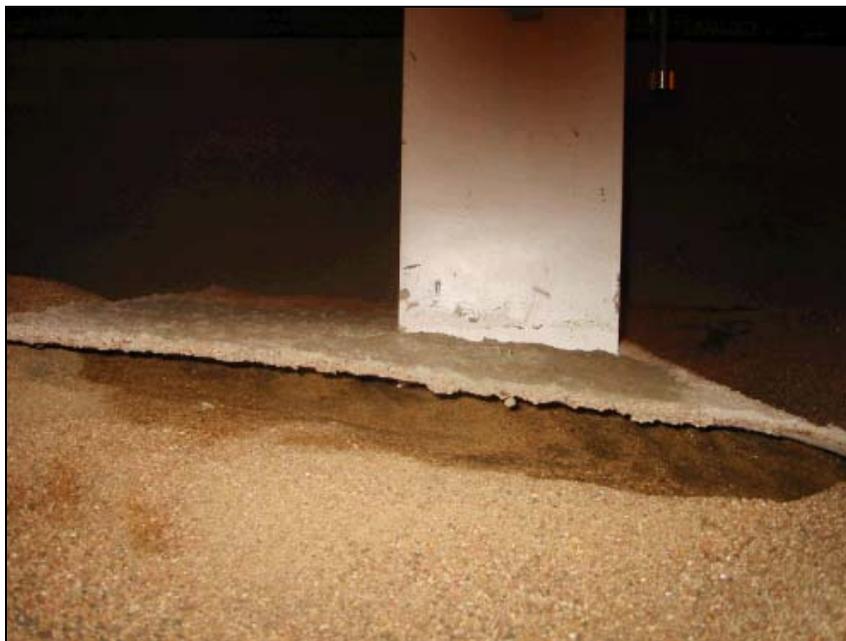
Figure 8.7. Pier C after Test C7b (flow is from right to left).

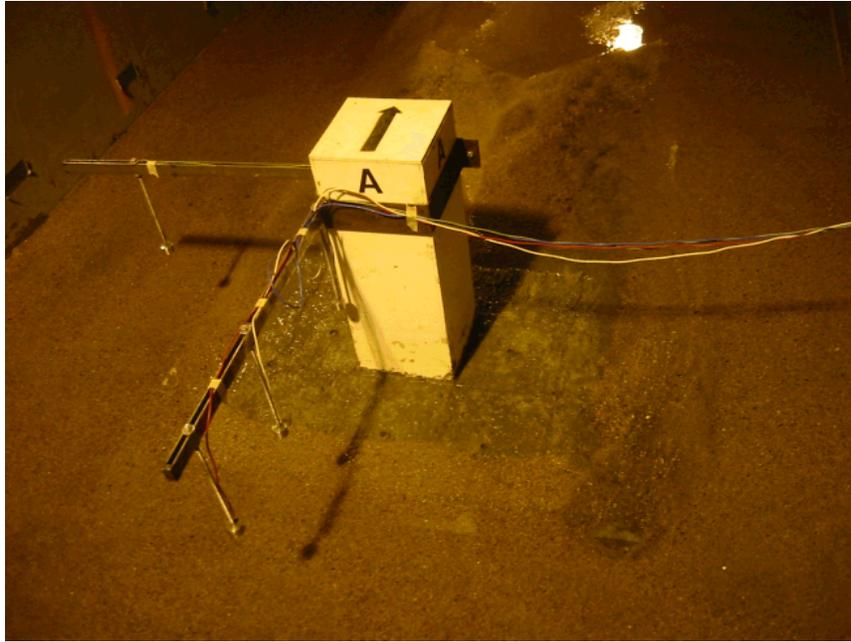
Test C8 was performed to investigate variations in termination details from the best performing layouts found in Test C7. Installations around each pier incorporated a geotextile extending from the pier face to the periphery of the grout-filled mats. The Pier A configuration from Test C7 was modified to include a 15 cm (6 in) turndown to a depth of 5 cm (2 in) around the entire periphery. The horizontal extension was flush with the initial bed elevation and was 15 cm (6 in) on the upstream and downstream sides and 25.4 cm (10 in) on the lateral sides. **Figure 8.8** shows Pier A after completion of Test C8a and **Figure 8.9** shows Pier A after Test C8b.

Figure 8.8. Pier A after Test C8a, looking downstream.

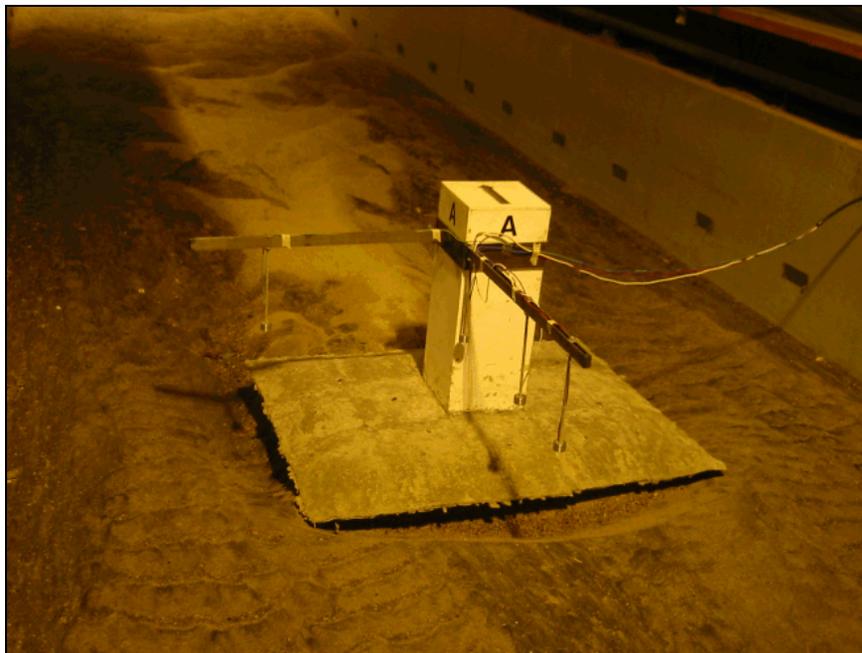
Figure 8.9. Pier A after Test C8b, looking downstream.

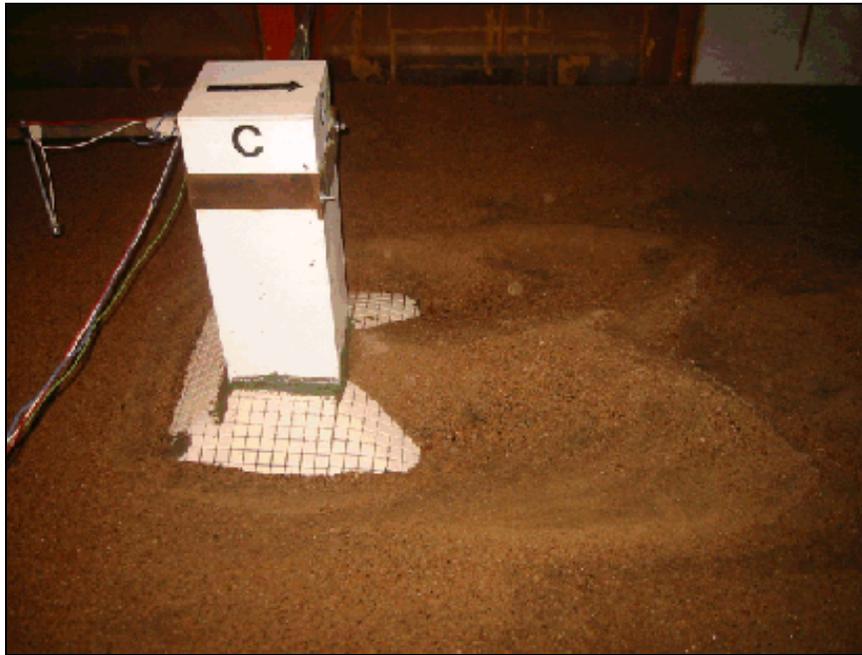
The Pier A configuration included a 15 cm (6 in) turndown to a depth of 5 cm (2 in) around the entire periphery. The horizontal extension was flush with the initial bed elevation and was 15 cm (6 in) on the upstream and downstream sides and 25.4 cm (10 in) on the lateral sides. Pier B incorporated a turndown detail of 4H:1V, extending from ambient bed level at the pier face to a depth of 7.6 cm (3 in) at the perimeter. Pier C incorporated a turndown detail of 2H:1V, extending from ambient bed level at the pier face to a depth of 15 cm (6 in) at the perimeter. **Figure 8.10** shows Pier C after completion of Test C18a and **Figure 8.11** shows Pier C after Test C18b.

Figure 8.10. Pier C after Test C18a, flow is from left to right.

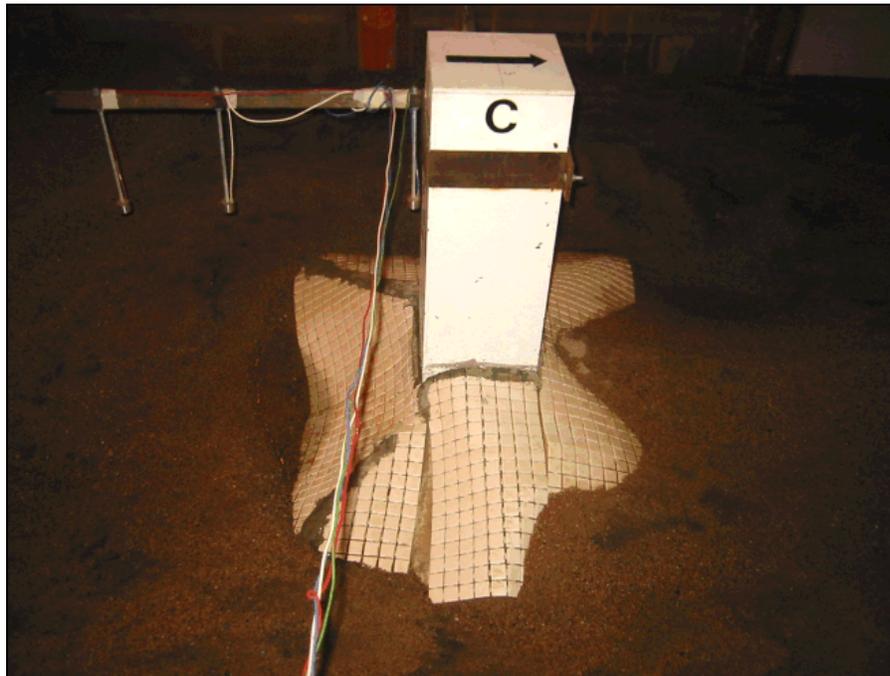
Figure 8.11. Pier C after Test C18b, flow is from left to right.
