#### CRASH TEST EVALUATION OF LONGITUDINAL BARRIERS ON CURVED-SUPER ELEVATED ROAD SECTIONS (NCHRP PROJECT 22-29A)

Authors: Dhafer Marzougui, Christopher Story, and Cing Dao (Steve) Kan,

Center for Collision Safety and Analysis (CCSA)
The George Mason University

February 2017

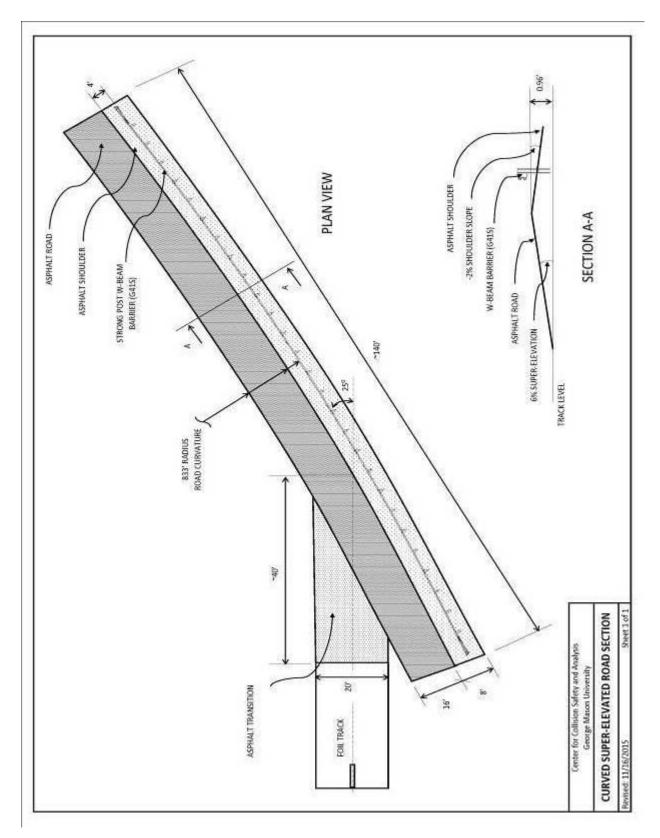
Figure 1: CSRS Test Bed used for Test 16004, 16010, and 16015

The design configuration of the CSRS test bed was developed by iterative computer simulation runs using finite element models of the barrier and impacting vehicle. Models of the test vehicle had been developed by the CCSA Team under joint efforts between the FHWA and NHTSA. The model of the barrier was created by replicating the geometry of each component, defining the connection details, and inputting information to characterize the materials used in the barrier. The impact performance of the barrier was evaluated in impact simulations in which the forces and resulting outcomes (e.g., deformations, fracture, slippage) of each element was analyzed for each time step for the entire duration of the impact event (about 1 second). The software used for these simulations allowed the output of various metrics to evaluate the barrier performance, including deformation, force levels, stress and strain, and dynamic measures (e.g., trajectory, yaw, pitch, and roll). Based on the simulation results, performance envelopes were generated of longitudinal barriers on CSRS.

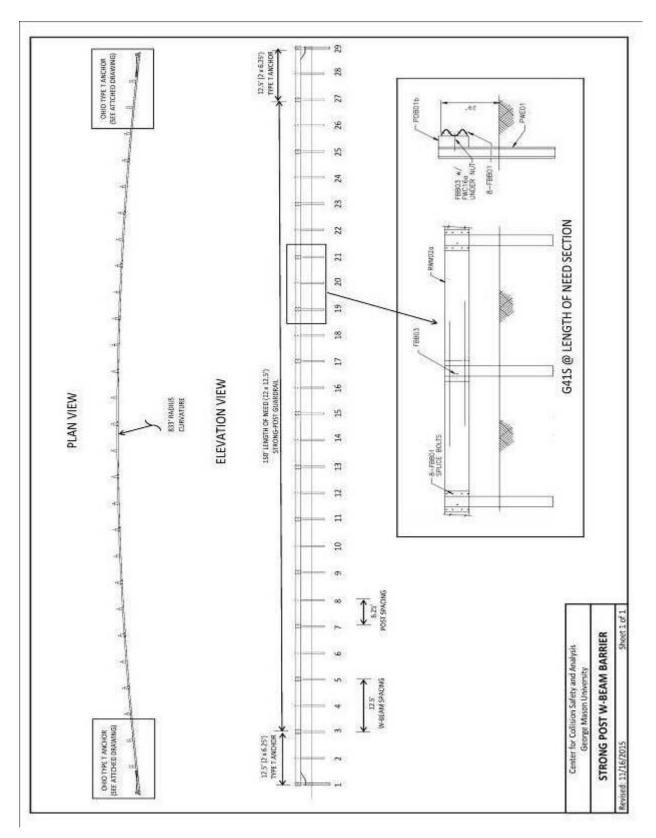
Figure 2: Drawing of G4(1S) Barrier Used for Tests 16004, 16010, and 16015

Table 1 lists the three tests conducted on longitudinal barriers installed on CSRS. The barrier in all three tests was a G4(1S) system with a top rail height of 737 mm (29 in). Standard G4(1S) steel posts and blockouts were used for the barrier. The spacing of each post was 1.9 m (6'3") for a total length of 53.3m (175'). All three tests were performed in accordance with the MASH Test 3-11 condition for longitudinal barriers, with a 2270P vehicle at an impact speed 100 km/hr (62 mph) and 25-deg angle.

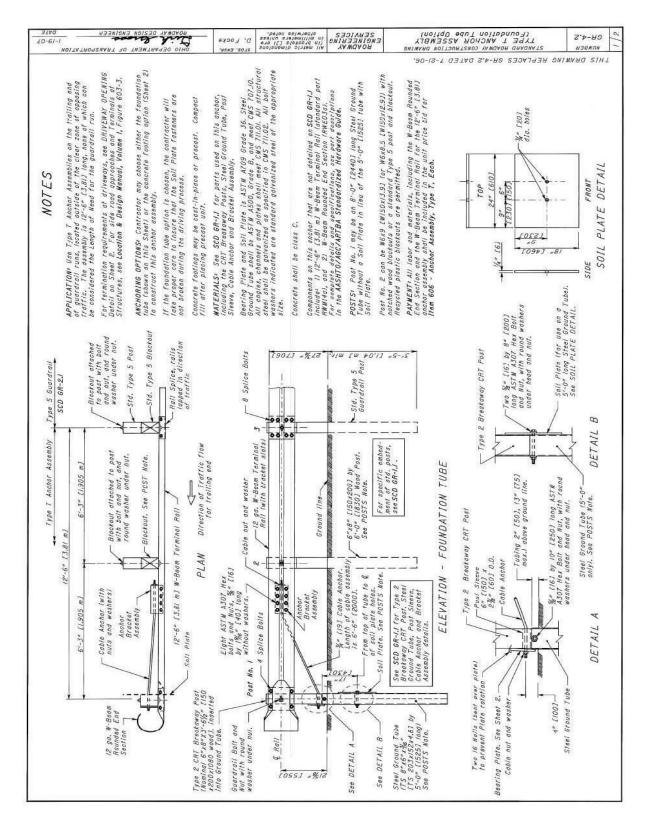
Figure 3: Drawing of End Termination user for Tests 16004, 16010, and 16015

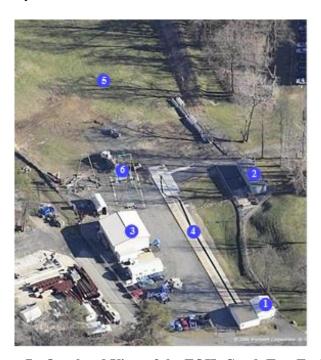
Figure 7 shows an aerial view of the FOIL. The FOIL facility consists of six main areas: (1) propulsion system building, (2) test control center trailer, (3) vehicle preparation garage, (4) track, (5) runway, and (6) pendulum area. Additionally, several storage trailers are located at different areas of the facility.

Figure 7: Overhead View of the FOIL Crash Test Facility

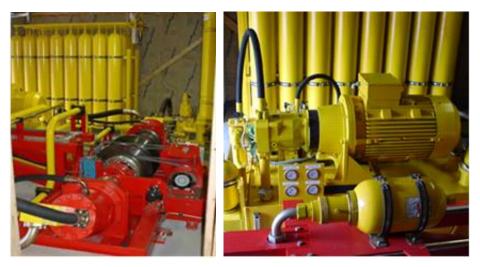
The test vehicle is pulled into the barrier using the FOIL track rail towing system. The towing system is a specially designed aluminum track rail for outdoor applications. The vehicle propulsion system (Figure 8) is capable of accelerating test vehicles of various sizes and types up to speeds commonly found on U.S. highways. The FOIL propulsion system is powered hydraulically with a capacity of more than 10,000 N•m (13,560 lb•ft) of torque. The vehicles are accelerated on a 67 m (220 ft) concrete runway with a 110 m (360 ft) runoff area. Typical vehicle weights, and the corresponding maximum speed, include the following:

Figure 8: Vehicle Propulsion System

The test vehicle is accelerated up to the desired speed using a cable driven tow trolley. The tow trolley travels the length of the runway in a ground level track system. A cable with sufficient slack to form a loop connects the test vehicle to the tow trolley. The two ends of this cable terminate at the attachment to the test vehicle's front axle near the tires; the center of cable loops over the front surface of the tow trolley. Prior to the test vehicle's collision into the test article, the test vehicle disengages from the tow trolley. With the test vehicle disengaged, the vehicle rolls freely until it collides with the test article. The propulsion system is computer controlled.

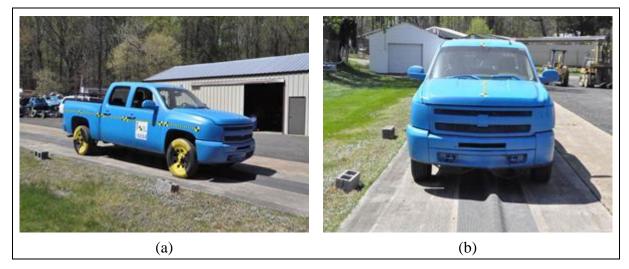
Figure 17 : Test Vehicle for Test 16004

The vehicles used in the test was a 2009 Chevrolet Silverado pick-up truck that were equipped with eight-cylinder gasoline engines. The pick-up trucks also had 4 full doors and were rear wheel drive (2WD). Pictures of the vehicle are shown in Figure 17. The exact curb mass of the vehicle in was 2308 kg (5088.3 lb) and its measured test inertial mass was 2315 kg (5107.3 lb). The height of the lower edge of the vehicle front bumper 54.2 cm (21.3 in); the upper edge of the front bumper was 66.3 cm (26.1 in) and the hood height was 114.2 cm (45 in). Additional dimensions of the vehicle are given in the Appendix E.1 of this test report.

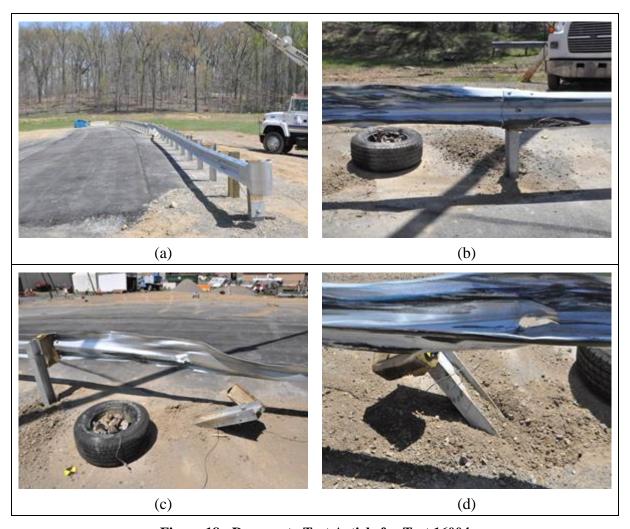
There was significant damage to the impacted area of the G4(1S) W-beam guardrail barrier. The damage to the barrier was contained between post 10 and post 16. There was considerable flattening of the W-beam guardrail with tearing. Also, there was significant twisting of the posts and broken blockouts. The damage to the barrier is shown in Figure 18.

Figure 18 : Damage to Test Article for Test 16004

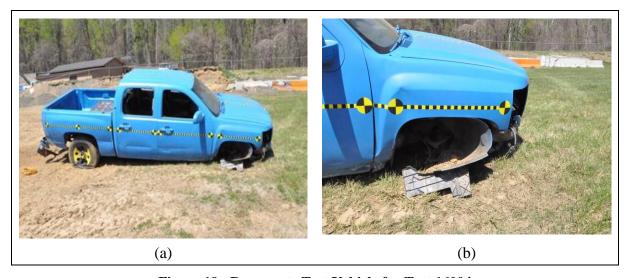
The 2009 Chevrolet Silverado had significant damage. The majority of the damage came on the right hand side of the vehicle due to being the impacted side. There was major denting to the passenger side of the vehicle. The front passenger side tire became detached during the impact and passenger rear tire was flat after impact. The front and rear bumper had considerable damage to the passenger side but the driver's side received minimal to no damage. The tires on the driver's side remained undamaged during the impact. The vehicle damage is shown in Figure 19.

Figure 19 : Damage to Test Vehicle for Test 16004

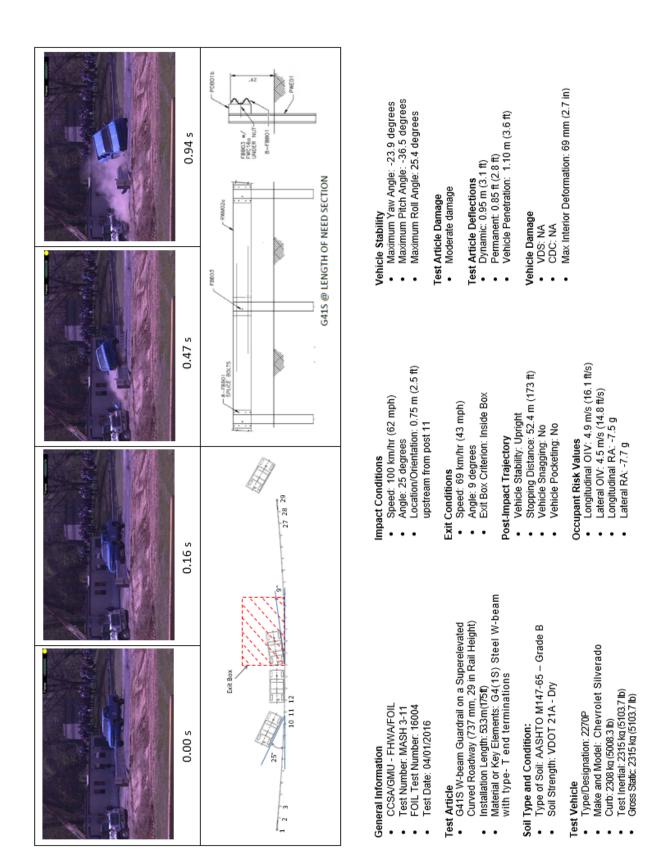
Figure 20 provides a summary of Test 16004 that includes all pertinent information about the set-up and outcomes of the test. It is noted that the test vehicle was within the mass tolerance range (+/-50kg) for testing requirements. The impact speed and angle were also within tolerance limits. Data from the tri-axial accelerometers and rate transducers mounted at the CG of the vehicle are graphed and included the Appendix E.1. These show the filtered pulses recorded during the impact point that provide the basis for computing the various crash test metrics.

Figure 20: Summary Results for Test 16004

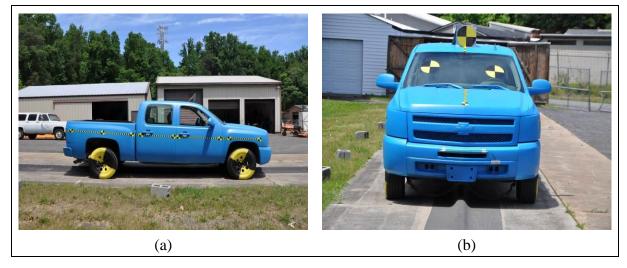
Figure 22 : Test Vehicle for Test 16010

The vehicles used in the test was a 2009 Chevrolet Silverado pick-up truck that were equipped with eight-cylinder gasoline engines. The pick-up trucks also had 4 full doors and were rear wheel drive (2WD). Pictures of the vehicle are shown in Figure 22. The exact curb mass of the vehicle in was 2313 kg (5099.3 lb) and its measured test inertial mass was 2283 kg (5033.2 lb). The height of the lower edge of the vehicle front bumper 55.9 cm (22 in); the upper edge of the front bumper was 68 cm (26.8 in) and the hood height was 114.1 cm (44.9 in). Additional dimensions of the vehicle are given in the Appendix E.2 of this test report.

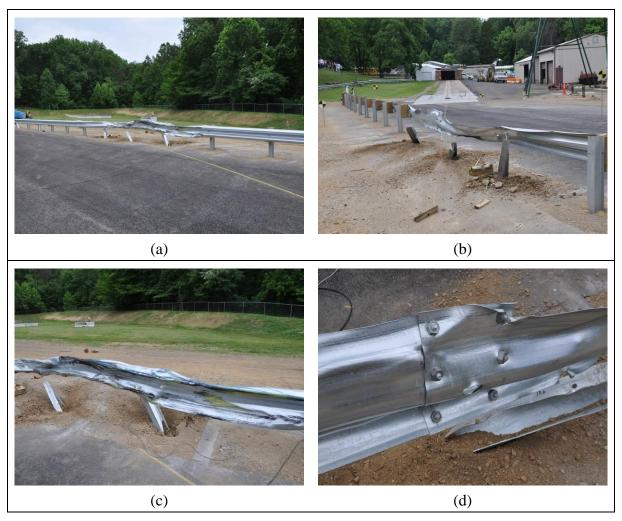
There was significant damage to the impacted area of the G4(1S) W-beam guardrail barrier. The damage to the barrier was contained between post 10 and post 16. There was considerable flattening of the W-beam guardrail with tearing. Also, there was significant twisting of the posts and broken blockouts. The damage to the barrier is shown in Figure 23.

Figure 23 : Damage to Test Article for Test 16010

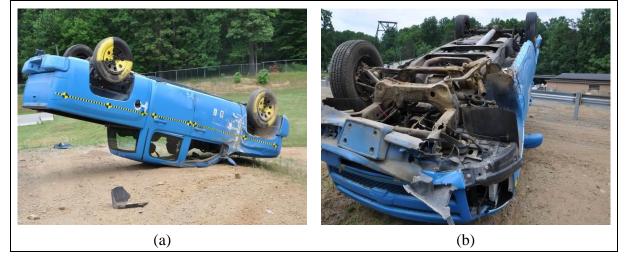
The 2009 Chevrolet Silverado had significant damage. During the initial impact the majority of the damage came on the right hand side of the vehicle due to being the impacted side. As in the previous test the front passenger side tire became detached during the impact but the other 3 tires remained intact and were undamaged. When the vehicle went to the opposite side of the barrier it rolled onto its roof causing damage to the roof. The vehicle had significant damage the cab, suspension parts, truck bed, and broken windshield. The vehicle damage is shown in Figure 24.

Figure 24 : Damage to Test Vehicle for Test 16010

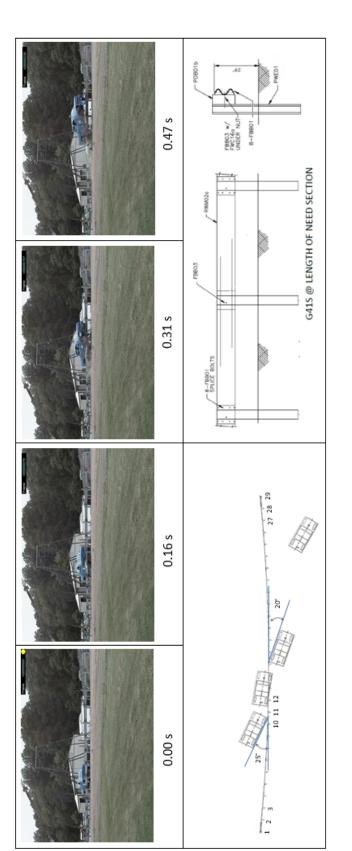
Figure 25 provides a summary of Test 16010 that includes all pertinent information about the set-up and outcomes of the test. It is noted that the test vehicle was within the mass tolerance range (+/-50kg) for testing requirements. The impact speed and angle were also within tolerance limits. Data from the tri-axial accelerometers and rate transducers mounted at the CG of the vehicle are graphed and included the Appendix E.2. These show the filtered pulses recorded during the impact point that provide the basis for computing the various crash test metrics.

- Speed: 100 km/hr (62 mph) Angle: 25 degrees
- Location/Orientation: 0.3 m (1 ft) downstream from post 11

Exit Conditions
Speed: 79 km/hr (49 mph)
Angle: -20 degrees

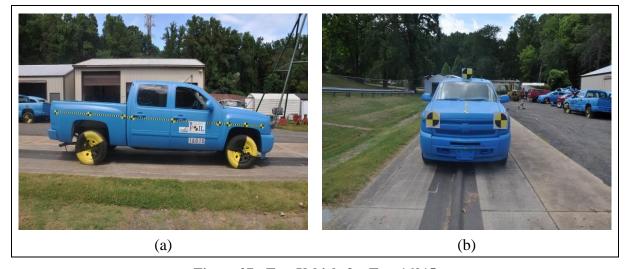
Figure 27 : Test Vehicle for Test 16015

The vehicles used in the test was a 2009 Chevrolet Silverado pick-up truck that were equipped with eight-cylinder gasoline engines. The pick-up trucks also had 4 full doors and were rear wheel drive (2WD). Pictures of the vehicle are shown in Figure 27. The exact curb mass of the vehicle in was 2257 kg (4975.3 lb) and its measured test inertial mass was 2268.5 kg (5001.2 lb). The height of the lower edge of the vehicle front bumper 56.9 cm (22.4 in); the upper edge of the front bumper was 69 cm (27.7 in) and the hood height was 115.1 cm (45.3 in). Additional dimensions of the vehicle are given in the Appendix E.3 of this test report.

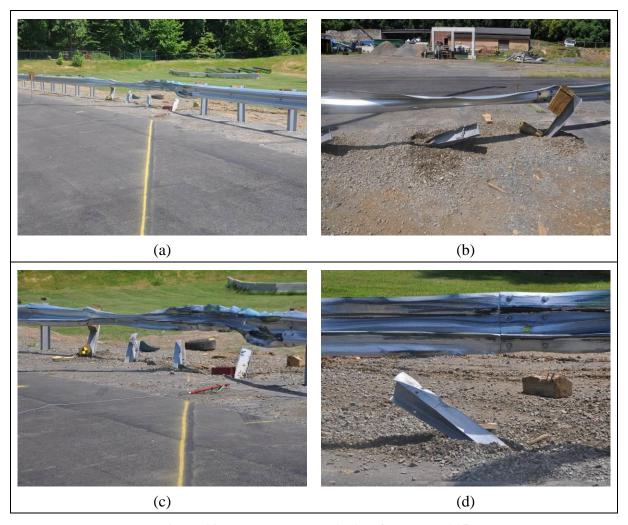
There was significant damage to the impacted area of the G4(1S) W-beam guardrail barrier. The damage to the barrier was contained between post 12 and post 18. There was considerable flattening of the W-beam guardrail with tearing. Also, there was significant twisting of the posts and broken blockouts. The damage to the barrier is shown in Figure 28.

**Figure 28 : Damage to Test Article for Test 16015**

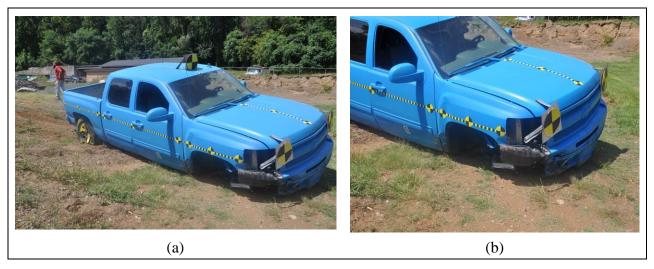
The 2009 Chevrolet Silverado had significant damage. The majority of the damage came on the right hand side of the vehicle due to being the impacted side. There was major denting to the passenger side of the vehicle. The front passenger side tire became detached during the impact due to broken suspension parts and passenger rear tire was flat after impact. The front and rear bumper had considerable damage to the passenger side but the driver's side received minimal damage. The tires on the driver's side remained undamaged during the impact. The vehicle damage is shown in Figure 29.

Figure 29 : Damage to Test Vehicle for Test 16015

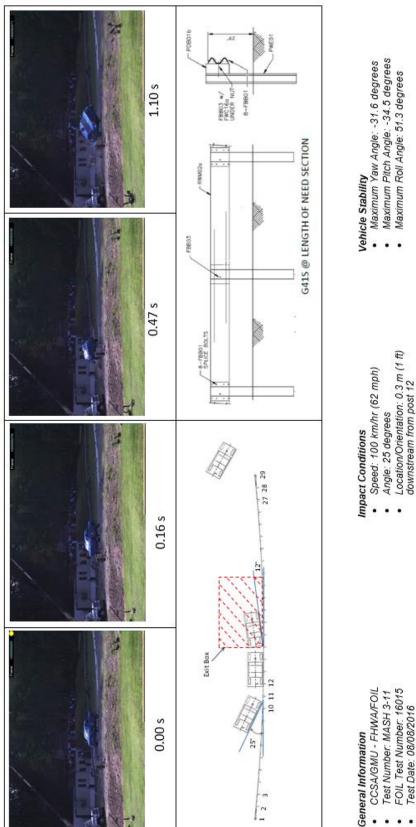
Figure 30 provides a summary of Test 16015 that includes all pertinent information about the set-up and outcomes of the test. It is noted that the test vehicle was within the mass tolerance range (+/-50kg) for testing requirements. The impact speed and angle were also within tolerance limits. Data from the tri-axial accelerometers and rate transducers mounted at the CG of the vehicle are graphed and included the Appendix E.3. These show the filtered pulses recorded during the impact point that provide the basis for computing the various crash test metrics.

Figure 30: Summary Results for Test 16015

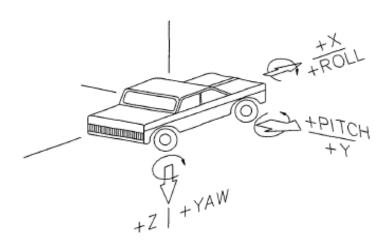
For each accelerometer, the X-axis is referenced from the center of the right front tire (X=0), the Y-axis from the centerline of the test vehicle (Y=0), and the Z-axis from ground level (Z=0).
