Breakaway Cable Terminals for Guardrails and Median Barriers

An NCHRP staff digest of the essential findings from the final report on Phase II of NCHRP Project 22-2, "Traffic Barrier Performance and Design," by M. E. Bronstad and J.D. Michie. Southwest Research Institute, San Antonio, Texas

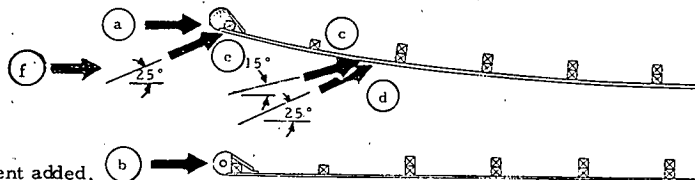
a. Tests 130, 133, 134, 135, 138, 140, 142, 159

b. Test 132

c. Test 131

d. Tests 137, 139, 141, 162, 160

e. Test 136

f. Test 164, 165

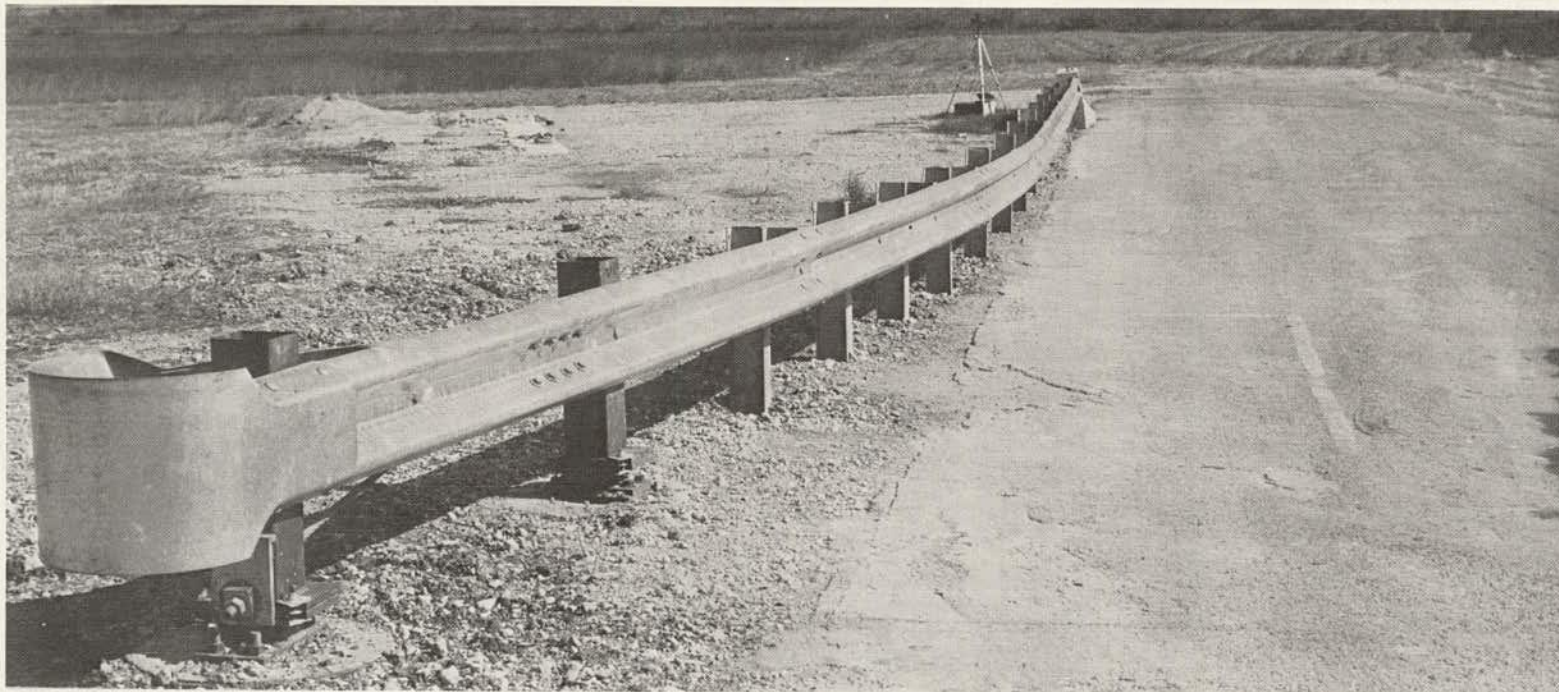
Figure 2 - Guardrail BCT With Steel Slip Base Terminal Posts

Guardrail Terminal. The significant modifications to the guardrail BCT are:

- Slip-base steel posts were used in the terminal for the G4S guardrail system.
- The cross-sectional dimensions of the timber posts in the BCT for the G4W system were changed from 8x8 inches to 6x8 inches.
- Post spacing in the third, fourth, and fifth spans from the end was reduced from 6' - 3" to 4' - 2".
- A 25-ft (nominal) W-beam element was substituted for the two 12.5-ft elements in the first four spans.
- One-piece anchor replaced the more costly device previously used to secure the cable to the rail element.
- Diaphragms were eliminated from the nose element.

Terminal posts with slip bases were tested in the pendulum facility. A three-bolt pattern utilizing ASTM A325 bolts with Hi-Lok nuts was developed and validated through full-scale crash tests. The BCT that was evaluated in Tests 162, 164, and 165 included the previously mentioned modifications and is shown in Figure 1. These slip-base terminal posts reduced the severity of the head-on impact of the small car and performed satisfactorily in all other crash tests; therefore, they are recommended for use in the BCT. On the basis of pendulum test results, 6x8-in. timber posts are recommended for use in the BCT to provide improved performance for small cars.

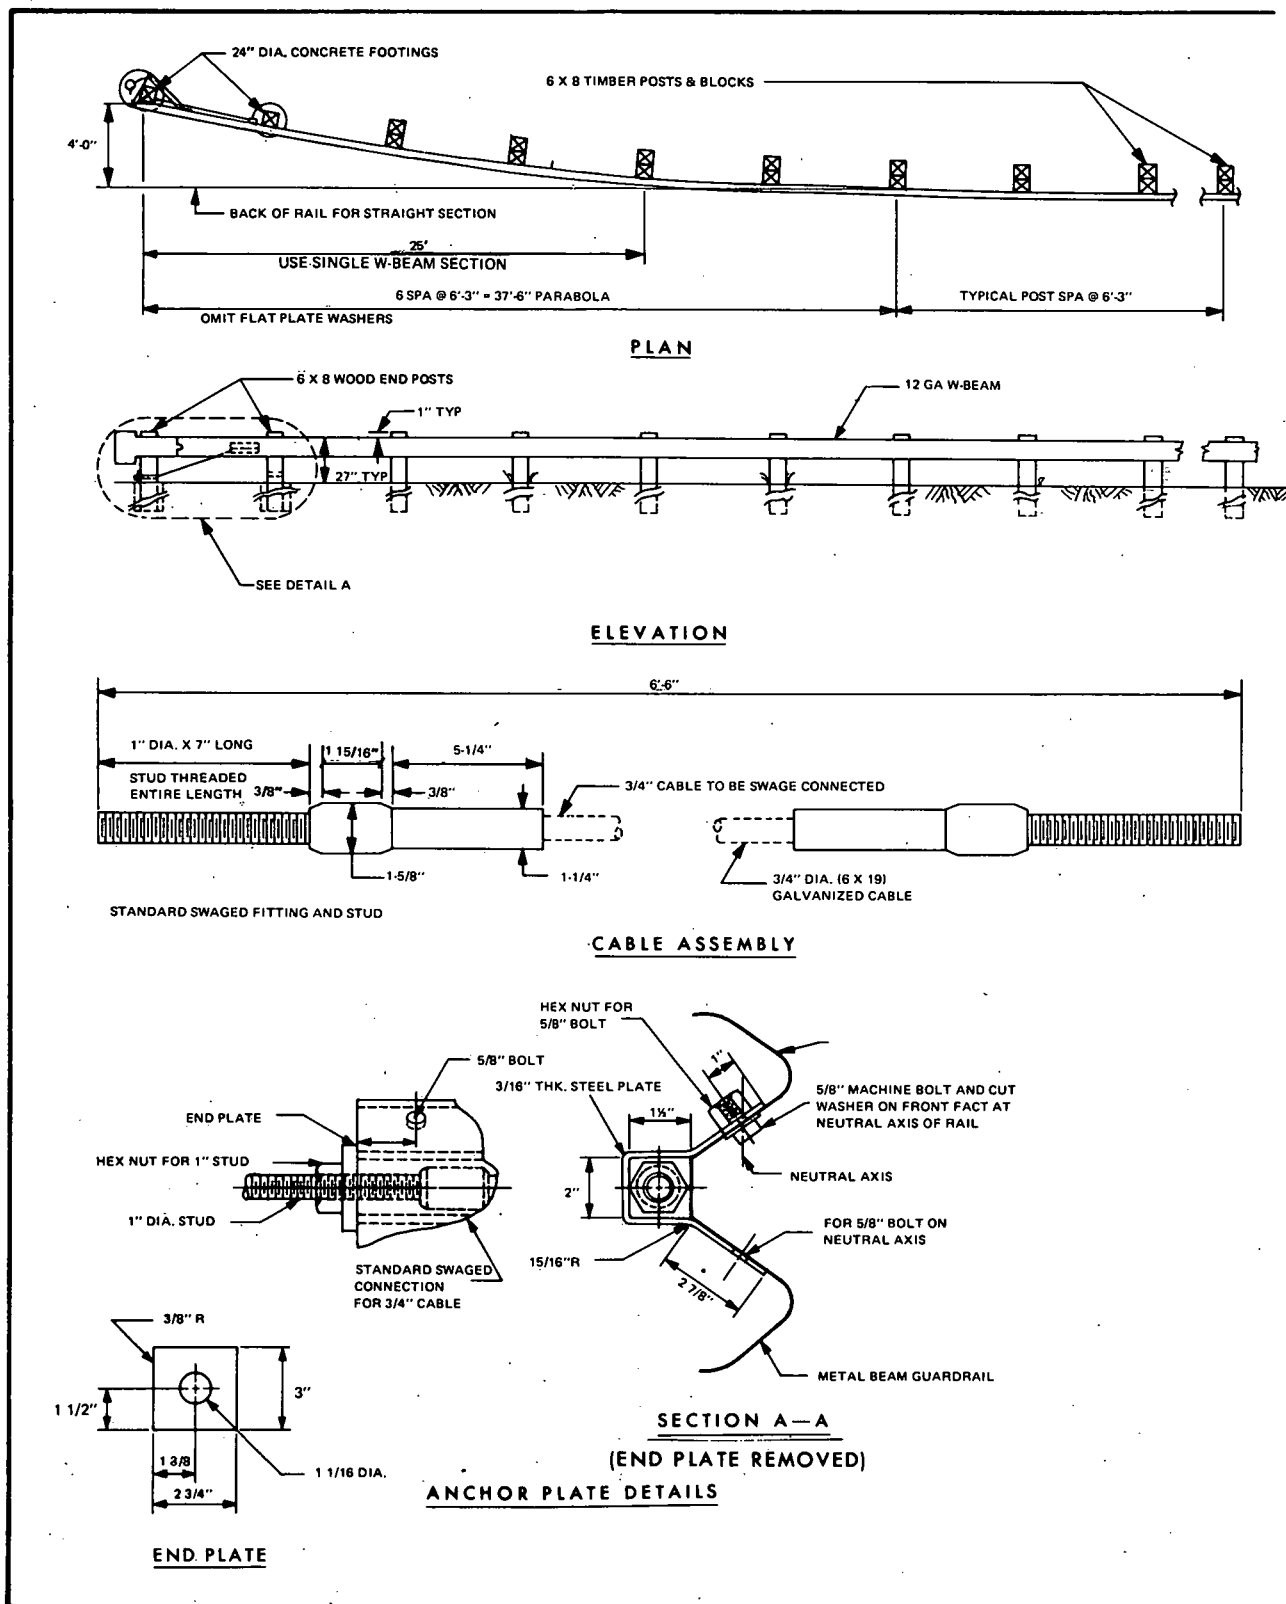
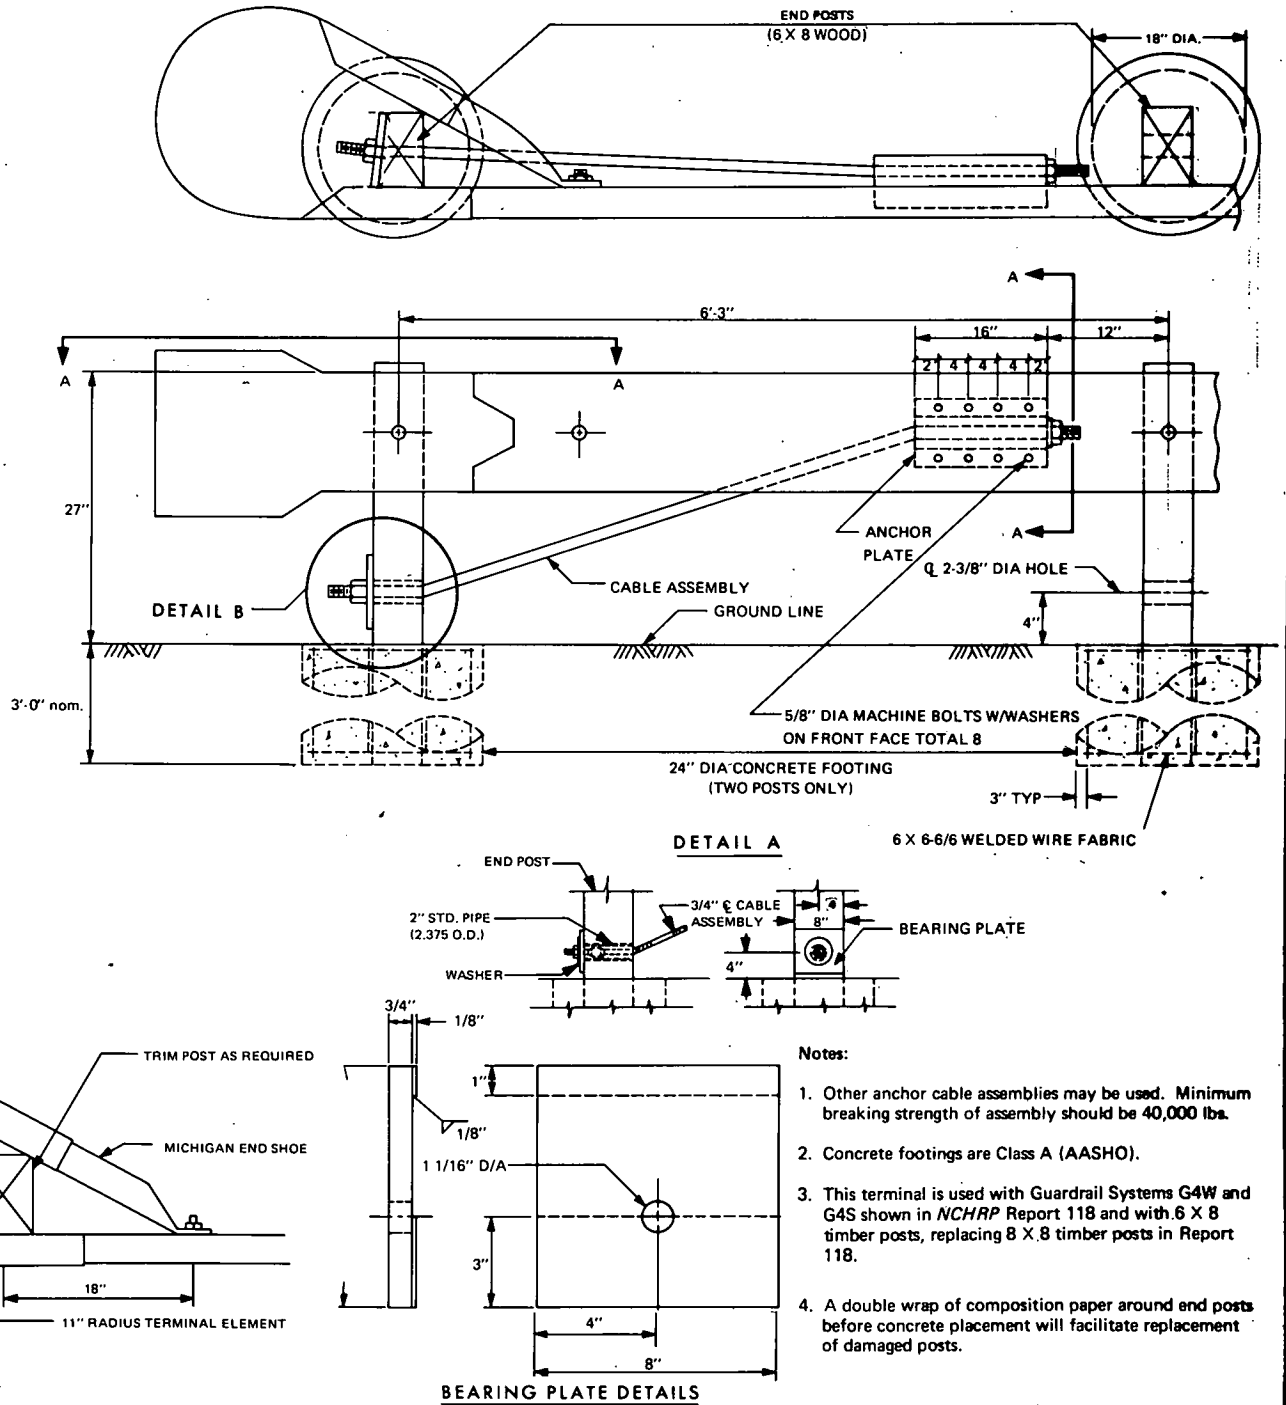
Figure 3 - Recommended Timber Post BCT Improvement

DATE June 1975	SCALE	BREAKAWAY CABLE TERMINAL - 6 X 8 TIMBER POSTS	
DRAWN BY T. Garza		DEPARTMENT OF STRUCTURAL RESEARCH	DRAWING NUMBER
DESIGNED BY M. Bronstad		SOUTHWEST RESEARCH INSTITUTE	03-3799-01
CHECKED BY M. Bronstad		SAN ANTONIO.	TEXAS
APPROVED BY

The guardrail BCT designs as detailed in Figures 1 and 3 are recommended for trial use. This relatively low-cost system (about \$300) provides the designer with a terminal that has been evaluated over a wide range of impact conditions, using both timber and steel posts. A slip-base breakaway steel post was developed and demonstrated to improve the dynamic performance. In addition, cost-saving concepts are presented for future implementation.

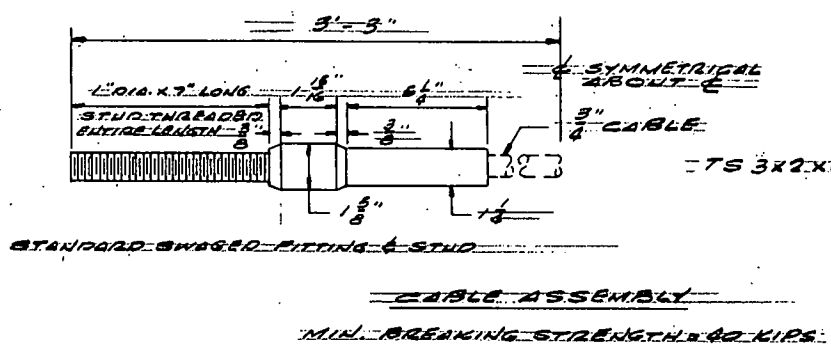
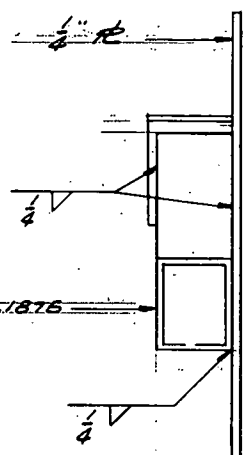
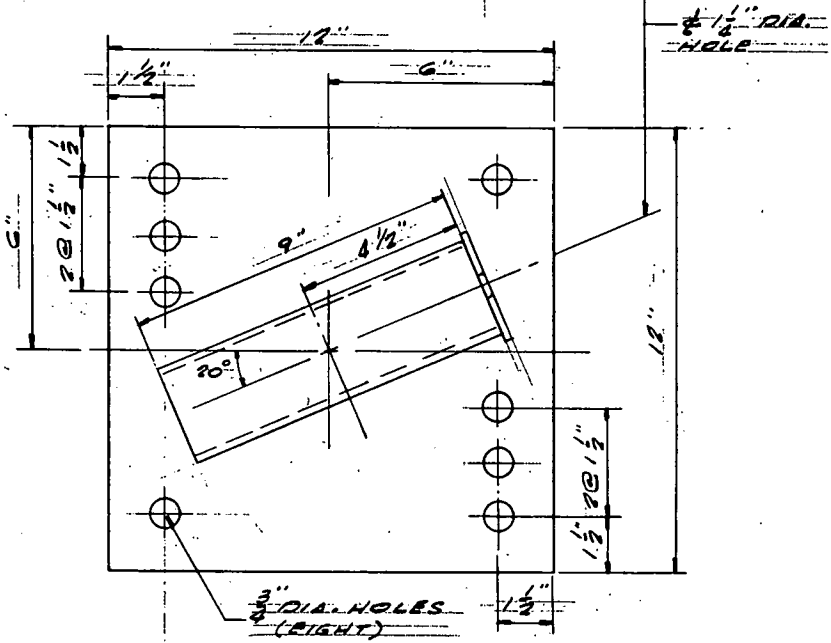
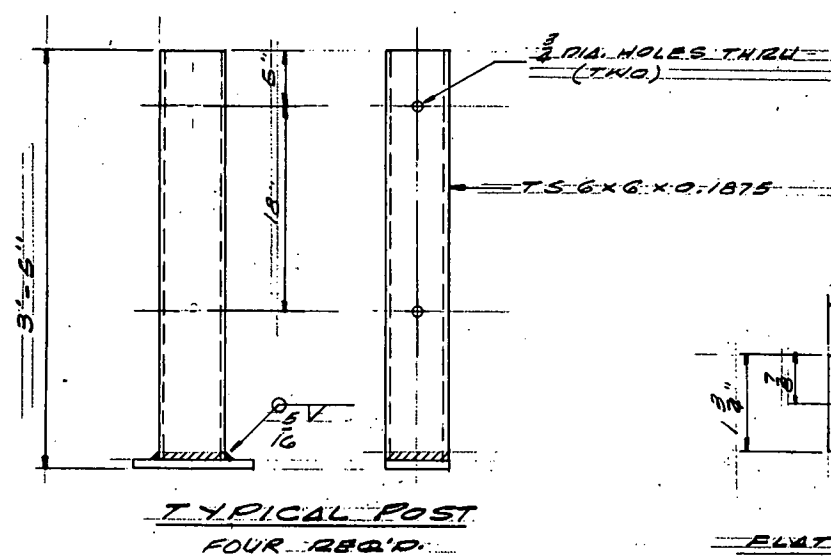
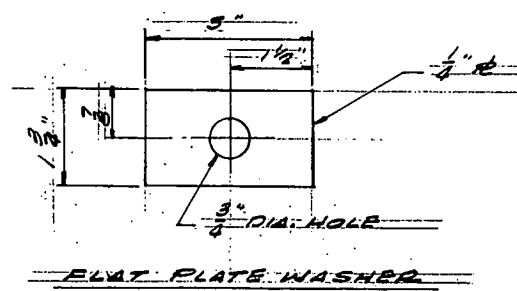
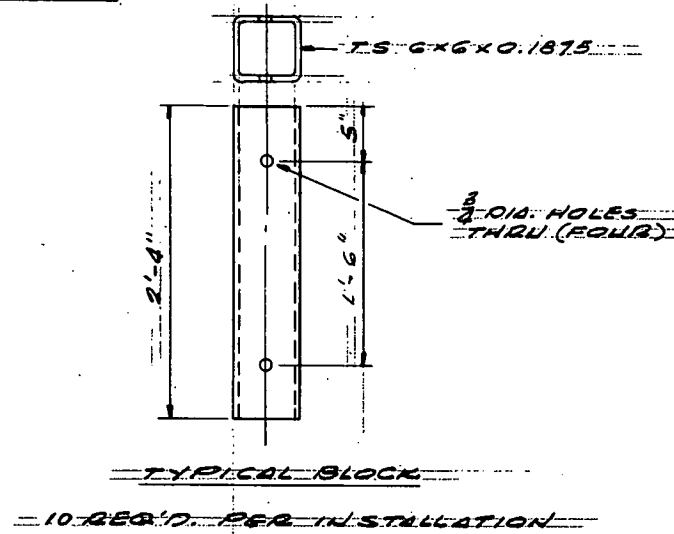
Figure 4 (continued)

5/8" DIA. BOLT X 2" LONG
BOLT W/ WASHER
(TYPICAL)

TYPICAL BLOCK/POST ATTACHMENT

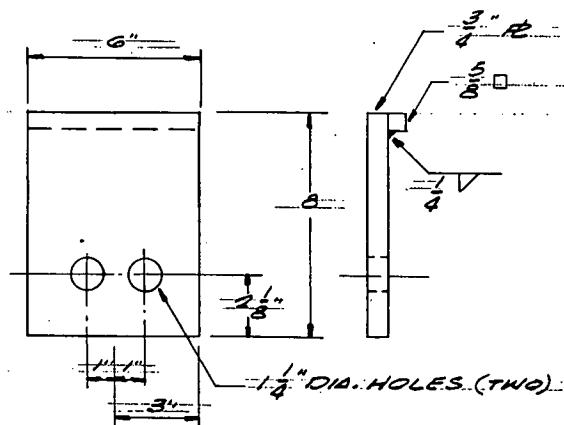
BEARING PLATE

In addition to providing breakaway performance for end-on impacts, the end post in the BCT concept must provide the necessary anchor strength for down-stream impacts. A design concept utilizing a bearing plate to beam the anchor loads from the cable directly to the rigid foundation was conceived and developed for slip-base and timber posts, as shown in Figure 6. The length of the bearing plate determines the portion of the load that is resisted directly by the foundation post and the portion that must be resisted by the friction force at the slip base or by shear in the net timber-post section. The capacity of this design to develop the minimum breaking strength of the anchor cable (42 kips) was demonstrated by pendulum testing.

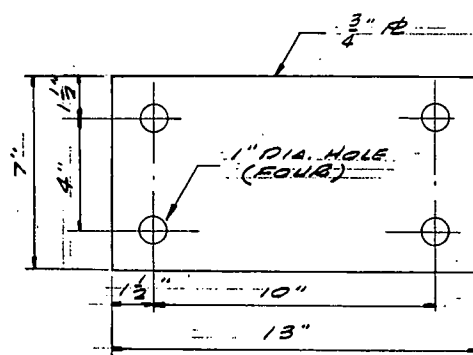
BASE PLATE C

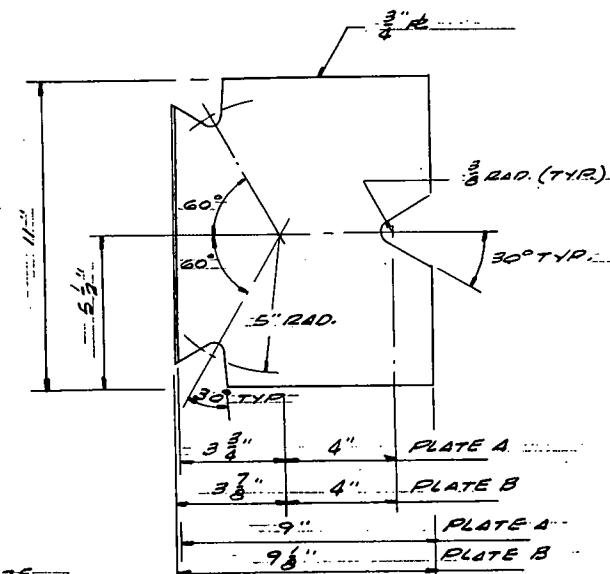
BASE PLATE A & B

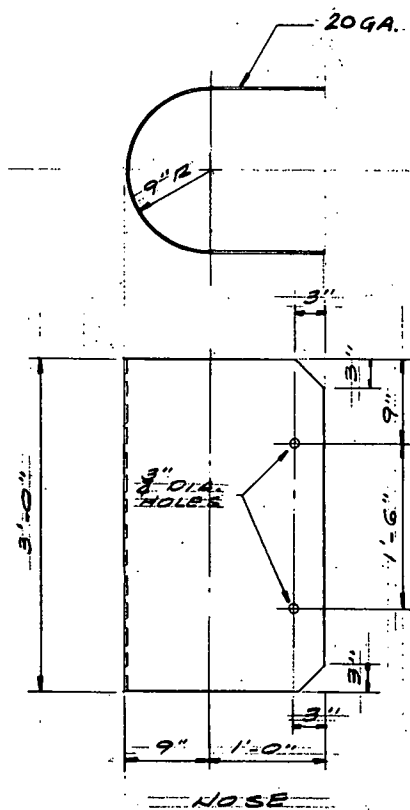
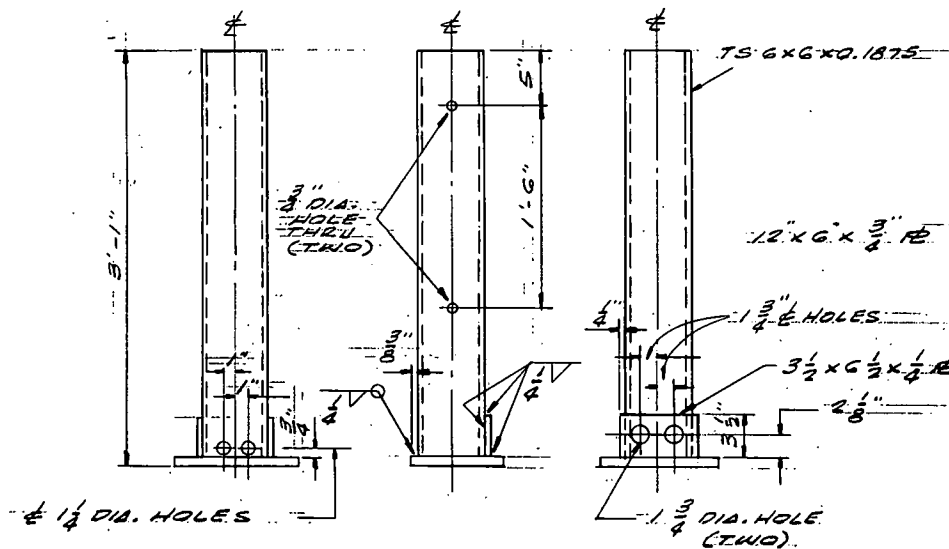
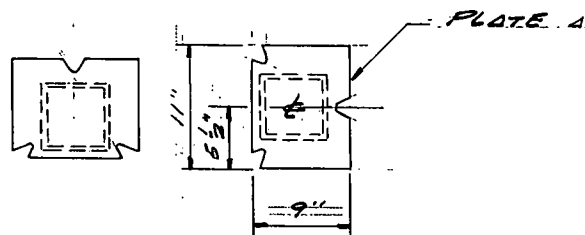
END POST
ONE REQ'D.

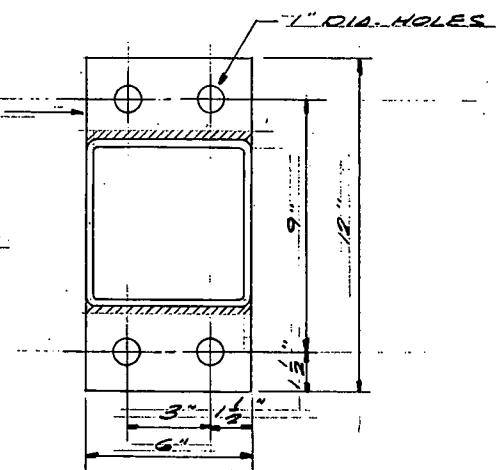
DETAIL C
TYPICAL TERMINAL POST BASE
