# NCHRP

Web-Only Document 117B:

## Guidelines for Accessible Pedestrian Signals

### Final Report

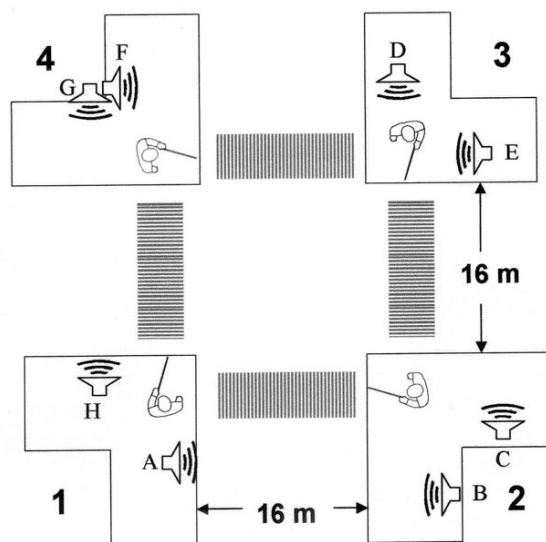
*Figure 2-1. Positions and headings of loudspeakers and pedestrians at each corner in NEI research. (Figure from Ashmead, et al., 2004). The figure is not drawn to scale.*

There was no evidence that response time differed across the four corners, that is, for different speaker arrangements. This suggests that the inaccurate judgments made from corner 3 about which crosswalk had the walk signal did not reflect uncertainty, but rather were mistakes of which the participants were largely unaware.

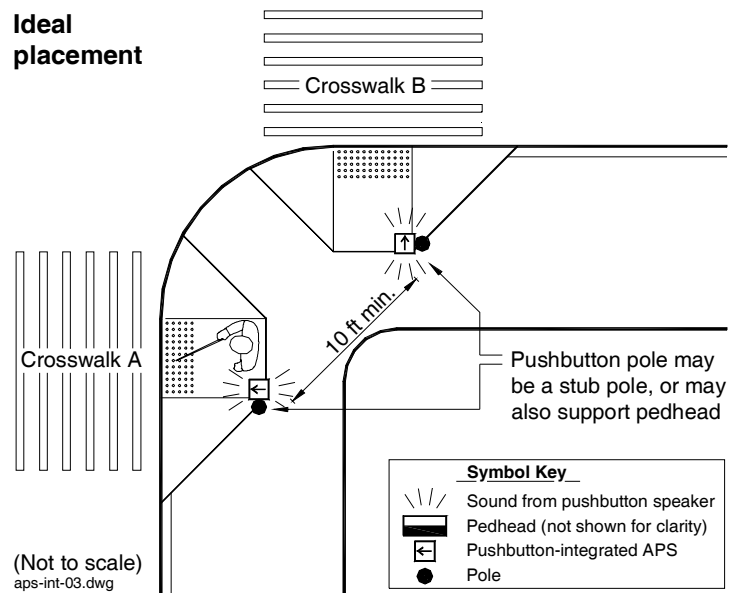
Figure 2-2. Optimal location of pushbutton-integrated APS.

Figure 2-2 illustrates the recommended placement of APS devices in relation to the crosswalk provided in the APS Synthesis in 2003. This arrangement was based on the NEI research described above. The NEI research was the basis for additional research on

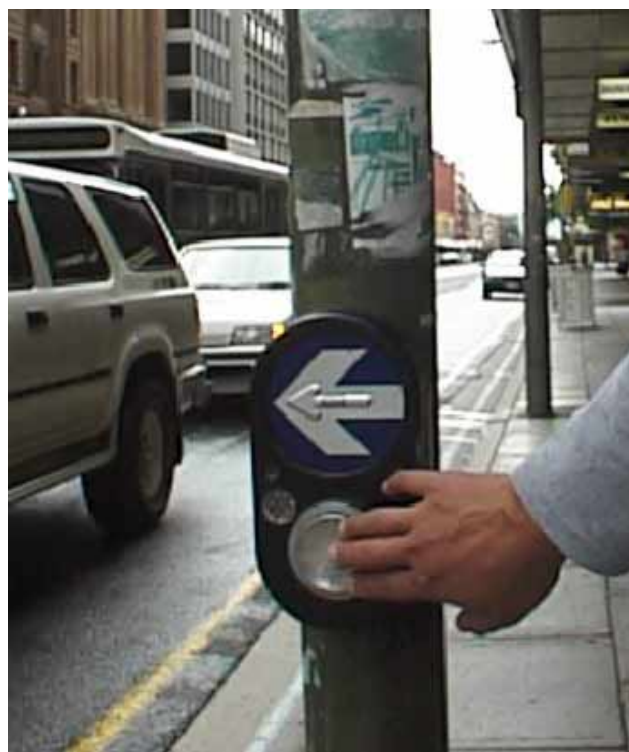
**Figure 3-1. Pushbutton-integrated APS with tactile arrow.**

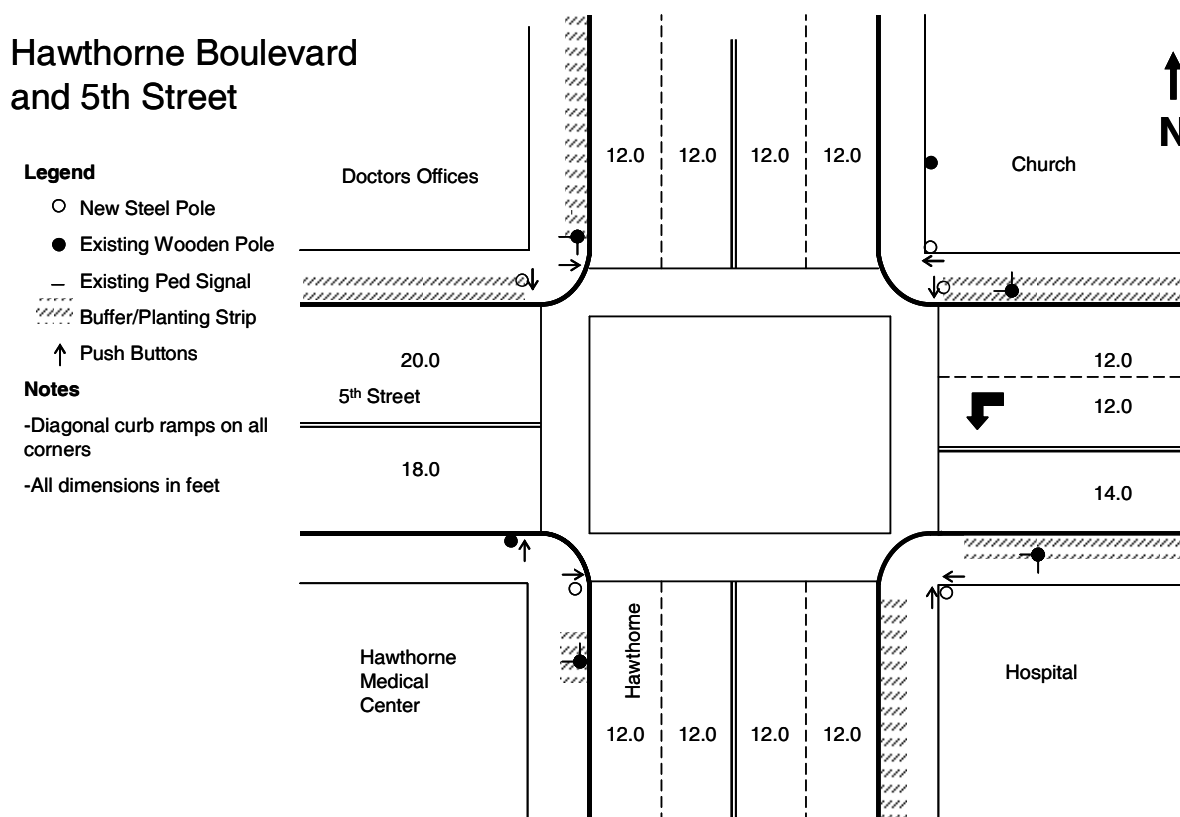
Figure 3-3. Intersection of Hawthorne Boulevard (major street) and 5<sup>th</sup> Street (minor street) in Charlotte, NC where APS devices were installed for the experiments.

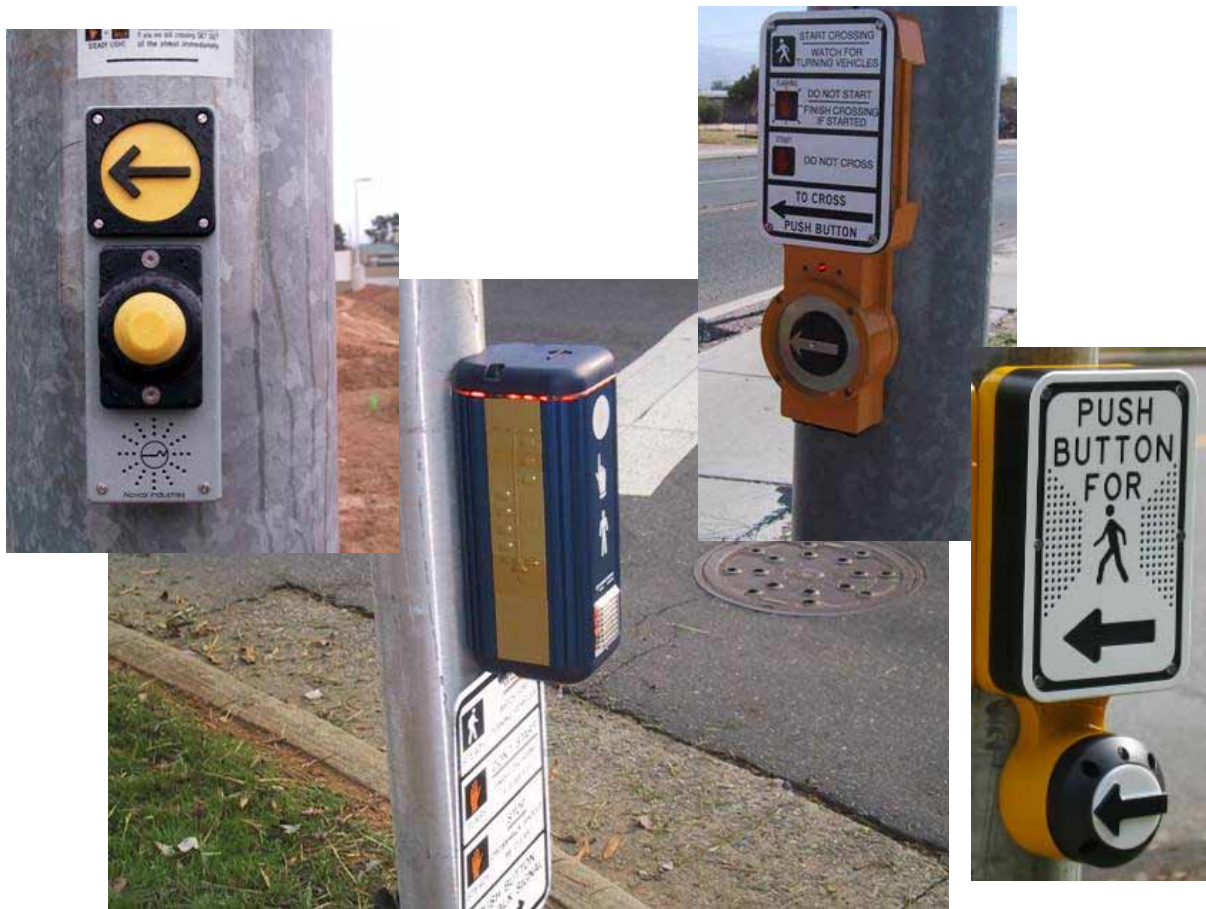
Figure 3-4. Pushbutton-integrated APS units from four manufacturers were deployed for the experiments.

devices with their ‘standard features’ for the project. The devices provided and tested are shown in Figure 3-4. These four APSs represented all that were being actively marketed in the U.S. at the onset of this research. While all pushbutton-integrated APS devices are capable of providing most of the features evaluated in this project, some manufacturers provide certain features as standard and others as optional. All APS had a pushbutton locator tone, an audible actuation indicator, an audible walk indication, a tactile arrow that vibrated during the walk interval and automatic volume adjustment. Because more than a year elapsed between data collection in Tucson and Charlotte, the manufacturers of devices B and C had developed new models, so the devices used in the two cities were not identical.

In the analysis that follows, the results are presented in terms of APS A, B, C and D. The purpose of the project was NOT to assess each product, but rather to determine the effectiveness of the specific features (e.g., pushbutton style, locator tone, etc.) on the ability of a pedestrian with visual impairments to safely cross the street. The recommended guidelines developed as a result of the research discuss the required features, which may be provided by multiple manufacturers.

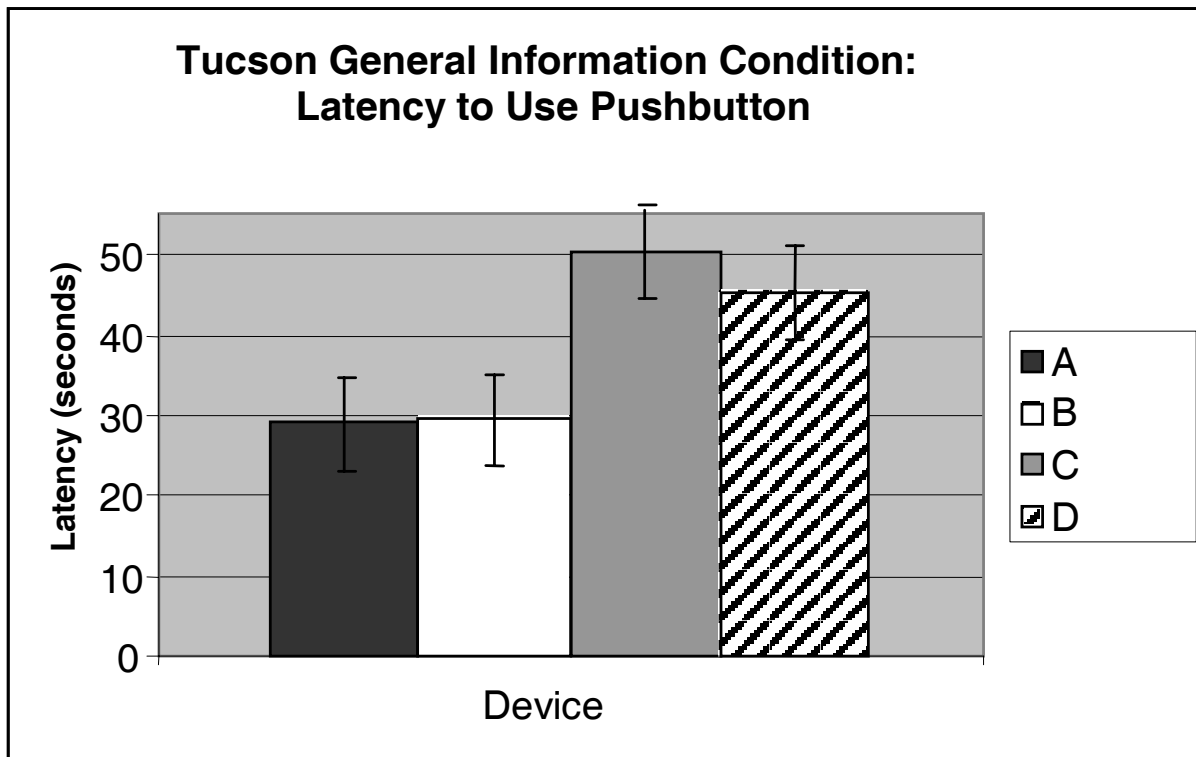
$F(3,57) = 3.560, p < .05, N=20$

Figure 3-5. Latency to use the pushbutton: general information condition – Tucson.

Looking from one Tucson figure to the other, it appears that there is a considerable improvement for the APS C and D buttons between the general information and specific information conditions. For the APS C and D, this does represent a significant improvement ( $t(19) = 2.32, p < .05$ , and  $t(19) = 4.85, p < .001$ , respectively). Furthermore, it appears that the average latency to find the pushbutton has decreased between the general information and specific information blocks. This is statistically confirmed ( $t(19) = 4.147, p < .001$ ) and reveals

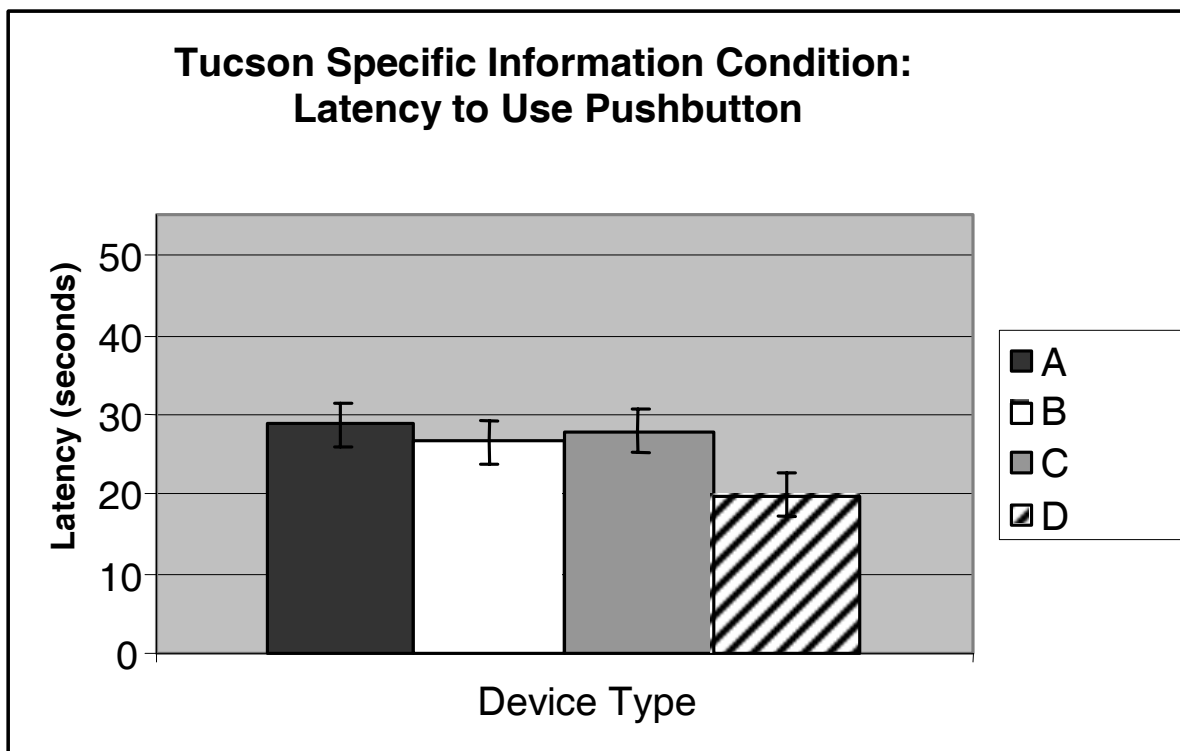
$F(3,57) = 2.106, p > .05, N=20$

Figure 3-6. Latency to use pushbutton: specific information condition – Tucson.

In the specific information condition, the use of median replacement resulted in the replacement of between three and six data points per device, and the ANOVA revealed no significant differences between latencies ( $F(3,57) = 2.106, p > .05$ ). The lack of significance clearly differs from the analysis in the general information condition, and furthermore, a closer look at the means reveals a different pattern than was present in the general information condition as well. With specific information, the means for the APS A, B, and C are very similar, and APS D had a trend towards faster latencies (*see Figure 3-6*).

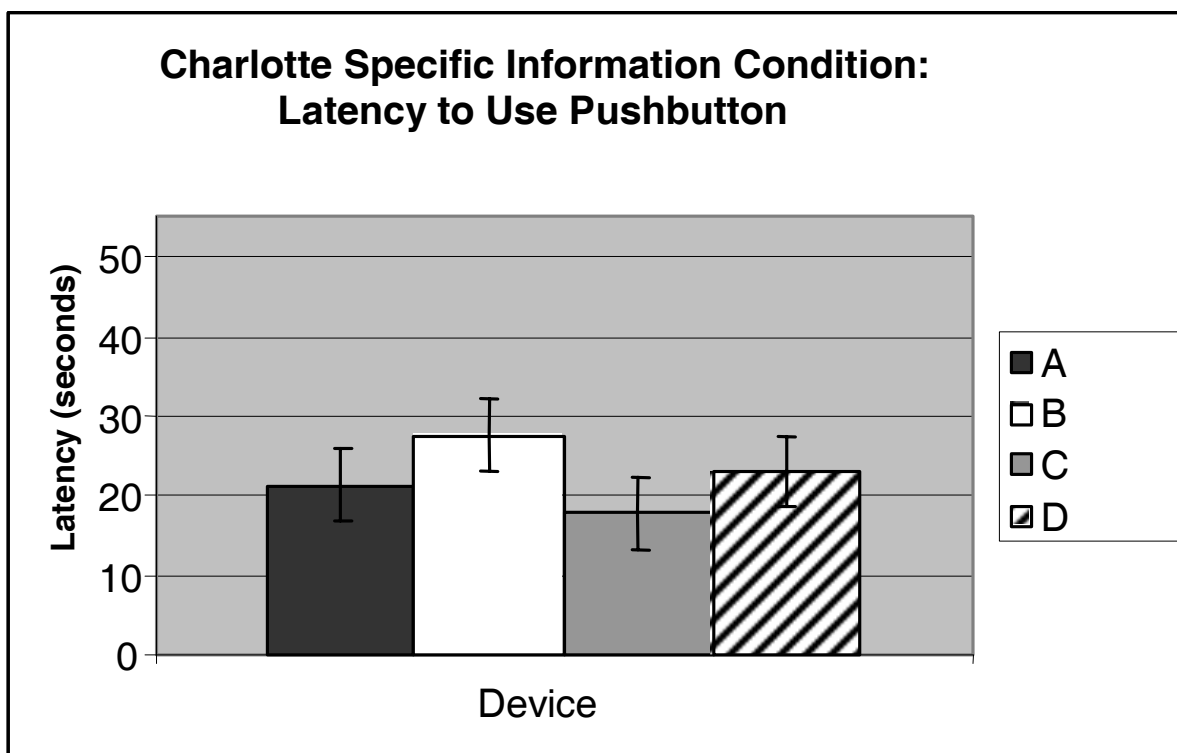
$F(3,57) < 1.00$ ,  $N=20$

Figure 3-7. Latency to use pushbutton: specific information condition – Charlotte.

Analysis of data from the specific information condition required median replacement of up to four missing values per device and revealed no significant differences attributable to device ( $F(3,57) < 1.00$ ) – (see Figure 3-7). The average amount of time to use the pushbutton following

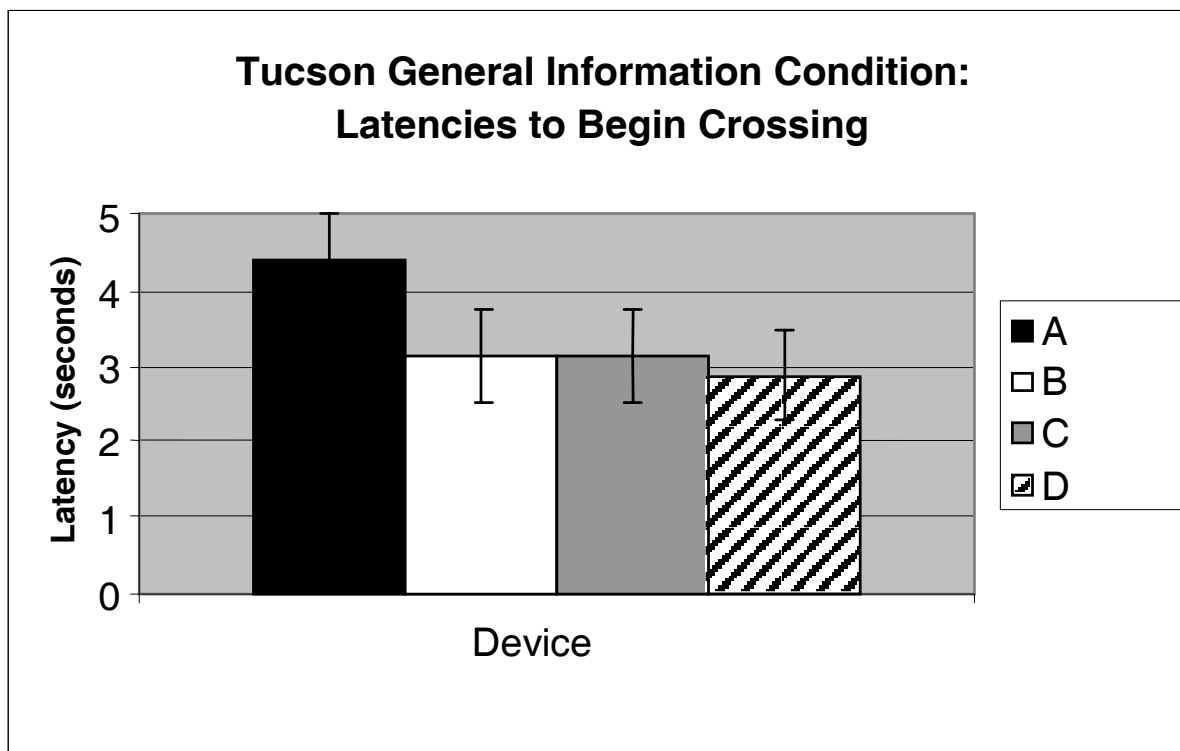
$F(3,18) = 1.390, p > .05, N = 7$

Figure 3-8. Latency to begin crossing by device: general information condition – Tucson.

**Tucson** – Data were not analyzed by device for the no information condition, as there was little use of APS. However, data for the general information condition was analyzed using the presence of audible WALK information at each intersection as the inclusion criterion, which resulted in only seven participants. The overall analysis failed to achieve significance ( $F(3,18) = 1.390, p > .05$ ) – (see Figure 3-8).

Looking back at general information (*see Figure 3-8*), there was a similar trend amongst the means even though there were not significant differences. APS D resulted in the fastest latencies (but keep in mind the large amount of missing data), APS C and B had identical latencies (to a hundredth of a second). The exception was that APS A resulted in the slowest latencies following general information. APS A was the device with pedhead-mounted walk indications and participants may have been momentarily confused by the fact that the WALK signal was coming from a different place than the locator tone. On the other hand, participants in Tucson were somewhat more familiar with cuckoo/cheep pedhead-mounted APS than they were with the other types, since APS having cuckoo/cheep WALK signals are commonly installed there.

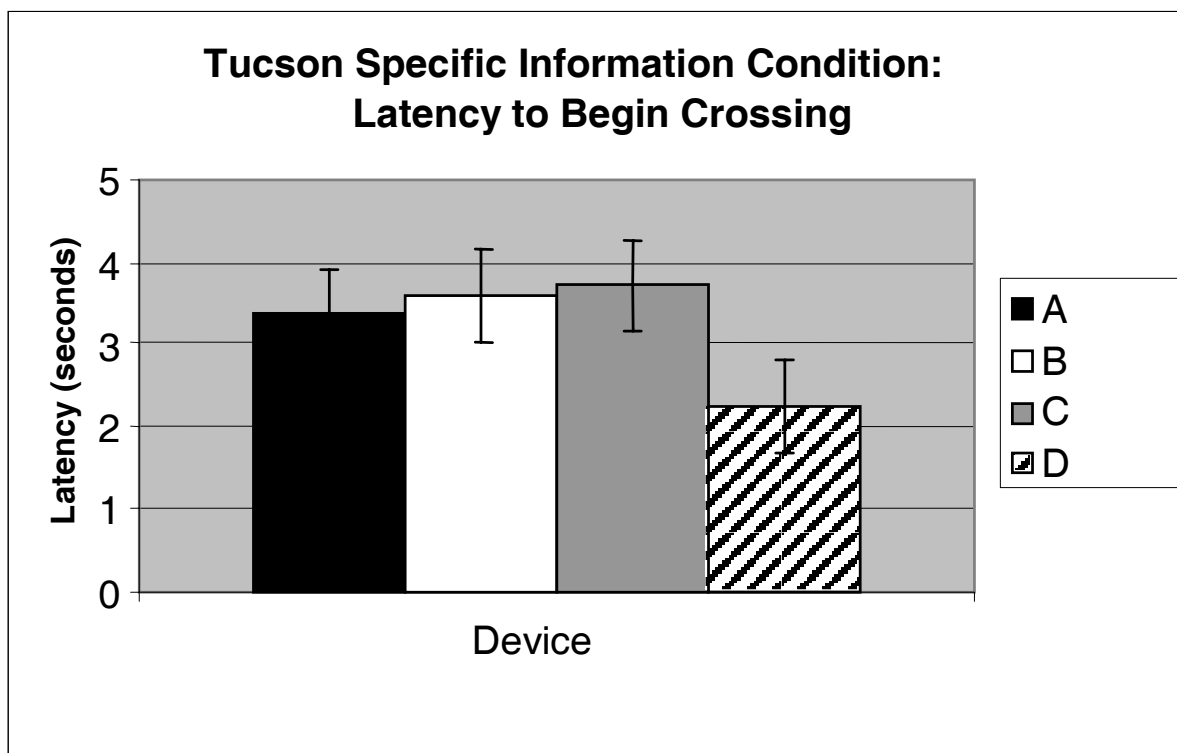
$F(3,48) = 3.466, p < 0.05, N = 17$

Figure 3-9. Latency to begin crossing by device: specific information condition – Tucson.

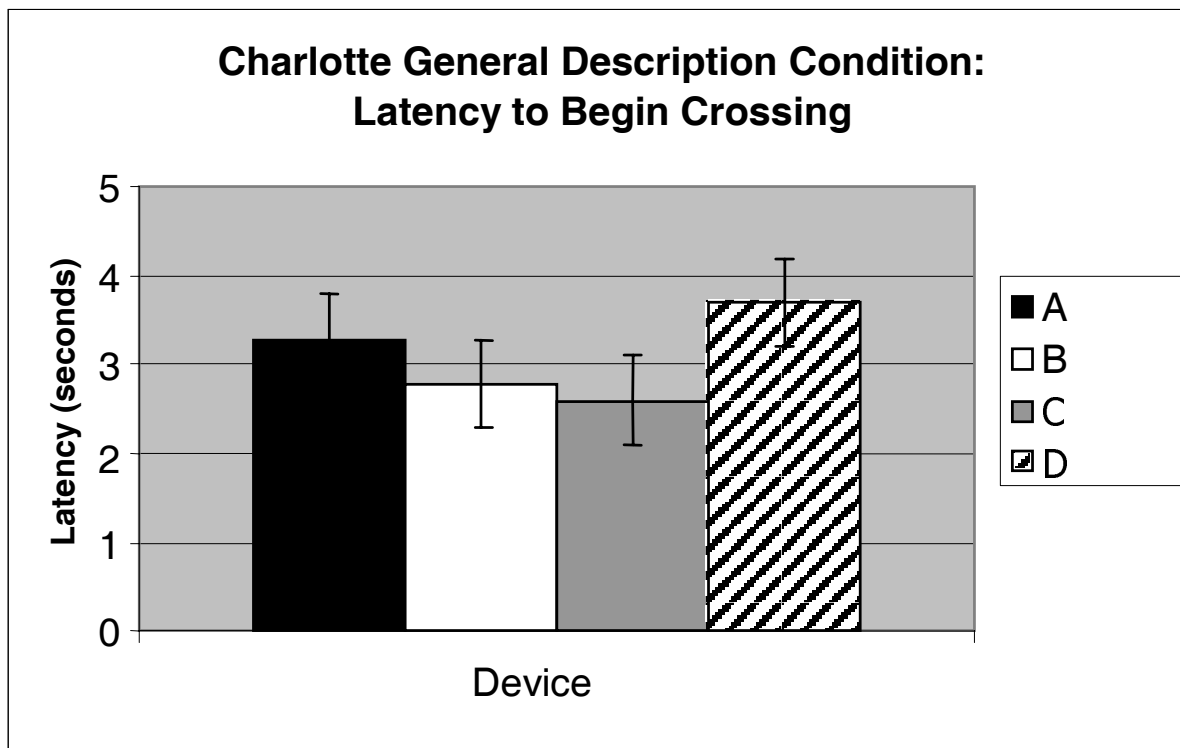
$F(3,27) < 1.00$ ,  $N=10$

Figure 3-10. Latency to begin crossing by device: general description condition – Charlotte.

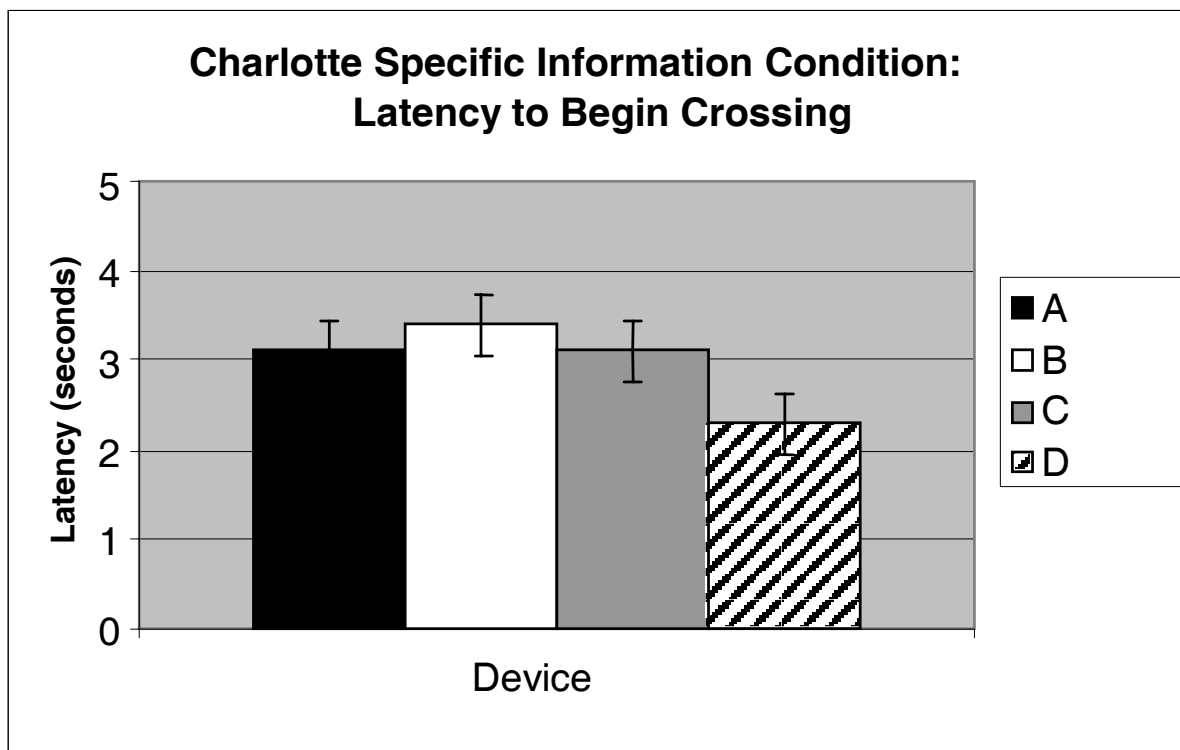
$F(3,51) < 1.00$ ,  $N=18$

Figure 3-11. Latency to begin crossing by device: specific information condition – Charlotte.

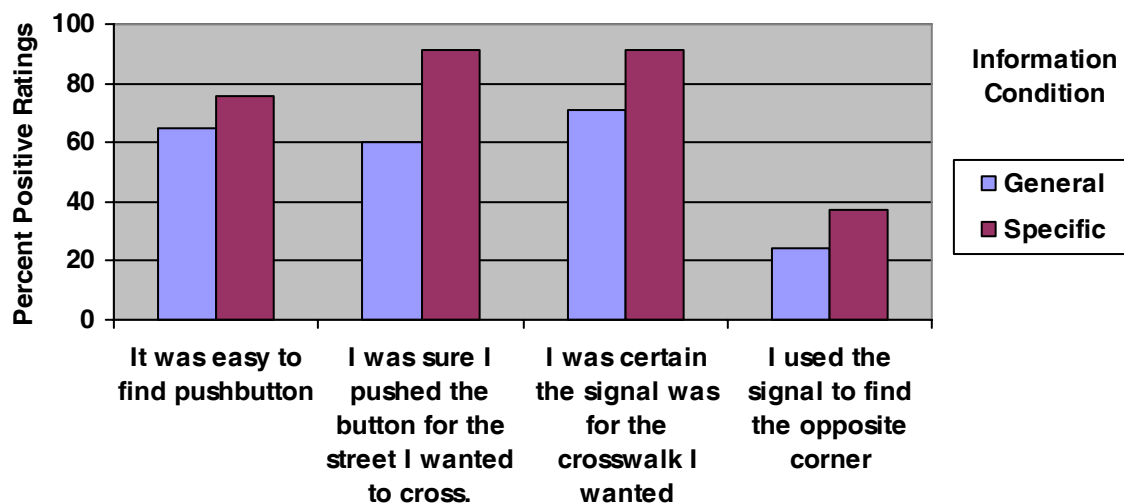
Figure 3-11. Percent of positive ratings (agree or strongly agree with statements) by information condition and statement, collapsing across devices and cities.

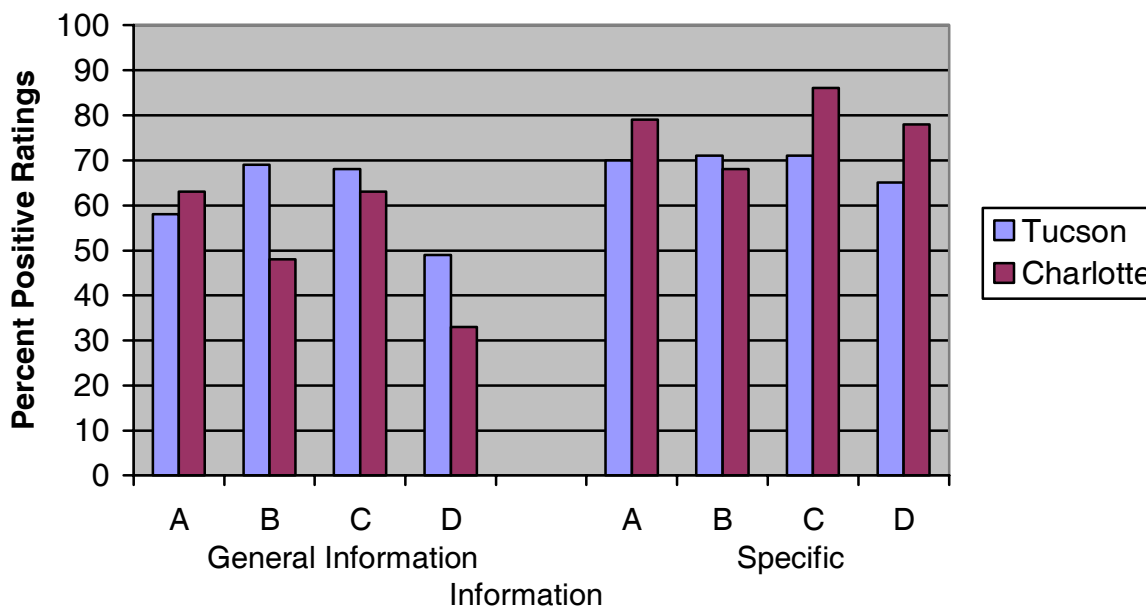
**Figure 3-12. Percentage of positive ratings (agree or strongly agree with statements) by information condition and device.**

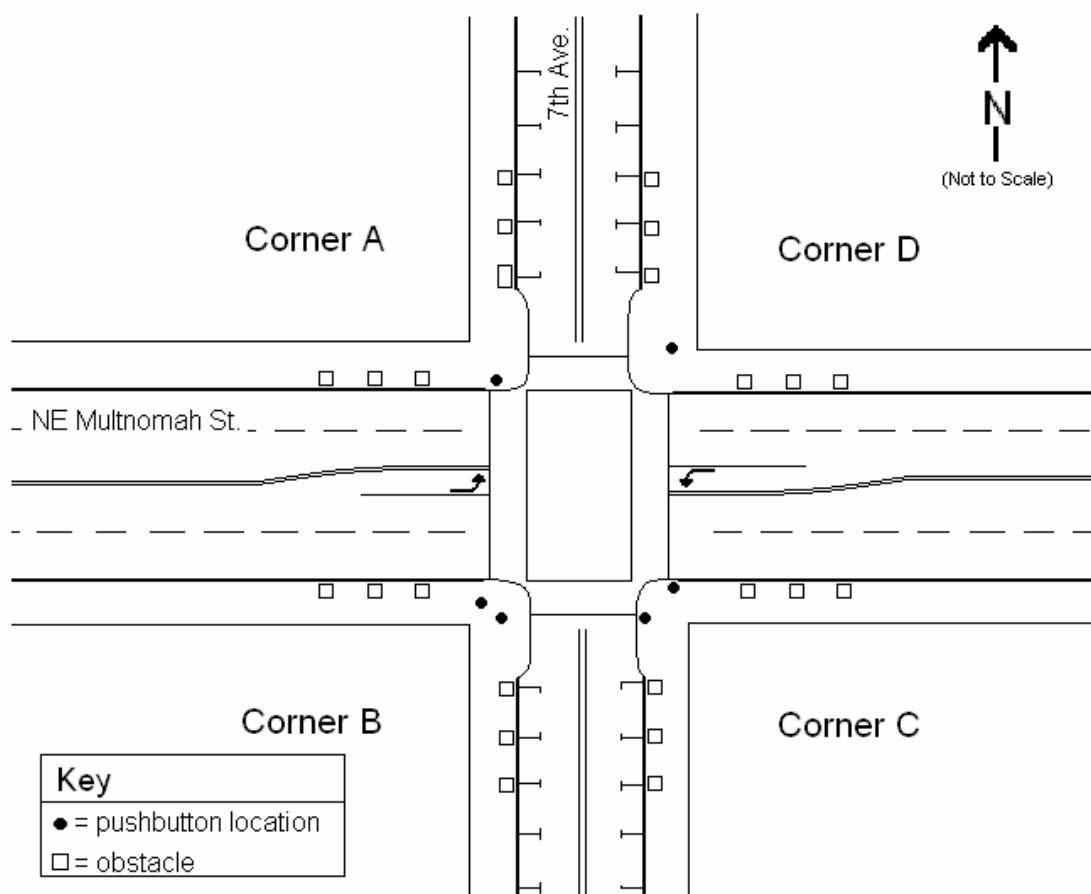
**Figure 4-1. Intersection diagram for NE Multnomah Street and NE Seventh Avenue in Portland, OR.**

Distance of the poles from the street was also varied. On corner A, the pole was installed approximately 3 feet from each street, and on corner D, the pole was installed approximately 10 feet from each street. The same was true for the corners with two pushbutton poles: on corner C, each pole was installed approximately 3 feet from the street, and on corner B, each pole was installed approximately 10 feet from the street.

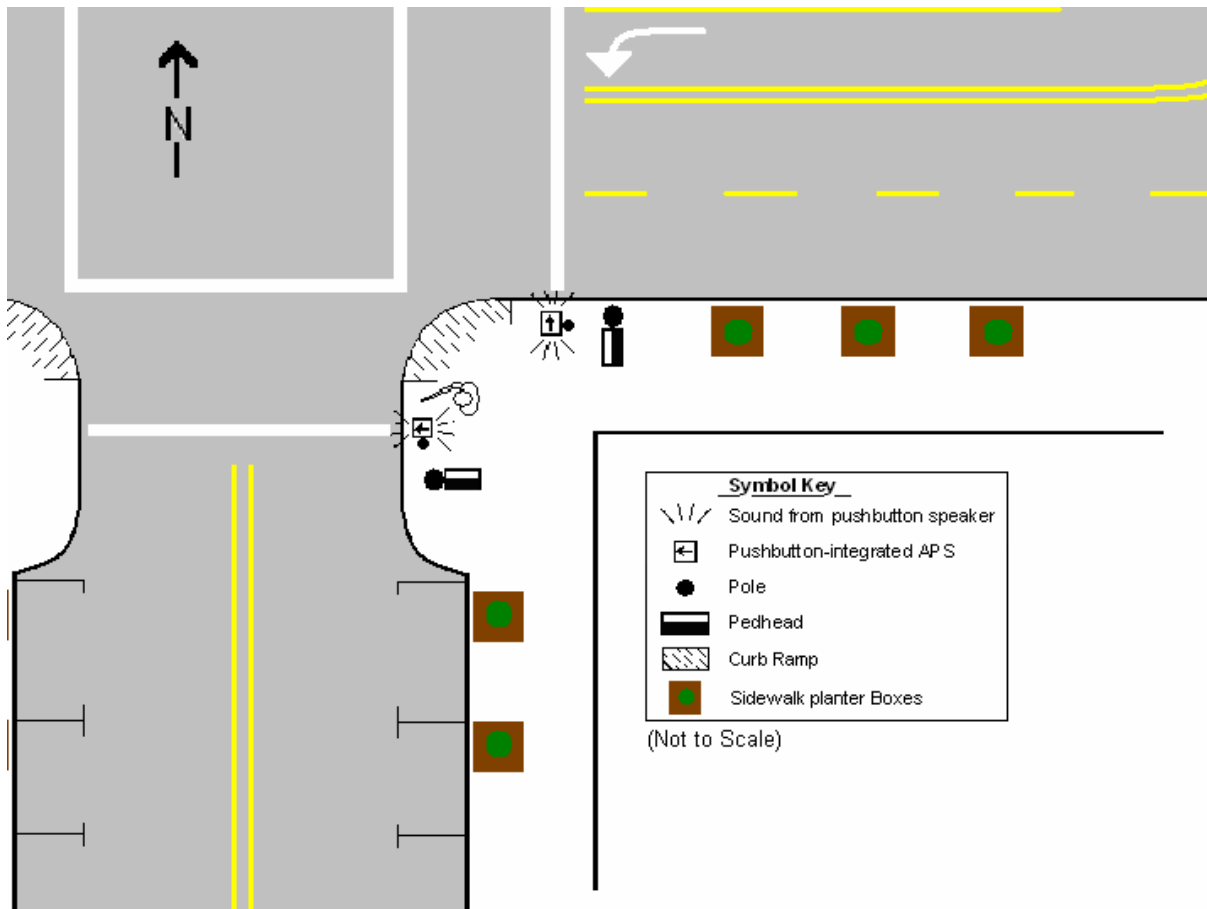
Figure 4-2. Diagram of Corner C (southeast corner of NE Multnomah Street and NE Seventh Avenue in Portland, OR).

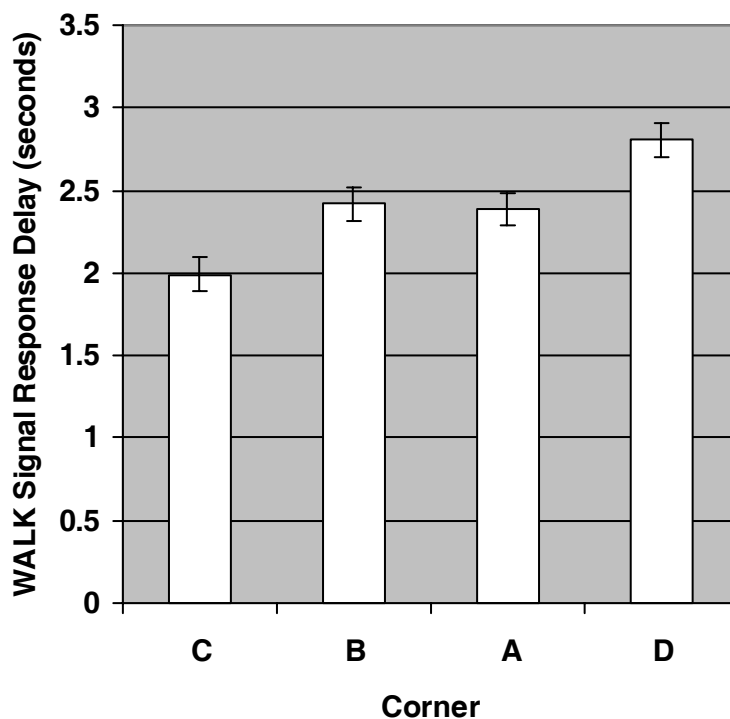
Figure 4-3. Mean WALK signal response delay by corner.

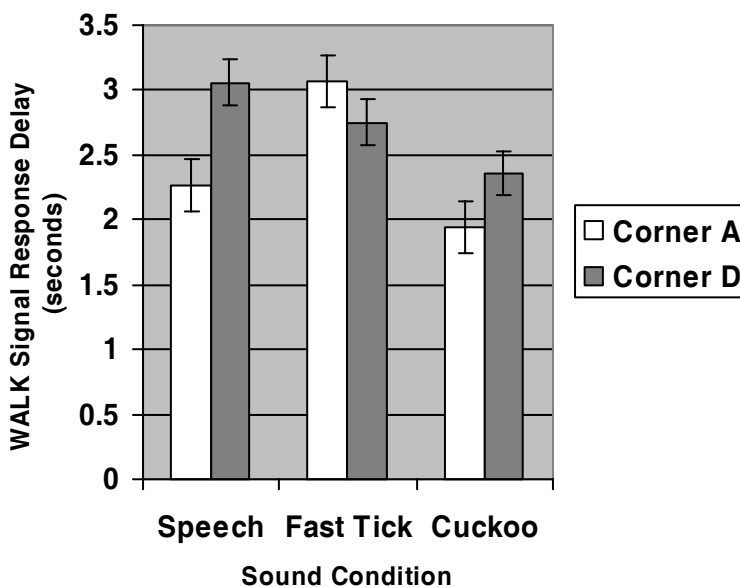
Figure 4-4. Effects of sound condition on WALK signal response delay at corners with two APS on one pole.

than that for the cuckoo WALK signal (1.9 sec, *see Figure 4-4*). This difference did not however achieve significance ( $F(1,29)=1.694$ ,  $p > 0.05$ ). At corner D, the mean response delay for the speech message WALK signal was quite high (3.1 sec) and was slower than the mean response delays for the rapid tick WALK signal (2.7 sec) and for the cuckoo WALK signal (2.4 sec). The speech message WALK signal resulted in significantly slower responses than the cuckoo ( $F(1,29)=6.976$ ,  $p < 0.05$ ), while the difference between response delays for the speech message and the rapid tick failed to reach significance ( $F(1,29)=2.407$ ,  $p > 0.05$ ).

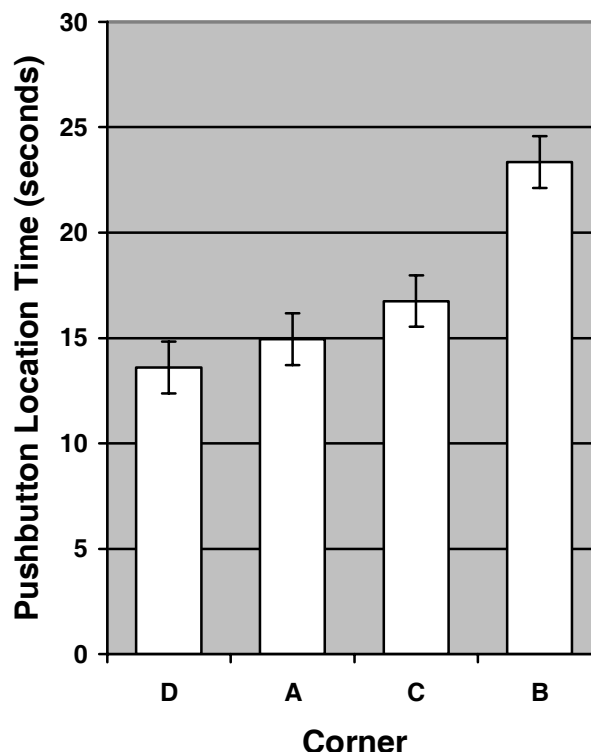
Figure 4-5. Pushbutton Location Time by Corner.

Another factor of particular interest is how quickly blind participants were able to locate and press the appropriate pushbutton given the different APS arrangements at the four corners of the intersection. The pushbutton location times were measured from the time the participant crossed a line that was 20 feet away from the appropriate pushbutton to the time that they pressed the correct pushbutton. Again, when participants were unable to find the correct pushbutton or pressed the incorrect pushbutton and stopped searching for the correct button, no pushbutton location time was recorded. On average, pushbutton location times were fastest at corners D (13.6 seconds) and A (14.95 seconds, *see Figure 4-5*). While the difference between mean pushbutton location time at corners D and A was not statistically significant ( $F(1,29)=2.497$ ,  $p > 0.05$ ), the mean pushbutton location time at corner D was significantly faster than that at corners C ( $F(1,29)=4.838$ ,  $p < 0.05$ ) and B ( $F(1,29)=20.156$ ,  $p < 0.001$ ). The mean pushbutton location time at corner A was significantly faster than that at corner B ( $F(1,29)=13.049$ ,  $p < .01$ ), but was not significantly faster than that at corner C ( $F(1,29)=1.395$ ,  $p > 0.05$ ).

One result of interest was the very large discrepancy in pushbutton location times between northbound approaches to corner C (12.0 seconds), and westbound approaches to the same corner (21.6 seconds). Figure 4-6 clearly shows that the mean pushbutton location time for the northbound approaches to corner C was amongst the fastest across all approaches and corners. Also, the mean pushbutton location time for northbound approaches to corner C was significantly faster than the mean pushbutton location time for westbound approaches to the

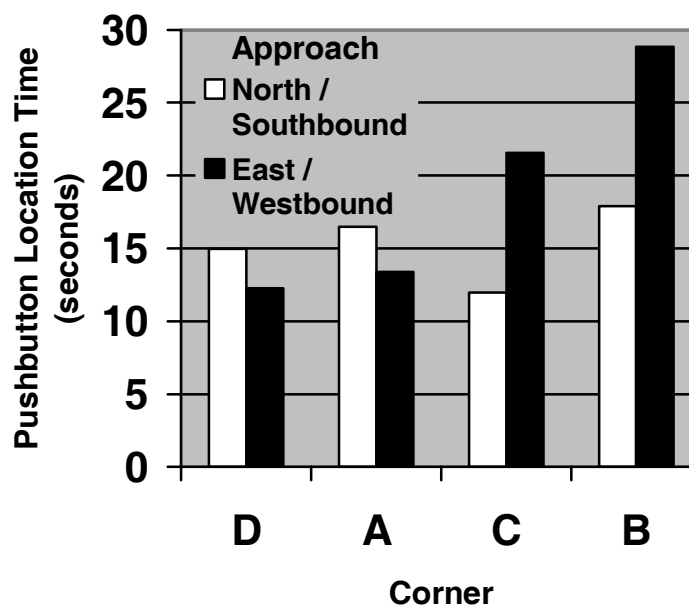
Figure 4-6. Pushbutton Location Time by Corner and Approach.

7.2 seconds due to rounding), and the slowest pushbutton location times were again recorded at corner B (7.7 sec).

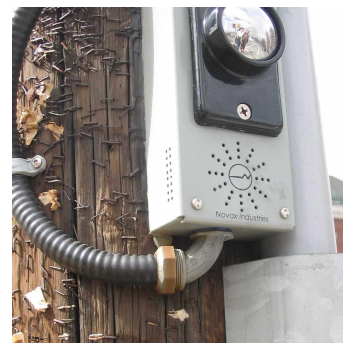
*Figure 5-1. APS mounted on wooden pole.*

The overhead speakers are typically mounted to the pedestrian signal head. Plastic (polycarbonate) signal heads gave problems with breaking when the APS speakers were mounted into them. Strong winds would push on the speaker and crack off the thin plastic of the signal head into which the speaker was mounted. In these cases, the speaker was mounted on the pole or

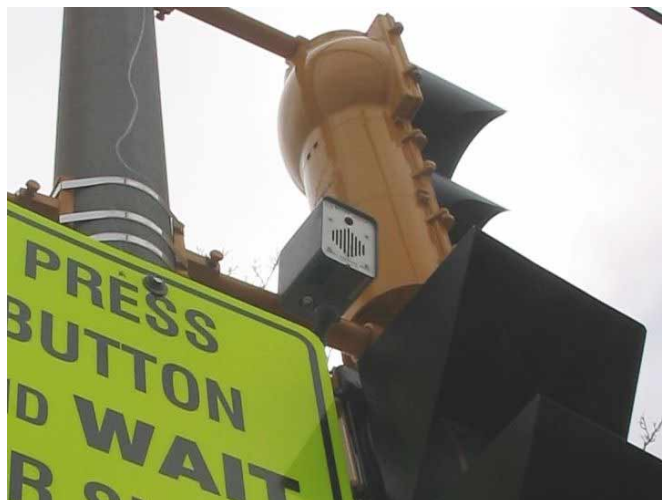
*Figure 5-2. APS overhead speaker mounted on signal head support arm.*

some other metal or wood surface, as shown in Figure 5-2. Pedestrian signal heads made of aluminum did not have this issue. In areas with less of a problem with strong winds, this may not be a concern.

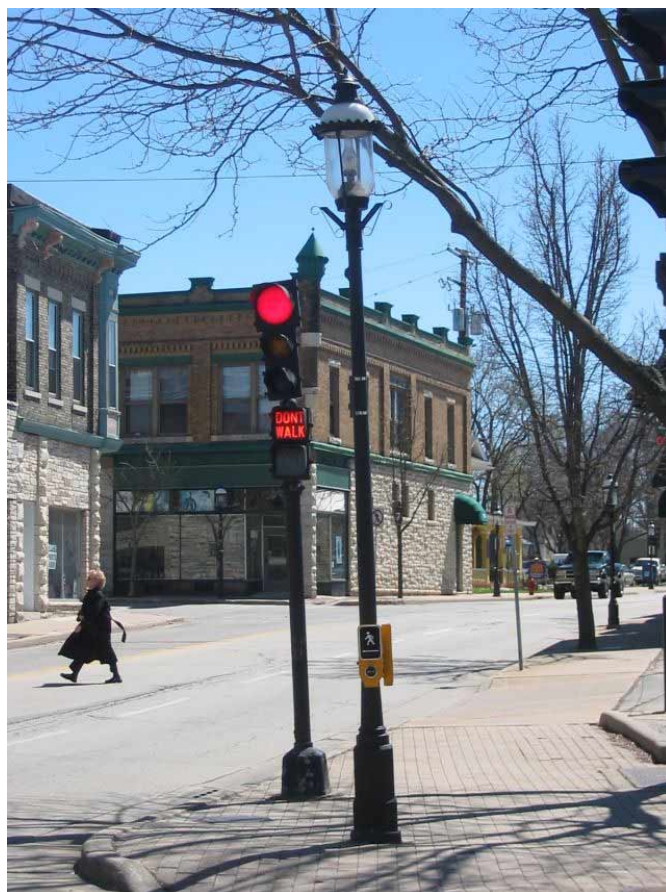
Figure 5-3. APS mounted on lamp post.

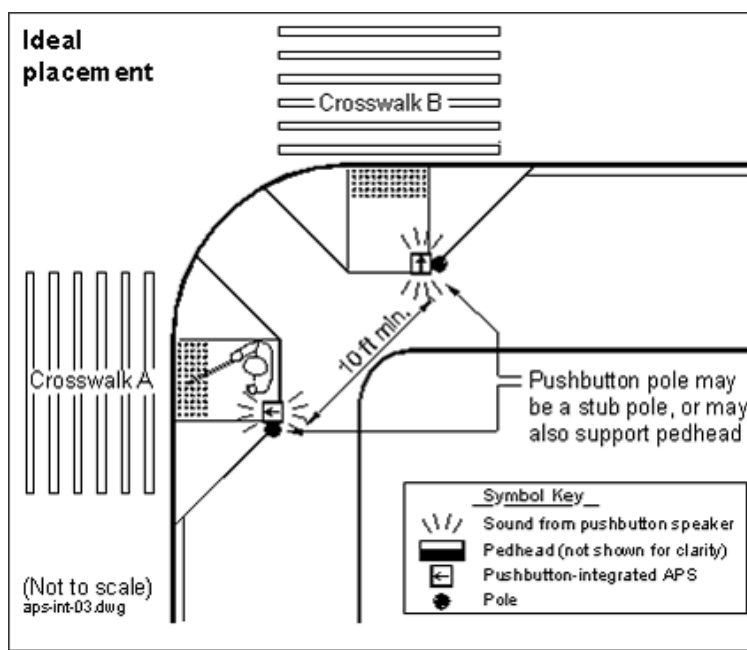
Figure 7-2. Optimal location of pushbutton-integrated APS.

When it is necessary to mount two pushbuttons on one pole, it is recommended that they should be required to use speech message WALK signals rather than tone signals. Moreover, to be sure users know the street name to listen for in the WALK message,

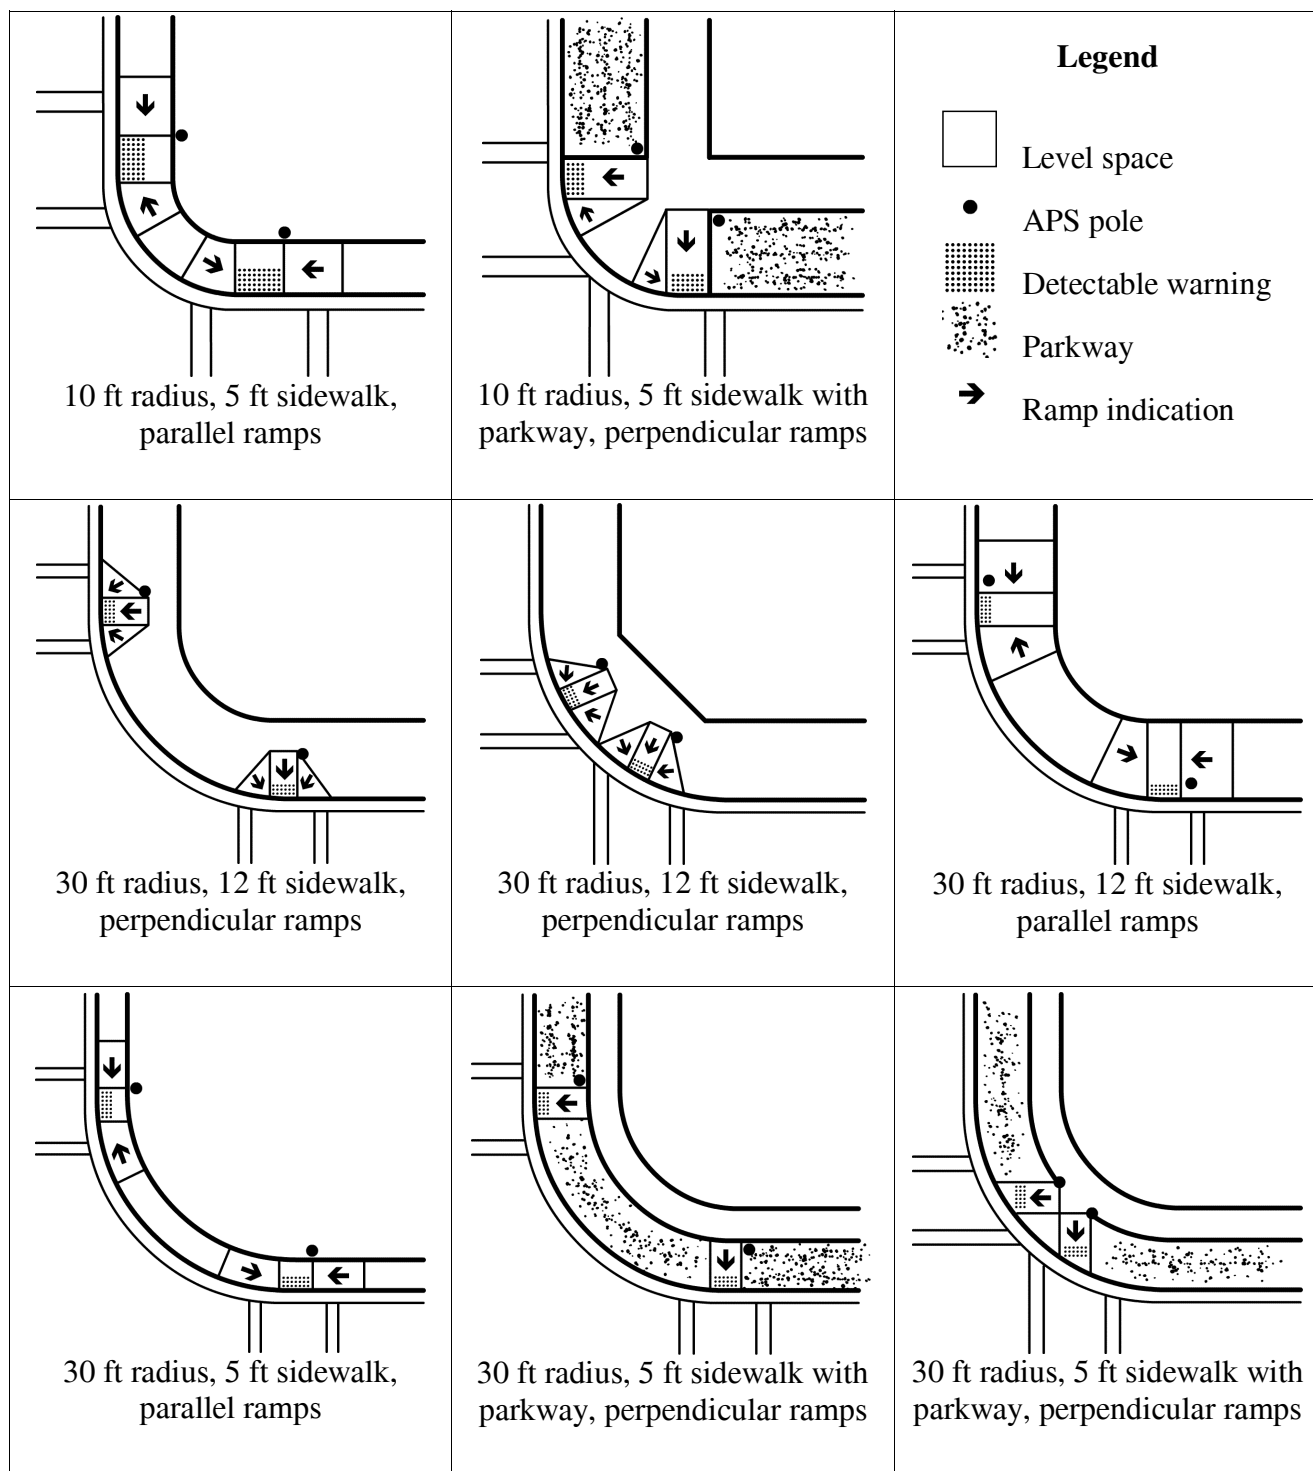
Figure 7-3. Examples of locations for pushbutton-integrated APS on corners having various geometries.
