SHRP-C/FR-91-101

# **Handbook For The Identification Of Alkali-Silica Reactivity In Highway Structures**

David Stark  
Construction Technology Laboratories, Inc.  
Skokie, Illinois

**Strategic Highway Research Program**  
National Research Council  
Washington, D.C. 1991

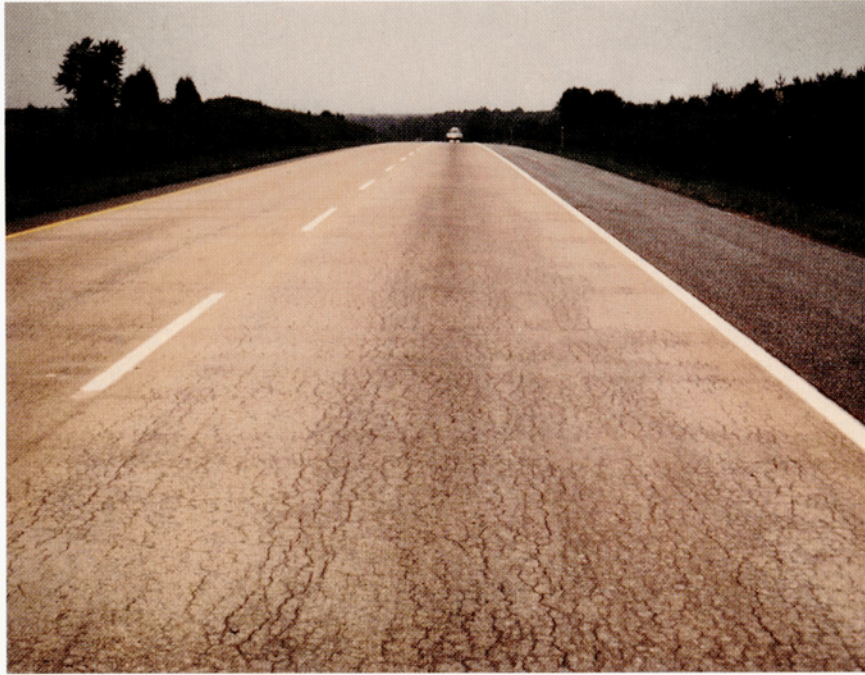
**Fig. 3** - A well-defined crack pattern associated with the development of **ASR** in highway pavement. Crack pattern is commonly identified as "map-cracking" or "pattern-cracking." Orientation of predominant cracks is longitudinal, as shown. Crack pattern is generally developed uniformly across the width of the pavement, although cracks in wheelpaths may be more apparent due to infiltration of dirt and apparent greater width due to crumbling of crack edges. Both result from traffic wear. The crack pattern is similar for jointed and continuously reinforced pavement.

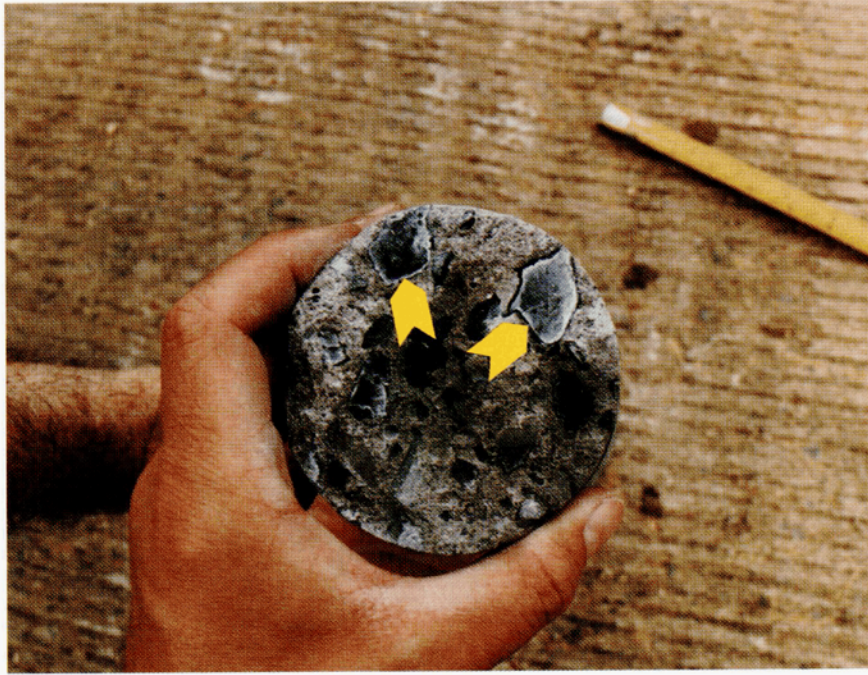
**Fig. 11** - Fracture surface of 4-in. diameter core from pavement where **ASR** has developed. Note white deposit in several dark coarse aggregate particles, with particular buildup along periphery of particles. This deposit contains **ASR** gel reaction product that is characteristic of reacted particles (arrows).

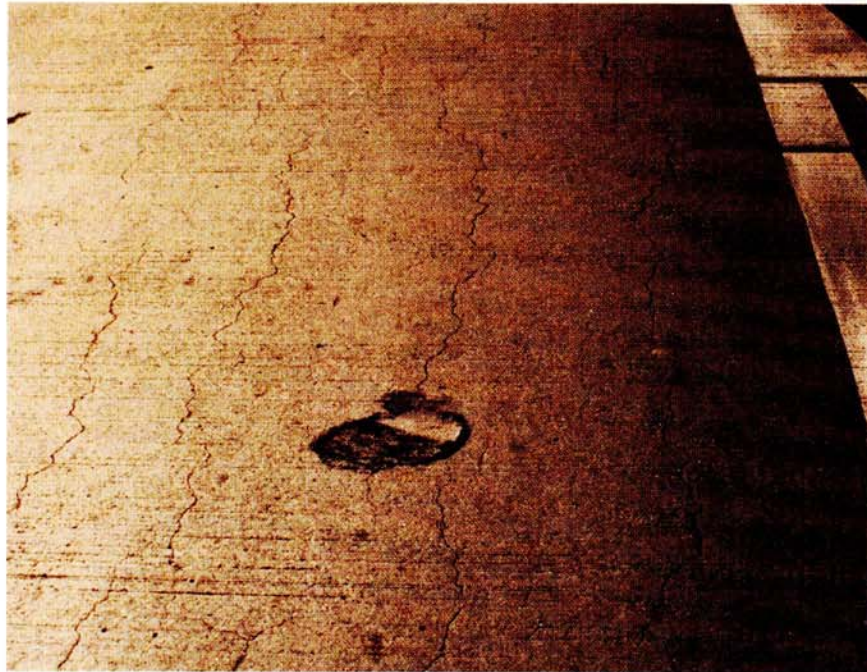
**Fig. 13** - Cracking associated with **ASR** at mid-span in bridge deck. Predominant cracks are oriented longitudinally with respect to deck (top to bottom in photo), and are interconnected by short, tight microcracks that extend transversely or randomly between longitudinal cracks. Cracking may be more severe over girders. No consistent relationship exists between location of cracks and steel in top reinforcing mat.

**Fig. 14** - Characteristic cracking associated with **ASR** in corner of bridge deck. Cracks tend to "curve" around corner from transverse orientation at end of deck to longitudinal orientation toward middle of span (see Fig. 13). End of deck is along tarred strip at bottom of photo.

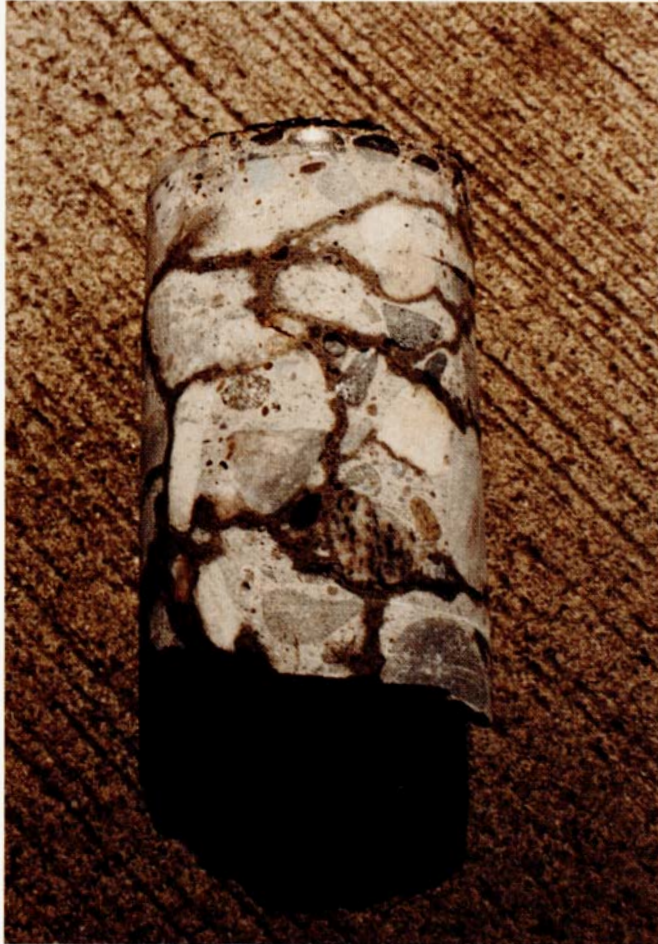
**Fig. 15** - 4-in. diameter core taken from area of bridge deck shown in Fig. 14. Major cracking occurs full-depth in the core and is enhanced by partial drying. Dark bands follow cracks that still contain water. Initiation of cracking is attributed to ASR. Restraint by reinforcing steel to volume change may have influenced crack pattern.

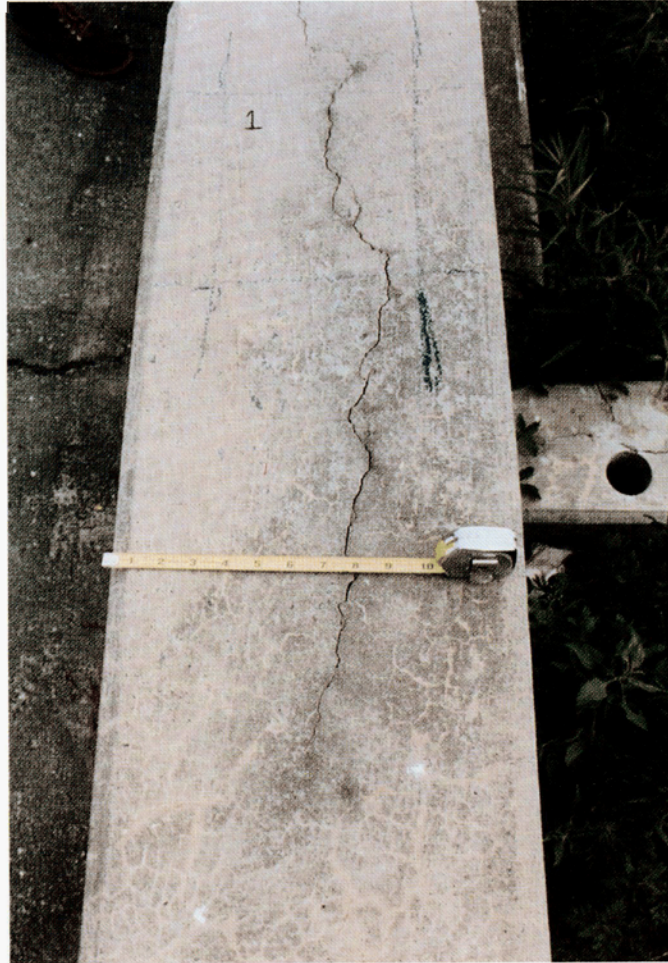
**Fig. 16** - Longitudinal crack, along top of parapet wall, associated with **ASR**. Other, much finer cracks form network of cracking on top surface. Such cracking could be attributed to drying shrinkage or corrosion of embedded steel. Corroborating evidence is necessary to verify association of **ASR** with cracking.

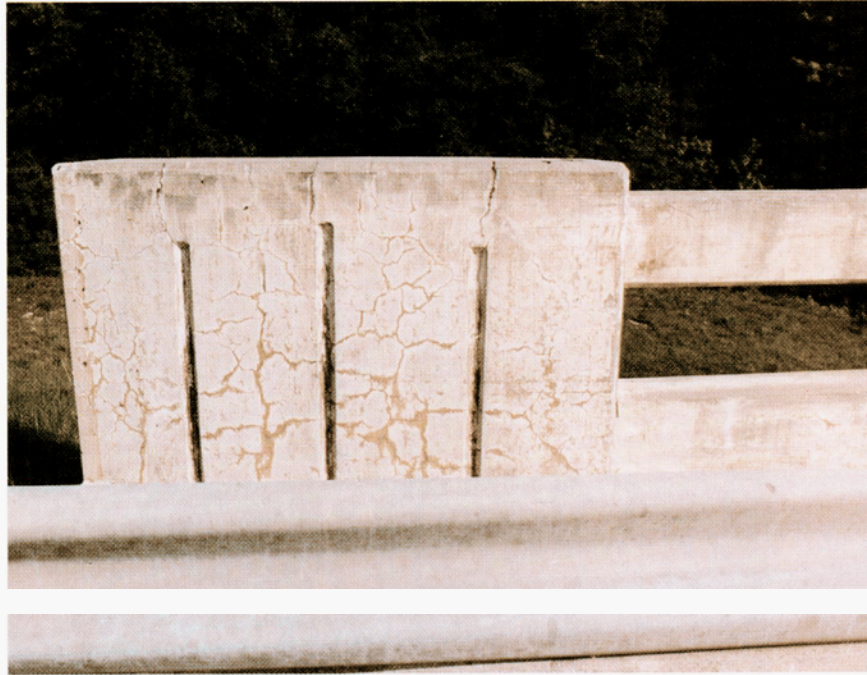
**Fig. 17** - Cracking associated with ASR in end block of concrete guard rail on bridge deck. This type of cracking could result from freezing and thawing. In essentially frost-free climates, ASR is the likely cause of cracking. Individual cracks are stained and filled with calcium carbonate and ASR gel. Evidence of overall abnormal expansion due to ASR may not be apparent in such concrete units. Do not interpret this type of cracking as confirming evidence of ASR in areas of freezing and thawing.

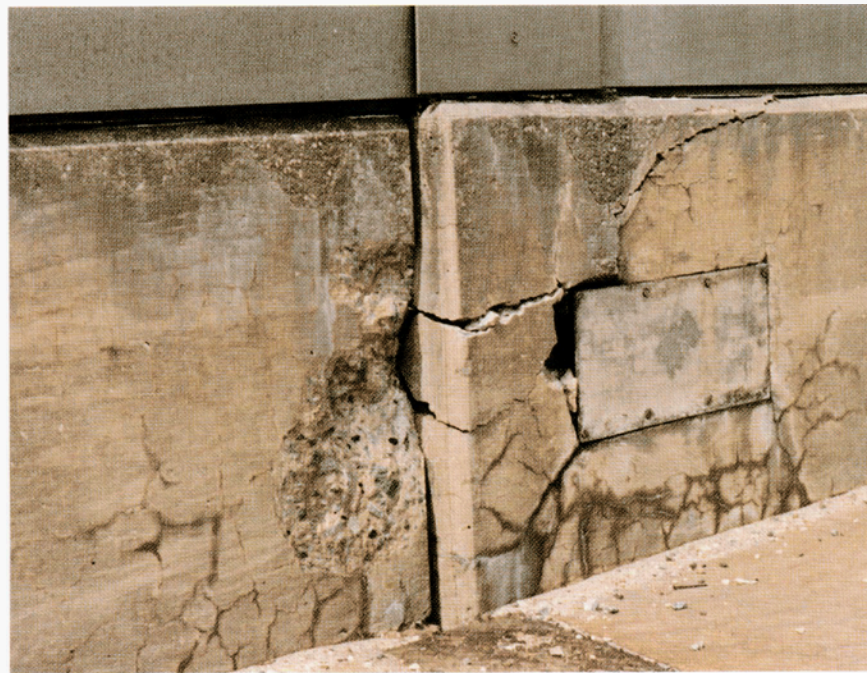
**Fig. 18** - Cracking and differential movement of abutting sections of parapet wall in bridge structure affected by ASR. Joint is tightly closed and lateral offset has occurred. Cracking and spalling have developed on left side of joint, and cracking and incipient spalling have developed around embedded metal plate on right side. In such cases confirmation should be made that distress has not resulted from other factors, such as foundation movements, freezing and thawing, or vehicle impact.

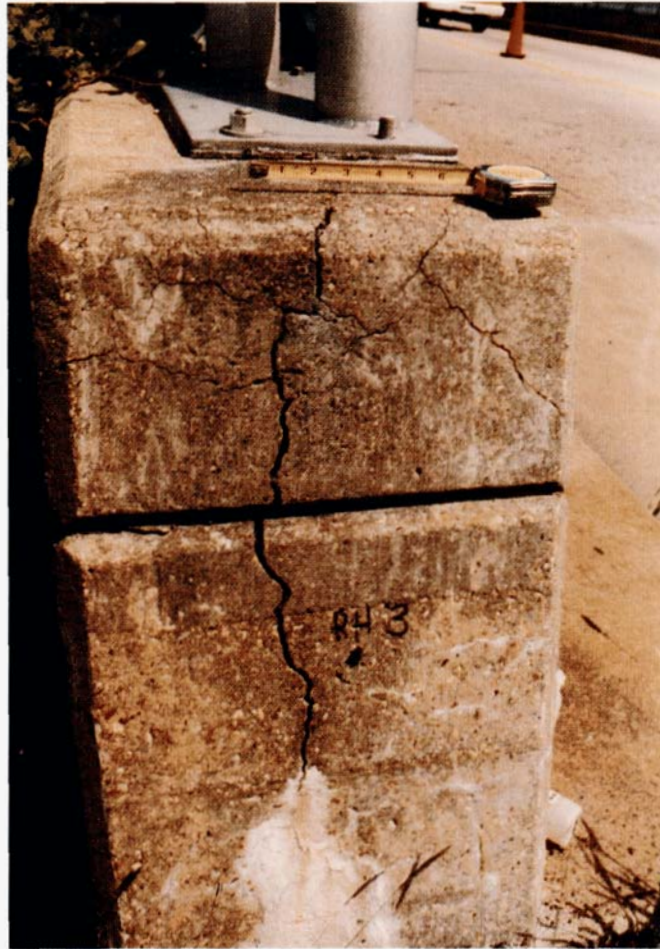
**Fig. 19** - Major vertical crack with less prominent horizontal and random cracks in end of parapet wall. White deposit at base is mixture of **ASR** gel and calcium carbonate. This evidence is typical of advanced stages of **ASR**. However, such deposits most commonly consist of calcium carbonate, which is not indicative of **ASR**. Presence of **ASR** gel must be confirmed in other ways.

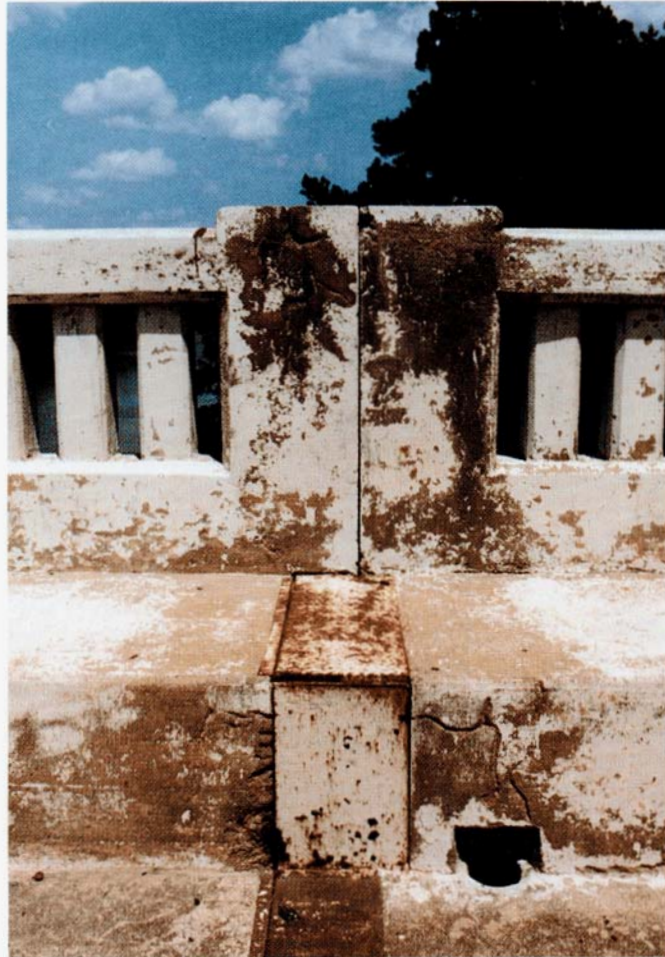
Fig. 20 - Closed joint between sections of parapet wall may have resulted from expansion due to ASR, as shown. Inspection should be made to determine if a foundation shift may have caused a tight joint. Such evidence should be used only as supporting evidence of ASR unless indicated otherwise.

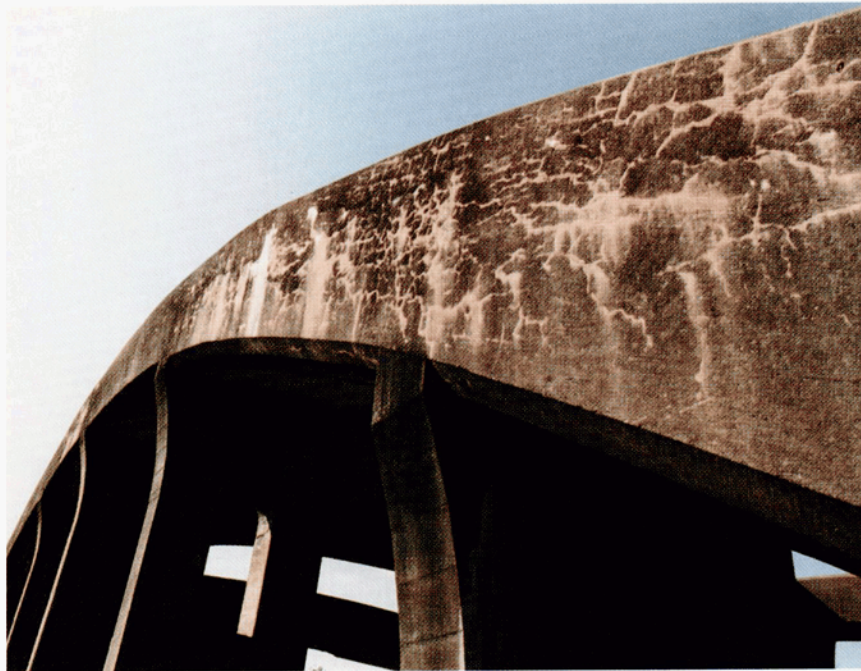
**Fig. 22** - Cracking in top cord of concrete arch bridge. White deposits of **ASR** gel and calcium carbonate exude from cracks. Such cracking might also develop from freezing and thawing, and the white deposits may or may not contain **ASR** gel. In frost-free climates, **ASR** is the most probable cause of the cracking but corroborating evidence should be obtained to confirm its development.

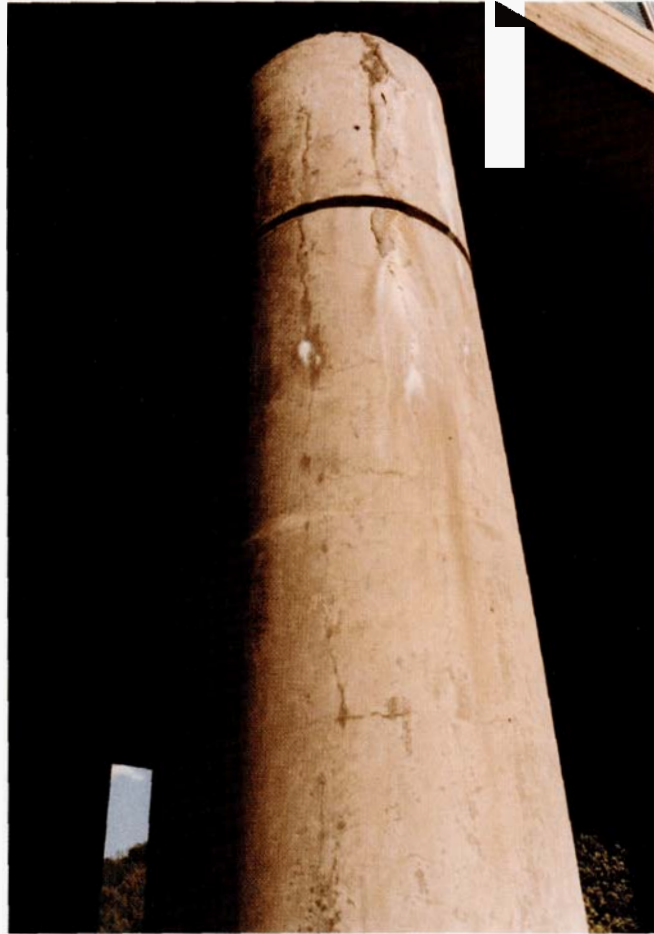
**Fig. 23** - Bridge column showing cracking associated with **ASR**. Predominant cracks are oriented longitudinally, but are interconnected in irregular pattern by short transverse cracks and by fine random microcracks. White deposits on column contain **ASR** gel.

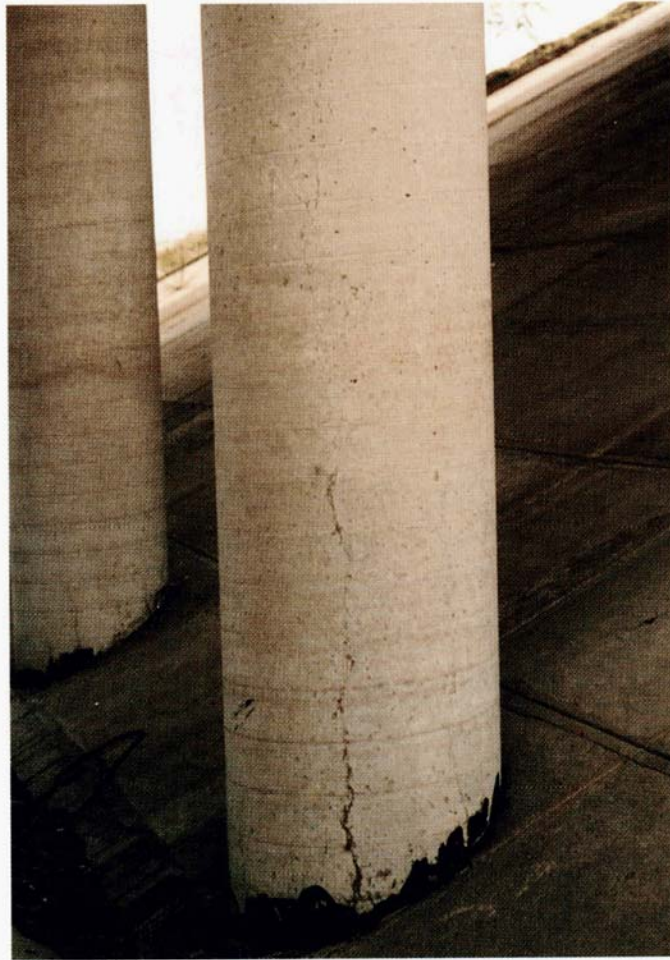
**Fig. 24** - Bridge columns showing longitudinal crack at base near sloped concrete surface of bridge embankment. This cracking could be due to **ASR** or, for example, to corrosion of embedded reinforcing steel. Further investigation, including microscopic examination of concrete is necessary to confirm causes. In this **case**, **ASR** has developed in the concrete.

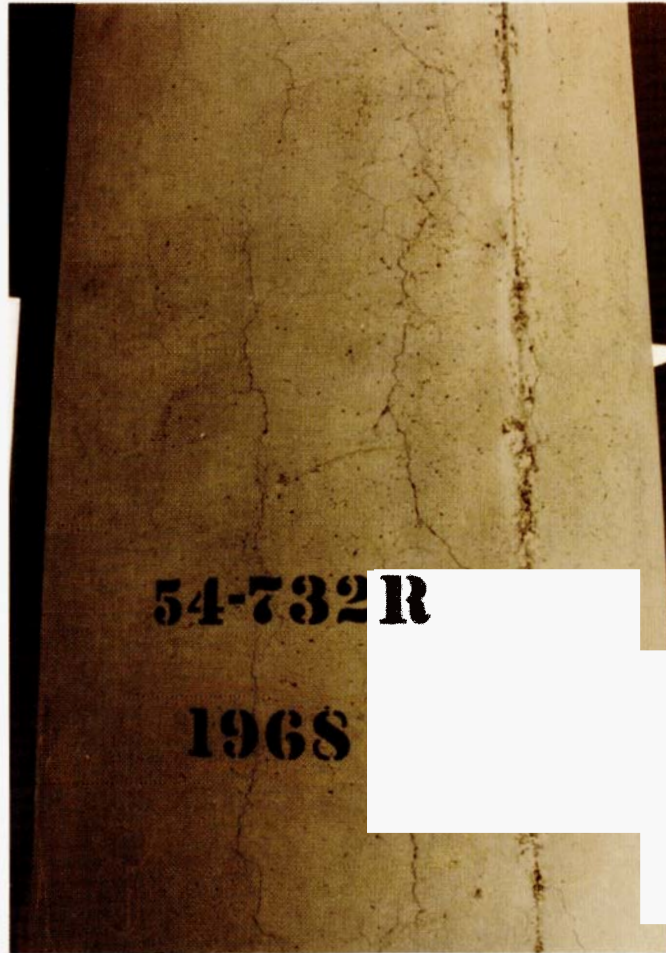
**Fig. 25** - Cracking associated with ASR in bridge column. Predominant cracks are oriented longitudinally in column, and are interconnected by short transverse and random cracks. Longitudinal cracks occasionally develop at regular spacings, possibly controlled by location of embedded vertical reinforcing steel. Drying shrinkage has probably enlarged cracks.

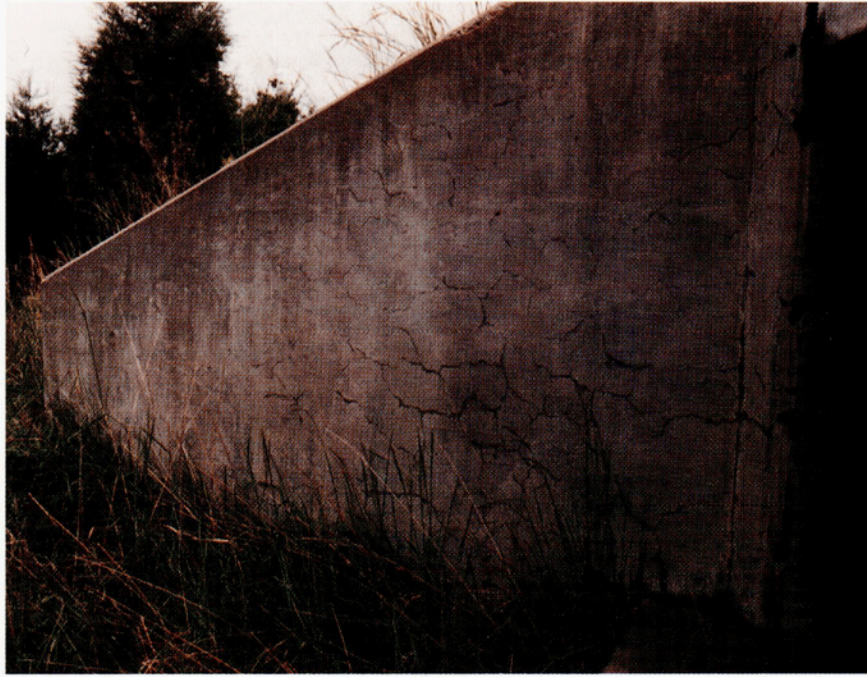
**Fig. 27** - Cracking associated with **ASR** in wingwall of bridge structure. Major cracks tend to show subhorizontal orientation, and are more strongly developed at lower levels. Cracking of this type also may result from frost action and must be corroborated with other evidence to positively assign **ASR** as a cause. In climates that are essentially frost-free, **ASR** is a probable cause.

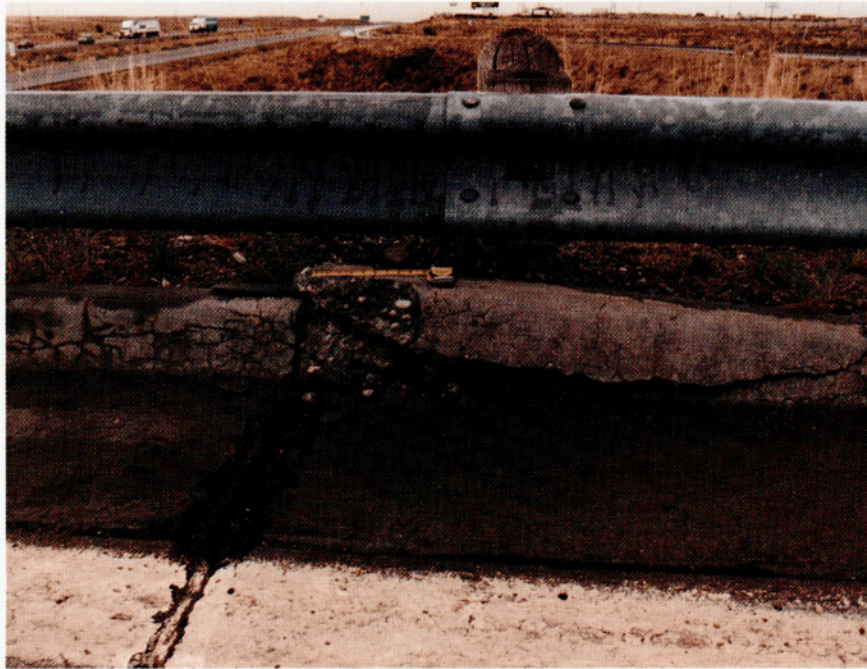
**Fig. 28** - Curb section bordering approach slab to bridge structure. Curb shows distress due to **ASR**. Displaced wedge-shaped curb section shows uplift from original position. Longitudinal and fine random cracks are typical of distress due to **ASR**, but uplift may have resulted from other causes, such as shifting of entire approach slab. Use such observations only as possible evidence of **ASR**.
