SHRP-S-405

Sprayed Zinc Galvanic Anodes for Concrete Marine Bridge Substructures

Strategic Highway Research Program
National Research Council
Washington, DC 1994

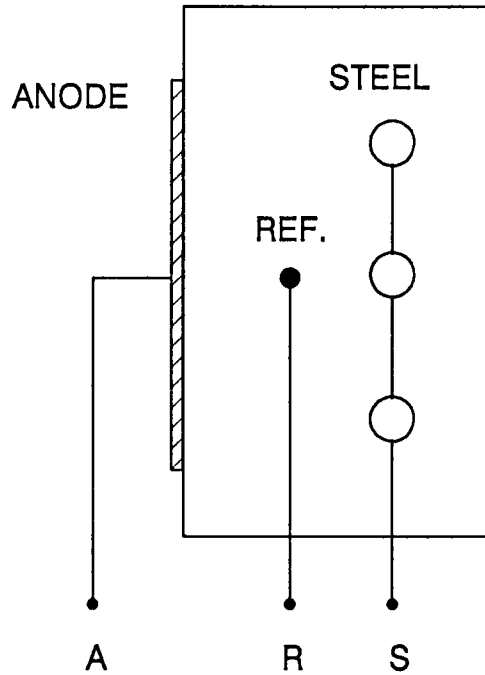
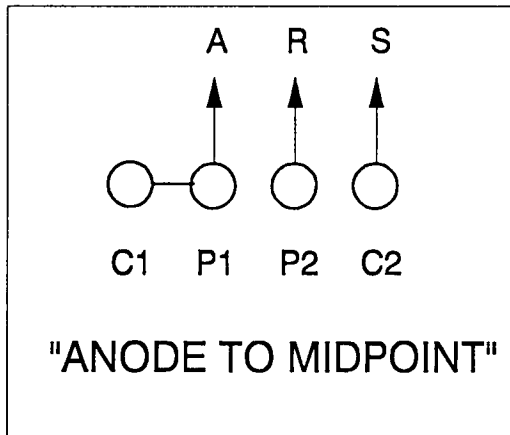
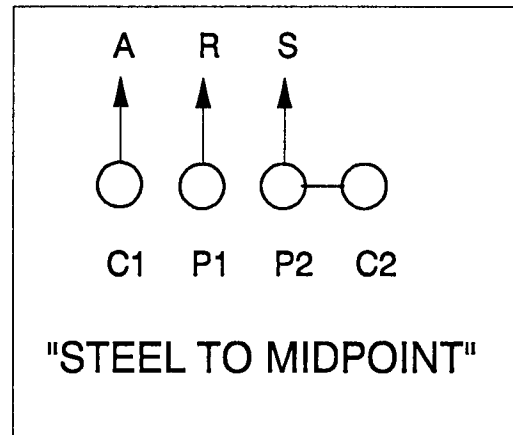
Figure 2.2 Connections of soil resistance meter used to measure "anode to midpoint" and "steel to midpoint" resistances. C1, C2 and P1, P2 designate current and potential terminals respectively of the Nilsson 400 meter.

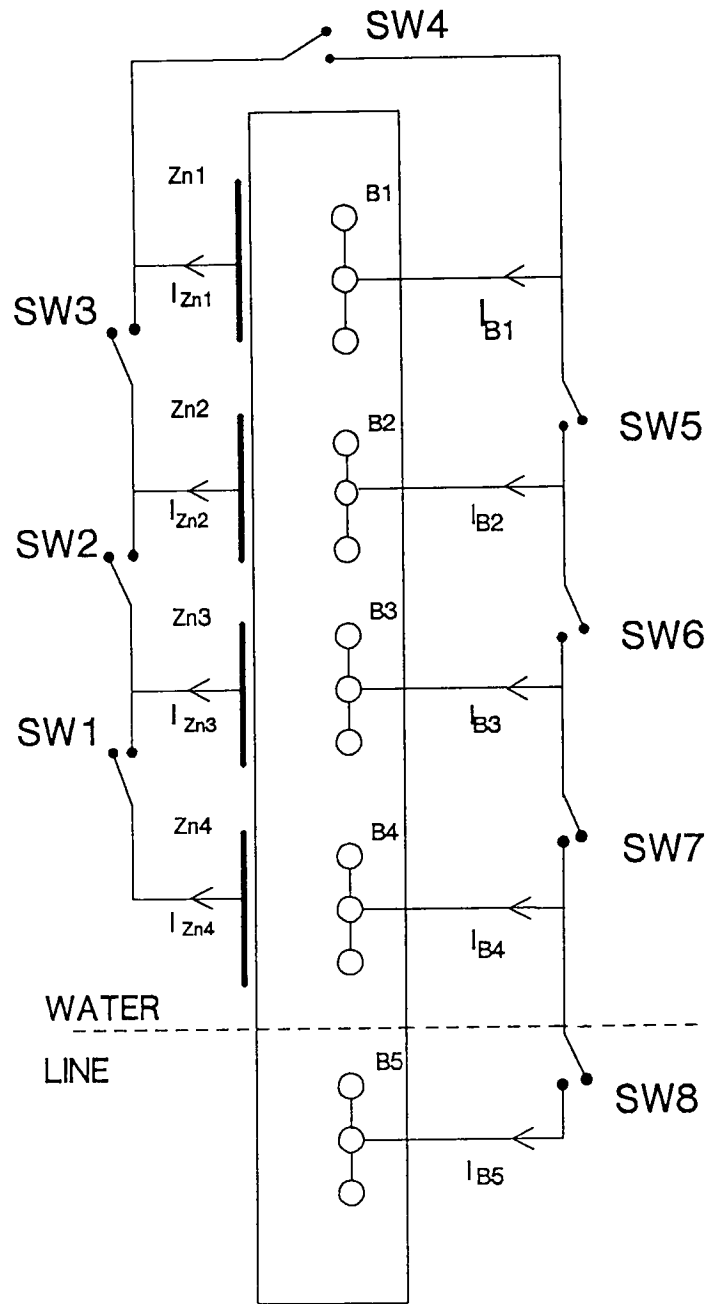
Figure 2.4 Schematic connection of the instrumented test columns. Electronic currents flowing in the direction of the arrows are defined as positive.

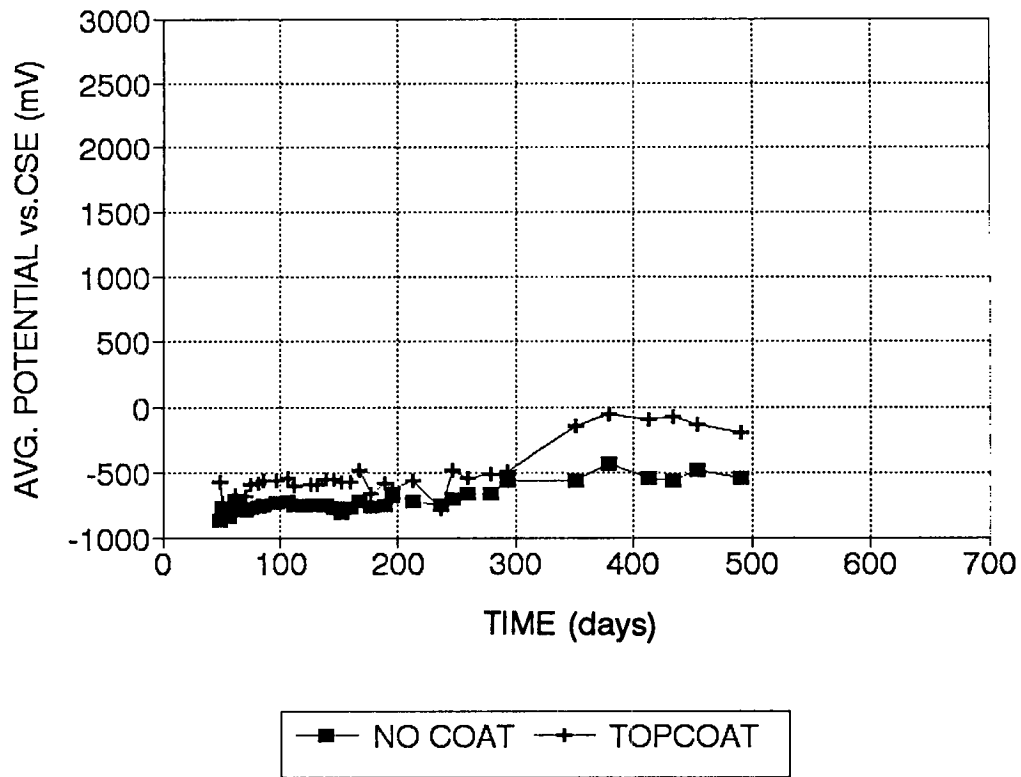
Figure 4.8 Average instant-off potential of the 85% Zn-15% Al anode of the 1 mA/ft² (1.1 μA/cm²) impressed current Type A3 and Type A4 (dual anode uncoated and coated, respectively) test specimens in the 85% relative humidity environment as a function of exposure time

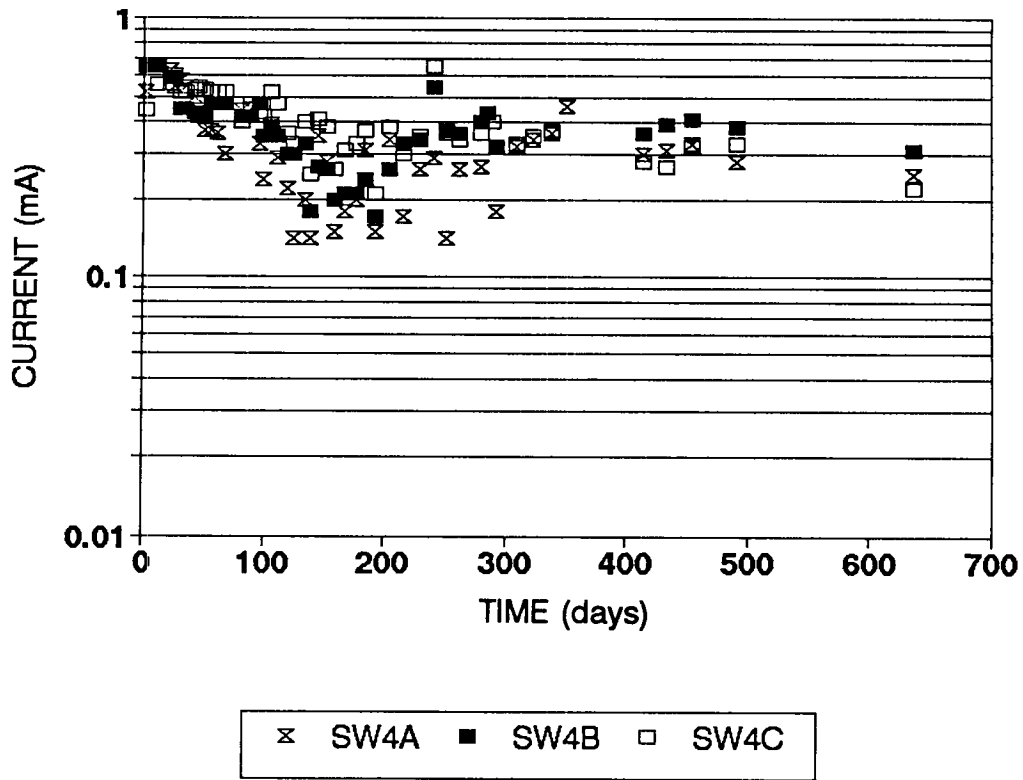
Figure 4.20 Current from all anodes for columns A, B, and C as a function of exposure time

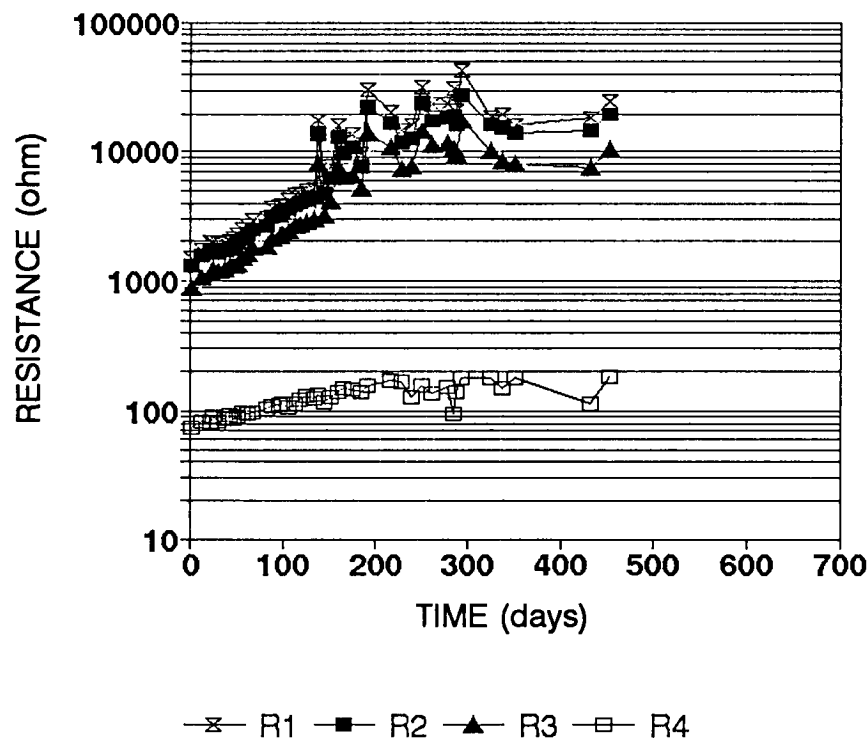
Figure 4.25 Average resistance between each anode and the corresponding steel bars as a function of exposure time. R1 to R4 correspond to zones 1 to 4, per Figure 2.4.
