SHRP-S-671

New Cathodic Protection Installations

Strategic Highway Research Program
National Research Council
Washington, DC 1993

**Evaluation Report on The
Repair and Rehabilitation of
Gandy Bridge, Tampa, Florida**

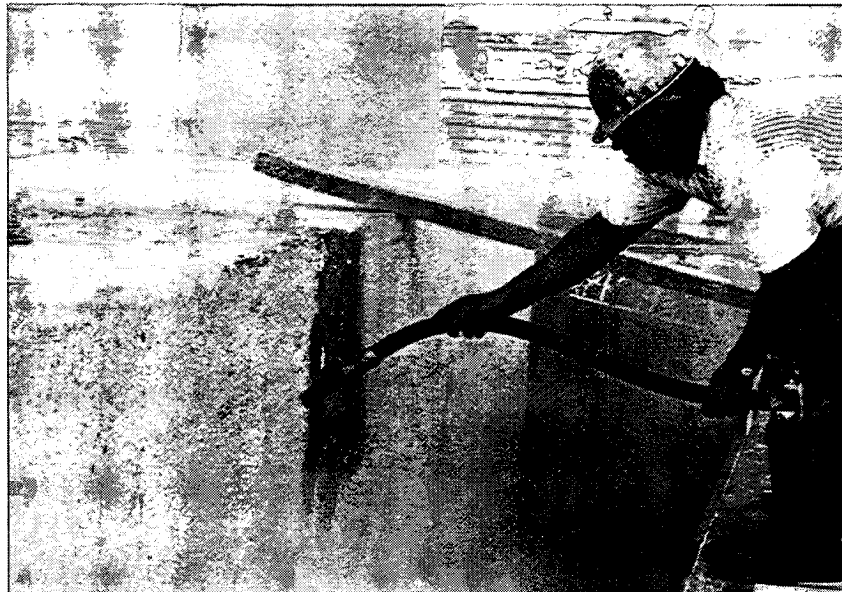
Figure 1. Installation and Activation of Anode

Sandblasting
in Progress

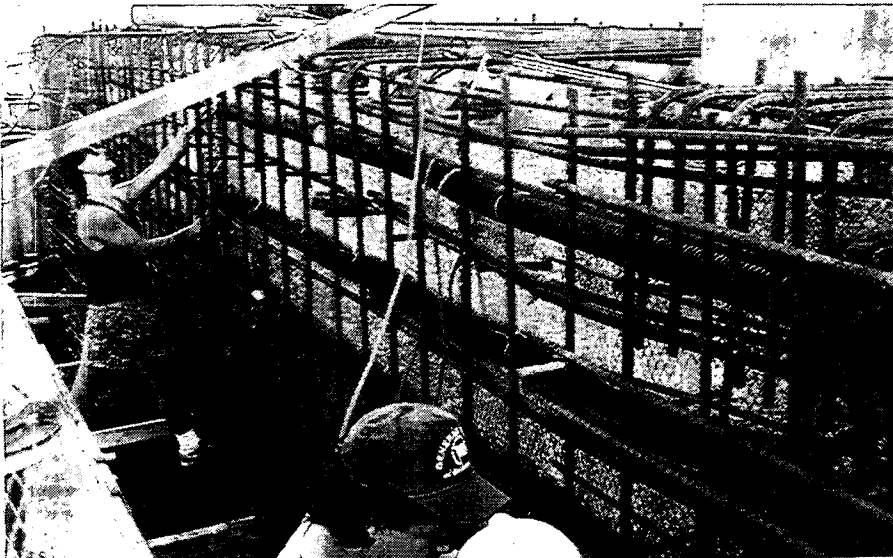
Figure 1. (cont'd) Installation and Activation of Anode

Post-tensioning
Duct and New Steel
in Place

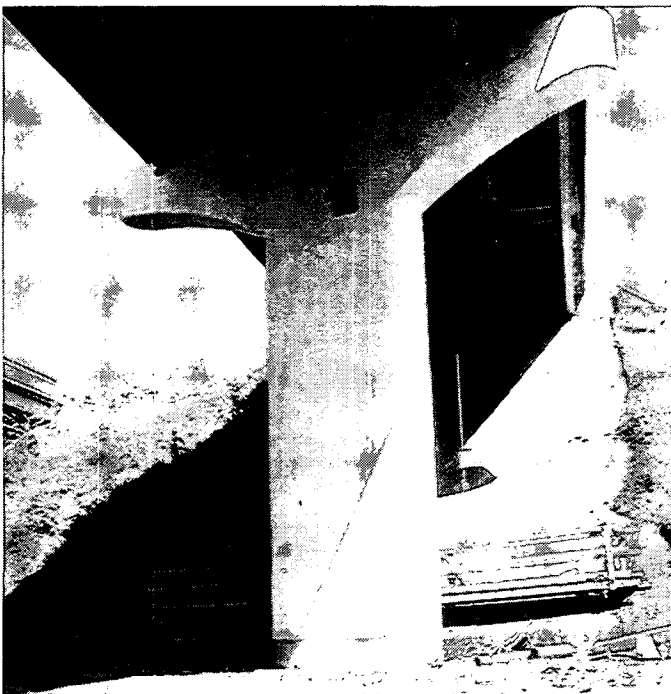
Figure 1. Installation and Activation of Anode

White Decorative Coat
(Latex SW B-66)
Over Conductive Paint

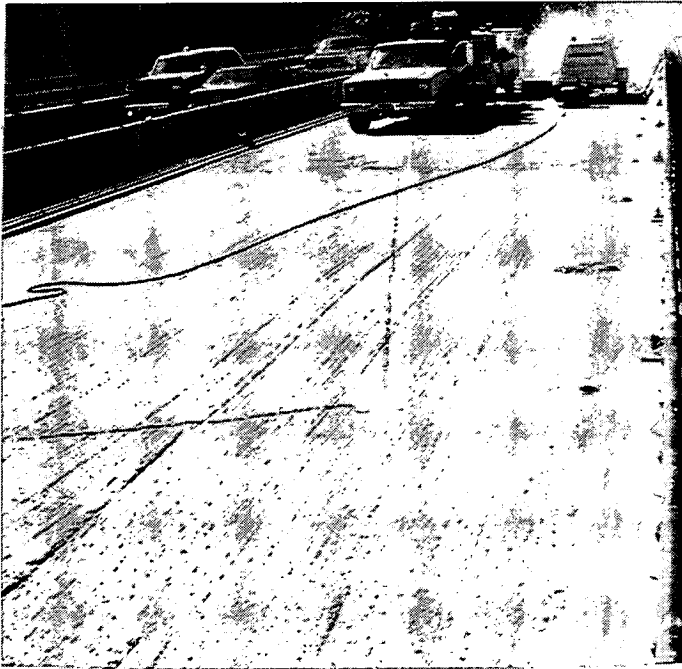
Scarified Deck Being Sandblasted

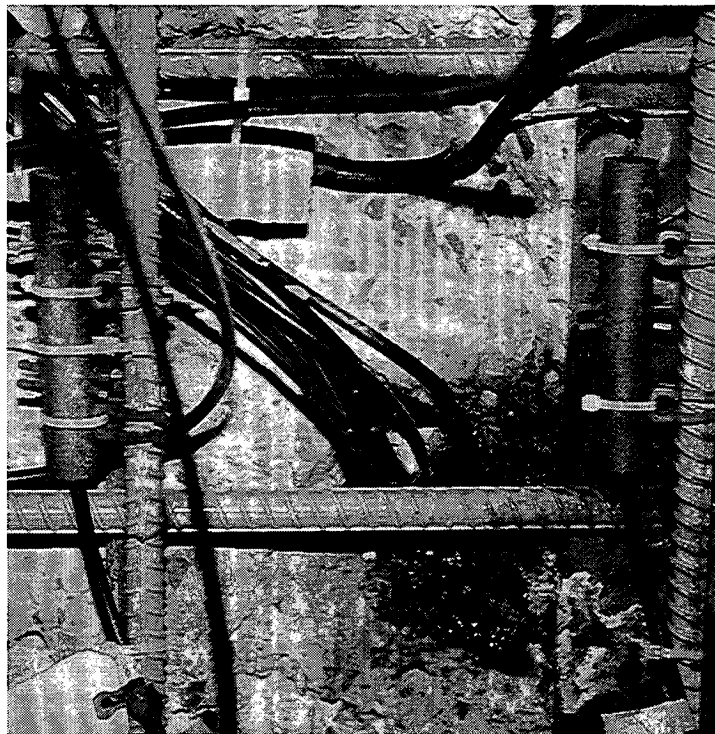
Graphite Half Cell and Rebar Probe
in Place
