## **A Mobile Road Condition Sensor as Winter Maintenance Aid**

Final Report for ITS-IDEA Project 85

Prakash Joshi, Physical Sciences, Inc.

***May 2002***

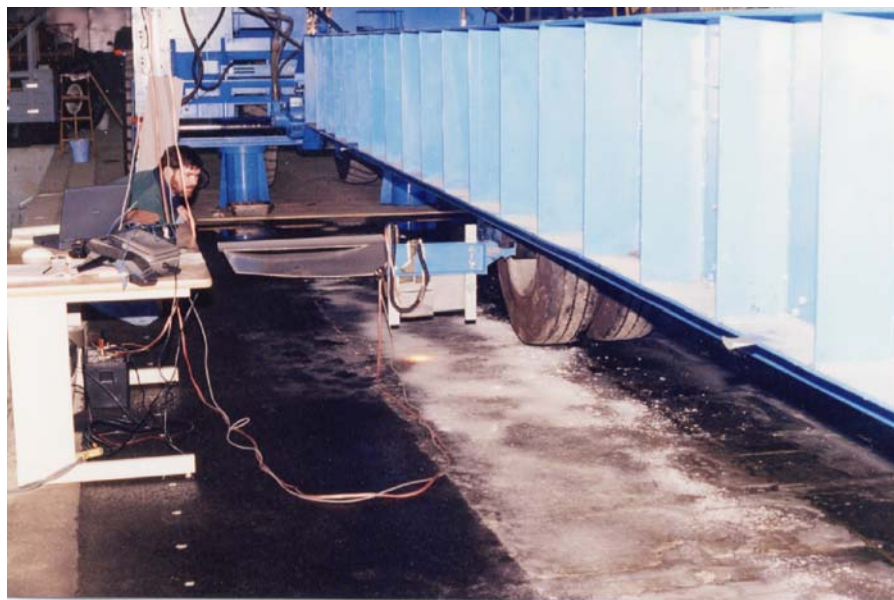
**FIGURE 21 Dry icy surface.**

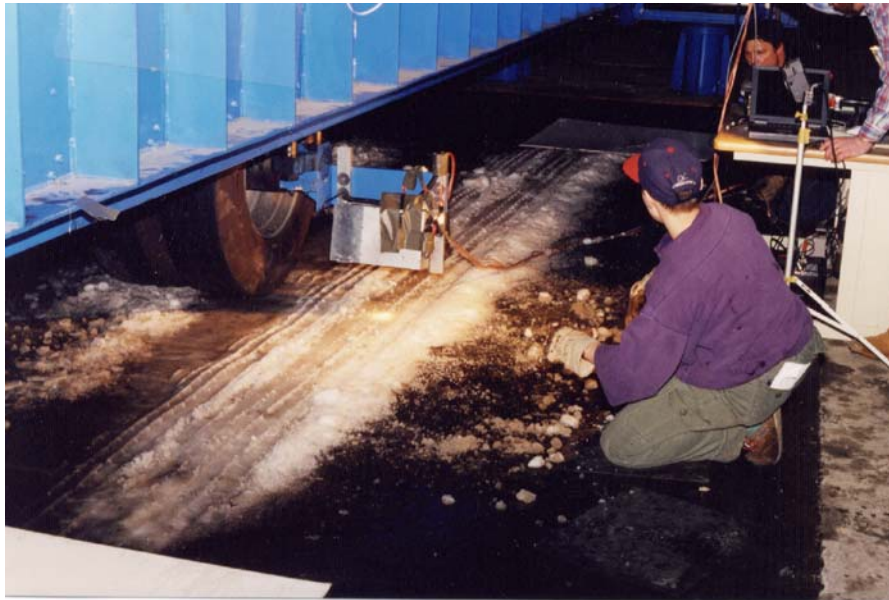
**FIGURE 22 Warm, packed snow surface.**

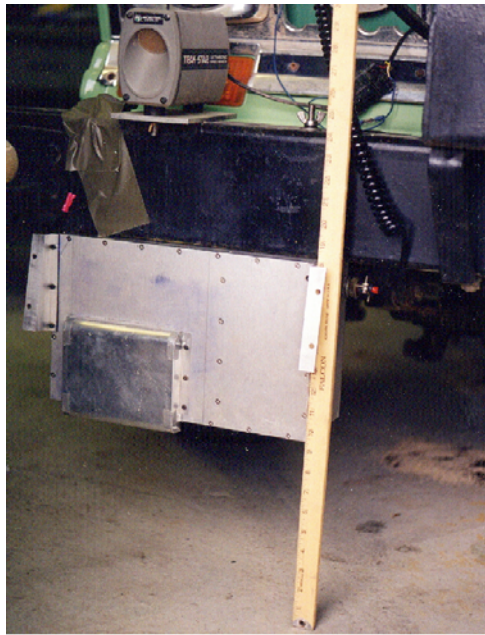
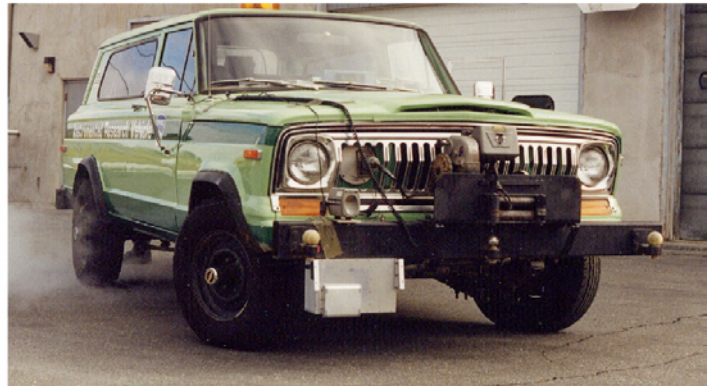
**FIGURE 28 Sensor mounted on CRREL Instrumented Research Vehicle.**

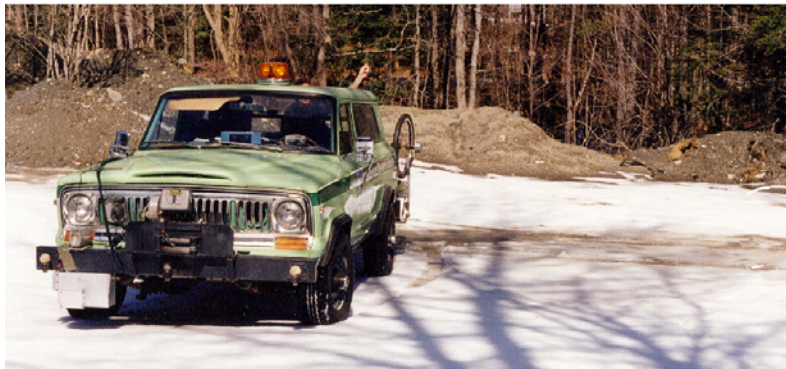
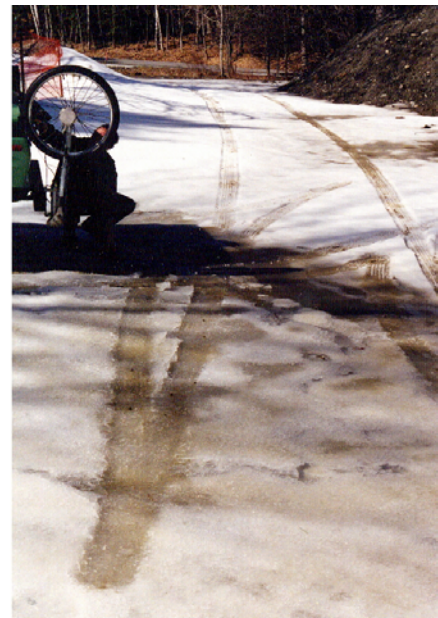
**FIGURE 29 CRREL IRV with traction monitoring device and road condition sensor.**

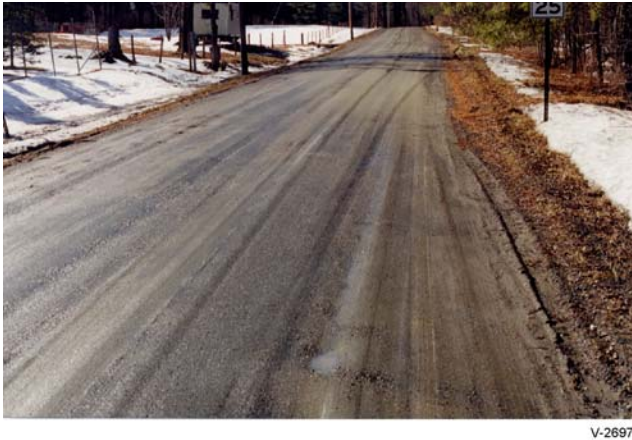
Figure 30 shows a road surface that was described visually by the IRV operator as pavement with dry and moist regions. Data was collected at 1 kHz sampling rate as in calibration tests. The test data is contained in Figure 31. The time series of averaged sensor outputs in  $\lambda_1$ ,  $\lambda_2$ , and  $\lambda_3$  wavelength channels are shown in

**FIGURE 30 Photograph of pavement with dry and moist regions.**

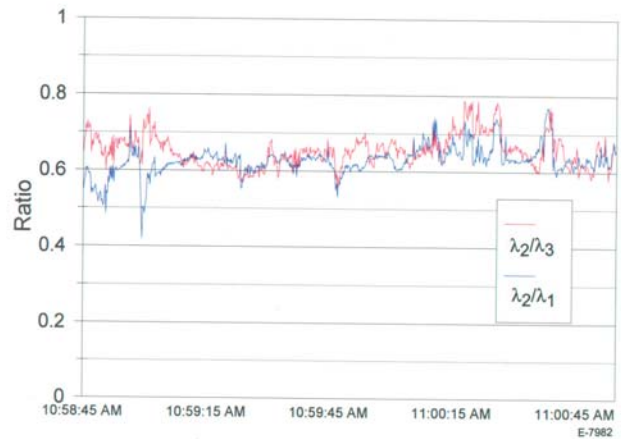
Figure 31(a). The signals also exhibit significant high frequency content on the roadway compared to the calibration data under controlled conditions (see Appendix B). Note that the intensity at  $\lambda_2$  is lower than that in the other two channels, indicating absorption due to the presence of water. The ratios of intensities in the  $\lambda_2$  and  $\lambda_3$  channels and intensities in the  $\lambda_2$  and  $\lambda_1$  channels are shown in Figure 31(b). The  $\lambda_2$  to  $\lambda_3$  ratio is less than 1 indicating either a dry or moist (wet) pavement, and the  $\lambda_2$  to  $\lambda_1$  ratio is greater than 0.5 indicating a moist pavement. This trend is reflected in the discrimination map of Figure 31(c) where the ratio of intensity in  $\lambda_2$  channel to the intensity in  $\lambda_3$  channel is plotted against the ratio of intensity in the  $\lambda_2$  channel to the intensity in  $\lambda_1$  channel. The sensor characterizes the pavement over which the IRV was driven as moist (wet) and dry, consistent with the operator's observations. Further, the sensor indicates that the wet regions were more predominant than the dry regions.

(a) Averaged sensor signals in outputs in  $\lambda_1$ ,  $\lambda_2$ , and  $\lambda_3$  wavelength channels.

(b) Ratio of intensities in  $\lambda_2$  and  $\lambda_3$  channels and ratio of intensities in  $\lambda_2$  and  $\lambda_1$  channels.

(c) Pavement condition discrimination map: Ratio of intensity in  $\lambda_2$  channel to intensity in  $\lambda_3$  channel is plotted against the ratio of intensity in  $\lambda_2$  channel to intensity in  $\lambda_1$  channel.

**FIGURE 31 Sensor data from CRREL IRV road test over dry pavement with moist patches.**

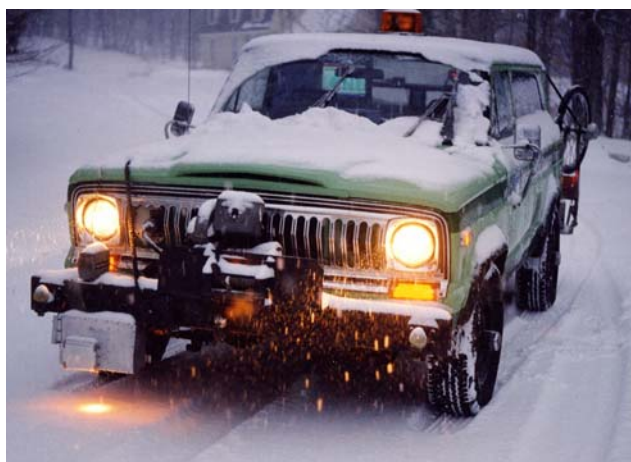
Next, we show data verifying sensor operation on a roadway covered with mostly packed snow, as shown in Figure 32. The averaged sensor outputs in  $\lambda_1$ ,  $\lambda_2$ , and  $\lambda_3$  wavelength channels are shown in Figure 33(a). As we saw in the indoor calibration tests at CRREL's Frost Research Facility (reported in Letter Report 1), all channels show significant increase in intensity due to high scattering from the snow. The signals also exhibit lot of fluctuations in intensities, as one would expect on real snowy roadways. On the intensity ratio plot, Figure 33(b), the  $\lambda_2$ -to- $\lambda_3$  ratio is very high, greater than 5, for the most part. The ratios are punctuated by higher intensity and lower intensity spikes. The  $\lambda_2$ -to- $\lambda_1$  intensity ratio, on the

**FIGURE 32 Sensor operation verification on a snow covered pavement.**
