HIGHWAY RESEARCH BOARD Special Report 61C

The AASHO Road Test

Report 3

Traffic Operations and AT LAB
Pavement Maintenance

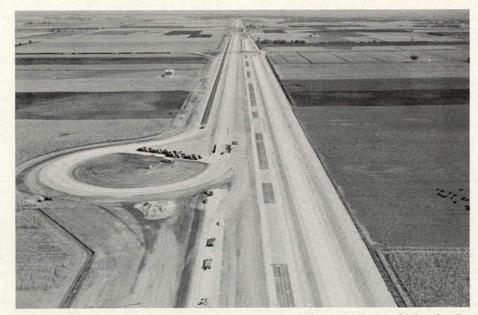
Figure 2. View of Loop 5 (at left) and a portion of Loop 2. Test vehicles for Loop 5 are parked in the crossover road in the turnaround.

The facilities were built in six loops (Fig. 1). The four large loops (3 through 6) were constructed for testing under tractor-semitrailer traffic, Loop 2 was constructed for testing under light truck traffic, and Loop 1 was designed for testing with static and creep speed

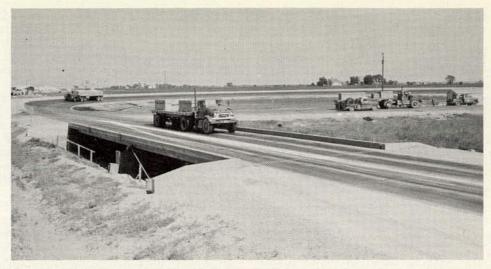
Figure 4. Test bridge site. Four 50-ft span bridges are built on common substructure.

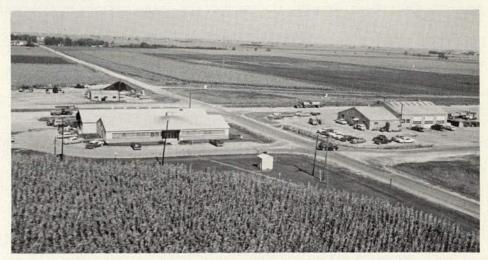
Figure 5. Administration Area at center of project. Building at left contains staff offices and laboratory. Building at right contains the Operations Branch and vehicle maintenance shop. Pavement maintenance building and equipment yard are to the rear.

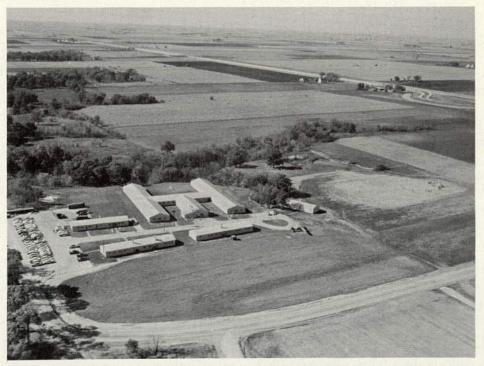
Figure 6. Housing, administration and recreational facilities for the Army Support Activity were in these five buildings near the east end of the project.

The Support Activity was made up of enlisted men and officers from the 10th and 62nd Medium Truck Companies, 48th Transportation Group, Fort Eustis, Virginia. Personnel were quartered in facilities provided by the Project and located just southeast of the eastern end of Loop 4 (see Fig. 1). These facilities, consisting of five prefabricated steel buildings (Fig. 6), were named Wallace Barracks.

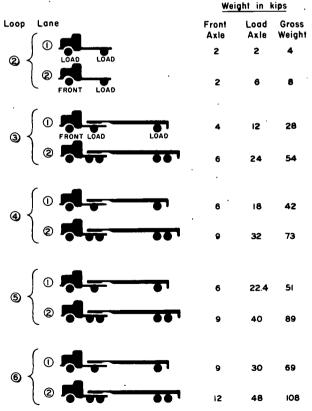
Figure 11. Typical test vehicle axle loadings.

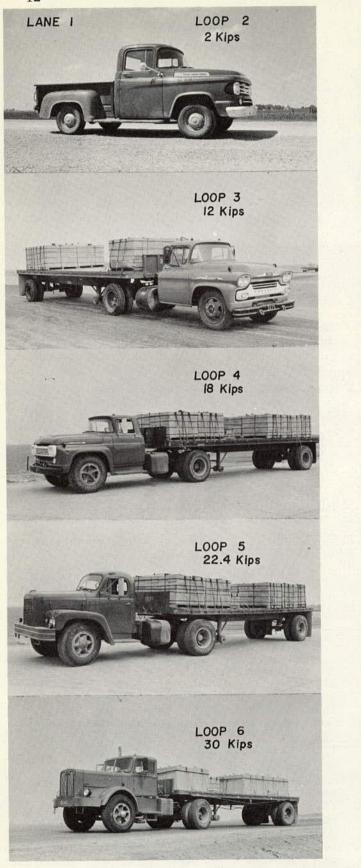
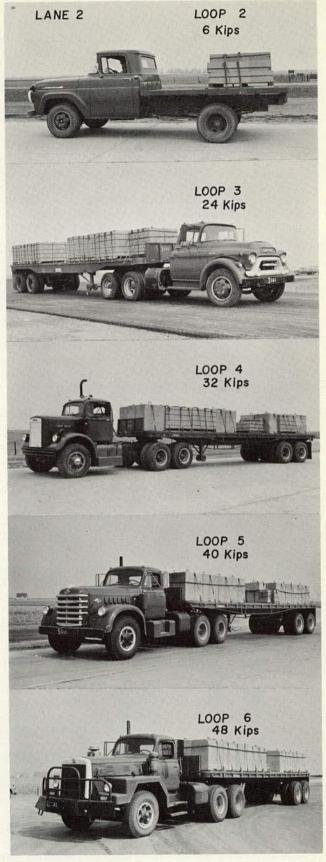
Figure 12. Loaded vehicle from each traffic lane.

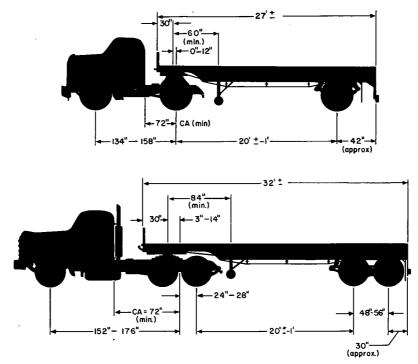
Figure 13. Test vehicle dimensions.

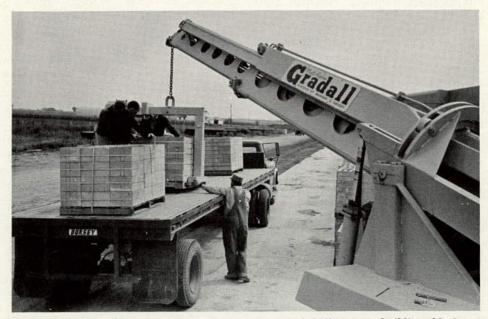
Figure 14. Project crews placing original loads of hollow-core building blocks on test vehicles.

The hollow-core blocks were used in an effort to create loads with the relatively high center of gravity commonly found on commercial vantype vehicles operating on the highways.

Accordingly, all vehicles except those on Loop 2 were reloaded with the load height limited to approximately 36 in. above the bed of the vehicle. On some vehicles this involved only the repositioning of the palletized building blocks. This was true of all vehicles on Loop 3

and on the inner (single axle) lanes of Loops 4 and 5. On all other vehicles the load height was reduced by using solid concrete blocks measuring 24 by 34 by 36 in. and weighing approximately 2,550 lb each.

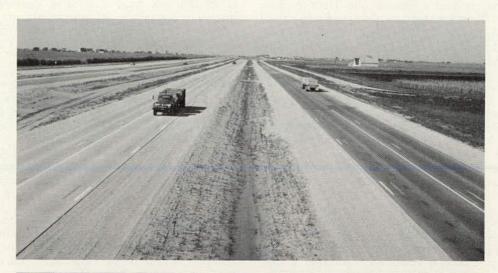
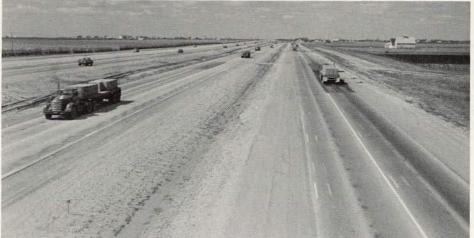
Figure 17. Typical traffic density on Loops 5 and 2 with 12 vehicles (upper) and 20 vehicles per loop (lower).

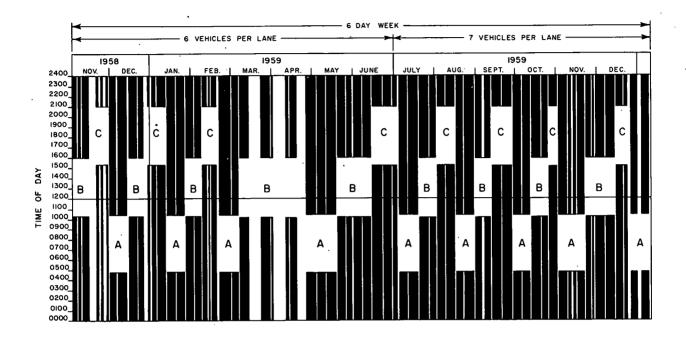
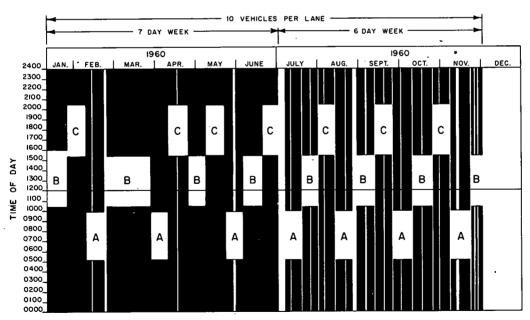
Figure 18. Test traffic driving schedules.

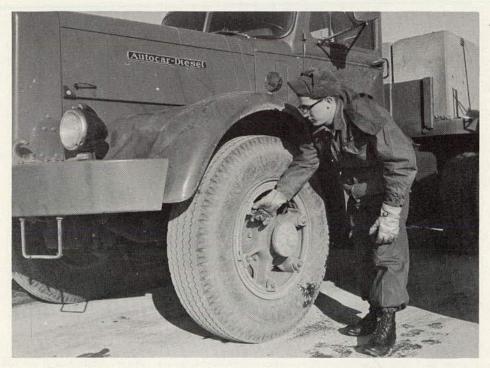
Figure 20. Drivers checked vehicles and loads before starting operations.

Insofar as possible, each driver was assigned to a particular vehicle. He was then responsible for checking the vehicle before starting operations and reporting any deficiencies noted dur-

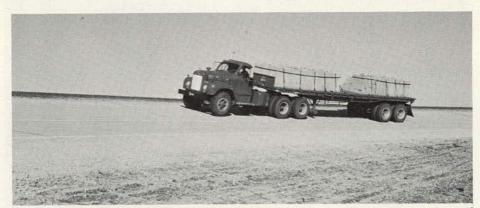
Figure 22. The loop turnarounds were superelevated at a rate of 0.2 ft per ft on the outer lane. All vehicles normally used this lane when traveling at 25 mph or faster.

The 30-mph speed on the turnarounds apparently caused excessive tire wear. In addition, many drivers reported feeling on the verge of losing control in the turns. Accordingly, speeds were set at 35 mph on the tangents and 25 mph on the turnarounds of the major loops (35 and 15 mph on Loop 2). At these speeds drivers were able to decelerate after leaving the test sections on one tangent and accelerate back to 35 mph before reaching test sections on the other tangent.

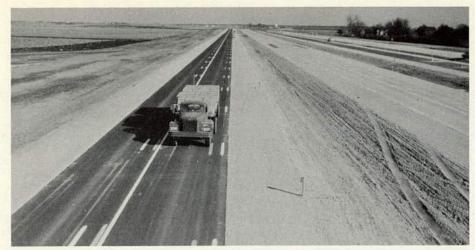
Figure 23. Guide lines were painted on left side of each traffic lane to assist drivers in maintaining proper transverse placement.

The transverse placement of the vehicles on the test pavements was programed to follow the observed placement of heavy trucks on actual highways as reported by the Bureau of Public Roads for two-lane roads with 12-ft lanes. Guide lines were painted along the left side of each traffic lane to assist drivers in maintaining transverse placement.

Because the automatic devices did not perform satisfactorily, the drivers were later instructed to drive always between the guide lines with the expectation that the random driving position of different drivers would accomplish the programed result. By observation and by sampling this procedure was found to be satisfactory.

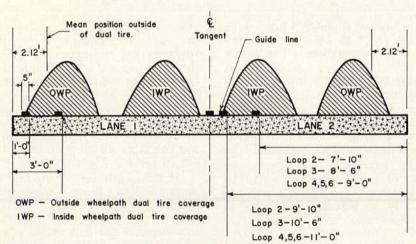
Figure 24. Programed placement.

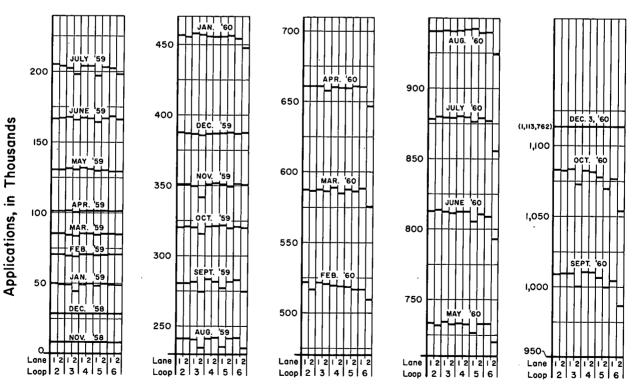
Figure 25. Cumulative axle applications at end of month.

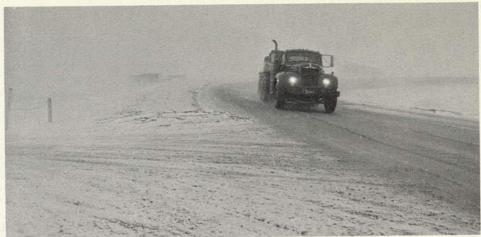
Figure 26. During periods of adverse weather traffic operations were governed by safety considerations. Snow and ice conditions usually resulted in operating at reduced speeds.

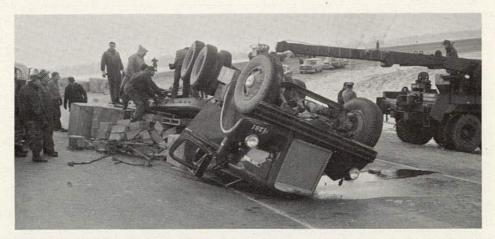
Figure 29. Several accidents such as this occurred on the loop turnarounds. The driver of this vehicle remained in the cab and was not injured despite the extensive damage to the vehicle.

Investigation of the accident centered upon the effect of the high-center-of-gravity loads, and it was decided that the loads created an unsafe condition when the vehicles were on the loop turnarounds or entering and leaving the parking areas.

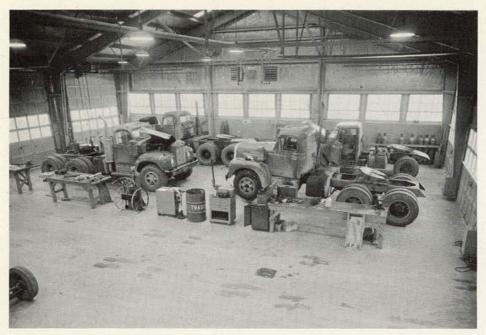
Figure 30. Interior of vehicle maintenance shop shortly after beginning of full-scale traffic in November 1958.

The problems of vehicle maintenance increased as the original fleet began to amass considerable operating mileage, and also as the number of test vehicles increased. In late 1959, when the fleet was being increased from 78 to 126 units, the shop was enlarged from 4 to 6 bays, or from about 3,800 sq ft to 5,700 sq ft of working space.

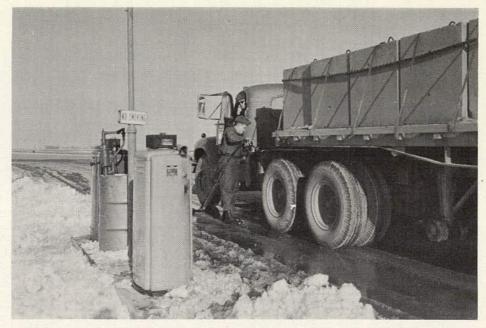
Figure 33. Army personnel refueled test vehicles from storage tanks located on the test loops.

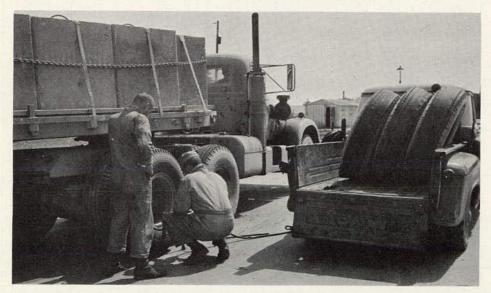
Figure 34. At the peak of operations, two three-man crews were used to check and service tires on the test vehicles.

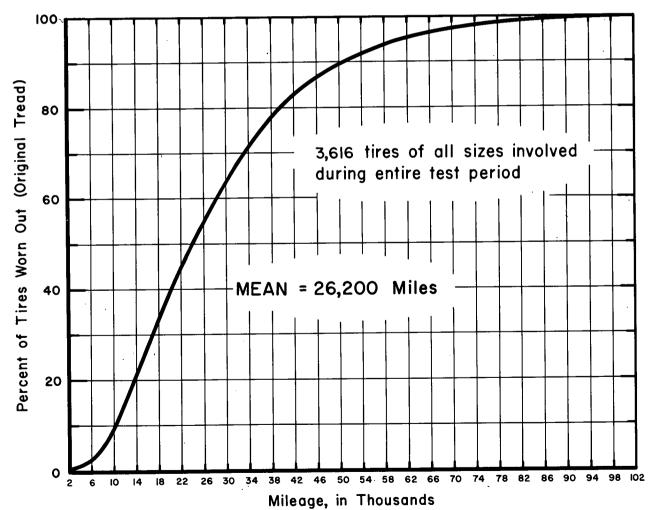
Figure 35. Cumulative frequency curve of original tread wear.

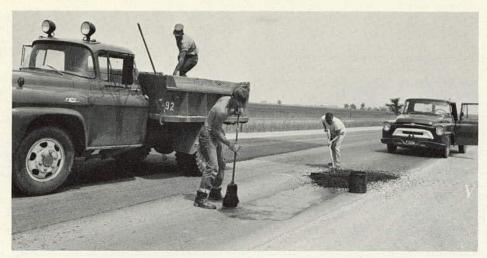
Figure 36. Project maintenance forces placing a skin patch consisting of an application of bitumen and pre-mixed bituminous patching material.

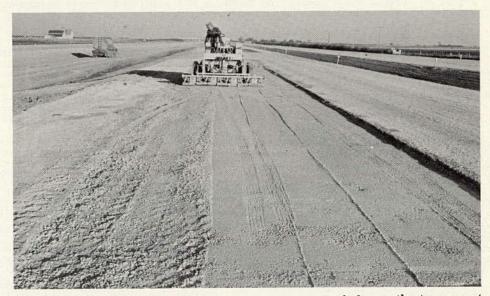
Figure 37. A multiple-pan vibratory compactor was used frequently to compact crushed stone used as a base in deep patches.

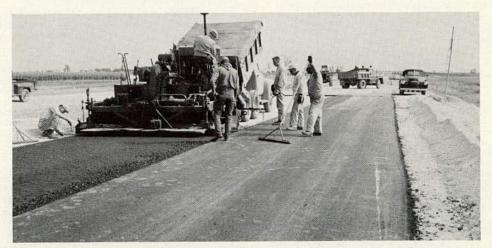
Figure 38. Many sections declared out of test were reinforced with a hot-mix asphaltic concrete overlay. Routine measurements and observations were continued on selected overlaid sections.

When an overlay was placed, it usually covered the entire test section. A few part section overlays were placed on sections of wedge construction and on those sections with tapered shouldered paving.

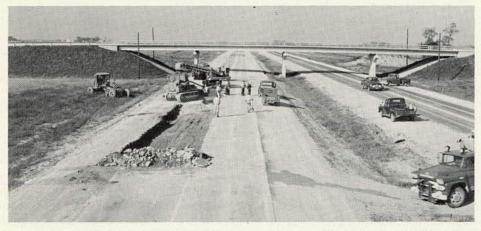
Figure 39. Many of the thinner pavement sections were excavated and rebuilt following their removal from testing. Here, an entire test section has been dug out prior to backfilling with crushed stone and surfacing with hot-mix asphaltic concrete.

Criteria: Reconstruction was permitted in either wheelpath or in a full test section which may or may not have had any previous maintenance, but had been discontinued from the basic experiment, if in the judgment of the Maintenance Review Committee the deterioration was so rapid that other maintenance procedures would not be effective. The rate at which distress was developing was an important consideration in determining if reconstruction should be done. When reconstruction was done an entire wheel-

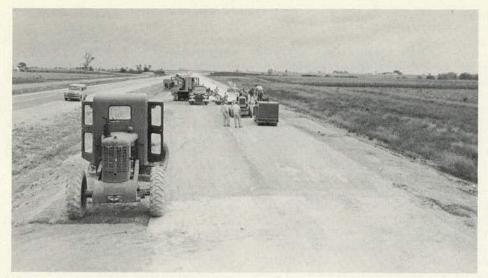
Figure 40. Manpower and equipment frequently were concentrated on small areas requiring maintenance in order to complete the work during the 5-hr traffic break.

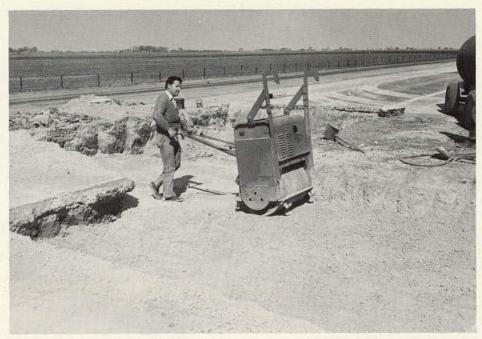
Figure 41. A hand-operated vibratory roller was used to compact crushed stone when excavated areas were too small for conventional compaction equipment.

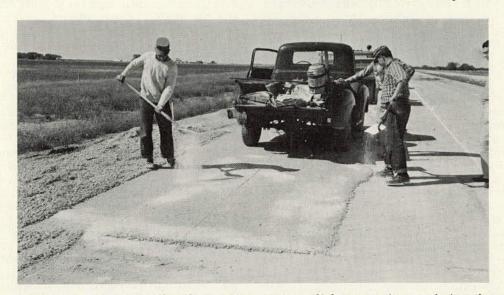
Figure 42. Traffic was allowed to operate over crushed stone prior to placing the surfacing. Calcium chloride was used to stabilize the granular material and reduce dust.

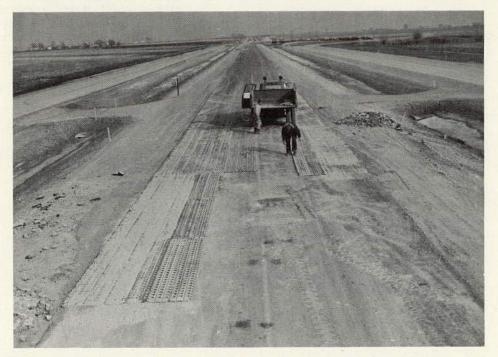
Figure 43. Pierced steel-plank mats were used successfully as a temporary riding surface over damaged areas pending more permanent repairs.

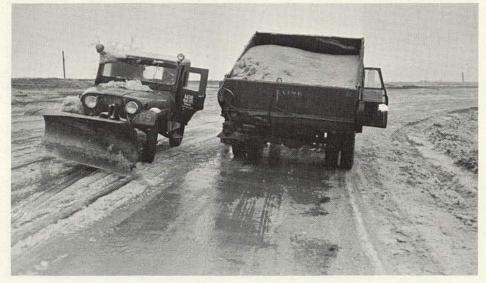
Figure 44. Salt and abrasives were used on the loop turnarounds to remove snow and ice and permit traffic operation.

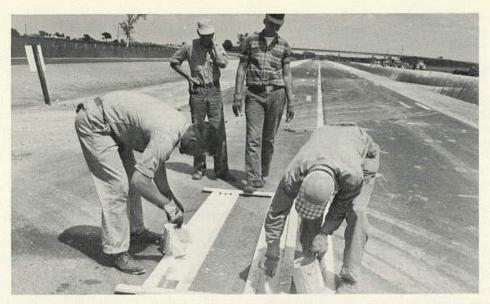
Figure 45. Guide lines on Loop 2 were painted by hand because the weight of paint striping equipment exceeded that of the test vehicles.

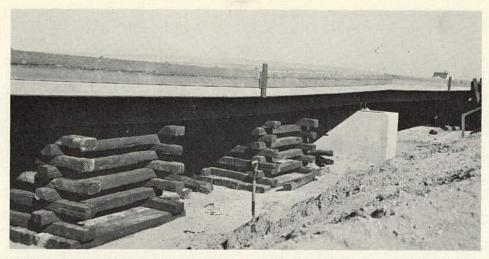
Figure 46. Maintenance forces placed railroad tie cribbing under test bridges.

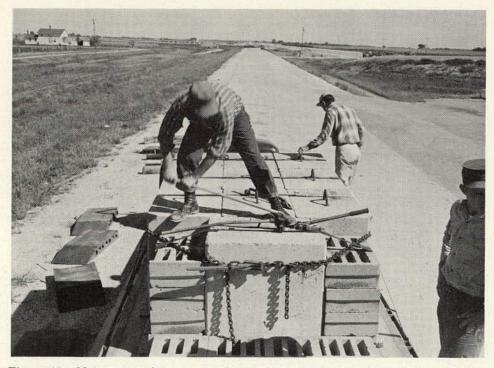
Figure 47. Maintenance forces assisted in loading and load banding on test vehicles.

Maintenance personnel and equipment were used in the loading, unloading and load maintenance on the test vehicles. Loads were made up of solid concrete blocks and hollow-core building blocks, and were tied down to the trailer decks with steel bands. Wooden cleats and heavy chains were also used to prevent load shifting. The Gradall was used to handle the blocks.

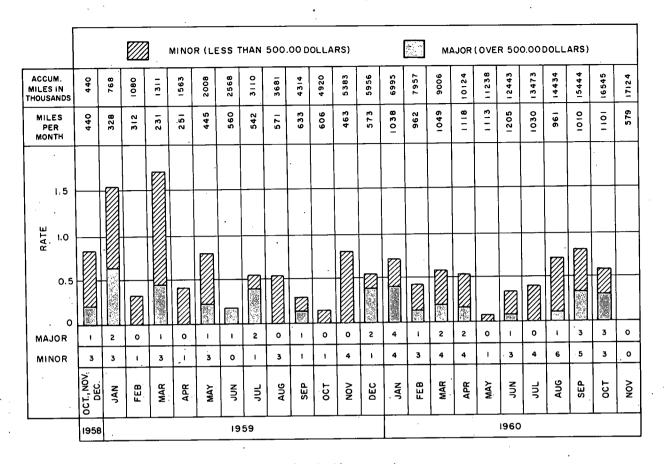
Figure 2-B. Accident experience.

Accident trends and experience in accordance with the foregoing criteria are shown in Figure 2-B. Four accidents (of all categories) were experienced in the 1958 traffic operations, 32 in 1959 and 54 in 1960 when traffic operations were approximately doubled. Weather conditions were the apparent cause of high accident rates in January and March 1959 and January, March and September 1960.
