# CONTROL OF WHEEL/RAIL FRICTION

## SUMMARY

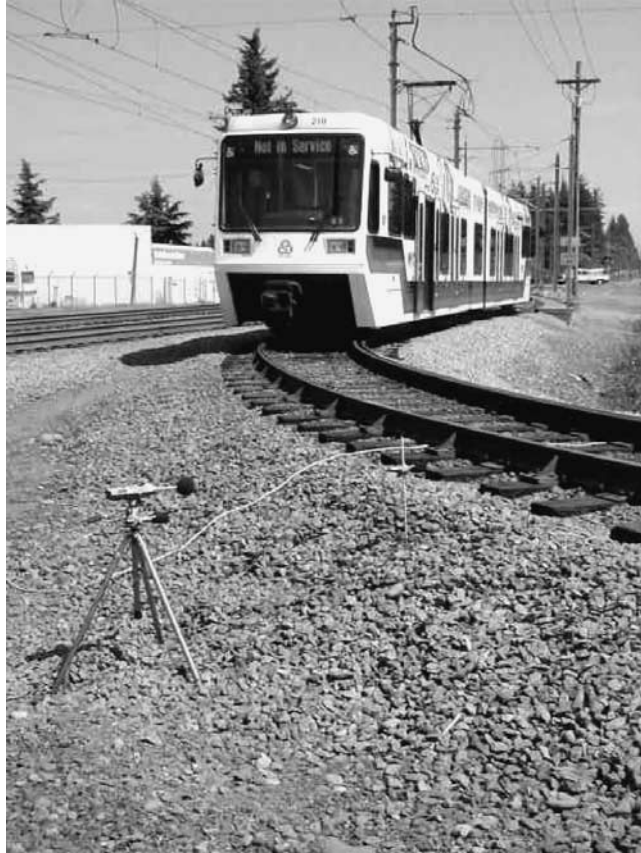
*Figure 2. Test site and typical Portland Tri-Met car.*

Portland Tri-Met personnel evaluated several curves for use in demonstrating the film-coating project. Although curves on the mainline track had been preferred, those with existing noise-related problems had already been fitted with wayside lubricators; ceasing this application for test purposes was not a viable option. For this reason, curves in heavily trafficked yard leads were evaluated. TTCI and Tri-Met personnel inspected several curves, after which curve C-538 was selected for the demonstration. Refer to Figure 1 for a map of the site, and Figure 2 for an overall view.

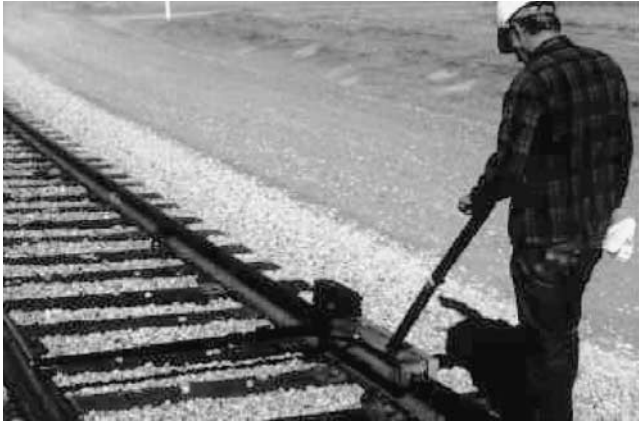
Figure 3. Hand-operated tribometer.

Rail friction was measured using a hand-operated tribometer (Figure 3). The tribometer can be oriented to measure the rail friction of a single location on the rail, gage face to the top of the rail. The location and clearances of the low rail guard rail were such that no friction readings could be obtained on the rail in the curve. All low rail readings represent locations at the extreme ends of the curve. Typical well-lubricated gage faces in heavy-haul freight railroads would be indicated by friction readings of  $0.2\mu$  or less, while dry rail conditions are defined as any friction reading of  $0.45\mu$  or greater.

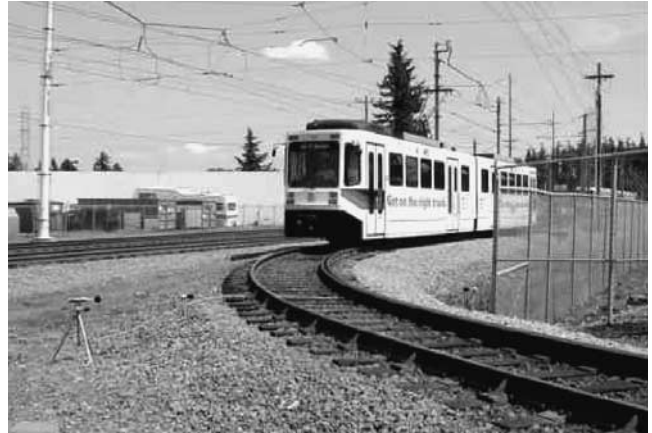
Figure 4. Noise data microphones located on test curve.

The Bruel & Kjaer (B&K) sound level meter, with a 4-Hz to 40-KHz frequency response microphone, was placed 8 ft from the rail gage and was used as the primary acoustic collection instrument (see Figure 4 for setup). In addition, two stereo microphones with 4-Hz to 20-KHz frequency response were placed within 4 ft of the passing transit car wheel-rail interface. All three test microphones were placed along a line perpendicular to the rails and at the top of the rail elevation.

In this arrangement, the microphones maintained a direct line of sight to all noise-generating locations on the wheel-rail contact during every car pass.

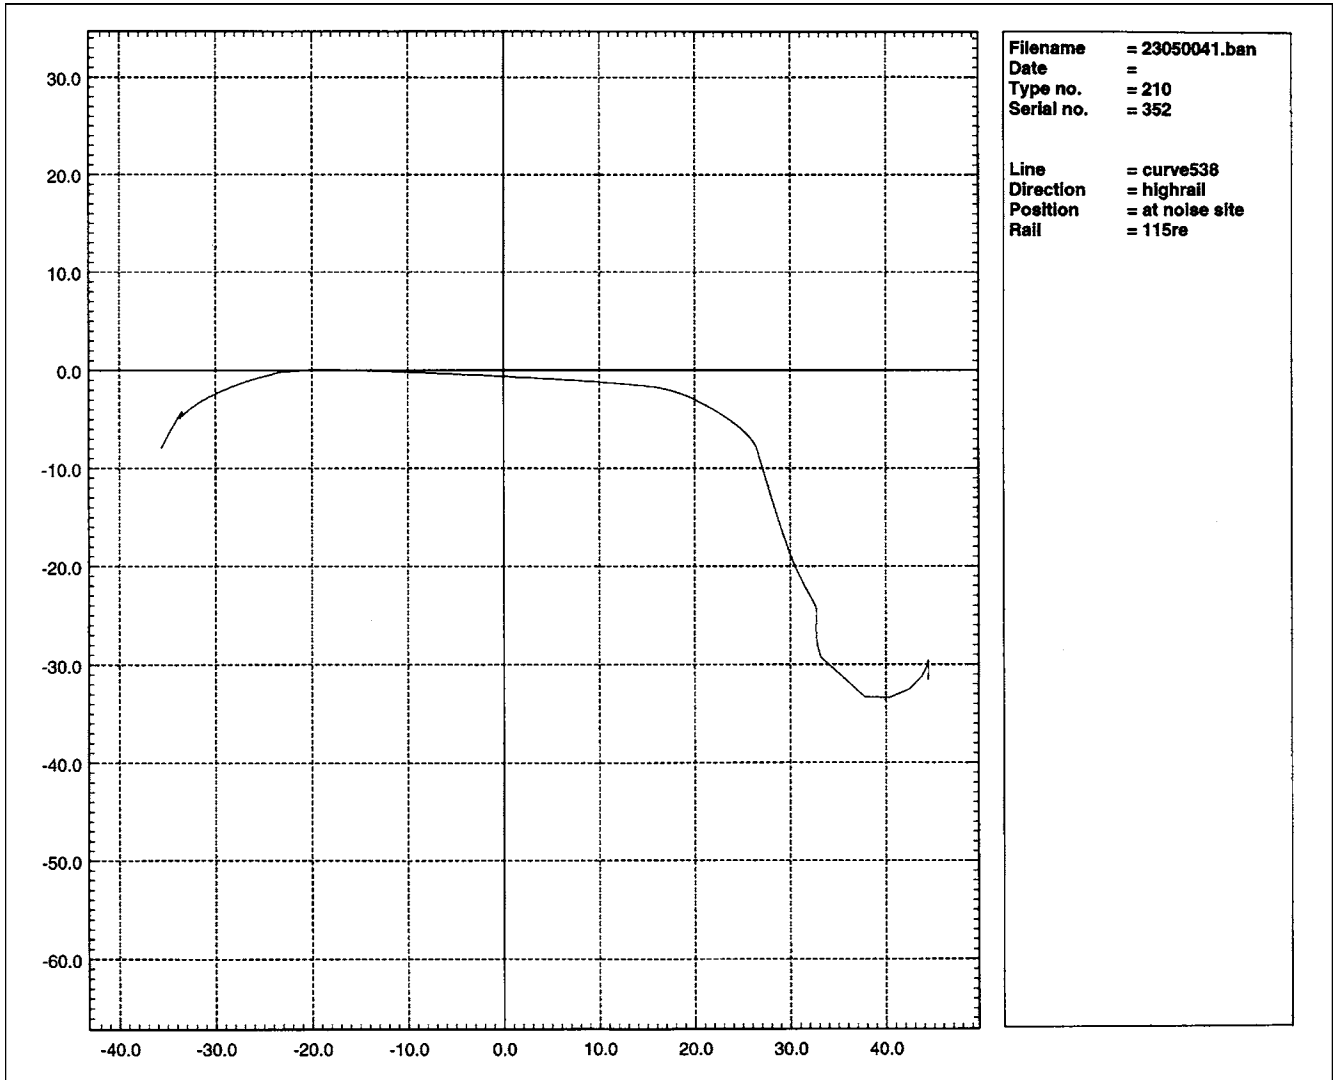
Figure 5. Typical MiniProf™ profile trace.

Tri-Met provided the use of a MiniProf™ rail profile measurement system during the test. The MiniProf™ uses a manually operated encoder mounted on a shaft with a linked arm. After inputting identification information into a laptop personal computer (PC), the operator traces the railhead using the linked arm, creating an  $x:y$  profile matrix, which is then stored in the PC's memory. The use of software allows the user to obtain various overlay, wear, and profile characteristic statistics. Figure 5 shows a typical MiniProf™ profile from one of the test locations. The accuracy of the MiniProf™ is a function of the operator properly setting up the device at exactly the same location for each successive measurement and ensuring that the unit support arm is perpendicular to the rail. Repeatability audits have indicated that the MiniProf™ is accurate to approximately 0.002 in.; however, as coating thickness and wear experience during this test appeared to be less than this value, no significant information was obtained from the profile data.

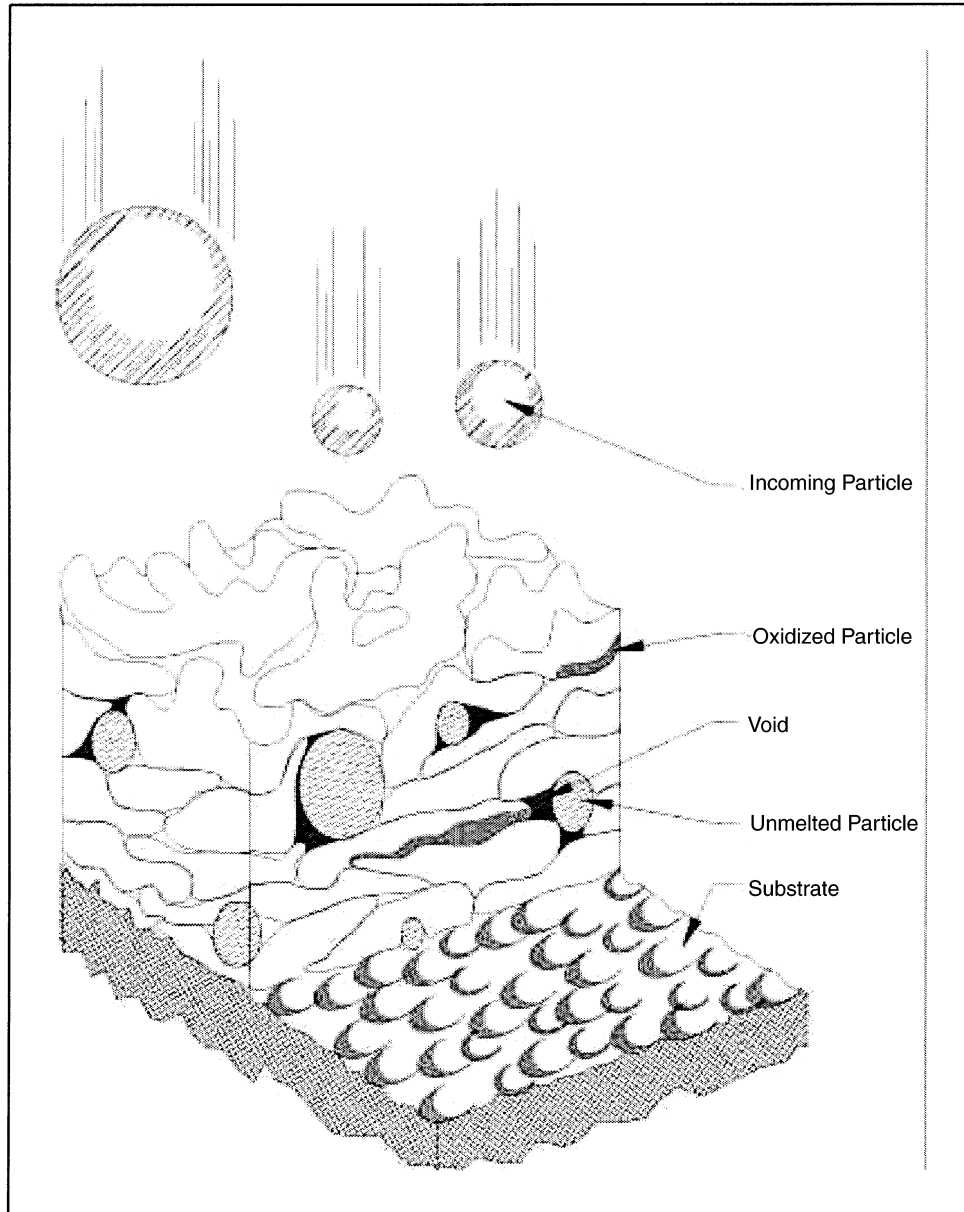
Figure 6. Schematic of a film coating.

Thermal spray coatings are formed by the aggregation of molten and semi-molten particles on a substrate, as Figure 6 illustrates. Figures 7 and 8 show the actual field process of sandblasting and film coating, respectively. Coatings can be formed from almost any material, ranging from polymers (such as nylon and Teflon) to metals (such as copper and lead) to ceramics (such as alumina and chromium oxide) to cermets (such as tungsten carbide-cobalt and chromium carbide-Nichrome). Almost any material that can be formed into a powder or a wire can be used.

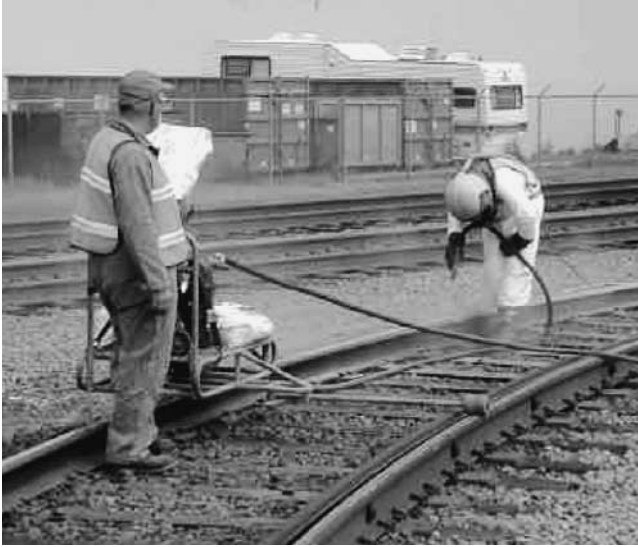
Figure 7. Sandblasting of rail prior to film coating.

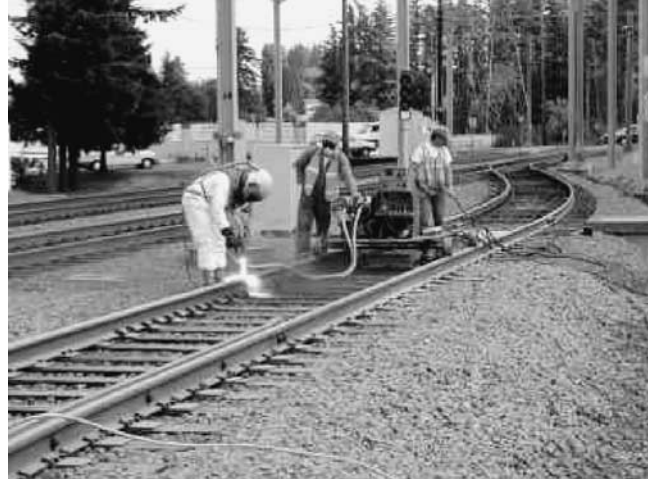
Figure 8. Application of coated film onto rail.

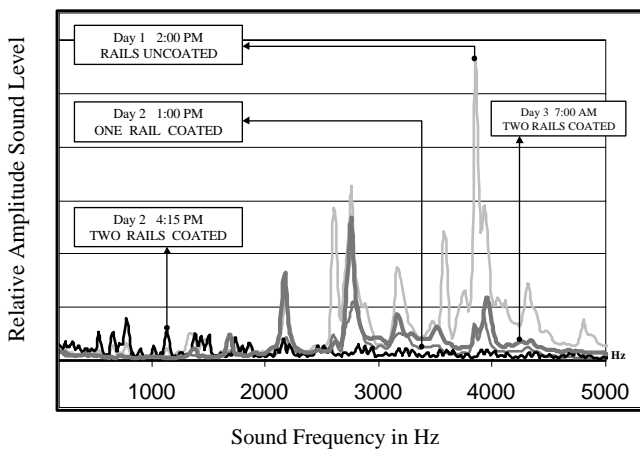
Figure 11. Acoustic changes before, during, and immediately after coating (relative amplitude sound level) Car 121 only.

The data show that, before coating, this car created very high relative amplitudes at 2200, 2600, 2800, and 3900 Hz; whereas, immediately after coating, all peaks were significantly reduced. In fact, all dominant peaks were about one-fourth the amplitude of that observed before rail coating. In the case of the highest peak, the reduction was more than a factor of six.

The information in Figures 11 and 12 has several implications. That the acoustic signatures were reduced in amplitude immediately after the rails were coated implies that noise normally generated by the wheel-rail interface had changed

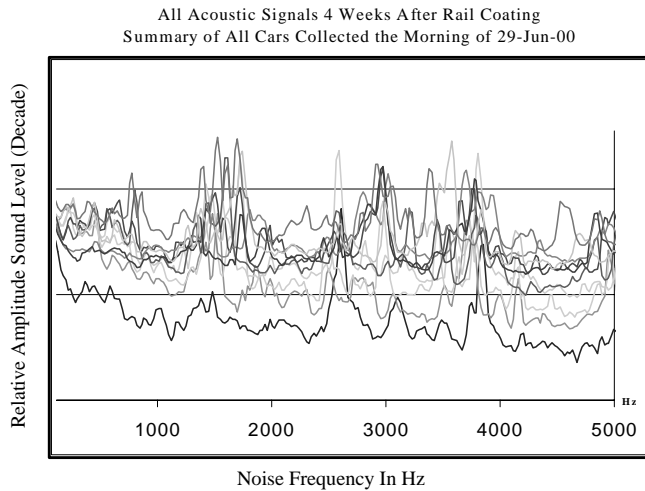
Figure 15. Noise data from 10, two-car trains departing yard noise frequency in Hz.

Figure 15 contains the acoustic signatures from every car that left the yard on the morning of June 29. There was a wide variation in emitted sound. Some cars emitted loud squeals and others generated little or no sound at all. The curves in Figure 15 provide a representative image of the sound spec-

The variations shown in Figures 15 and 16 are quite typical when stick-slip instability occurs at the wheel-rail interface. Stick-slip is a condition in which a mechanical system, such as the wheel rail, oscillates rapidly, resulting in noise such as squeal. This type of sound generation is similar to that of a snow shovel on pavement. With just the right pressure and movement, the tip of the snow shovel can oscillate rapidly, creating a very loud squeal.

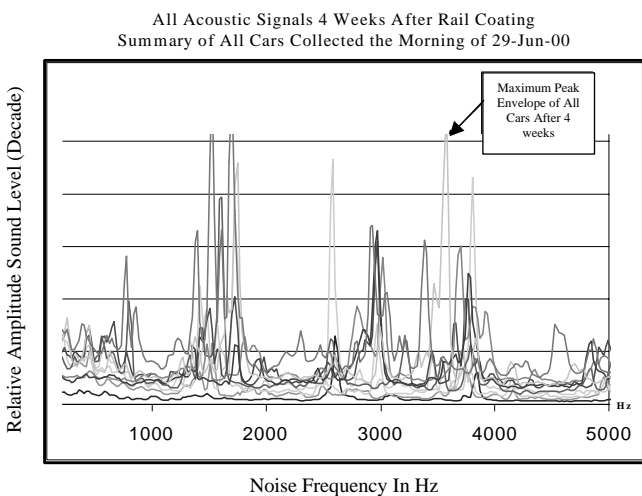
Figure 16. Noise data from 10, two-car trains departing yard relative log amplitude sound level.

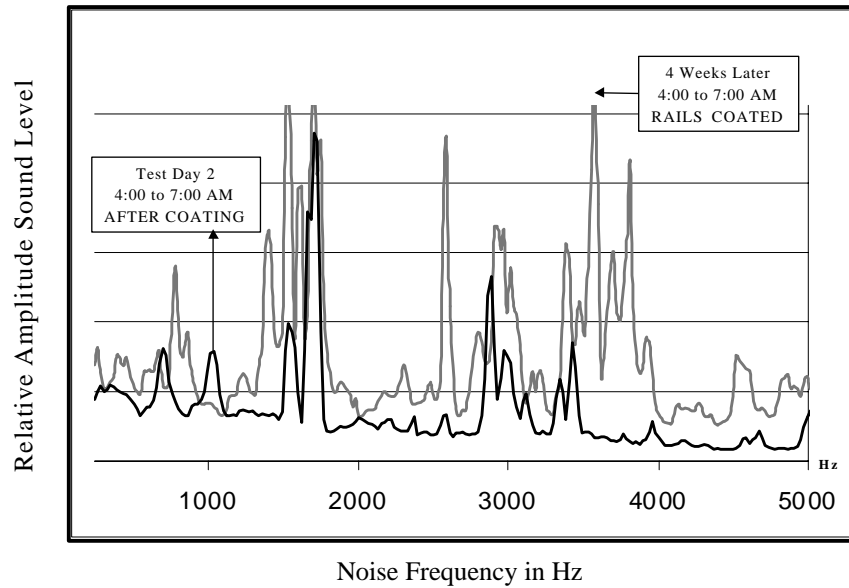
Figure 19. Maximum peak noise for morning train fleet, after coating and 4 weeks after coating, relative amplitude sound level.

effect of the coating over this period can be shown. This is shown in Figures 19 and 20, and as the single car (121) data show, the noise level after 4 weeks is considerably higher than immediately after coating.

The data collection times compared on Figures 19 and 20 were from May 24 and June 29, respectively. The car fleet making up the 10 trains on the 2 days was different. Of the 20 cars making up the noise databases, only 6 had been in both consists on both days.

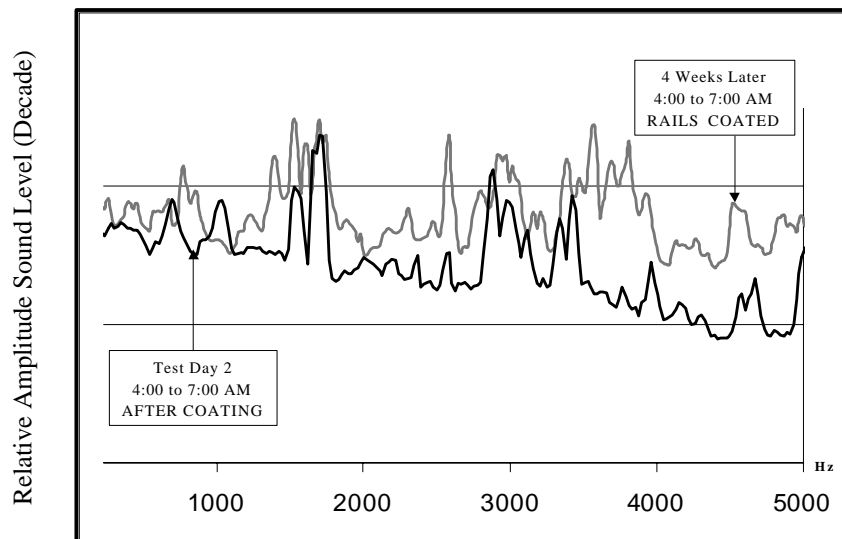
Figure 20. Maximum peak noise for morning train fleet, immediately after coating and 4 weeks after coating, relative log amplitude sound level.

Again this figure demonstrates that the wheel-rail interface sound observed immediately after rail coating was approxi-

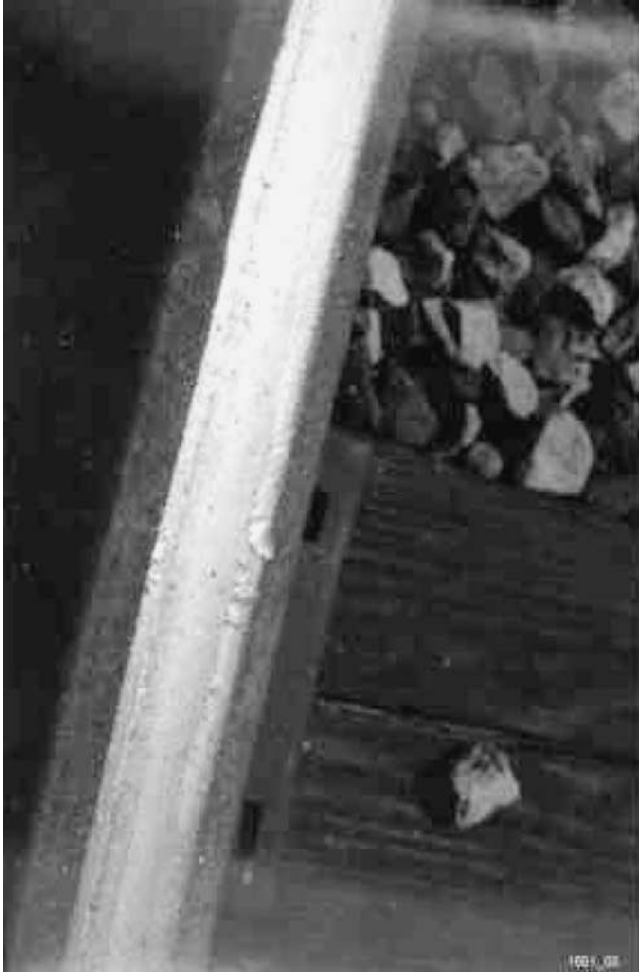
*Figure 21. Top of rail flaking 4 weeks after treatment.*

The film was applied on the top surface of both the inside and outside rails. After several weeks of operation, observers noted small flakes appearing on the rail surface at or near the

edge of the rail-wheel contact patch. During the 4-week measurement cycle, additional larger flakes were noted at isolated locations along the curve. Figures 21 and 22 show the appearance of the top of the rail at locations where thin metal flakes were being created on the rail surface.

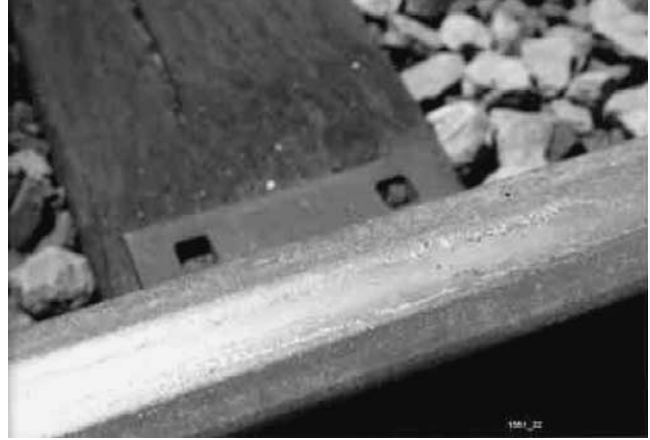
*Figure 22. Top of rail 4 weeks after coating, showing film flaking off rail.*
