Preventing Pavement Failure Caused by Hot-Mix Asphalt Temperature Differentials

Washington State's Systematic Approach

STEVE MUENCH AND KIM WILLOUGHBY

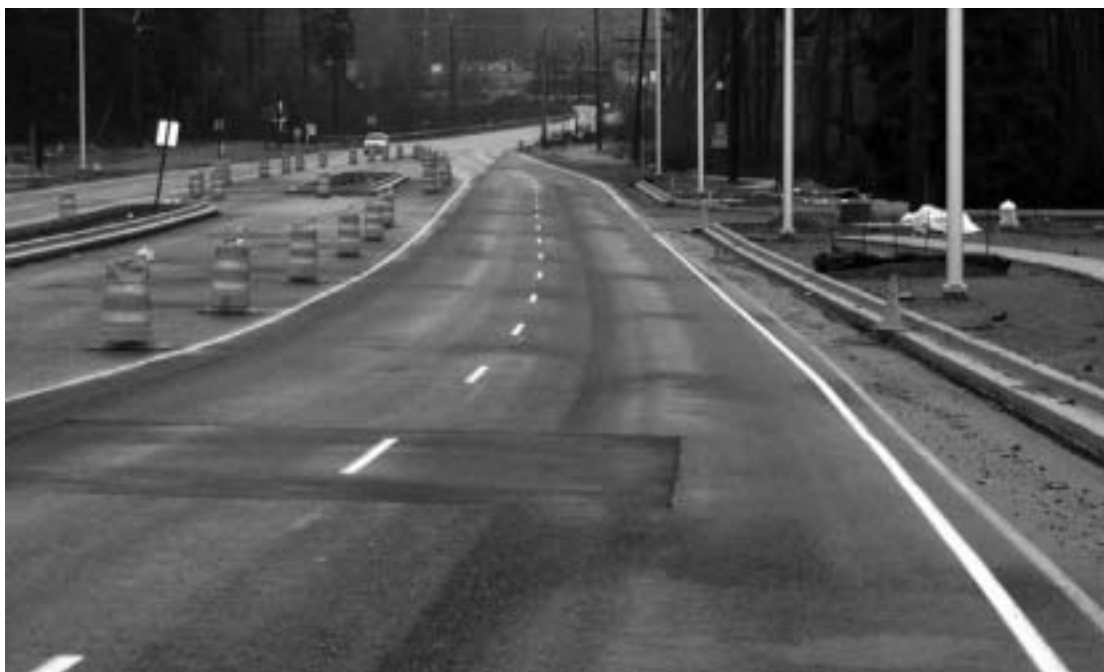
FIGURE 1 Cyclic low-density spots just after construction.

produce low-density areas (Figure 1). These areas are susceptible to isolated damage in an otherwise serviceable pavement.

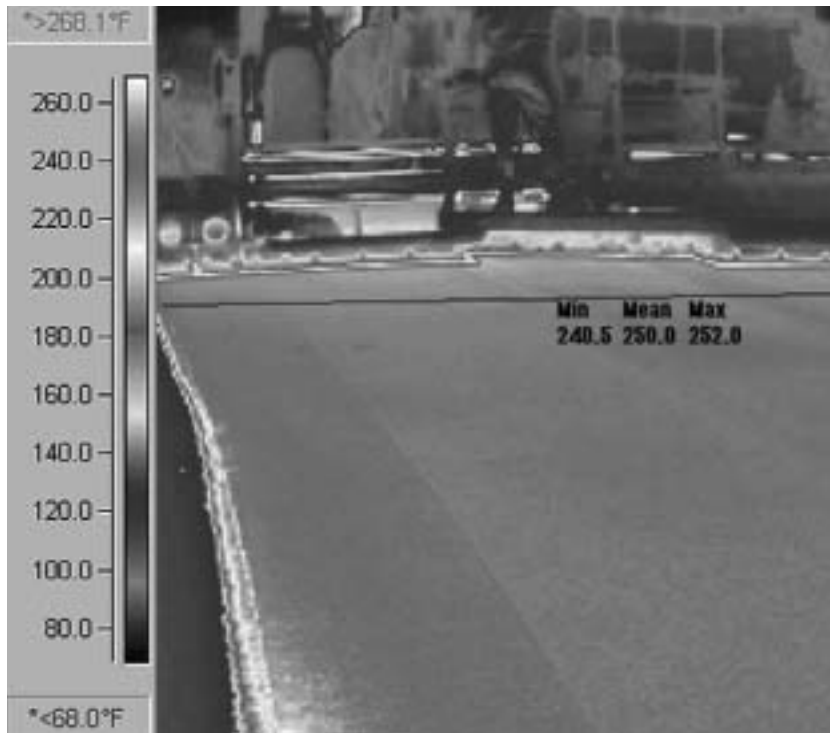
FIGURE 3 Infrared image showing a mat with uniform temperature as a result of remixing in a material transfer vehicle before the paver.

Remixing the HMA before placement reduced or eliminated temperature differentials, but some material transfer vehicles (MTVs) did a better job of remixing than others (Figure 3). Good compaction practices and higher HMA mix temperatures—which allowed additional compaction time—were found to reduce the density differences attributed to temperature differentials.
