# Assessing the Load Capacity of Oregon's Aging Bridges

STEVEN M. SOLTESZ

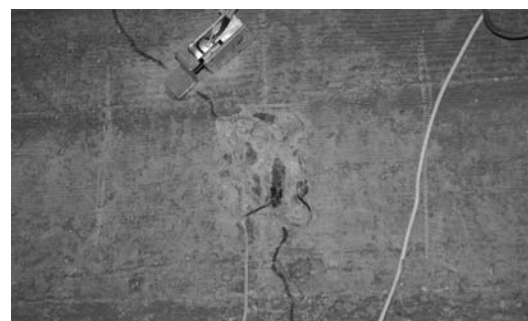
Cracked RCDG bridges were instrumented and monitored.

In 2002, the Oregon Department of Transportation (DOT) contracted with Oregon State University to investigate the load capacity and fatigue damage of cracked RCDG bridges. The researchers installed instruments on in-service bridges to determine the stresses on the steel reinforcement in cracked girders. The measurements were made for weeks under ambient traffic conditions and with truck loads of known axle weights. The data were used in computer models and were incorporated into the laboratory portion of the research.
