Geofoam

Colorado's Innovative Answer to an Emergency Highway Repair

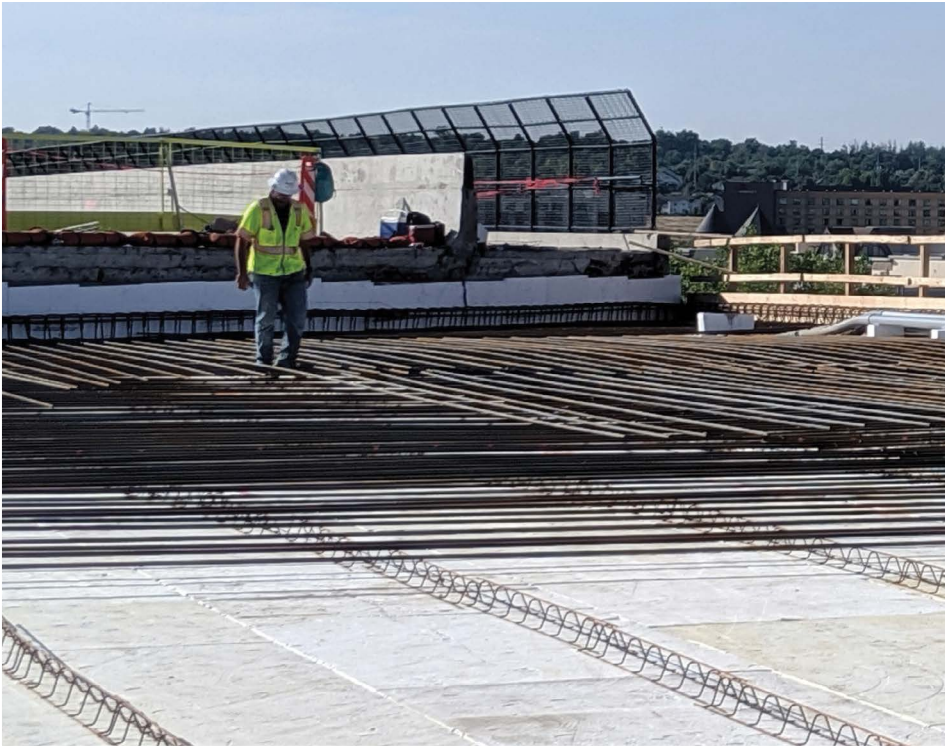
Crews assemble the rebar mat that will reinforce the concrete slab that rests on top of the Geofoam structure.

Embankment construction during September 2019 went smoothly. The refrigerator-size Geofoam blocks replaced the earthen embankment by being stacked in an interlocking pattern. It was critical that the blocks be fitted tightly together to minimize the compression of the structure. When stacking was complete, the Geofoam was protected with a membrane and a concrete panel wall. The roadway deck was placed on the Geofoam, while the Colorado DOT engineers carefully measured the compression

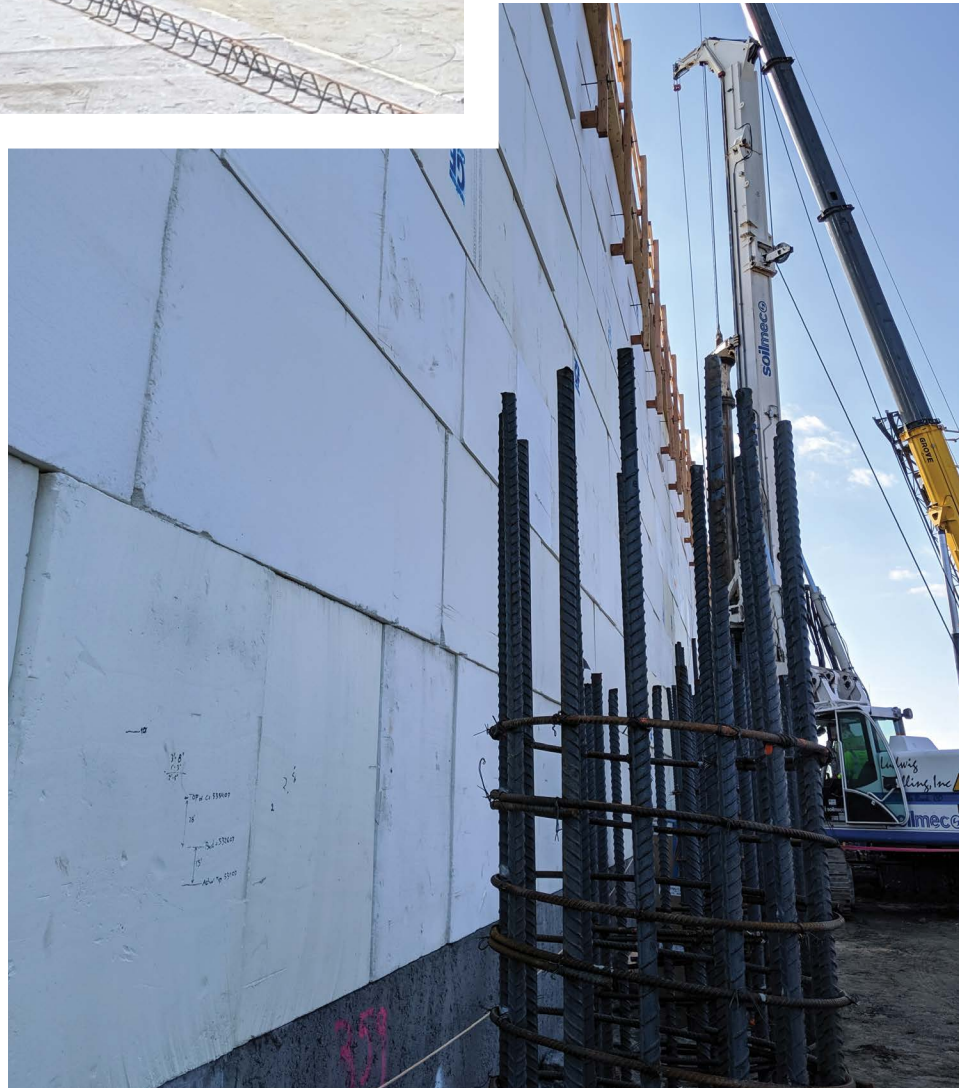
Precisely stacked Geofoam blocks form the face of the new structure. A steel-reinforced concrete caisson is one in a series that will support the precast concrete panels that protect the Geofoam wall.
