Roller-Compacted Concrete: Recent Research and Development

Webinar
November 30, 2016
2:00 – 3:30 PM Eastern Time

RCC Pavement Surface Performance South Carolina Experience

Roller compacted Concrete

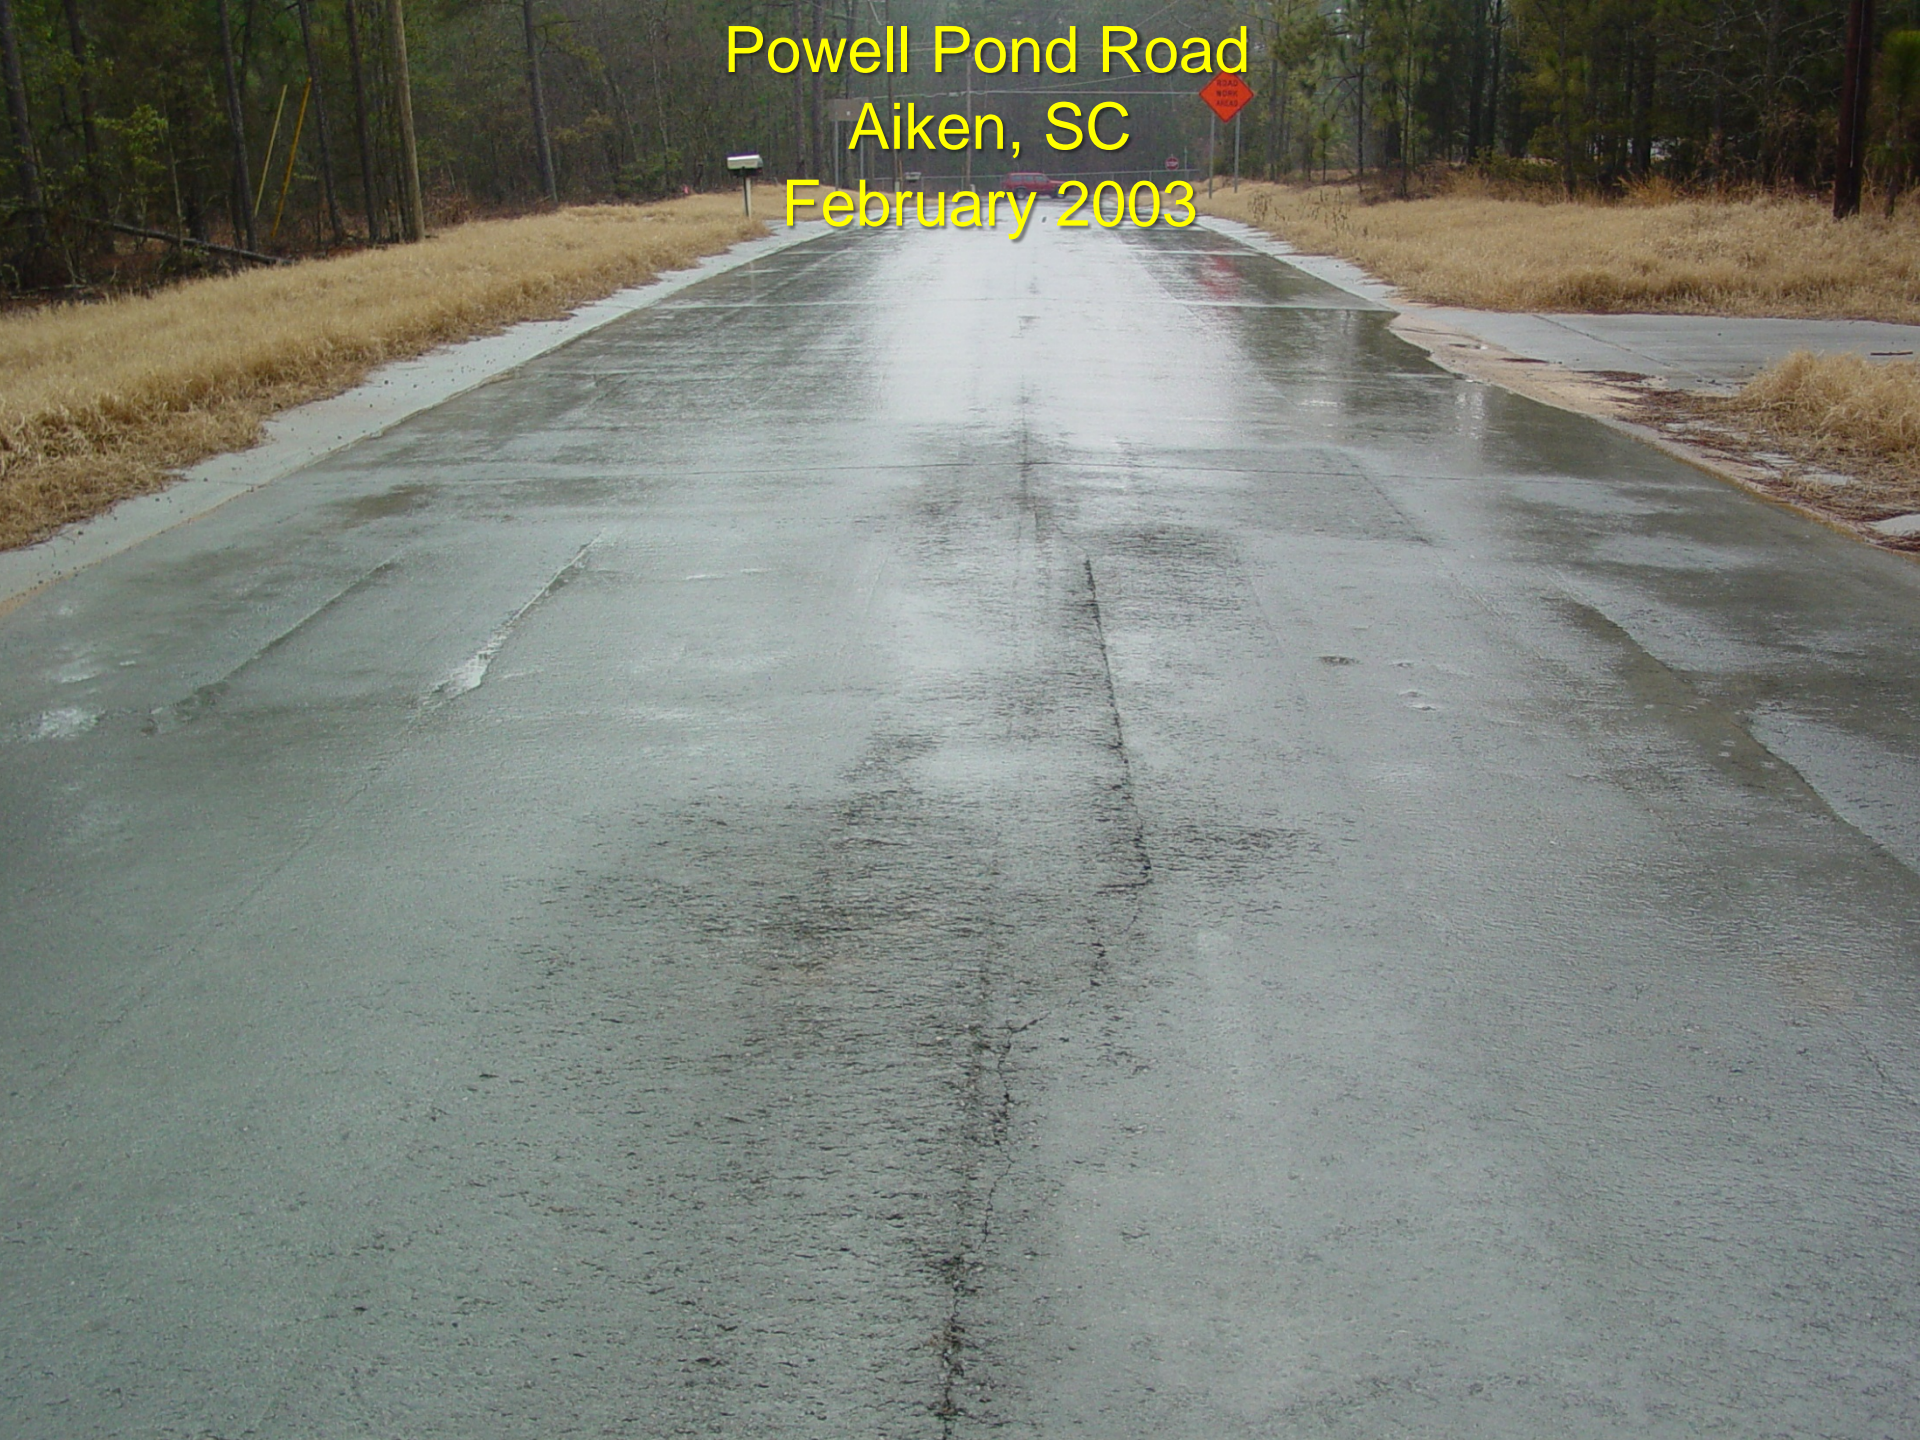
Powell Pond Road
Aiken, SC
February 2003

- First project had natural RCC texture.
- Was a very “tender” mix prone to shallow tension cracks at surface. Also had some coarse areas.
- Based on asphalt experience, there were concerns that the surface would not be durable.

- In a wet, non-freeze climate like SC, natural RCC surfaces are generally unaffected by environmental factors in the 8 to 10 year timeframe.
- RCC can be successfully diamond ground, but the surface needs to be sound prior to grinding.
- Ground surface also appears durable if no other problems with RCC exist.

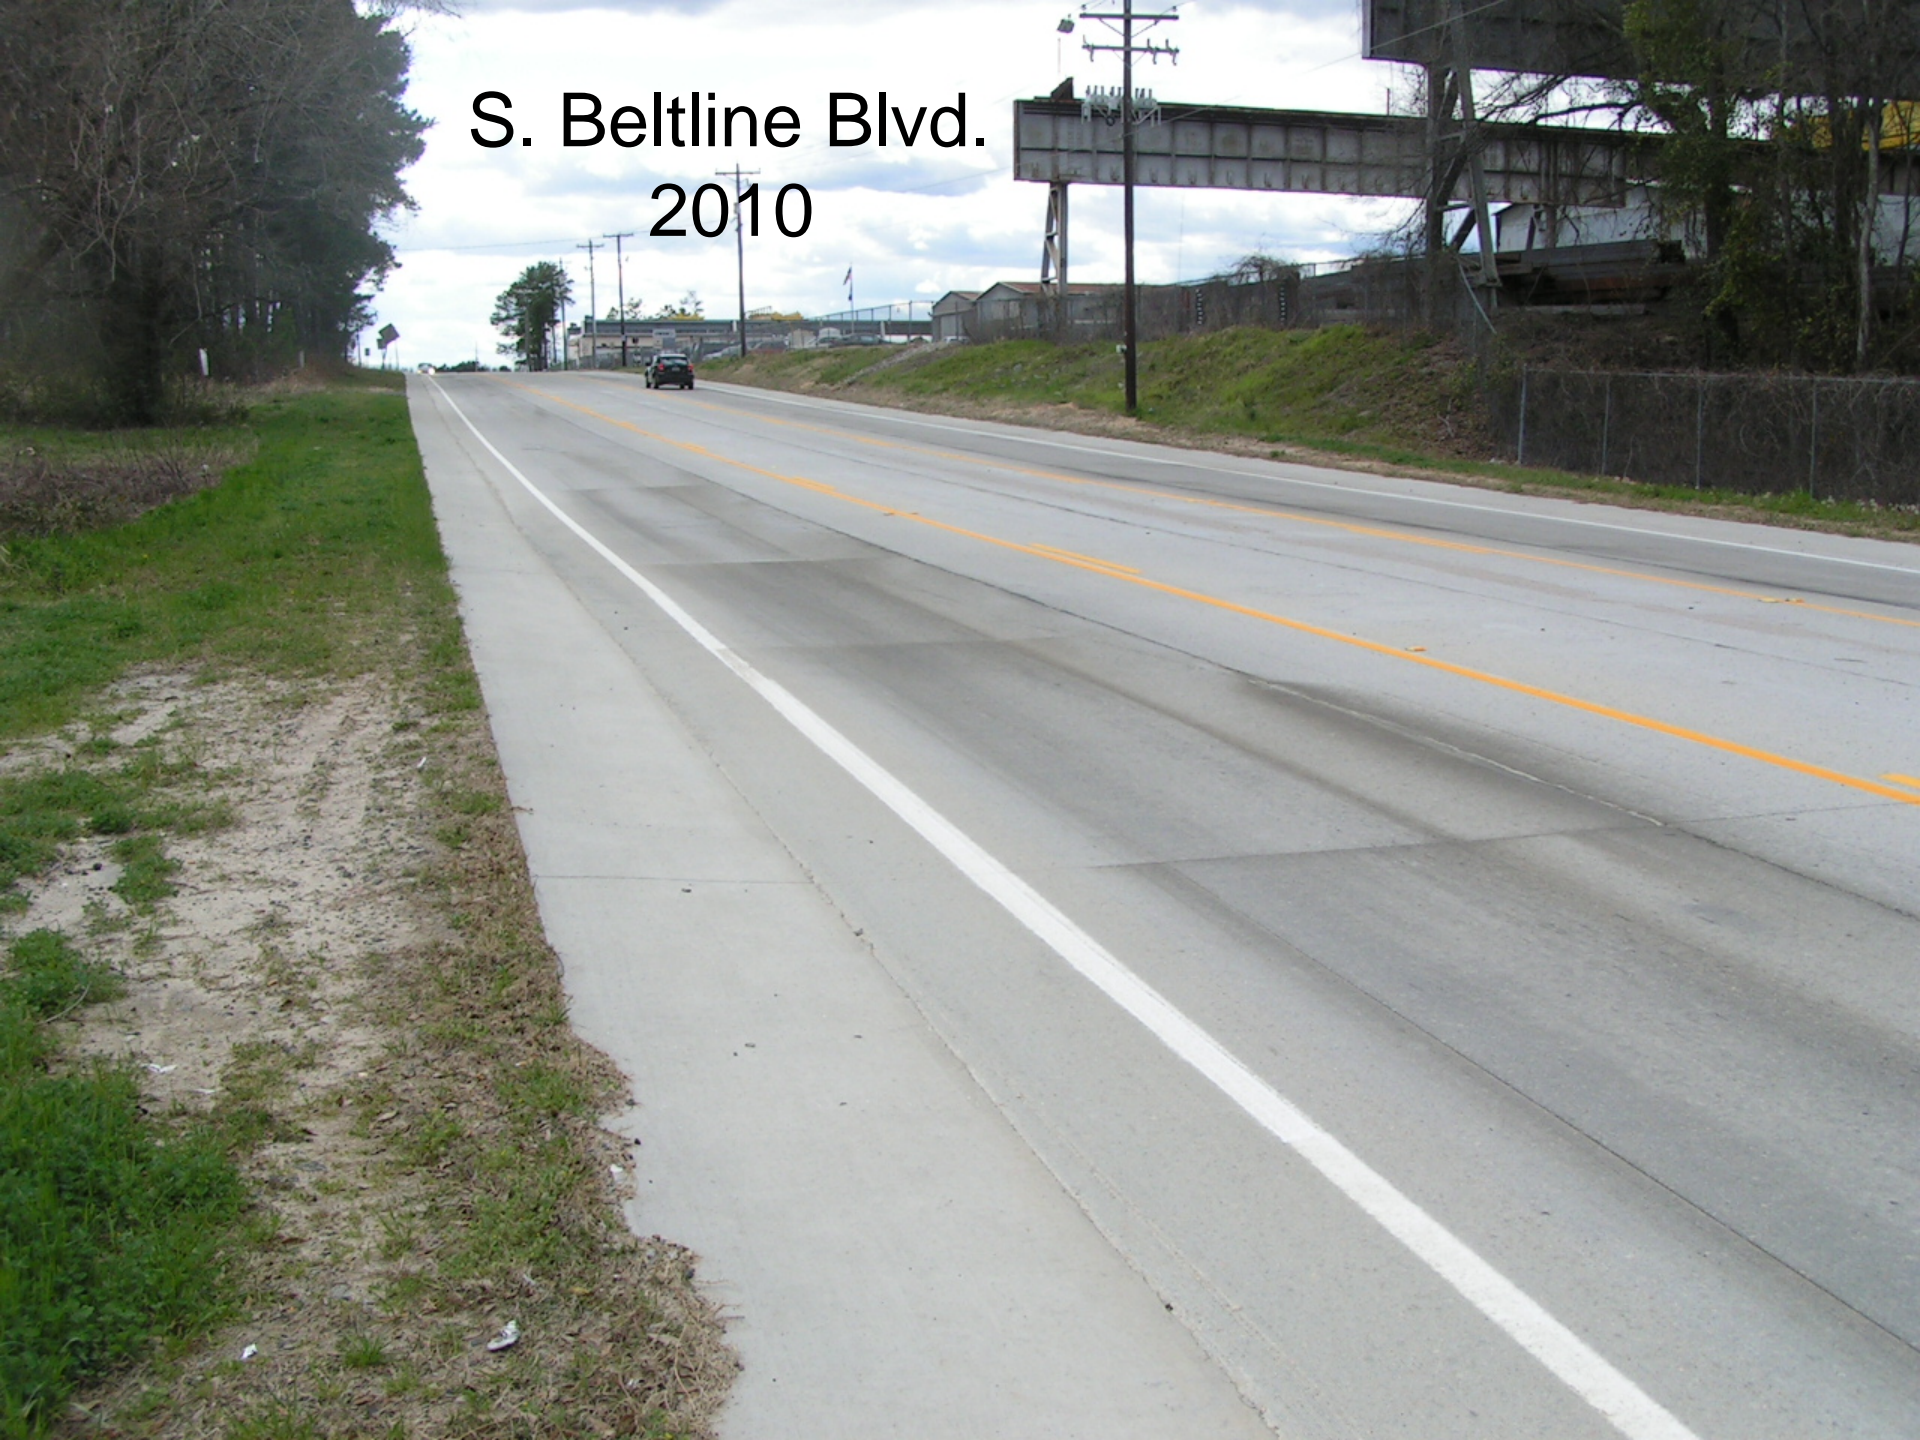
S. Beltline Blvd. 2010

- SCDOT's second diamond ground project, done same year as US-25.
- Did not go well...
- Numerous problems encountered with QC, unfortunate decisions made regarding construction.

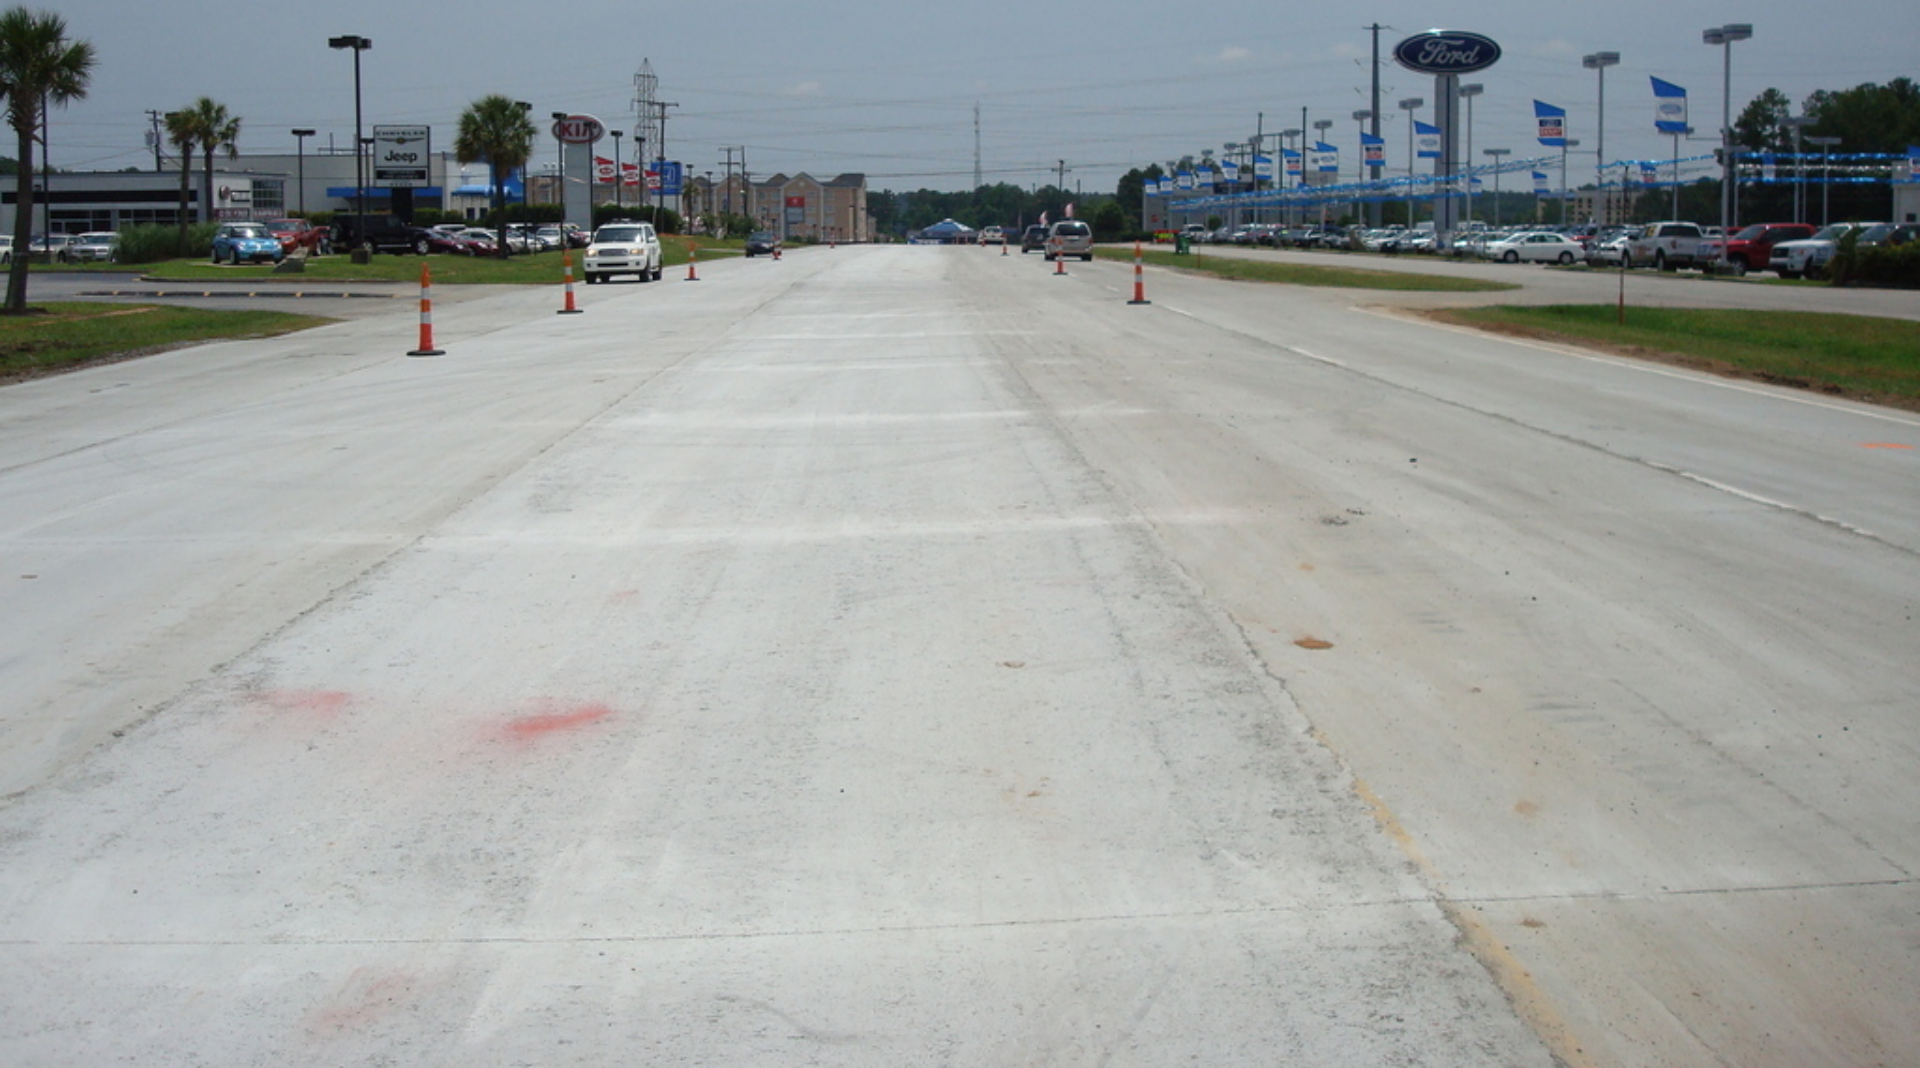
Greystone Blvd. - 2009

- Done on same contract as S. Beltline.
- Asphalt surface.
- Reflection cracking typical of other projects.

- When overlaid with a single lift of asphalt, RCC can cause reflective cracking promptly within the first year.
- Cracking can continue to appear for several years after completion.
- Surface cracking does not appear to cause deterioration in underlying RCC or subgrade. (YMMV in harsher climates.)

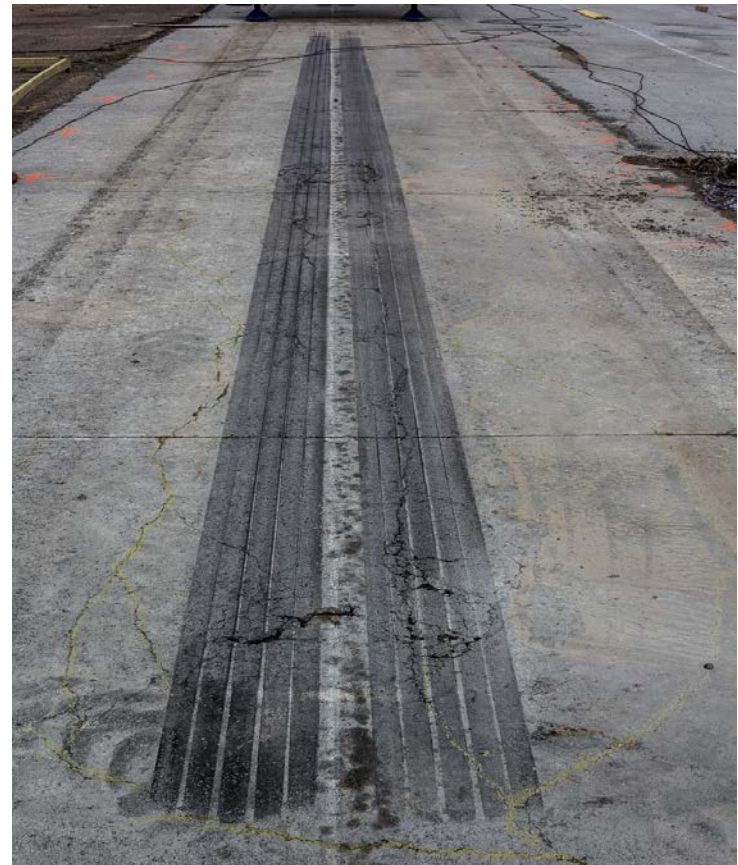
706,500 Passes

Distress Observed (4+8.5RCC) – Section 6

- Visual Distresses
- Longitudinal cracks were observed along the wheel path and at the middle of the tire print
- Pumping action was observed through the cracks and joints
- 19.2 million ESALs to failure
- ***0.7 million ESALs predicted***

**Pavement Condition at the
end of testing**

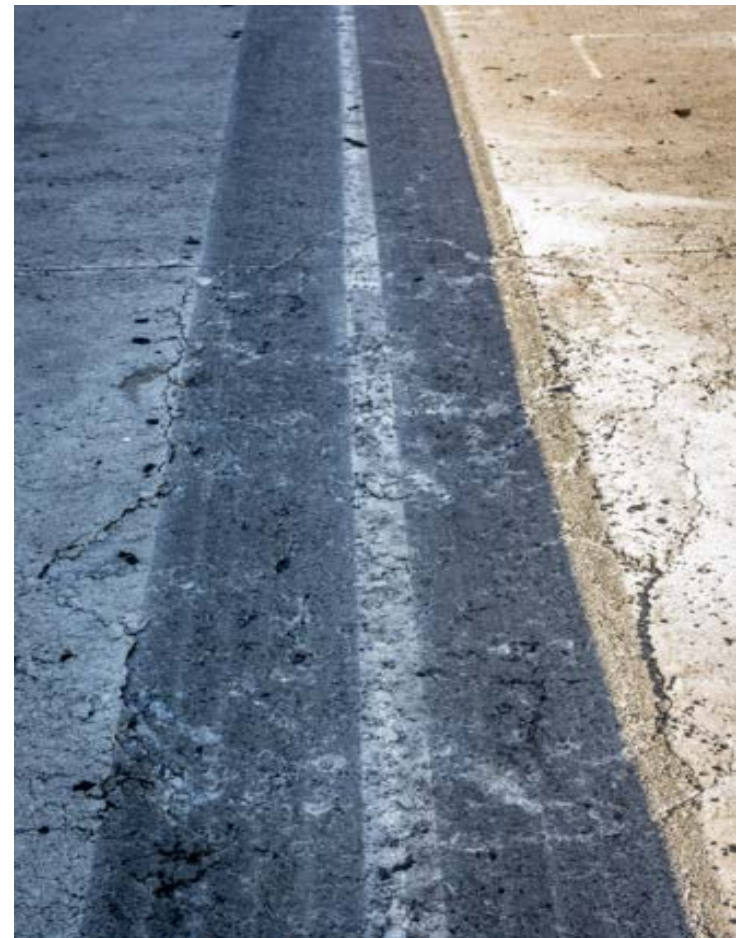
637,000 Passes

Distress Observed (6+12RCC) – Section 2

- Longitudinal cracks
- Pumping and Local failure
- About 19 million ESALs to failure
- ***Predicted 1.9 million***

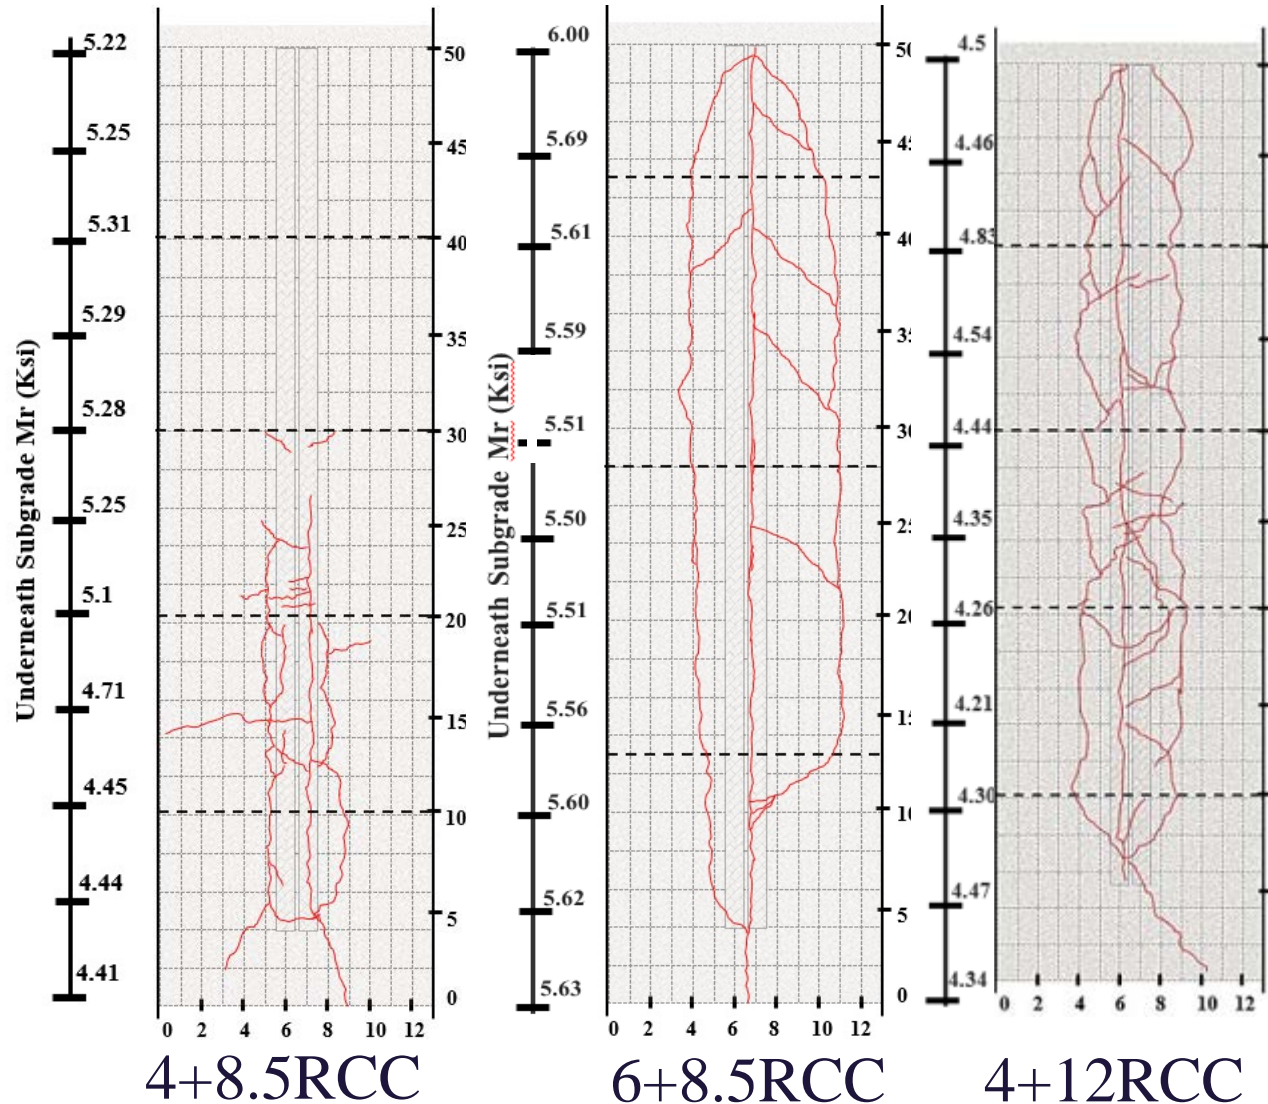
Comparison of Cracking Pattern of Failed RCC Sections

- Crack initiated at the weakest subgrade location
- Cracking pattern for thicker section was much wider than the thinner section
- Uniform subgrade resulted in a final cracking failure covering the entire loading area for 6+8.5RCC & 4+12RCC

- ❑ RCC sections failed under fatigue cracking. The observed fatigue cracks were initiated first either in the middle or at the edge of the tire print along a longitudinal direction;
- ❑ The width of fatigue cracking pattern was found much wider for 6-in RCC sections (e.g. 6+8.5RCC) than that for 4-in. RCC sections
- ❑ RCC-Pave fatigue models were found not suitable for the fatigue life prediction of thin RCC sections evaluated.
- ❑ Two preliminary fatigue models for thin RCC pavement fatigue analysis have been developed
 - ❑ Will finalize the developed fatigue model
 - ❑ Will perform cost-benefit analysis
 - ❑ Will build a Finite element model to simulate thin-RCC pavement

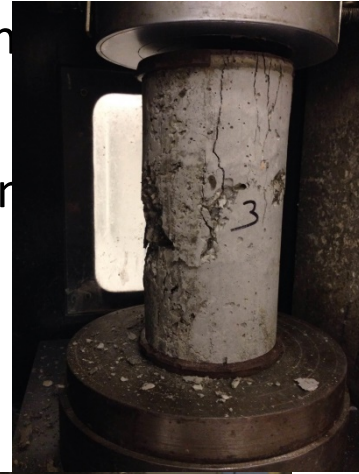
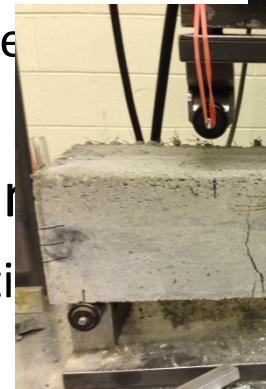
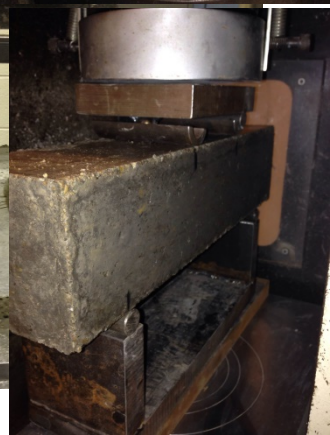
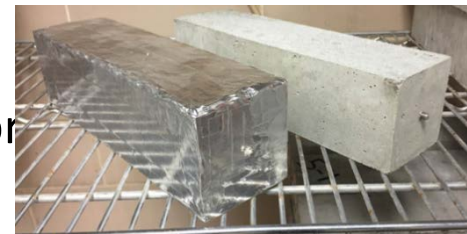
- 6x12" Cylinders: strength and DCT fracture testing
 - ASTM C1435: Molding RCC in cylinder molds using a vibrating
 - 5.5" diameter compaction plate
 - RCC placed in 5 lifts, each lift vibrated until visible mortar rise (i.e. about 3-5 seconds)
- 4x8" Cylinders: strength testing
 - 3.5" diameter compaction plate
 - RCC placed in 3 lifts, each lift vibrated until visible (i.e. about 3 seconds)
- 6x6x21" MOR Beams: flexural strength and modulus of elasticity
 - Draft ASTM standard, placed in 2 lifts with vibration
- 4x4x16" MOR Beams: flexural strength
 - RCC placed in 2 lifts with vibrating hammer
- 3x3x11.25" Shrinkage Beams: drying shrinkage
 - RCC placed in 2 lifts with each lift vibrated with the vibrator and a rectangular plate for 5 seconds.

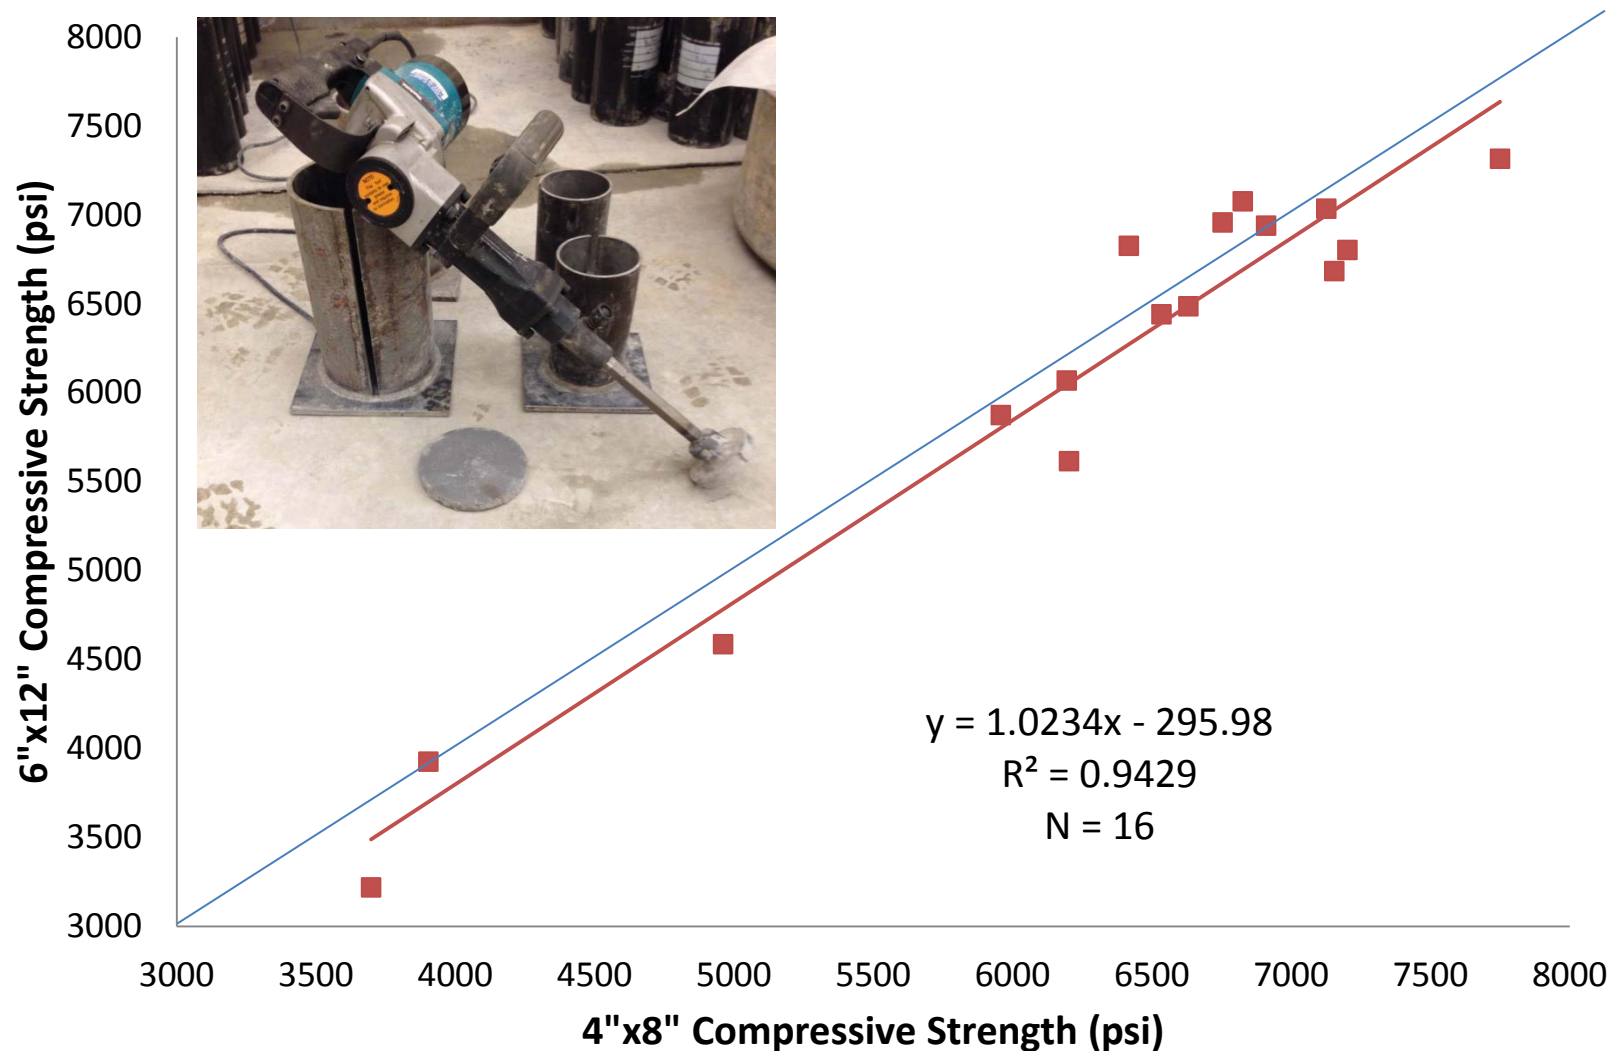
Potential for 4x8" Cylinders for QC/QA

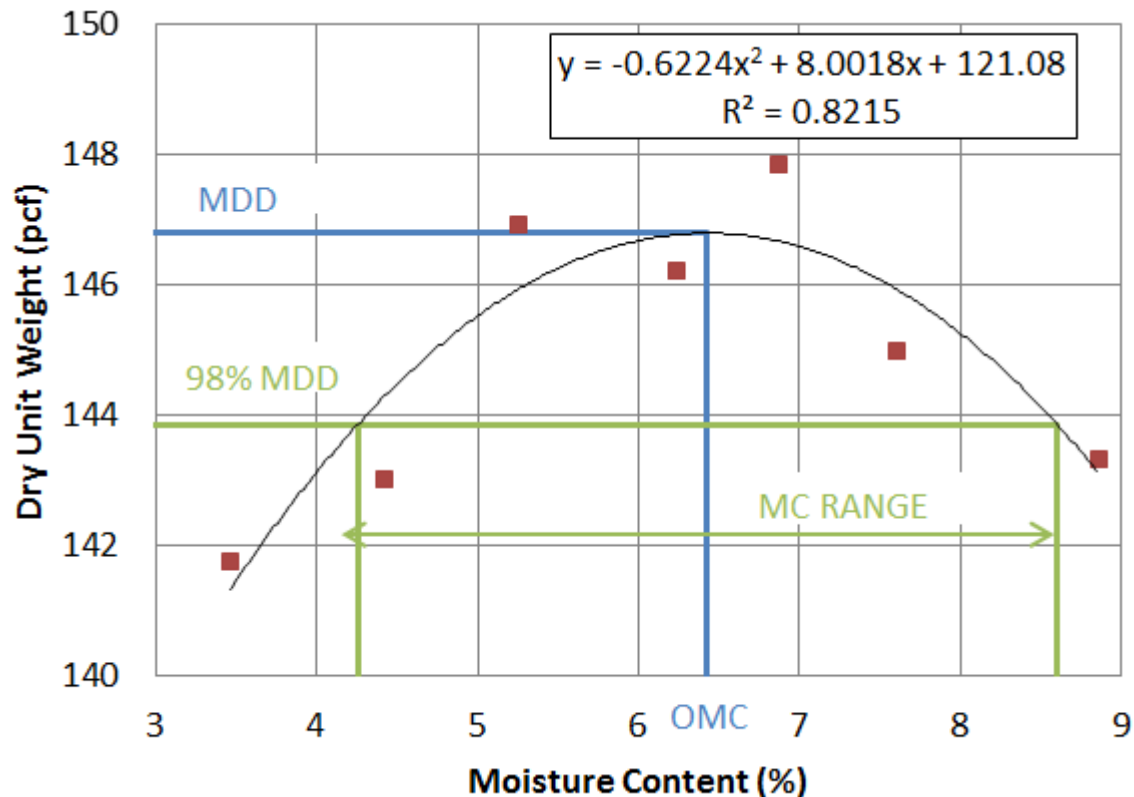
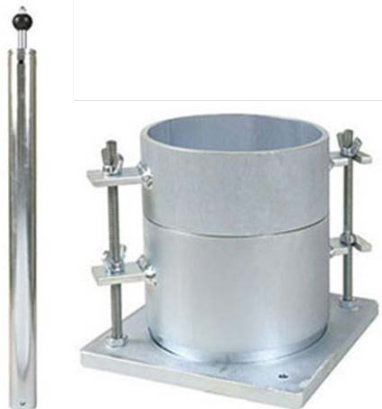
Mix Design: Moisture Density Relationship

- Modified Proctor tests were conducted to determine maximum dry density (MDD) and optimum moisture content (OMC) for each mix

- OMC: 6.1 – 7.2%
- MDD: 145.4 – 152.1 pcf
- MC range of **2.9 – 5.1%** to achieve 98% MDD

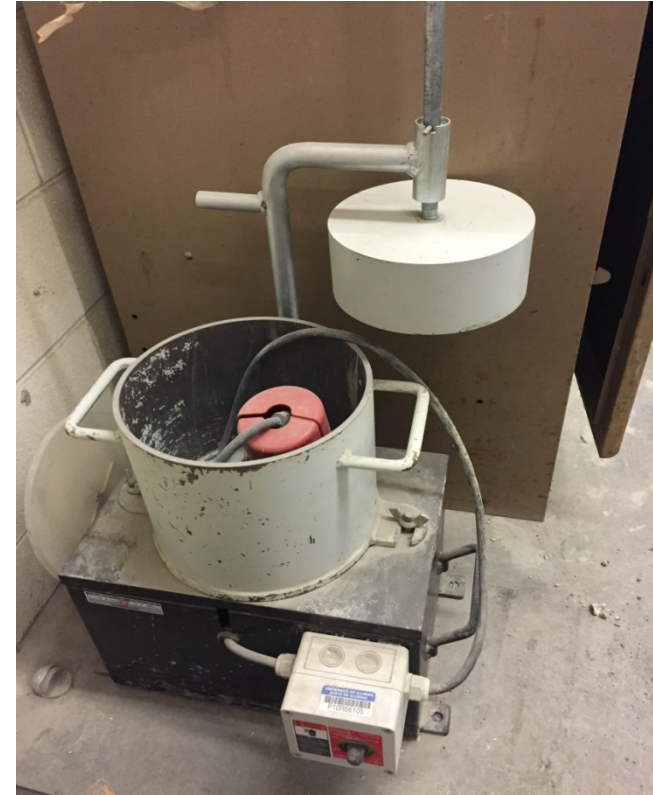
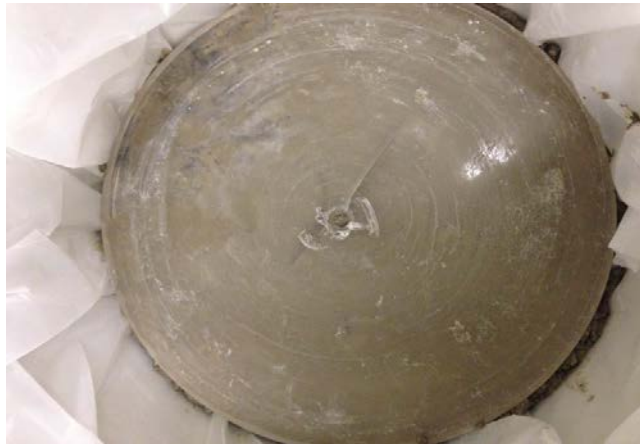
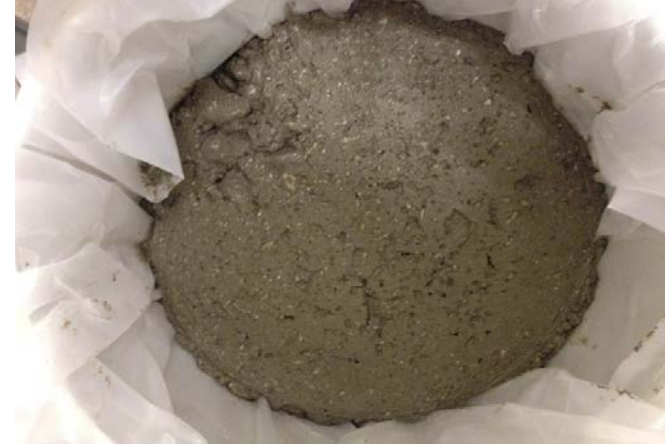
Effect of Aggregate Gradation – Fresh Properties

- **Modified Proctor Testing:**
 - Similar MDD for all 16 gradations
 - 2,330 to 2,440 kg/m³
 - Similar OMC for all 16 gradations
 - 6.1 to 7.1% with most being 6.4 to 6.8%
- **Vebe Testing (right):**
 - Measure time to form mortar ring
 - Typically under 25 seconds for low fines gradations
 - Higher aggregate fines mixes had 30-40 seconds
 - ACI recommends 30-40 seconds for RCC pavements

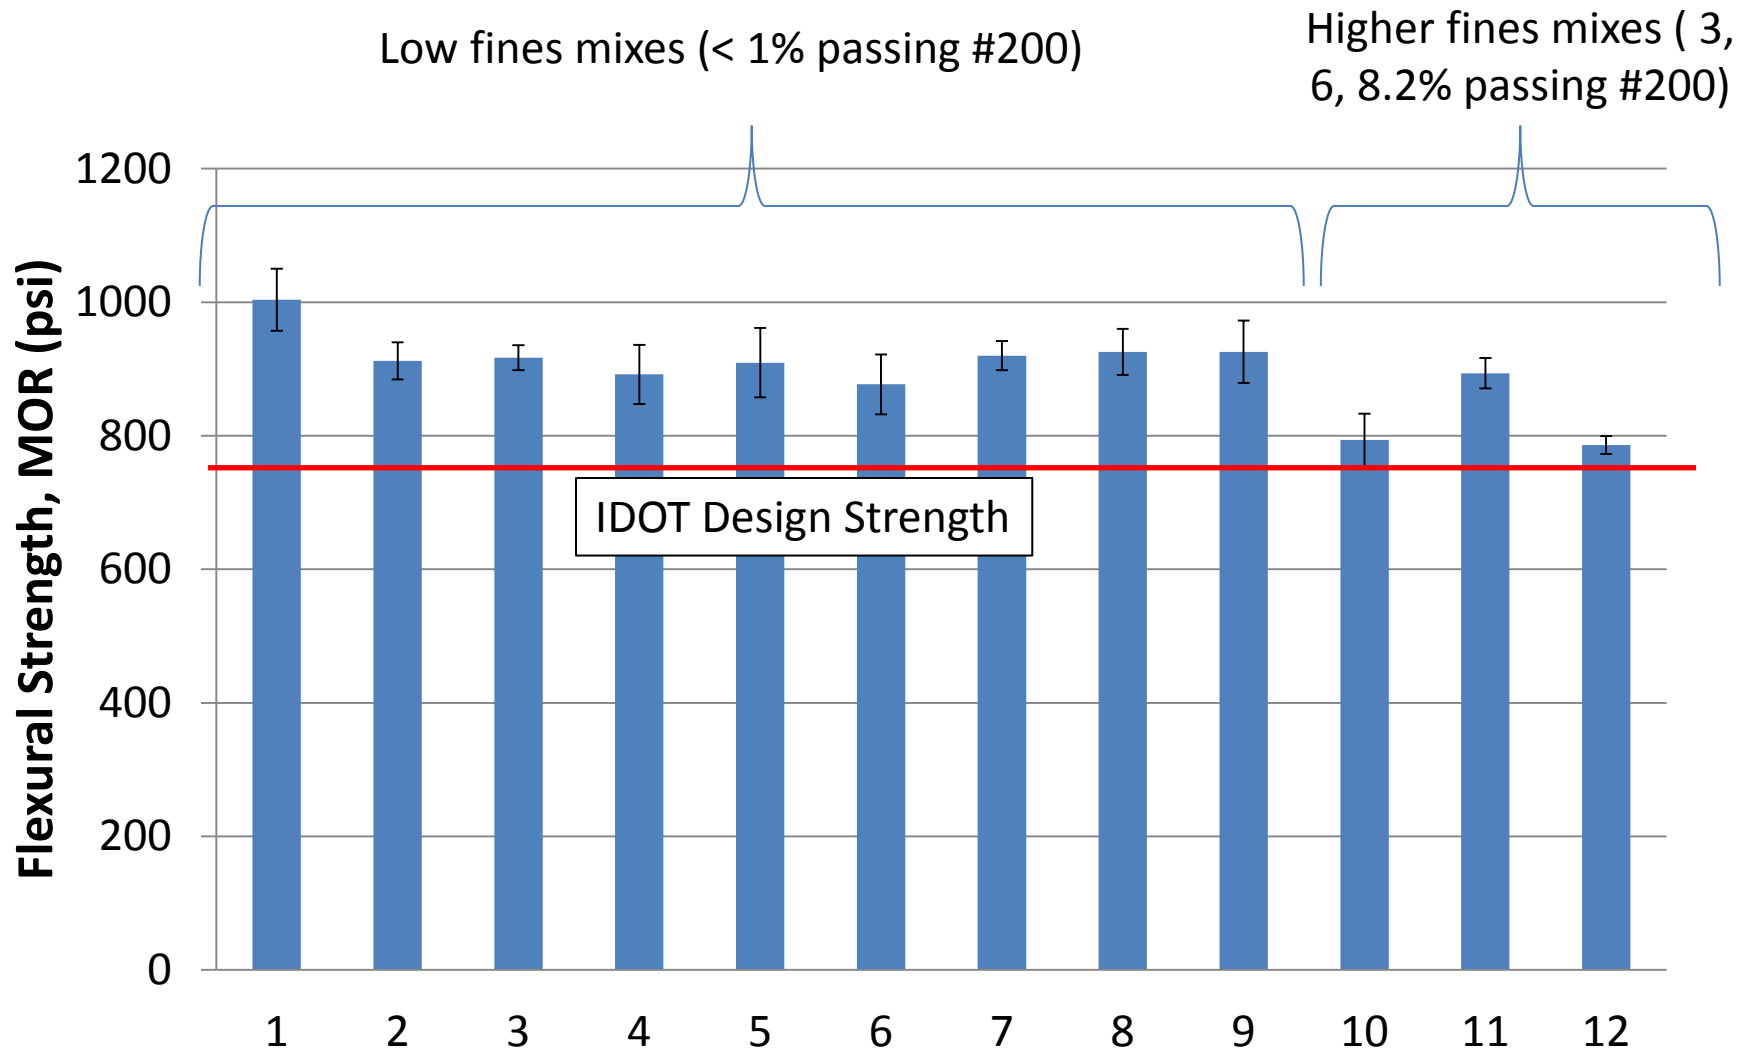
28-Day Flexural Strengths (4x4x16")

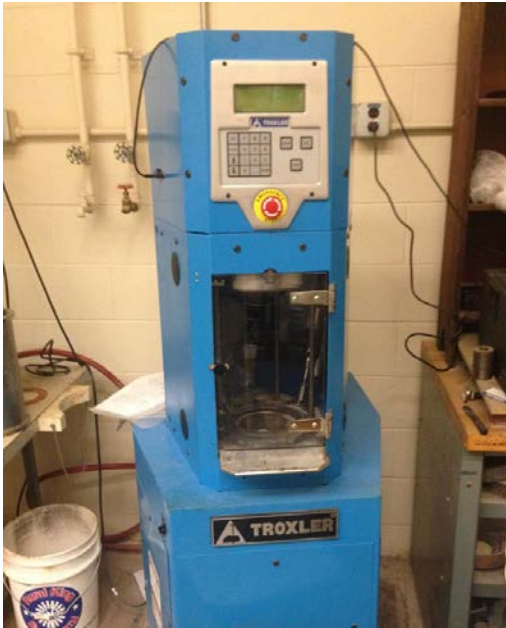
Gyratory Compaction of RCC

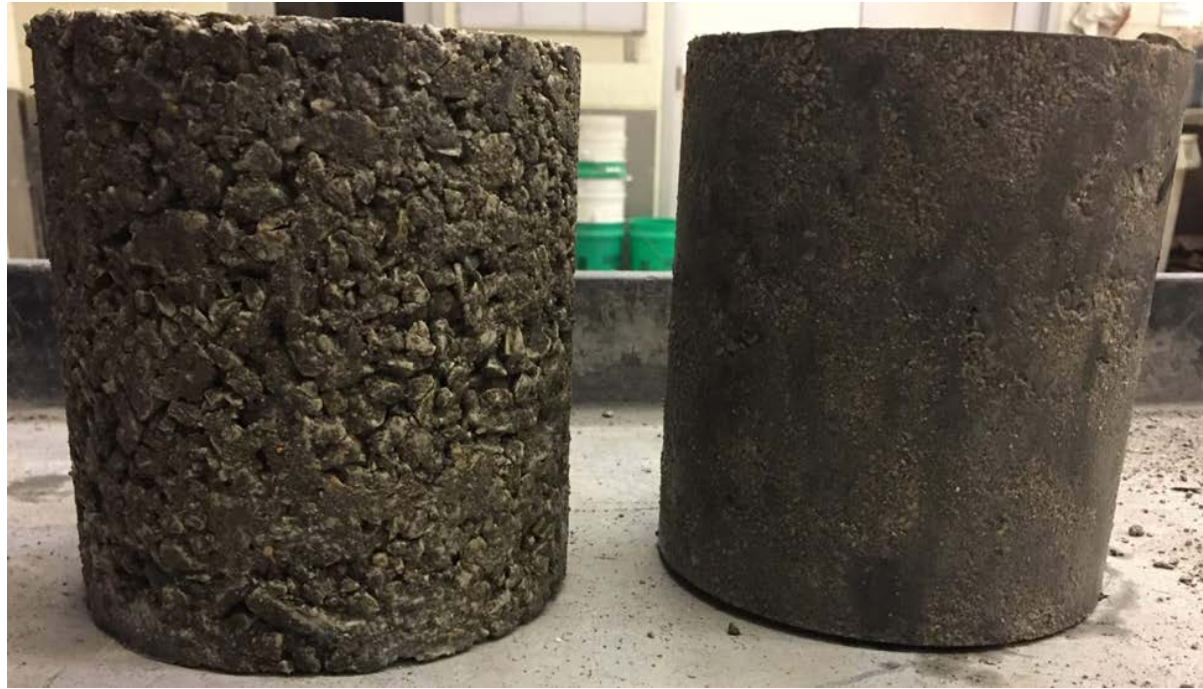
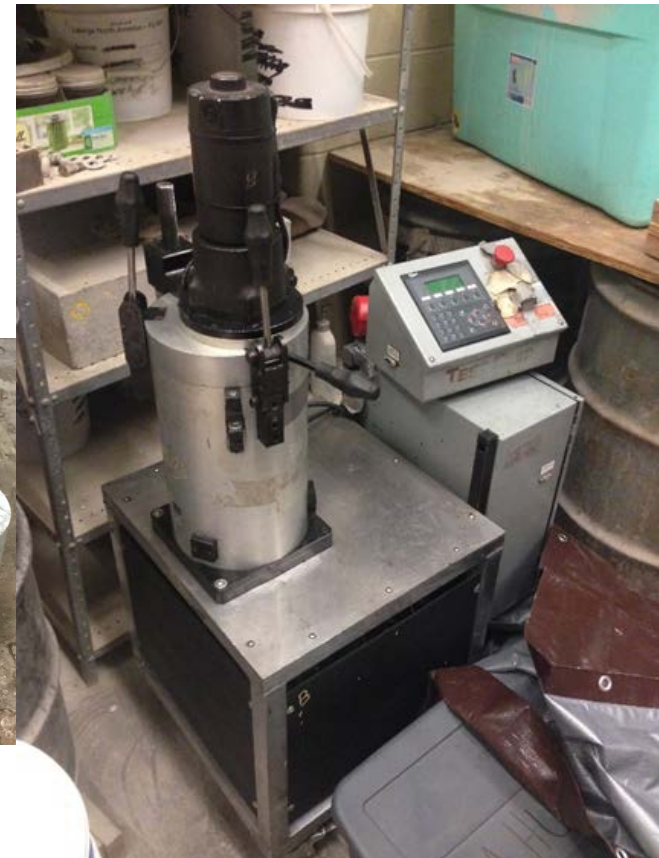
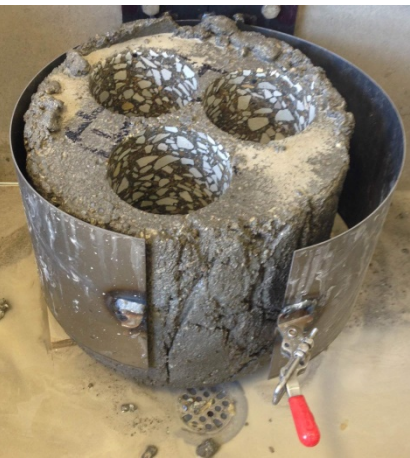
RCC Compaction Methods - Specimens
