TRANSPORTATION RESEARCH BOARD

Using Artificial Intelligence to Predict Deterioration of Highway Bridges

February 22, 2021

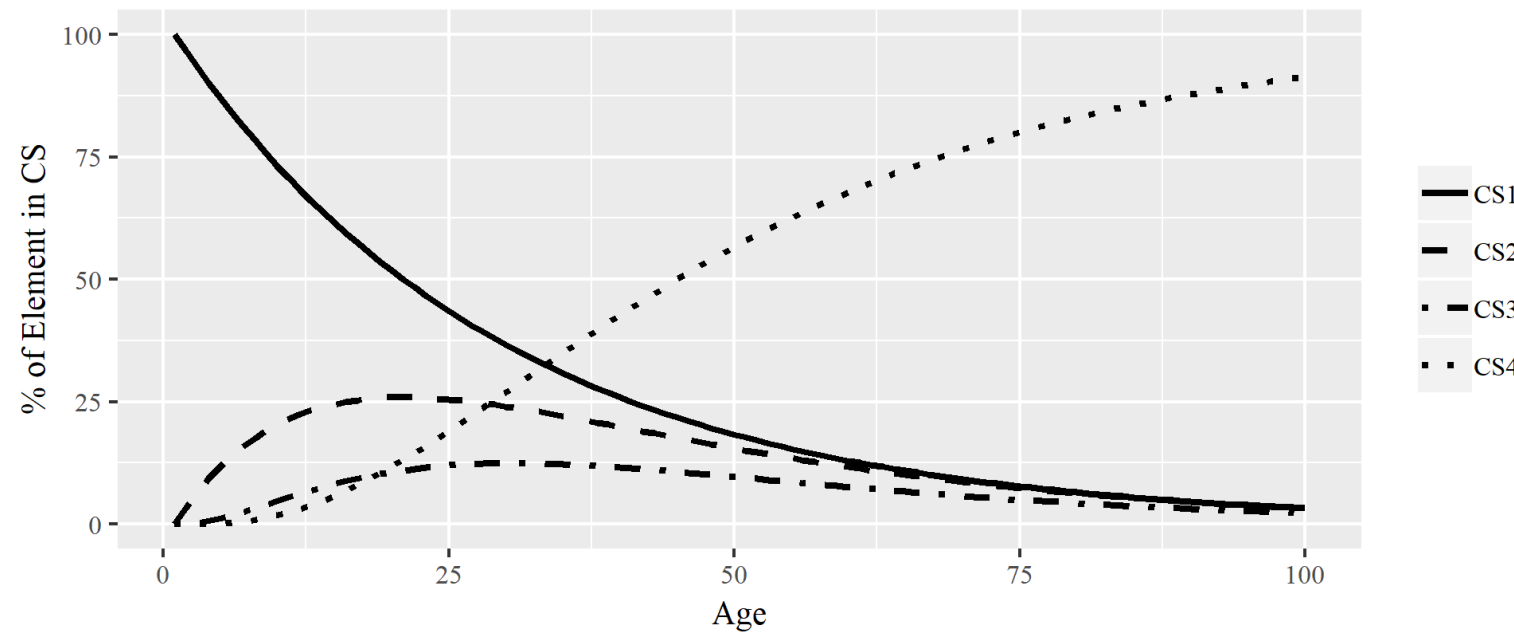
Predicted transition probabilities
from one condition state to the next

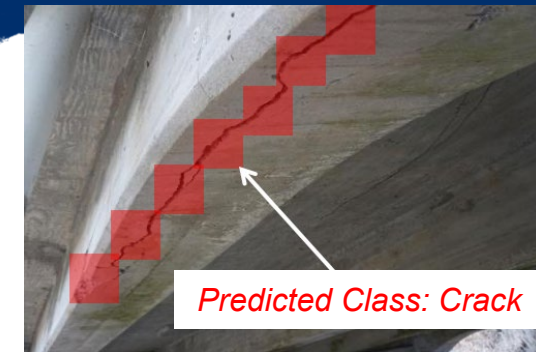
(a) Image Classification

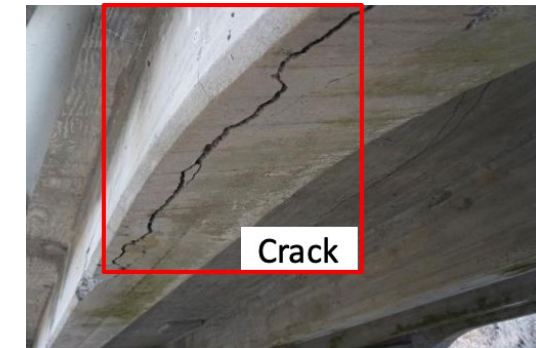
(b) Object Detection

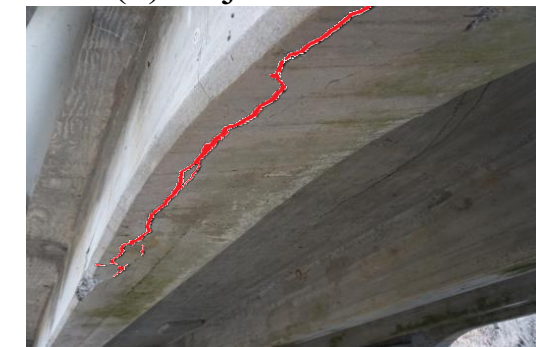
(c) Semantic Segmentation

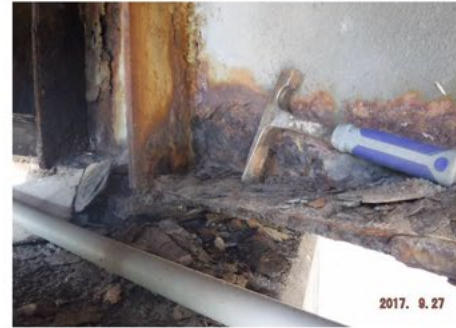
Photo #13

Looking at Span F,
Pier 5, Bay 12 side of
Beam 12.

Up to 1/2" loss of
section (previously
1/4" loss of section)
on Bay 12 side of
bottom flange x 2'
long. Web has up to
1/4" loss of section x
6" high, with up to
1/8" loss of section x
full height behind
bearing stiffener.

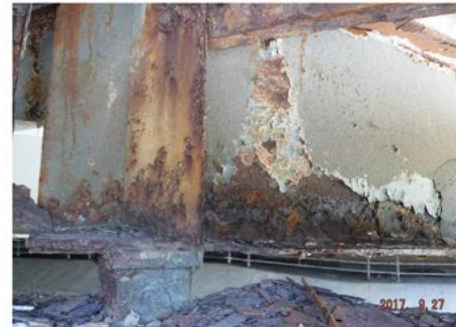
Photo #14

Looking at Span G,
Pier 6, Bay 13 side of
Beam 13.

Up to 3/8" loss of
section x 3' long x 8"
wide on bottom flange
due to water/debris
channeling and
localized severe
corrosion with up to
100% section loss 12"
long x 6" wide (3/4"
original flange).
Bottom flange has a 4"
long x 3" wide
perforation near
bearing. Adjacent
beam web has up to
7/16" loss of section x
6" high x 2' long.

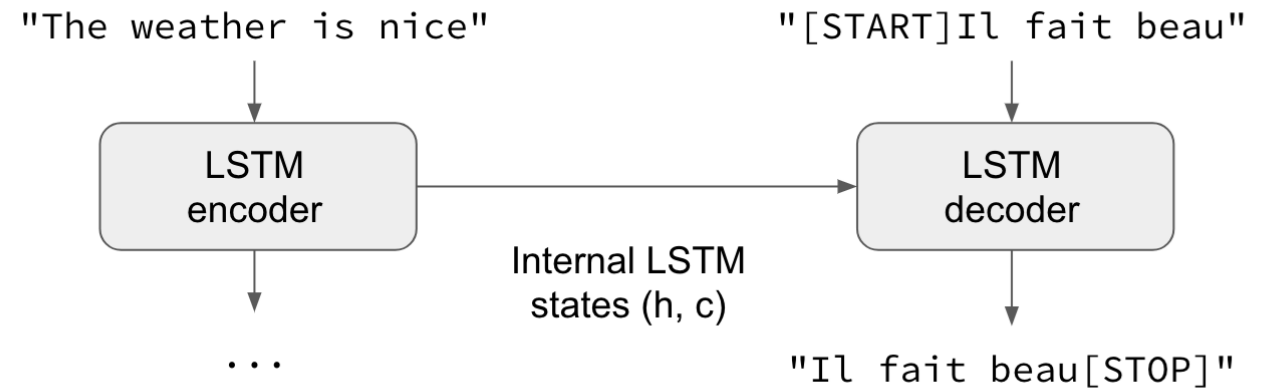
- State-of-the-art performance in time series prediction, language translation and speech recognition
- LSTMs (Gers et al., 2000) can capture dynamics of the sequence
- Current decisions are affected by the previous states

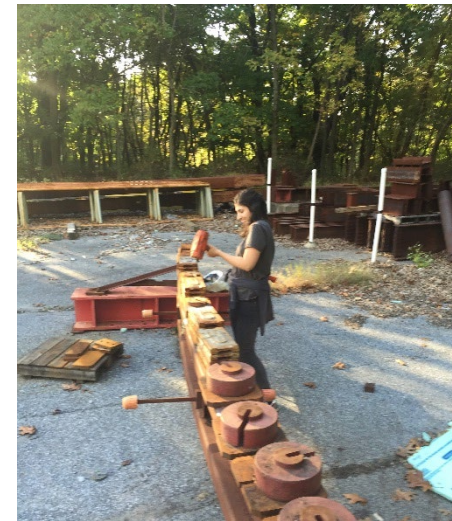
Excitement by using hammer

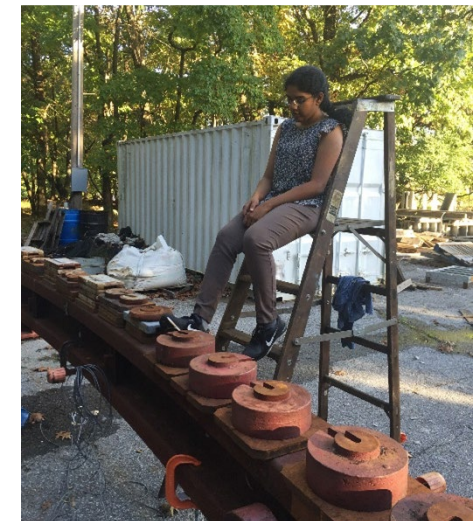
Excitement by stepping

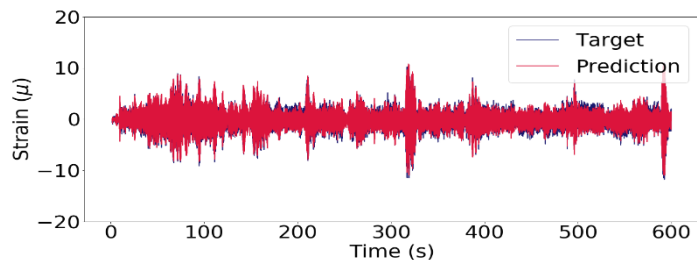
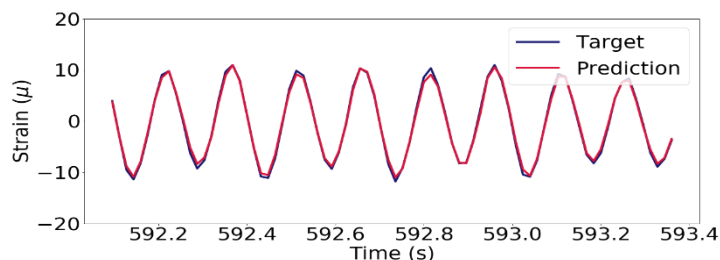
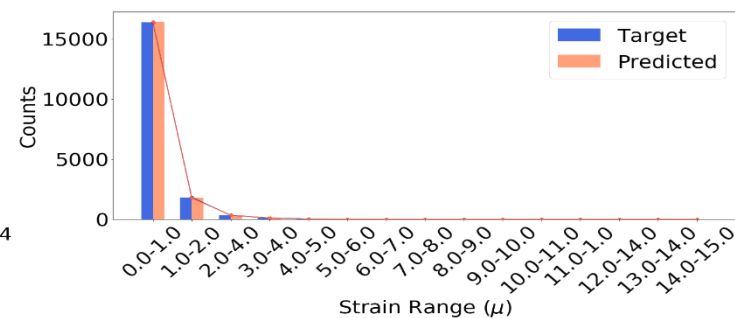
Type I

10-min time history

RMSE = 0.55 $\mu\epsilon$

Zoomed time history

Rainflow counting histograms

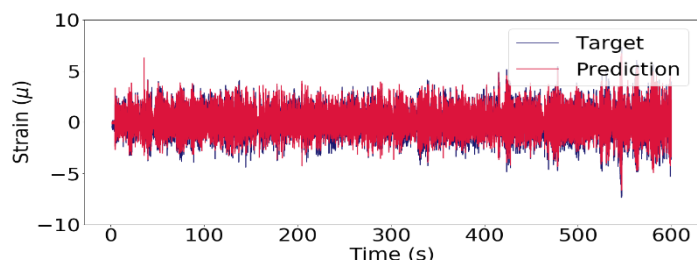
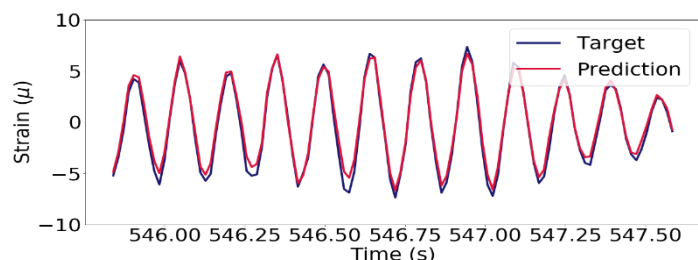
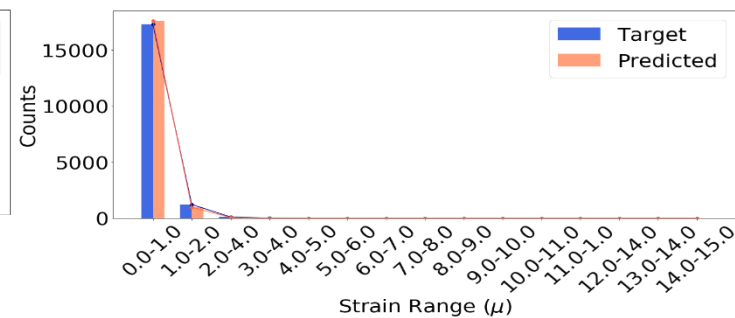
Type II

RMSE = 0.47 $\mu\epsilon$

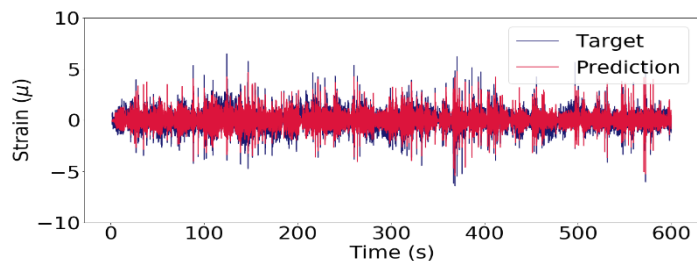
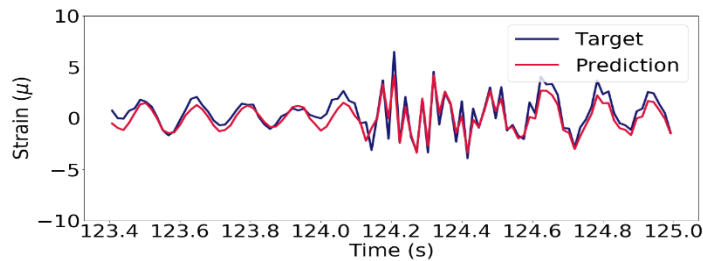
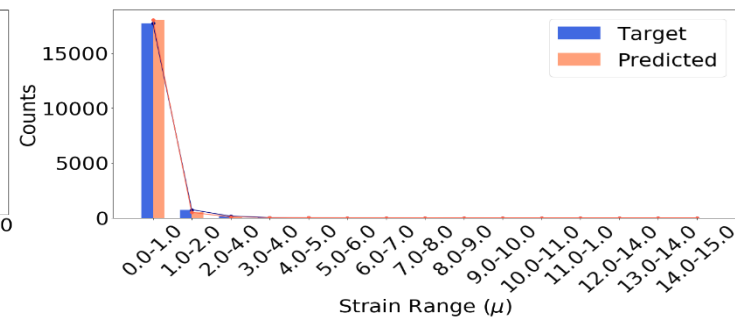
Type III

RMSE = 0.48 $\mu\epsilon$

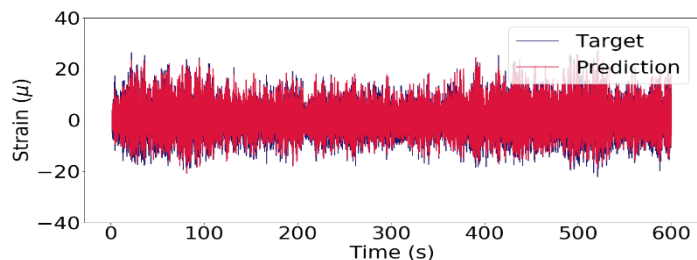
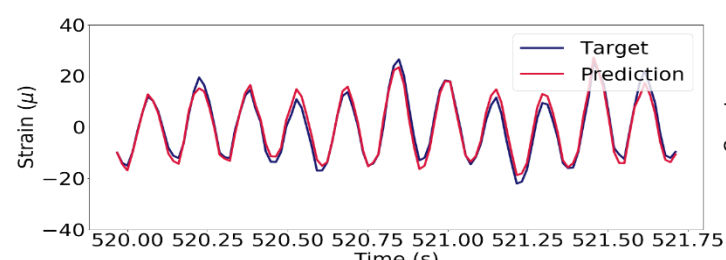
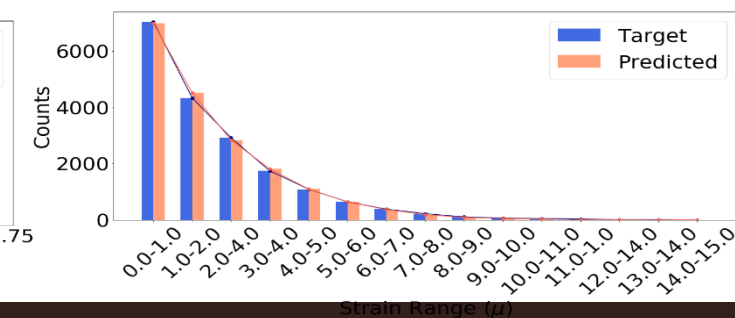
Type IV

RMSE = 2.13 $\mu\epsilon$
