TRB Webinar: T-1 Steel, I-40 Bridge, and the Way Forward

T-1 Steel, I-40 and the Way Forward

Non-Destructive Evaluation of Fracture Critical Members Fabricated from AASHTO M244 Grade 100 (ASTM A514/A517) Steel

NDT of T-1 Steel and Lessons Learned

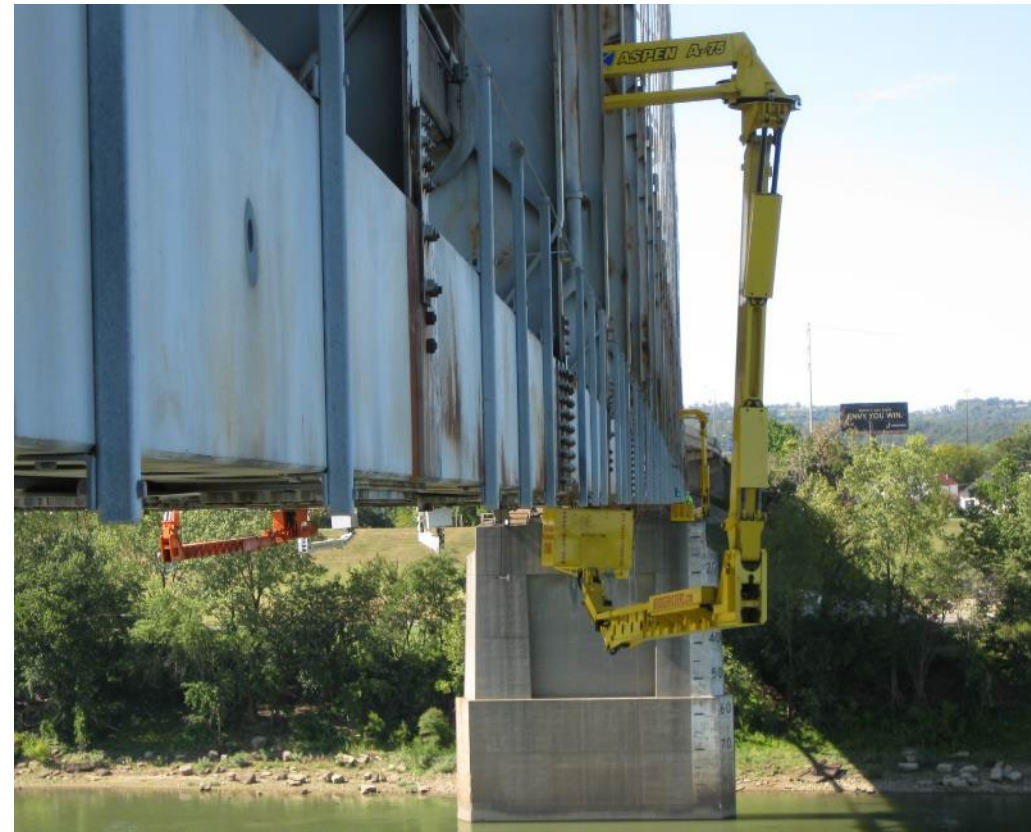
Inspection & Testing - 2011

- Hands-on visual inspection of weld metal on the tie girder
 - What can we find?
- Nondestructive testing (MT, UT, RT, X-Ray)
 - What can we find that we can't even see?
- Sampling of bridge materials
 - How strong, how tough, how big of a crack is "too big"?
- The most comprehensive visual, NDT & physical testing program ever conducted on this bridge

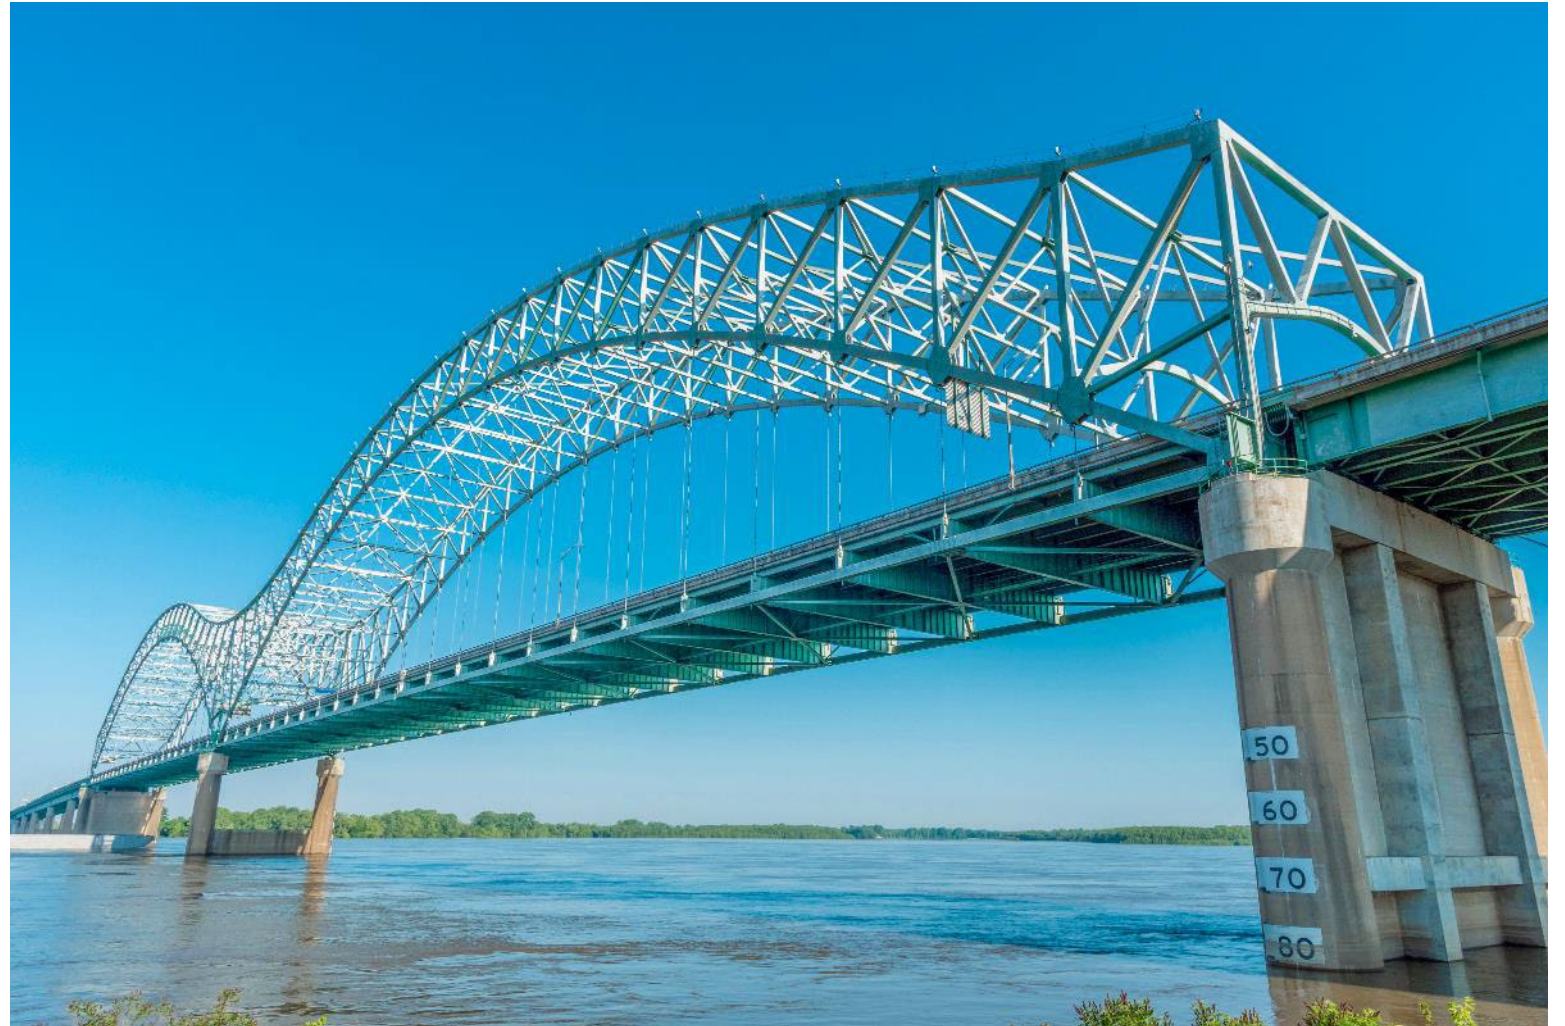
Interstate 40 Hernando de Soto Bridge

- Hernando de Soto
- Constructed 1967-1973
 - Opened August 2, 1973
- Two Span Continuous Tied Arch Bridge
 - 2 – 900ft spans
 - 109ft above the water
 - Designed by Hazlett and Erdall

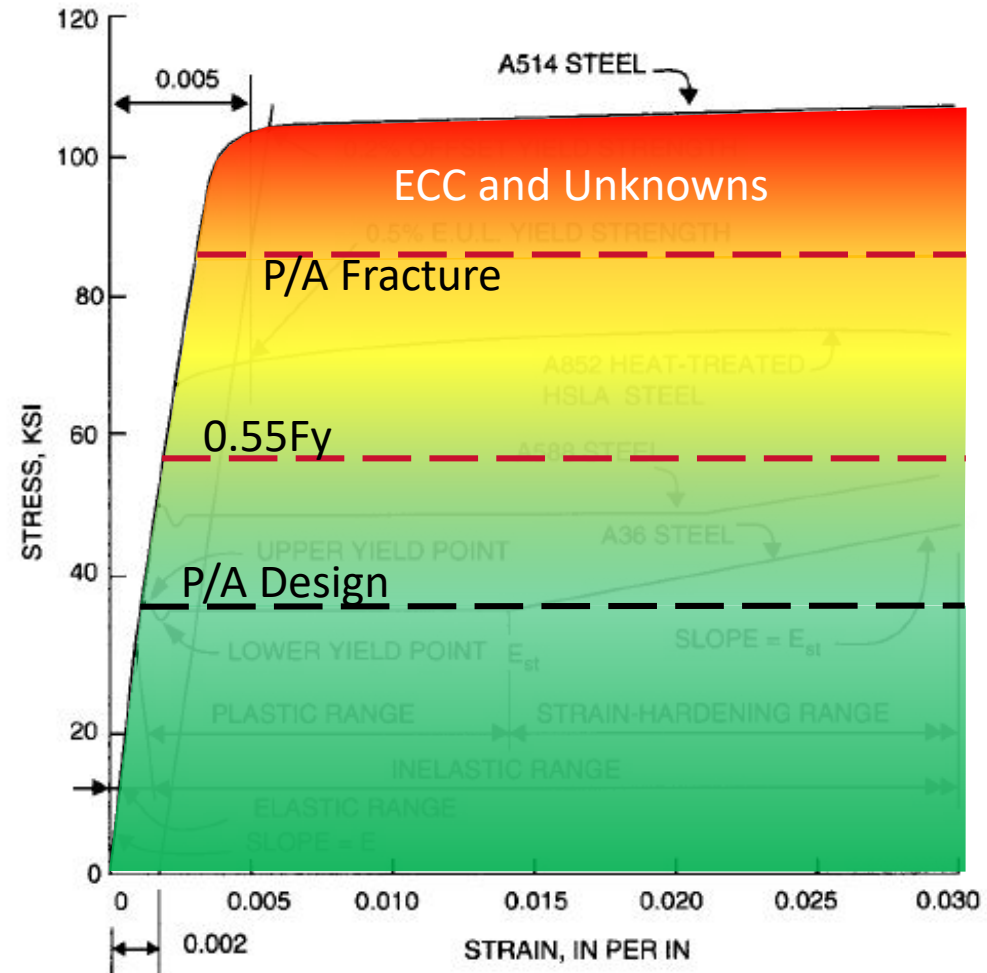
FIGURE 1.4 Partial stress-strain curves for structural steels strained through the plastic region into the strain-hardening range. (From R. L. Brockenbrough and B. G. Johnston, *USS Steel Design Manual*, R. L. Brockenbrough & Associates, Inc., Pittsburgh, Pa., with permission.)

- T1 steel = 100 ksi (+)
 - P/A design = 38ksi
- Fracture 113 in² -> 51.5in² (**45%!)**
 - P/A after Fracture = 83ksi
- Eccentric Loading
 - Refined Analysis
- Unknowns
 - Actual force in the tie

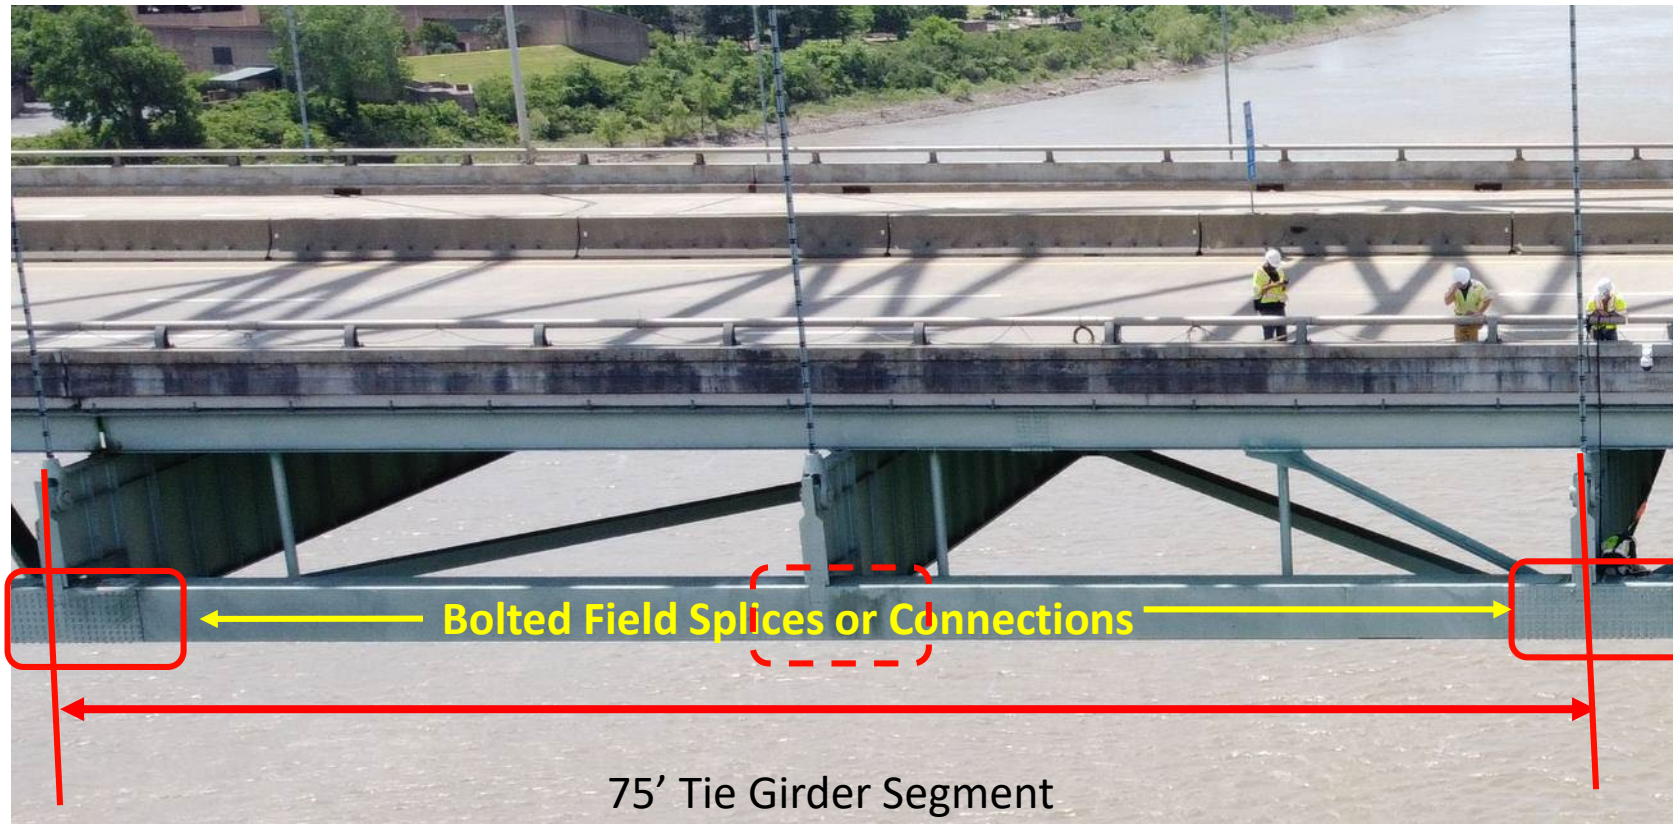
Phase 1: Stabilize the Structure

- Design Challenges for
– 100 ksi plate in tie girder
– Thin (1.375") plate section
– Geometry (twist) of c

- Design Challenges for Phase 1 –
 - 100 ksi plate in tie girder and select high truss members
 - Thin (1.375") plate sections limited bolting options due to net section limitations
 - Geometry (twist) of current tie girder impacted plating design

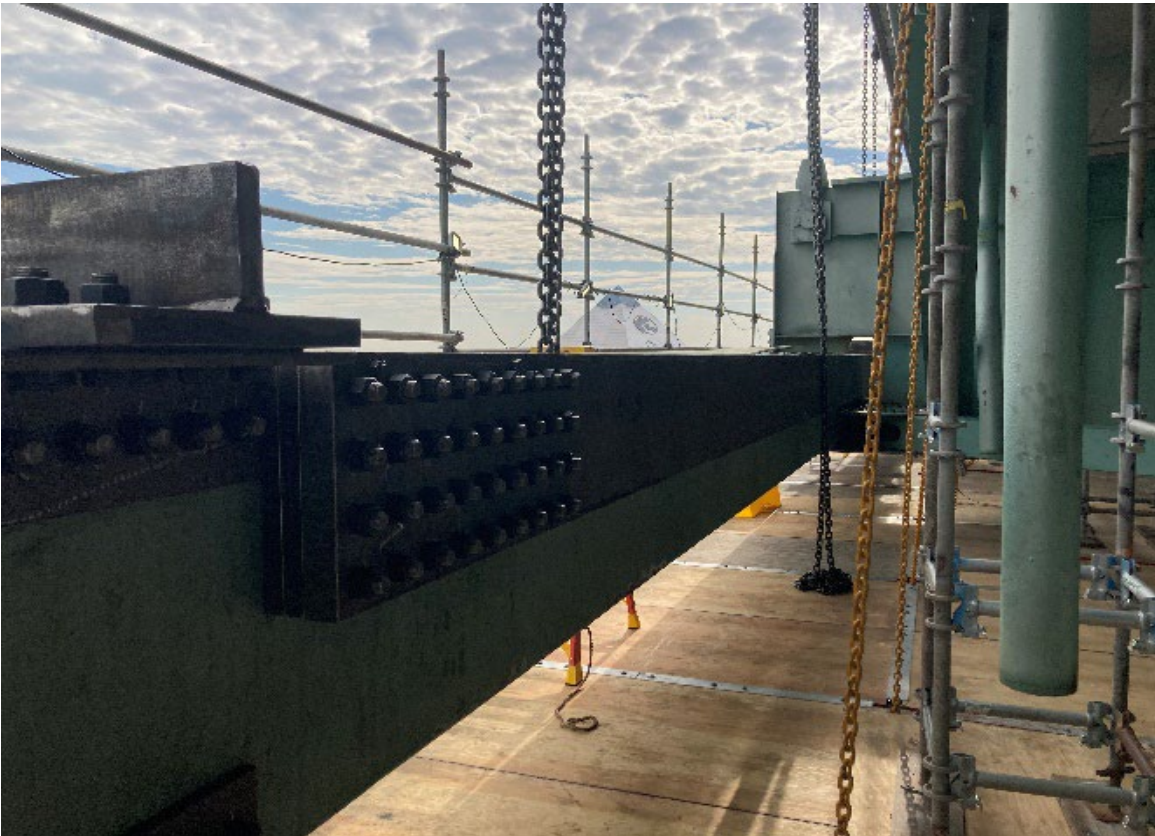
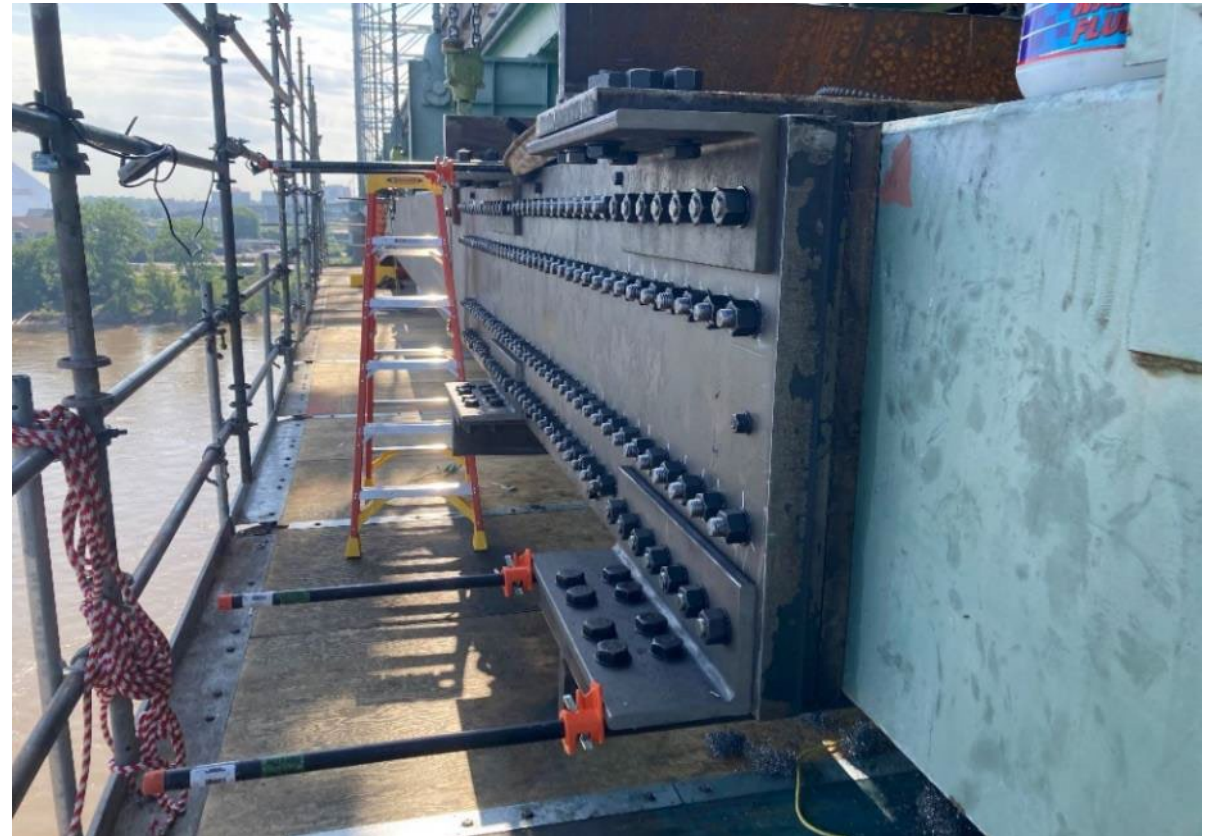
- Kiewit Infrastructure began installing the plates Saturday, May 22nd.
- Phase 1 plate installation was completed on Tuesday, May 25th.
- Completing Phase 1 allowed for starting the Phase 3 inspection work

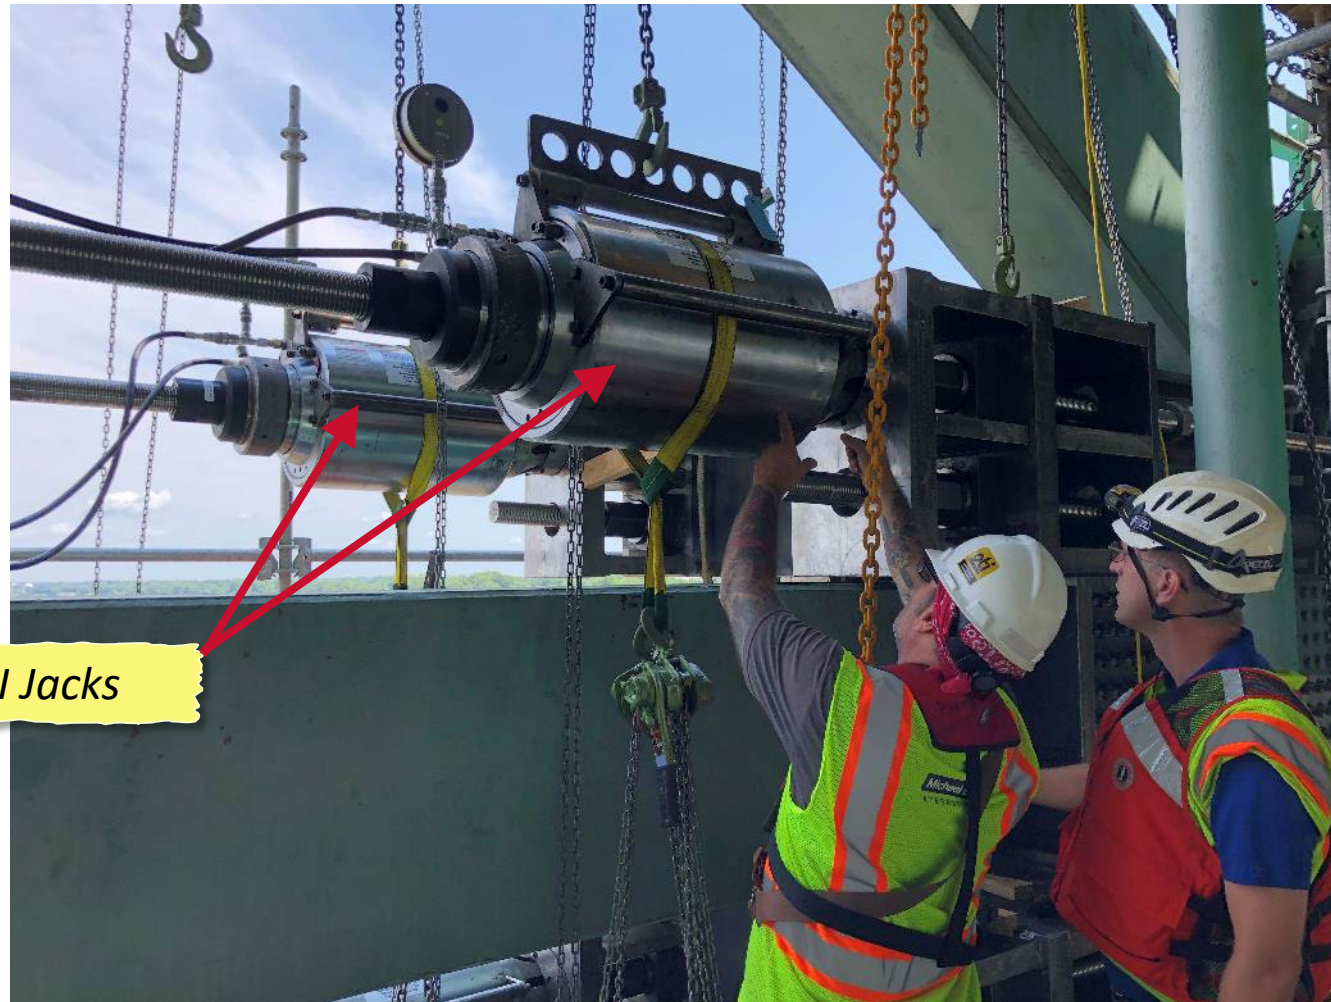
DSI Jacks

Stressing

PT Stressing began Sunday, June 20th and was completed June 22nd

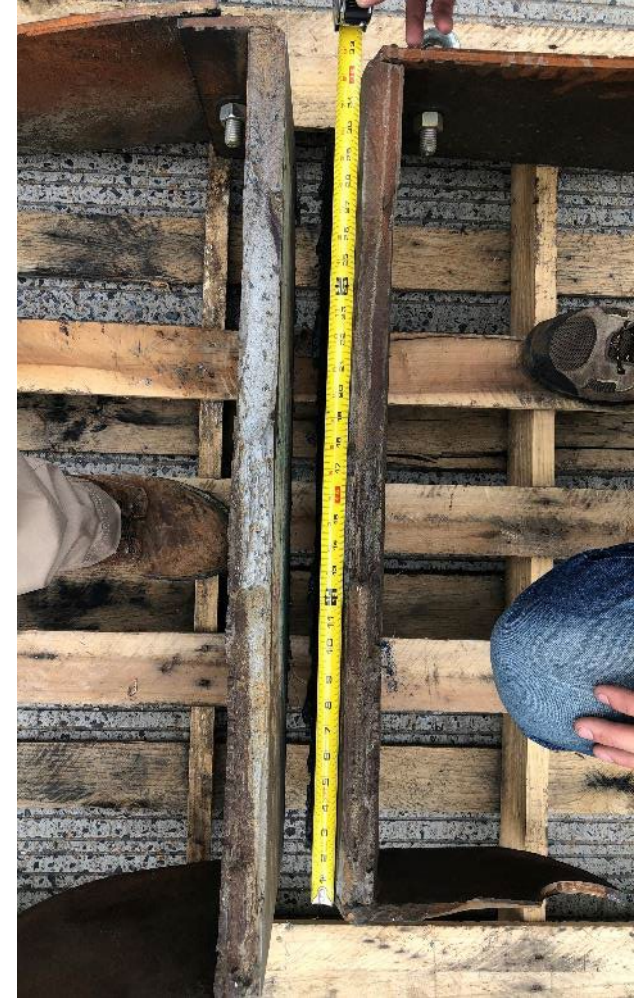
Removing the Fracture

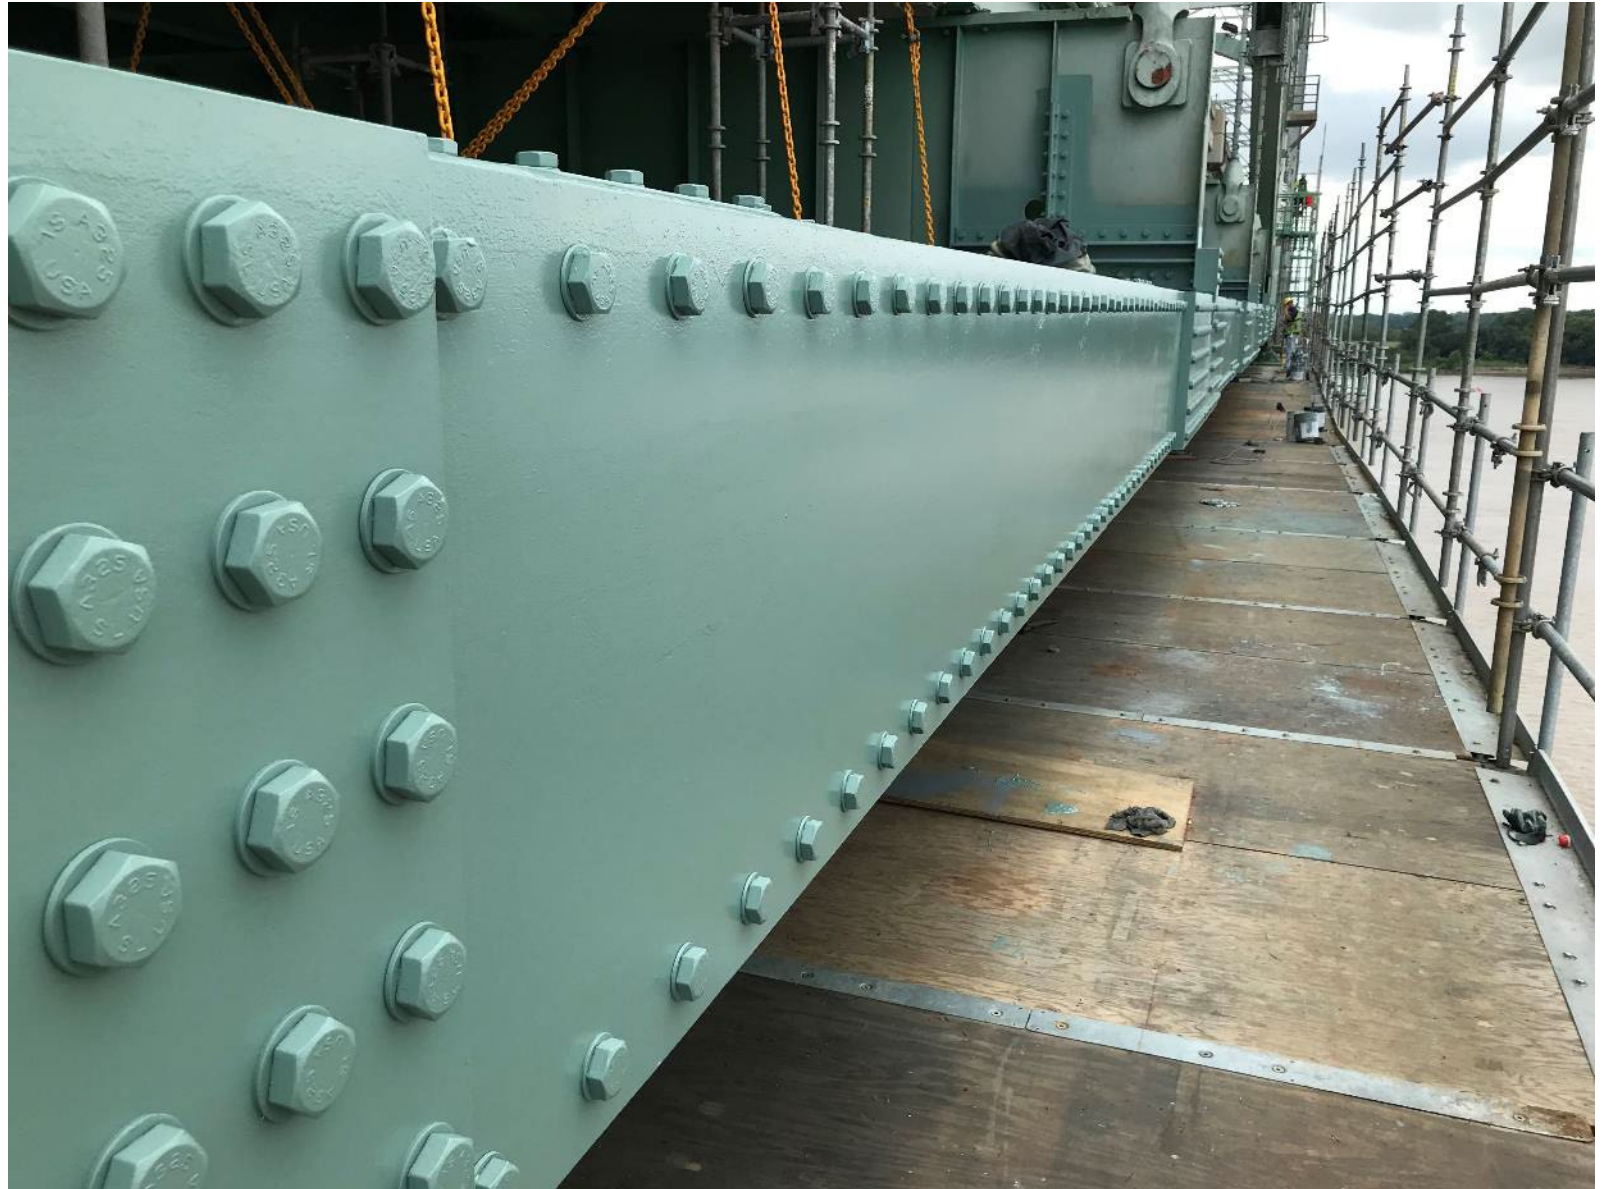
Phase 2 Completion

- Final Painting
- Phase 2 Complete

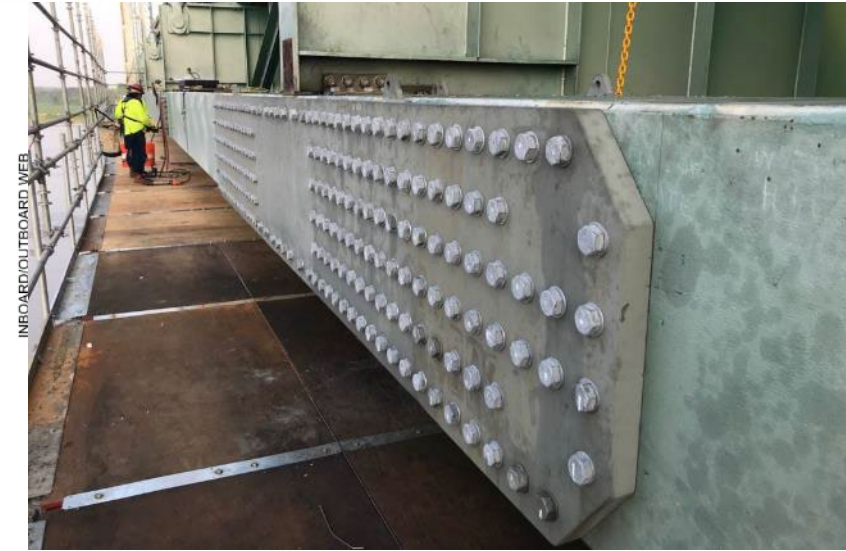
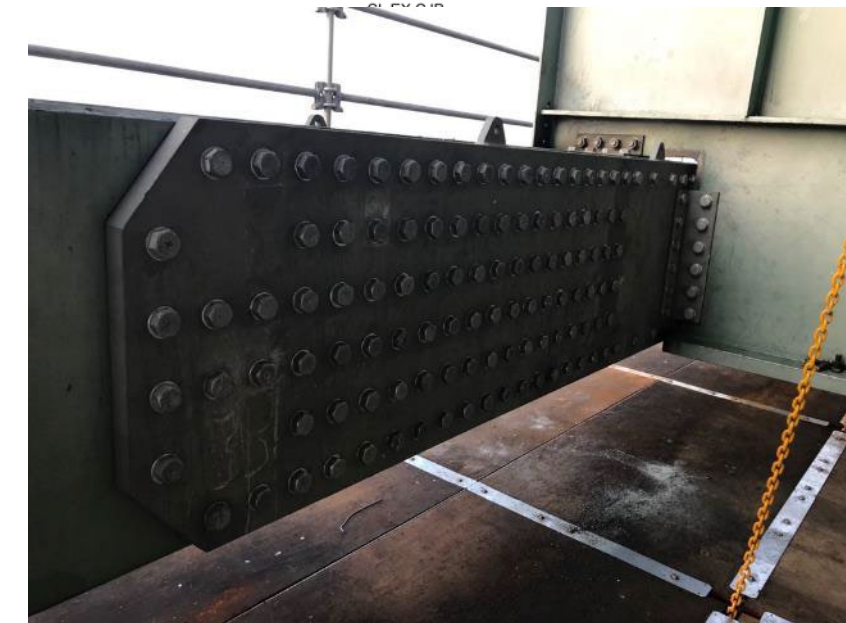
Phase 3 – Repair Types (Typical Odd)

Plating with "Dogbone"
(17 locations)

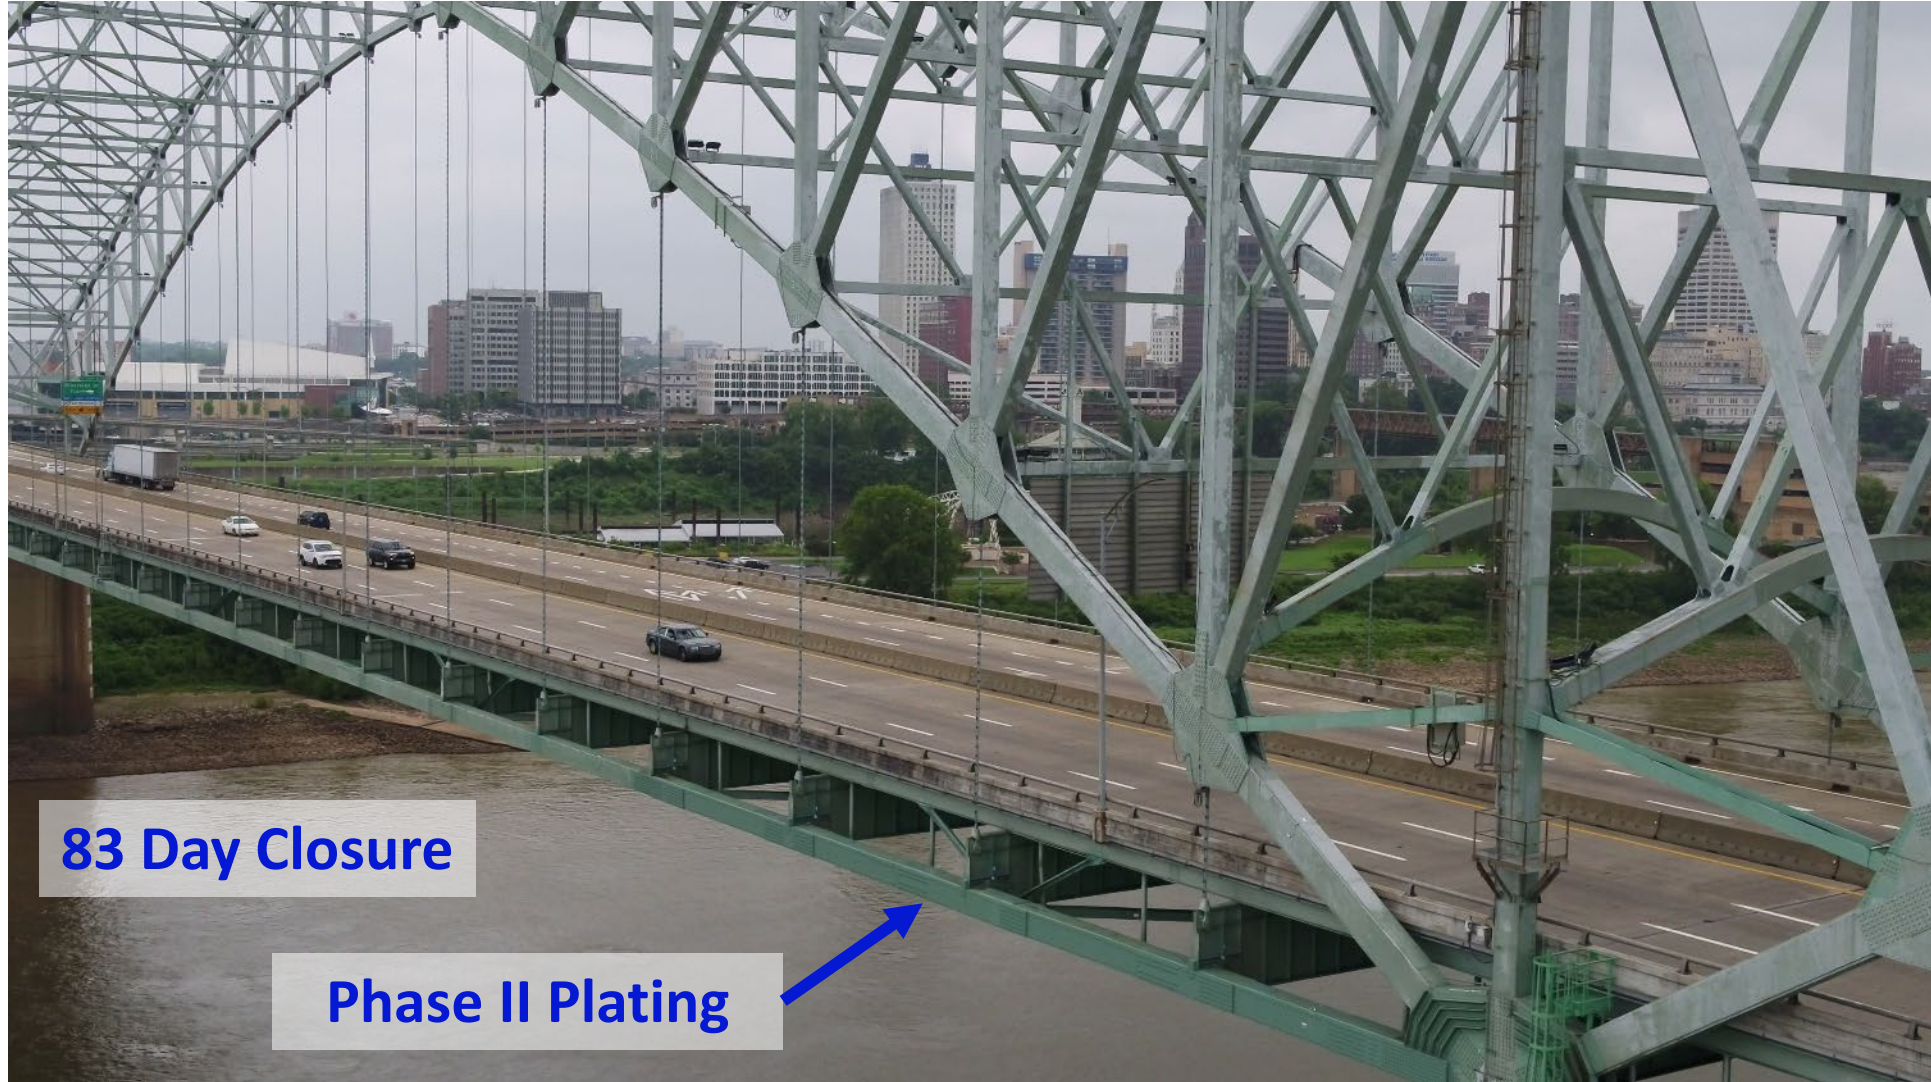
83 Day Closure

Phase II Plating

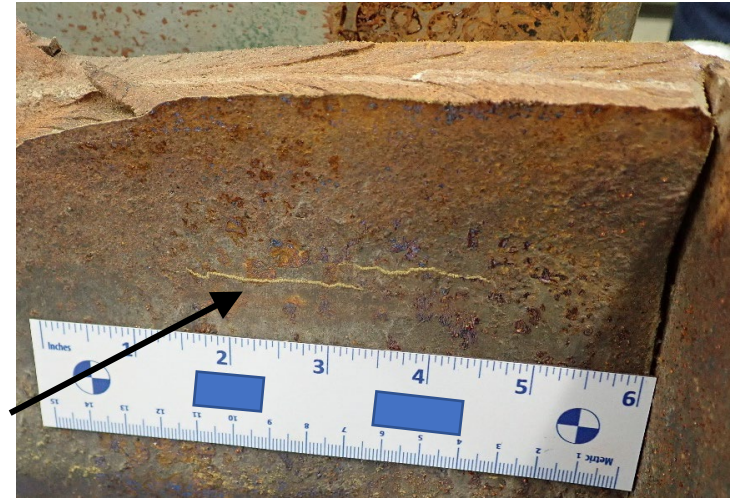
Conventional UT of Extracted Fracture Pieces

- Fracture specimen had hydrogen cracks in weld region which remained attached to thick base plate
- Initially scanned with conventional UT with 2 rejectable indications using 70° transducer
 - Group of two surface-breaking cracks (Shown in top photo)
 - Class A; UT Combined Length: 3.3"
 - Missed in 1982 UT Inspection
 - Smaller surface-breaking crack (Shown in bottom photo)
 - Class B; UT Length: 1.1"
 - Destructive Evaluation
 - 3/32"H x 5/32"L
 - Detected in 1982 with same Indication Rating
 - Reported as "Accept" and characterized as "Slag"
 - Although exceeded the UT acceptance criteria limits

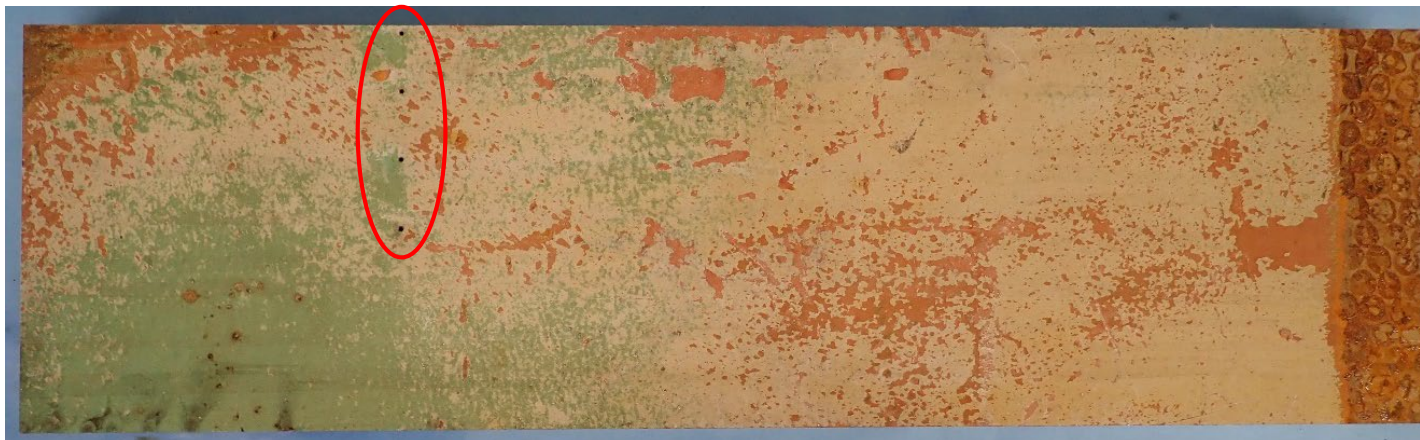
MT and PAUT of NDE Verification Sample

- Saved portion of weld as a NDE Verification Sample
 - Containing 4 MT indications
- Performed PAUT per AWS D1.5 Annex J
- Time-Corrected Gain (TCG)
 - Used in lieu of standardized attenuation factor for PAUT
 - Fabricated calibration block from I-40 base metal
 - Much lower attenuation in T-1 material than 1018 IIW block

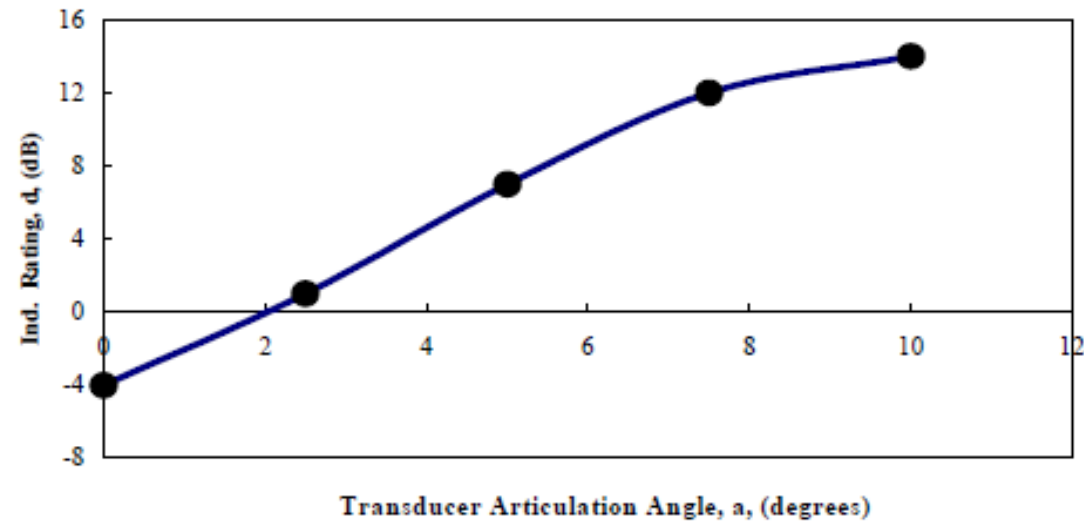
Figure 147. Influence of transducer articulation angle on the maximum amplitude of the reflected signal.

Why is Transducer Raster/Rotation Important?
