TRB Webinar: Guidelines for Adjacent Precast Concrete Box Beam Bridge Systems

Project Number 12-95A

**Proposed AASHTO Guidelines for Adjacent
Precast Concrete Box Beam Bridge Systems**

September 20, 2023

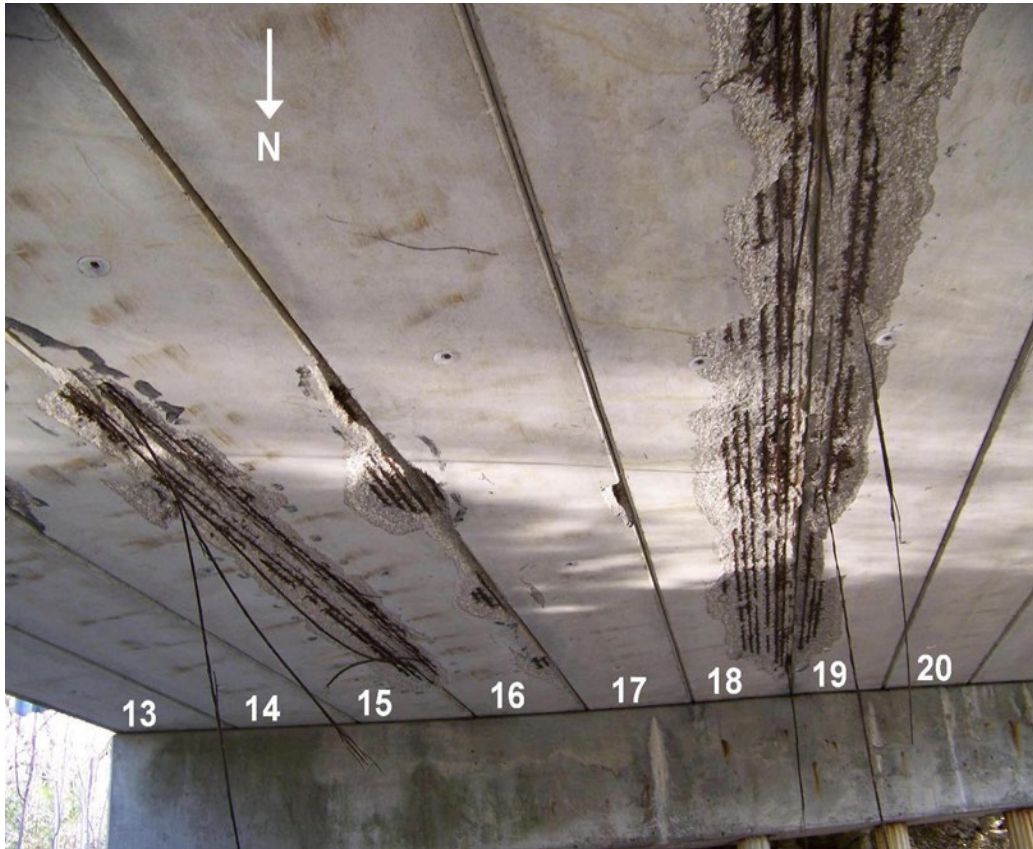
A typical adjacent box girder bridge damaged by leaking joints.

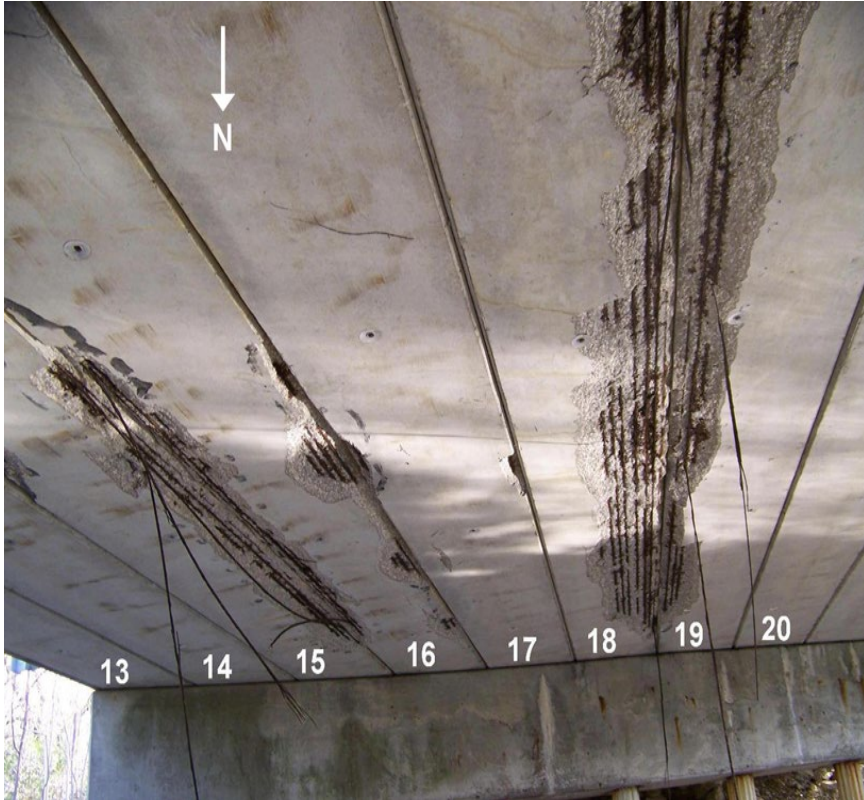
The problem of cracking in the shear keys needs to be addressed.

Cracking leads to leakage and leakage of chloride laden water eventually damages the girders.

Severe cracking may also prevent load transfer between girders.

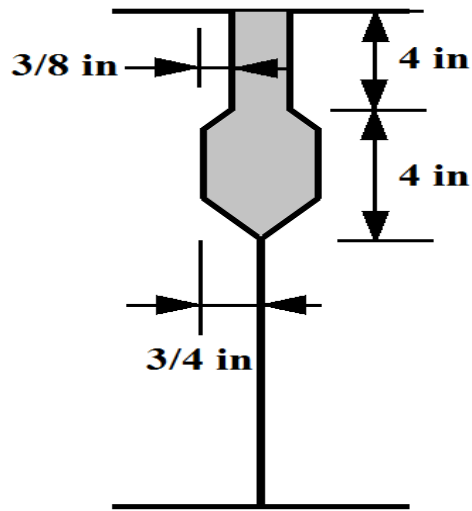
Type III Shear Key

This is a typical joint, or shear key, in an adjacent box girder bridge. The actual size varies from state to state, but the important factors is that they are near the TOP of the girder and are filled with a cementitious material.

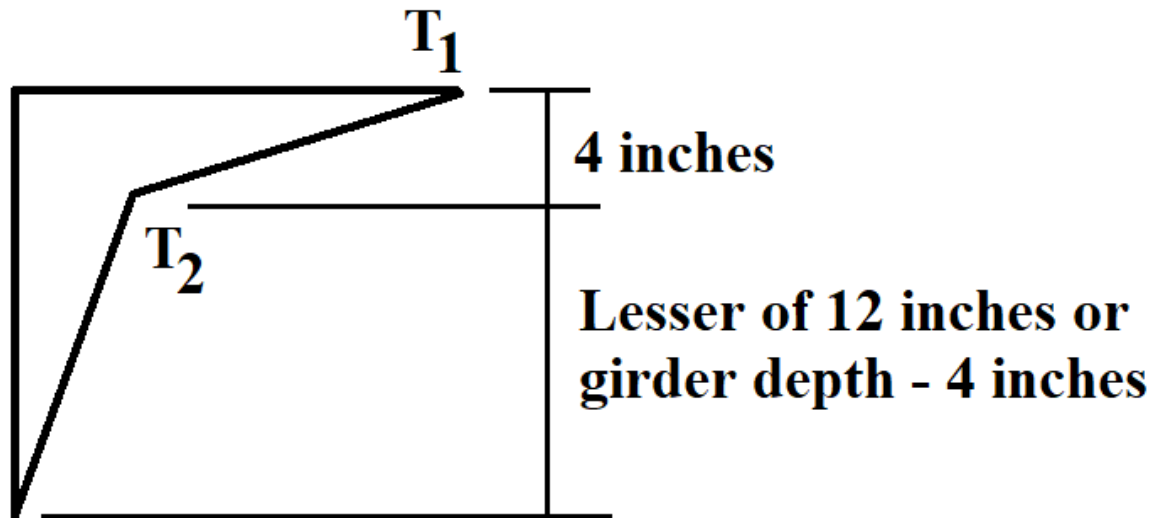
AASHTO LRFD
Specifications, Art
3.12.3.

This is the AASHTO temperature gradient. The difference between T_1 and T_2 is 29° F to 40° F, depending on the zone.

It occurs over the top 4 inches!

Zone	T_1 (°F)	T_2 (°F)	ΔT (°F)
1	54	14	40
2	46	12	34
3	41	11	30
4	38	9	29

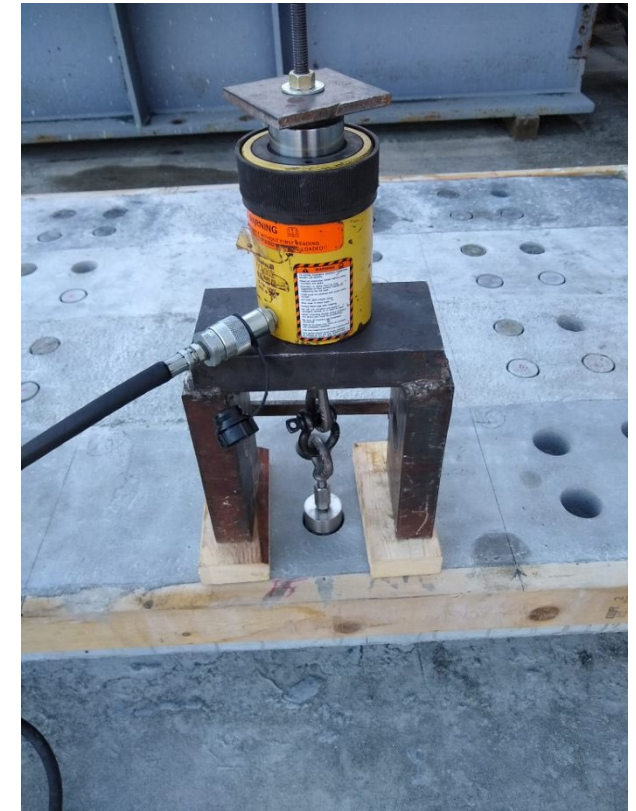
ASTM C1583 Standard Test Method

- Grout material was placed on a substrate. In this case the grout layer was 1.5 inches thick = shear key width.
- A 2 inch diameter core was taken through the grout and at least 0.5 inches into the substrate.
- A 2 inch diameter disk was epoxied to the core.
- Tensile load was applied to the disk to try to separate the grout from the substrate.

- Four Possible outcomes:
 - The grout fractures (good test)
 - The substrate fractures (good test)
 - The bond fails (good test)
 - The epoxy fails (unusable test)
- Testing was repeated until at least 3 tests with the same failure mode were obtained.

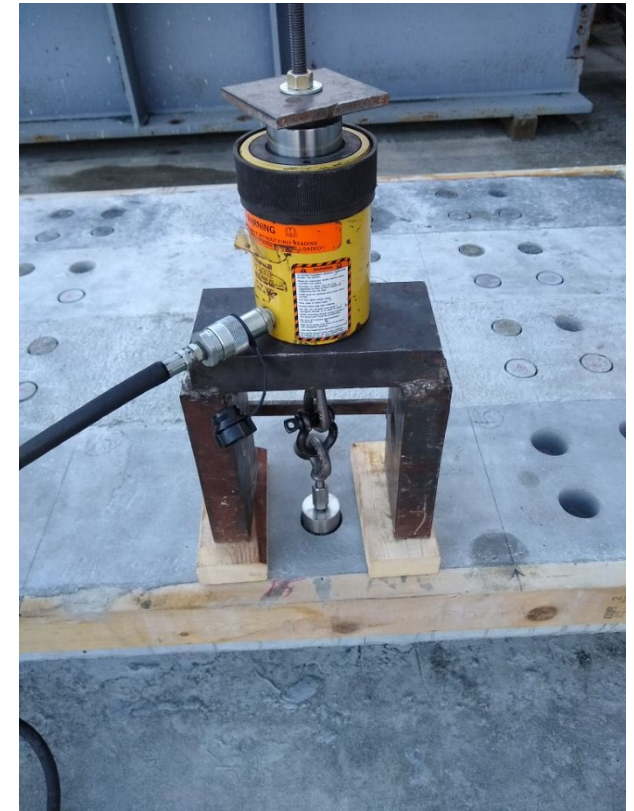
Test panel I

- Surface finishes: steel formed and round aggregate
- Grout materials: Sika 212, Masterflow 928, Masterflow 4316, small aggregate concrete
- Surface prep: Light sandblasting followed by prewetting of half the portion

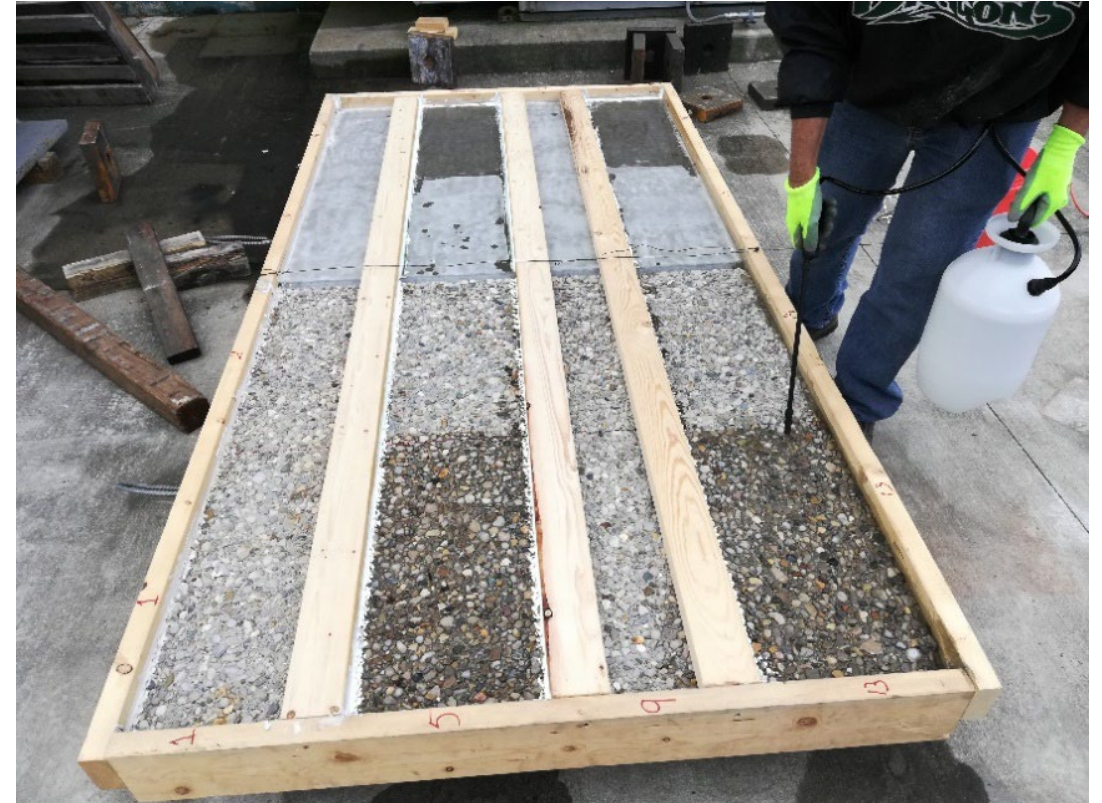
Test panel II

- Surface finishes: crushed exposed aggregate
- Grout materials: Sika 212, Masterflow 928, Masterflow 4316, small aggregate concrete
- Surface prep: Light sandblasting
 - Dry surface
 - Prewet surface
 - Applied wet burlap for 24 hours

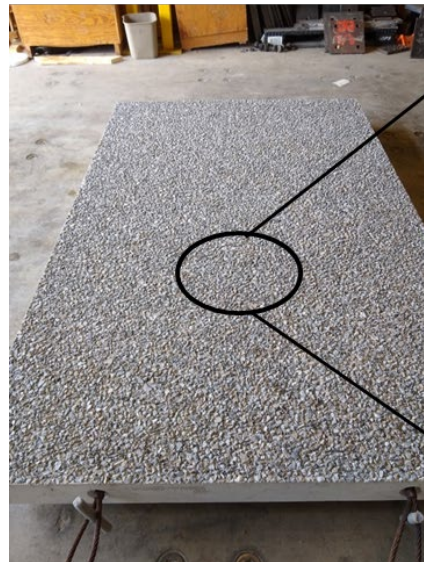
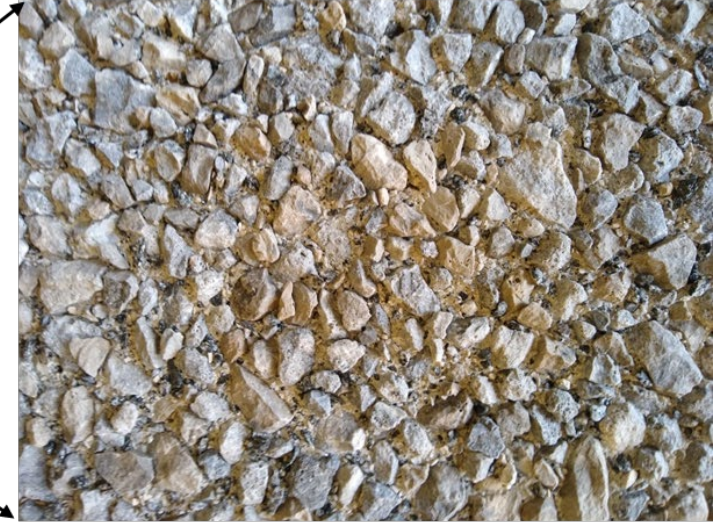
Test panel II

Observations:

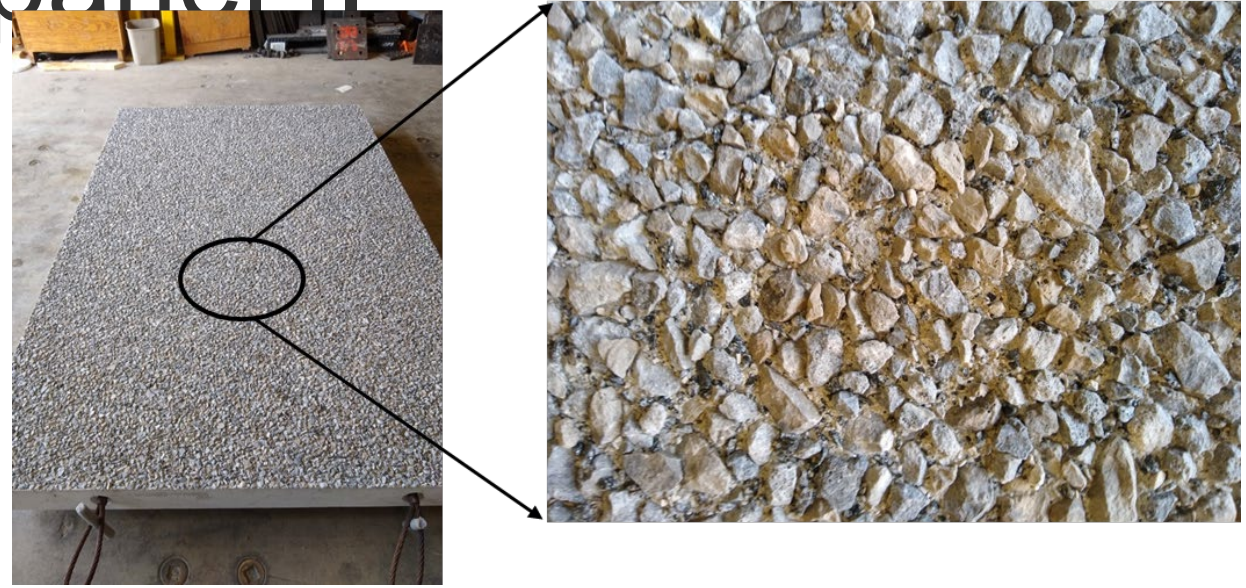
Test panel III – Made with Full Size Specimens

- Surface finish: Sandblast to International Concrete Repair Institute Concrete Surface Profile-3
- Grout materials:
 - Sika 212, Masterflow 4316
 - small aggregate concrete
- Surface prep: Light sandblasting followed by prewetting

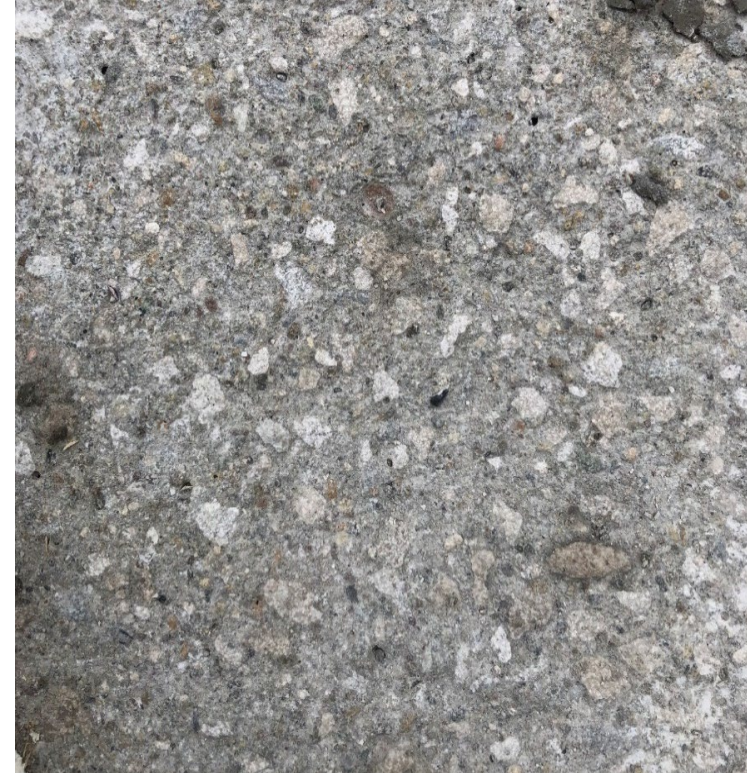
Test panel III

- Masterflow 4316 again failed in substrate indicating sufficient bond strength even on CSP-3 to 4 surface
- SIKA 212 performed poorly, but there were problems with the grout (discussed later)
- Concrete failed at unexpectedly low bond strengths, but the mix started to set before placing on the panel (discussed later).

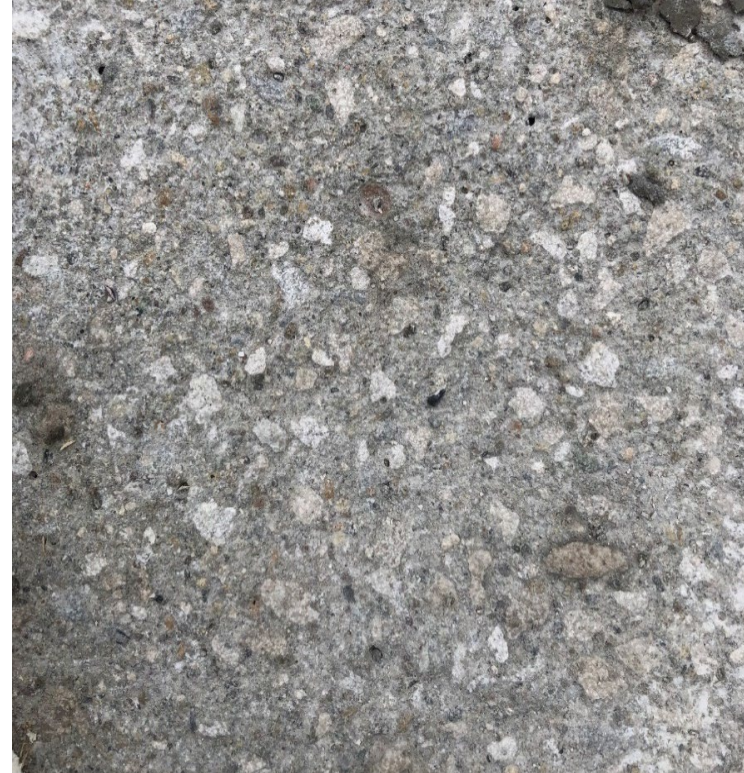
Girder sides

- Surface finishes: CSP-3 to 4 surface
- Grout materials:
 - Sika 212(used in Type IV shear key)
 - small aggregate concrete (used in Type V shear key)
- Surface prep: Light sandblasting followed by prewetting

- Concrete:
 - Average failure strength for concrete increased from 136 psi on panel to 306 psi on the girder surface
 - Failure was in the bond for both the cases
 - This verifies the RT's suspicion that the low failure strengths in the original pull off tests was due to concrete setting before casting the panel.
- Sika 212:
 - Strength increased from 268 psi on panel to 464 psi on girder surface
 - Mode of failure changed from grout failure to bond failure.
 - This indicates that for a good quality Sika grout, the performance is adequate.

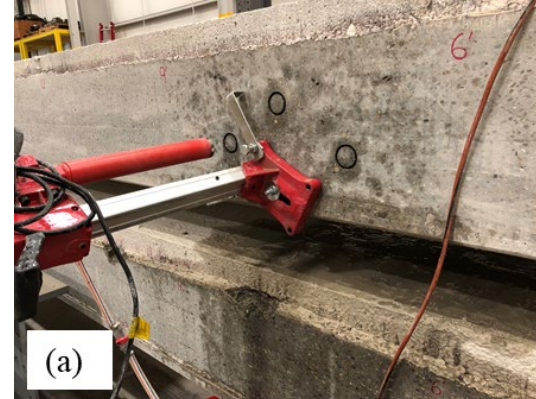
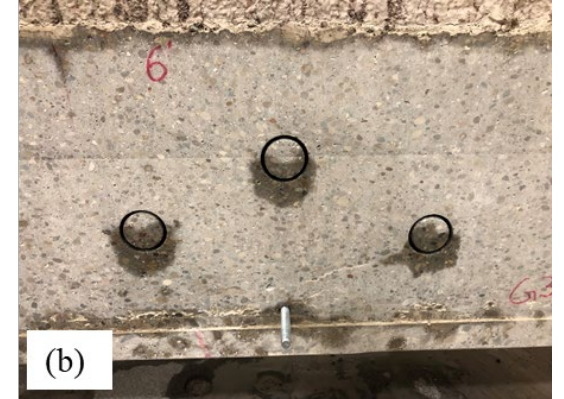
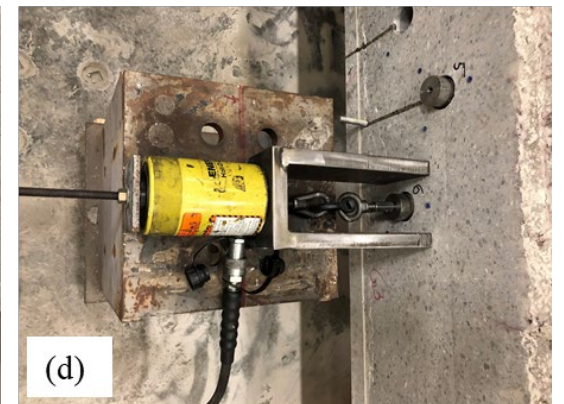
Girder Sides

Observations:

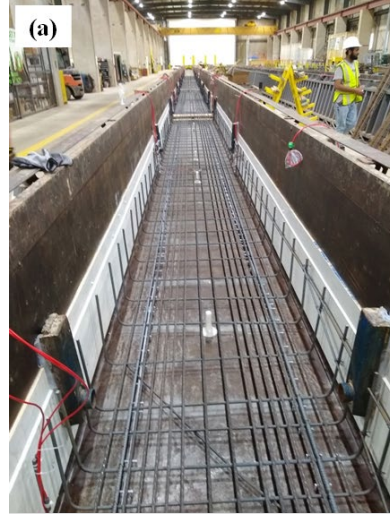
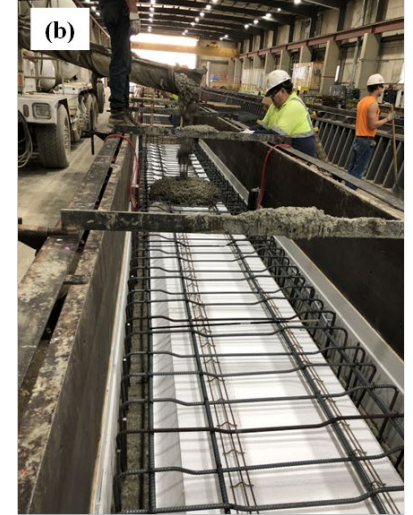
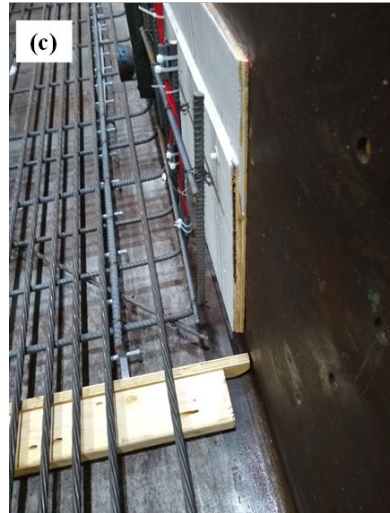
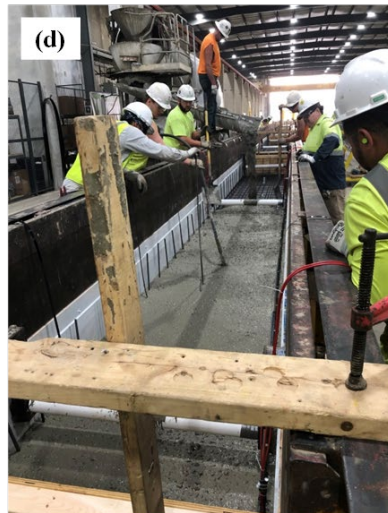
Girder Fabric

Girder Fabrication

- Girders were fabricated at the Prestress Services plant in Mount Vernon, Ohio
- Instruments were installed during fabrication

- VW gages and Thermistors installed at the midspan and each end of the girder
- These gages were used to obtain the strain and temperature profile of the girders

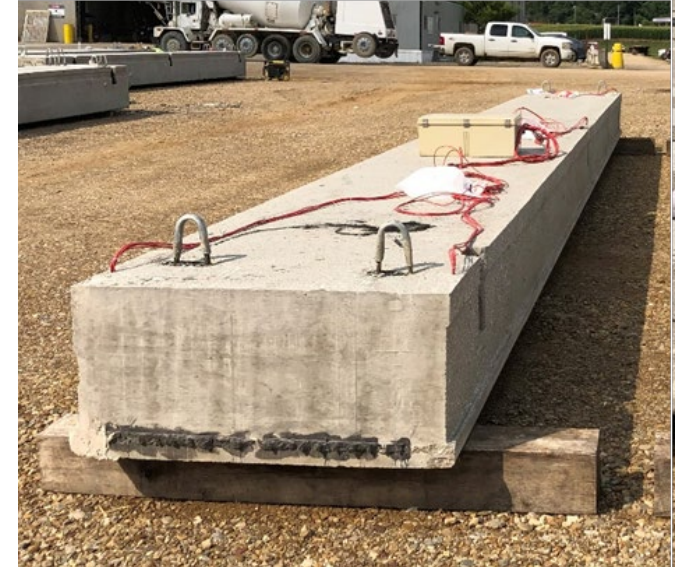
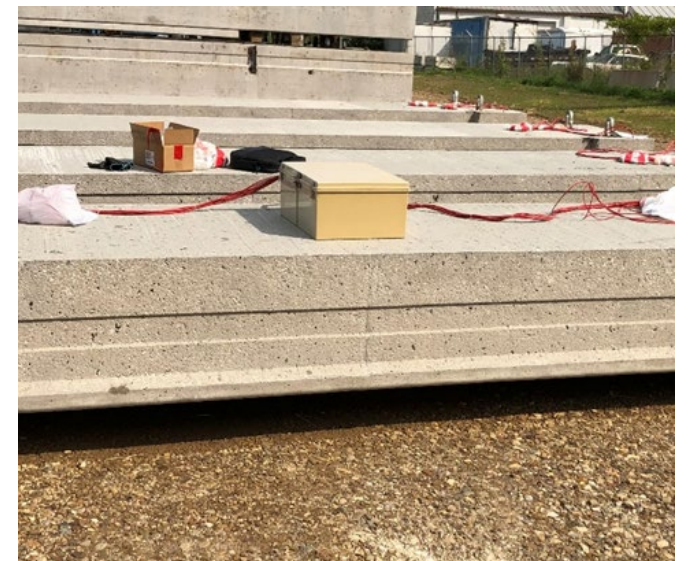
Field Monitoring: Temperature variation

Filed Monitoring of the Girders

- While girders were in prestressing yard, they were monitored for temperature profiles along their depth
- Embedded instruments were connected to a data acquisition system and monitored for 24 hours
- For most of the day during monitoring, one face of the girder was shaded from the sunlight while the other was directly exposed.

SHADED
FACE

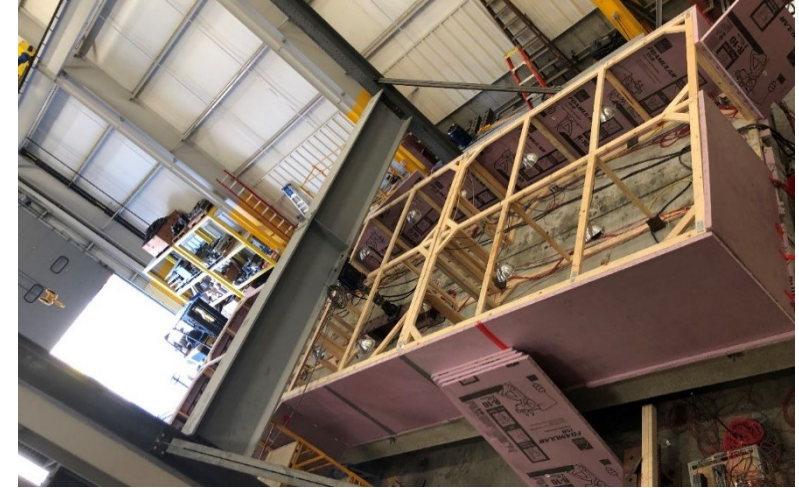
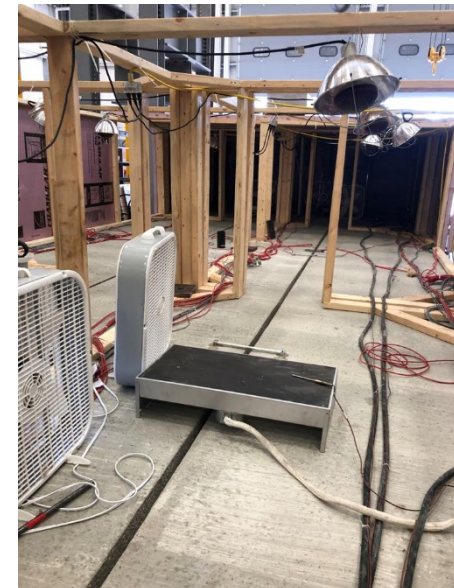
Type IV shear key test

- Girders assembled on lab floor and “heat box” was built to apply temperature load
- Heaters, lamps and fans were used to heat the top of the girder
- VW gages and thermistors embedded during fabrication were monitored to measure temperature profiles

Method suggested by Liu and Phares (2019)

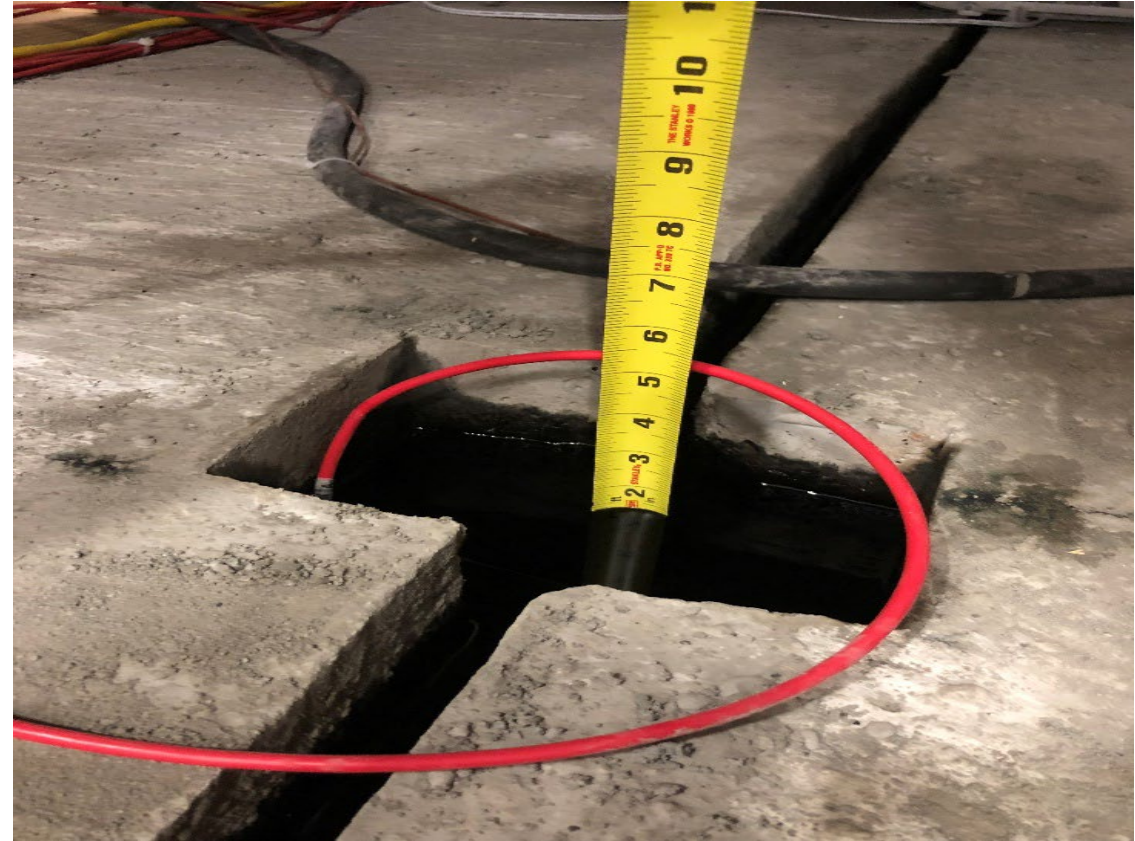
Type IV shear key: Thermal load and flooding after grouting

- From the day after grouting, thermal loading was applied to the girder system
- A total of 30 thermal cycles were applied to the system
- Joints were flooded with different colors of dyed water after 1st, 5th, 15th, and 30th cycle to look for leakage.
 - The dye will indicate where any cracking occurred. The color indicates when it occurred.

- Masterflow 4316 joint showed no signs of leakage during any dye test
- Sika 212 joint showed leakage in part of the joint that was done using the poor quality grout

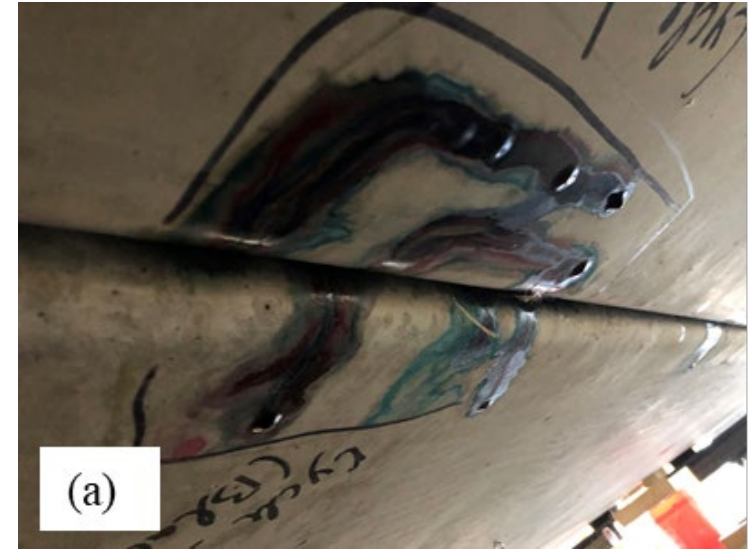
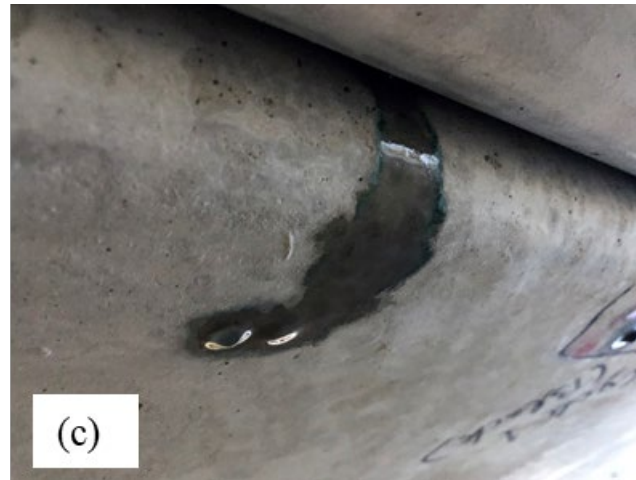
Type IV shear key: Live Load

- The live loading consisted of a cyclic load between 0 kip and 66.5 kip applied at a frequency of 2 Hz for a total 100,000 cycles
- This load represents a tandem load of two, 25 kip loads plus a 33% impact
- Static load of 66.5 kip was applied after 0, 5000, 10000, 25000, 50000, and 100000 cycles to find any deterioration of joints
 - the instruments do not respond fast enough to read them under cyclic load

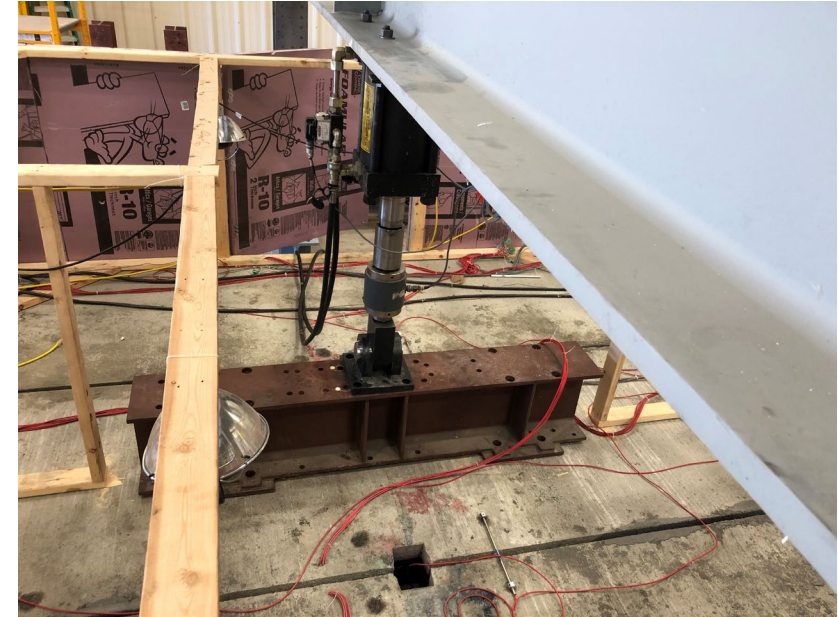
Type IV shear key: Live Load

- Graph shows the support reactions during static load at the start and end of live loading
- The load applied at the center distributed almost equally to all six support points indicating complete load transfer
- Load distribution before and after live load testing showed no change. That indicates no degradation of joints due to live load

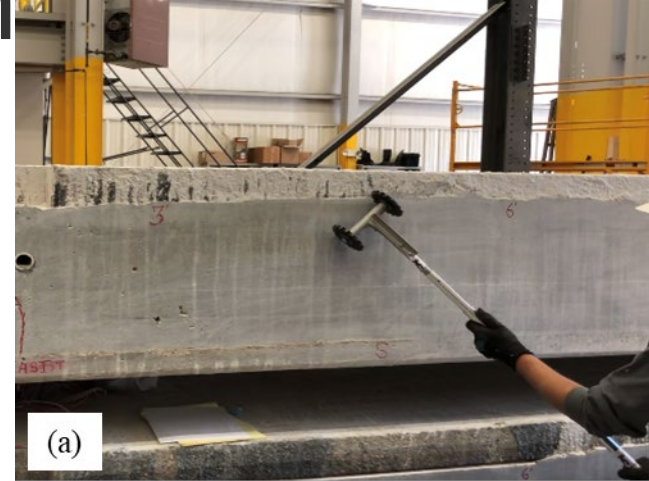
Type IV Shear Key: Joint cutting and inspection

- After testing was complete, joints were cut and visually inspected
- Delamination sounding device was used to check for delamination

Masterflow 4316 Joint:

- Cracking at the tie rod locations
- No delamination
- No through cracks

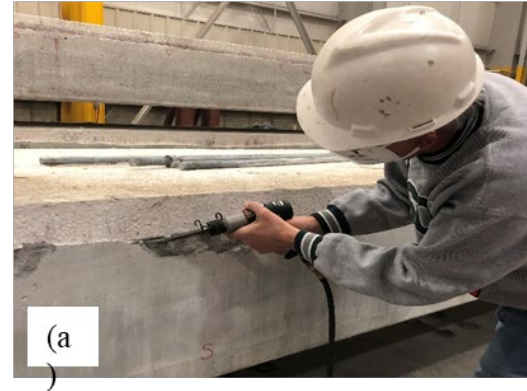
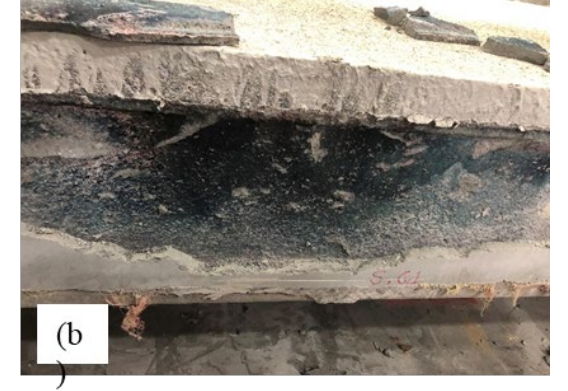
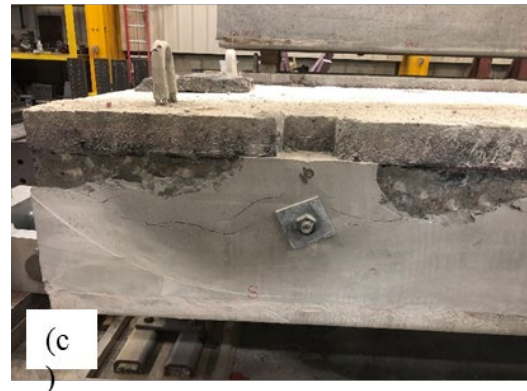
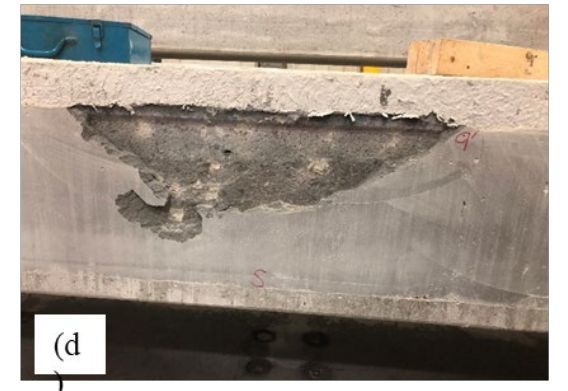
Type IV Shear Key: Joint cutting and inspection

- Grout was removed to reveal the girder surface using a chipping hammer.
- Masterflow 4316 grout had a very strong bond with the girder surface.
- Sika 212 could be removed
 - Dye pattern was observed under delaminated surfaces
 - Dye was not found on the surface where no delamination was observed during sound test

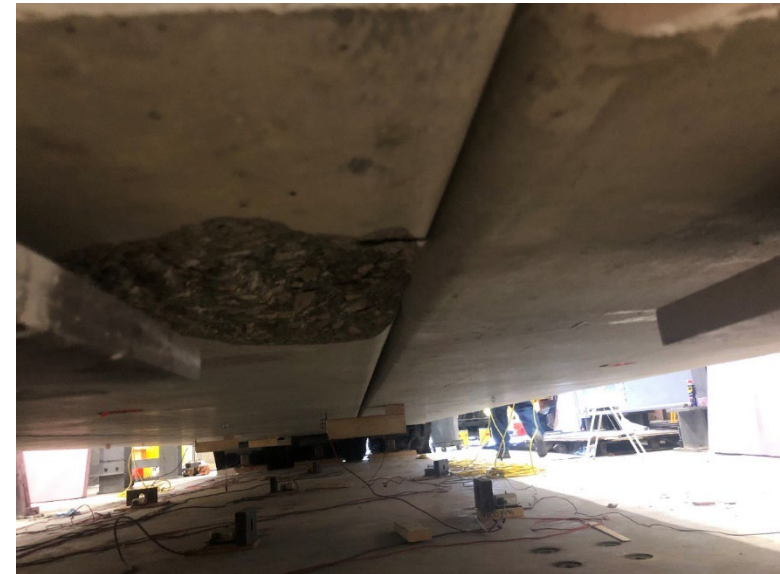
Type V shear key

- After Type IV testing was complete, girders were cut and assembled into Type V configuration
- Instrumentation and testing procedure was similar to Type IV shear key
- The only difference was the shear key material used (concrete instead of grout)
- Concrete on the bottom of the girder spalled when tightening the lateral tie rods

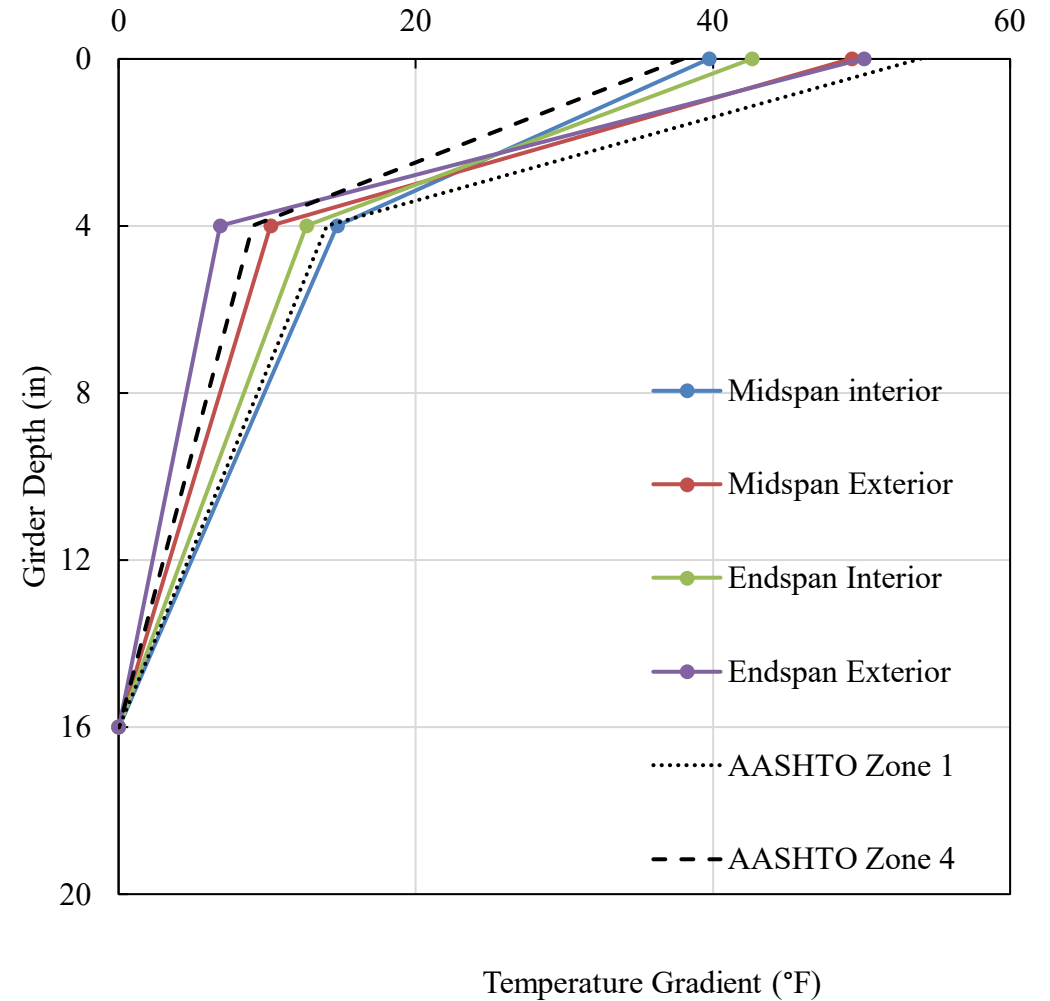
- Graph shows the gradient through the depth of the girder
- Similar to the previous test.

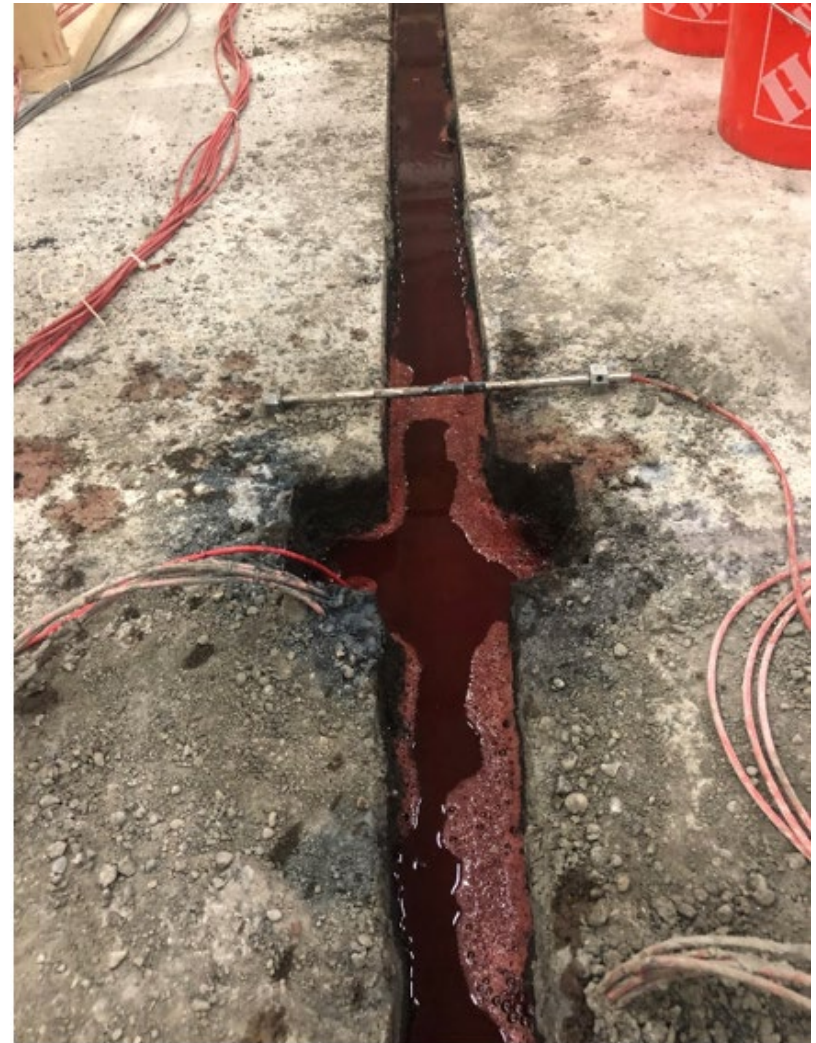
Type V shear key: Thermal load and flooding after grouting

- A total of 30 thermal cycles were applied to the system
- Joints were flooded with dyed water after 1st, 5th, 15th, and 30th cycle to look for leakage

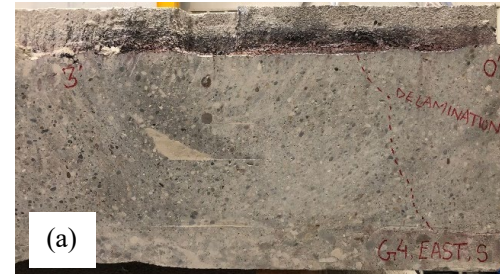
Type V Shear Key: Joint cutting and inspection

Joint poured later (with additional HWRA):

- Some spots with bad compaction with dye impressions
- Delamination at the ends with dye under them
- Black dye suggests the delamination occurred during the early age after casting shear keys
