Properties of Lime-Flyash-Soil Compositions Employed in Road Construction

L. JOHN MINNICK, Chief Chemist, and

G. and W. H. Corson, Inc.

AN evaluation of field projects in which lime and flyash are used for the stabilization of several types of soil indicates that the resulting compositions are very satisfactory as road bases. The evaluation includes laboratory tests for unconfined compressive strength, wetting and drying, freezing and thawing, and pulse group velocity. The equipment used to measure pulse velocity is described in some detail. The velocity measurements are found to be beneficial in evaluating the strength and durability of the compositions and good correlation is found to exist between the different test series. The construction work utilizes the mixed-in-place method. Several types of surface treatment have been applied to the stabilized bases.

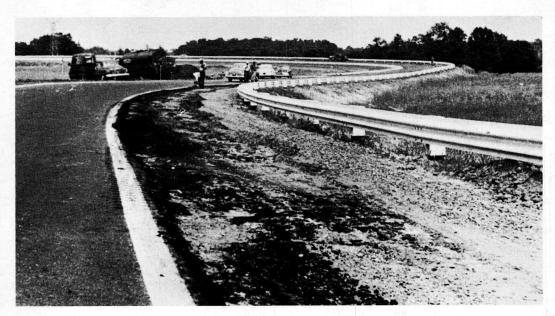
Figure 6. New Jersey Turnpike project: Condition of shoulder prior to treatment.

For the mixed-in-place operation, the procedure in general followed that illustrated in Figures 6 to 11. The chief concern during construction was to establish good mixing and proper compaction. Constant check of moisture and density was carried out during the operation. Figures 12 to 19 show scenes taken from field projects constructed with the materials referred to in this paper.

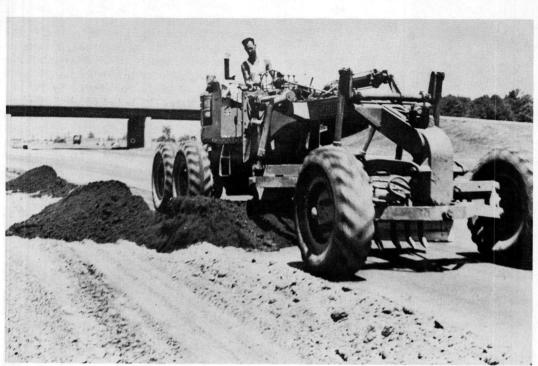
Figure 8. Bulk flyash being spread by motor grader, N. J. Turnpike project.

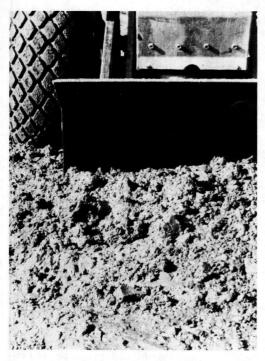
Figure 12. Soil at HiNella, N. J.: Project contained appreciable quantities of green sand marl.

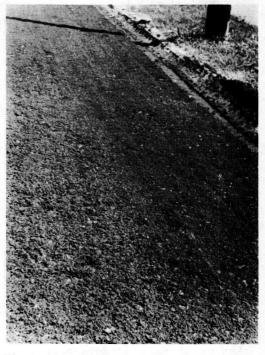
Figure 13. Condition of road base prior to compaction and after mixing lime and flyash into the soil, HiNella, N.J.

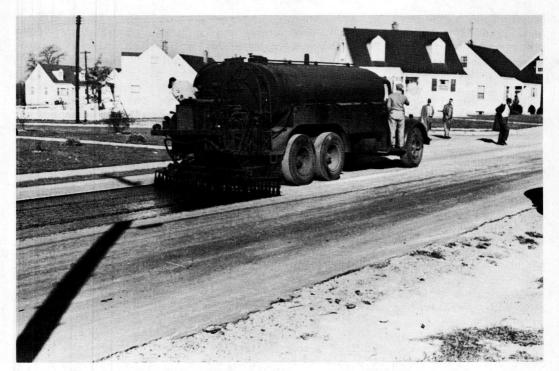
Figure 16. Application of MC-3 oil on stabilized base at project in Lindenwold, N. J.

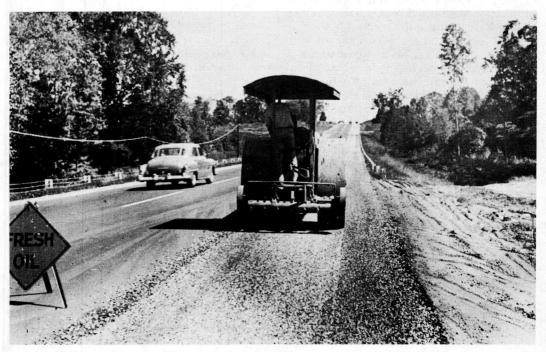
Figure 17. Application of stone chips over shoulder project at US 301, Marlboro, Md.

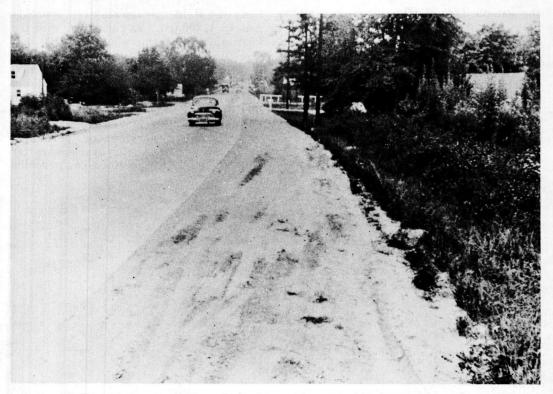
Figure 19. Condition of shoulder adjacent to stabilized section. US 1 Bypass, Laurel, Md.
