Automobile-Barrier Impacts

D. M. SEVERY and J. H. MATHEWSON

Department of Engineering, University of California

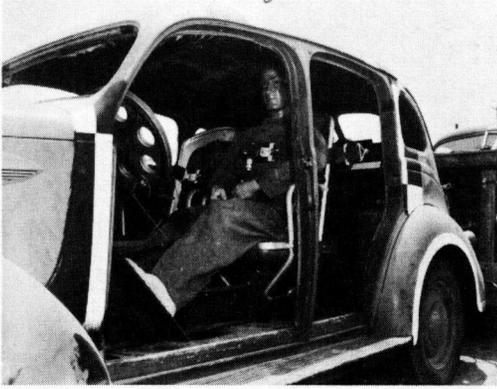
Figure 1. The test car and dummy.

1. The front and rear doors on the driver side were removed to provide an unobstructed view of the dummy (Fig. 1). This provision allowed the dummy's movements during impact to be photographed by the high-speed camera. The removal of the doors did not affect the car's structural properties significantly. Experience has shown that doors frequently fly open under similar conditions of impact, and the cabin structure of the automobile was not subjected to decelerative forces sufficient to produce a permanent set in the cabin structure, even without the doors.

The two seat and foot rest supports were secured to two parallel 4-by-6-inch steel I beams mounted longitudinally on the floor of the car (Fig. 1). This permitted the loading of the seat and footrest during impact to be detected by electric strain gages.

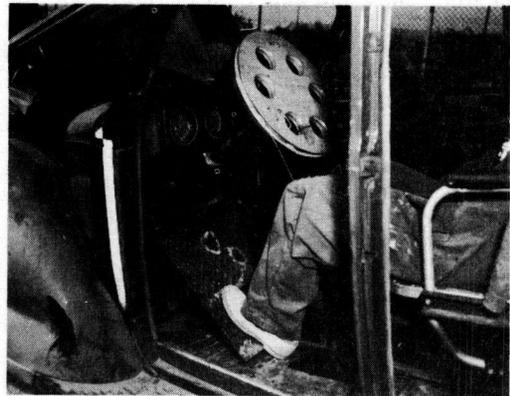
Figure 2. Remote control steering apparatus.

6. Remote steering was provided by a large pulley bolted to the steering wheel and, as shown in Figure 2, actuated by a cable joining it to the pulley of a selsyn, mounted on the horizontal I beam between the legs of the dummy. This selsyn was connected electrically with a similar unit on the instrument truck used for remote control.

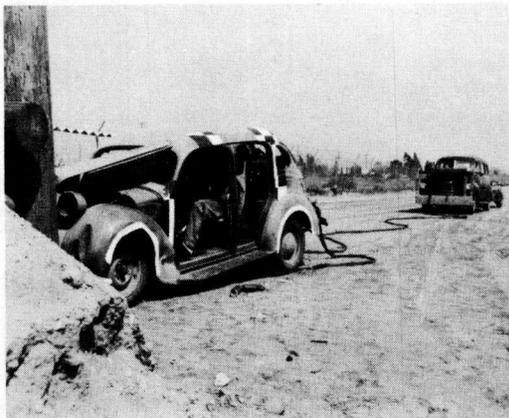
Figure 3. 1½-ton carryall used to push test car into barrier.

A 1½-ton Chevrolet carryall was used to push the test car into the barrier and to carry the electrical recording equipment (Fig. 3). A horizontal deck, 4 feet deep and 6 feet wide was built over the engine hood of the truck to provide an area on which to lay the excess length of instrumentation wires used to connect the test car with the instrument truck. The wires were bound together to form a cable, and this cable was laid on the deck in a manner which prevented it from snagging as it was drawn rapidly from the decelerating truck by the test car coasting on into the barrier.

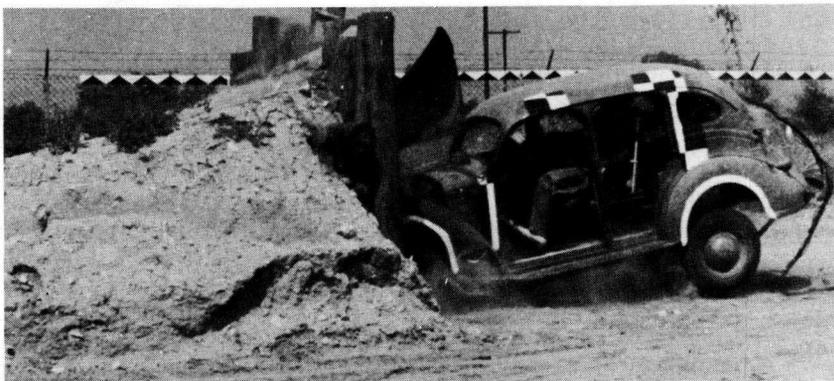
Figure 6. Checker board pattern on car for calibration with photographic film.

was used for length calibration of the film at the instant just before the car impact occurred. Other reference markers were painted on the side of the car and calibrated marker boards were mounted on a fence behind the car and in view of the cameras. This film was subjected to a frame-by-frame analysis using a Bausch and Lomb optical comparator¹ to provide accurate information on the deceleration of the car and dummy. A Kodak 16-mm. Ciné Special II operated at 64 frames per second and a 4-by-5-inch Speed Graphic camera provided additional photographic records.

An impact speed of 25 mph. was considered advisable for the high-speed test, using an instrumented dummy, so that the data obtained could be compared directly with a previous study (unpublished) conducted by this institute of a head-on collision staged at approximately the same speed. Trial runs showed that if the test car were pushed to a speed of 30 mph. until it was 100 feet from the barrier, it would decelerate, while coasting, to 25 mph. just as it passed to one side of the barrier. This break-away distance of 100 feet enabled the instrument truck which was doing the pushing to break away and decelerate at a moderate rate and stop 40 feet short of the barrier while the test car pulled the instrumentation cable from the cable deck of the truck as it coasted into the barrier at 25 mph. (see Fig. 9). The practical runs familiarized each member of the research team with their responsibilities, and enabled operational problems and equipment failures to be observed and corrected. At the test run speed of 30 mph., the operator experienced some difficulty in remotely controlling the test car by the relatively low-torque selsyn. Fortunately, appropriate corrections were possible so that the car struck the middle of the barrier at 24.9 mph. (Fig. 6).

Figure 6 shows the dummy's position shortly after the instant of maximum deceleration. The arms of the dummy were thrown forward and upward from the lap position in a flailing motion despite the

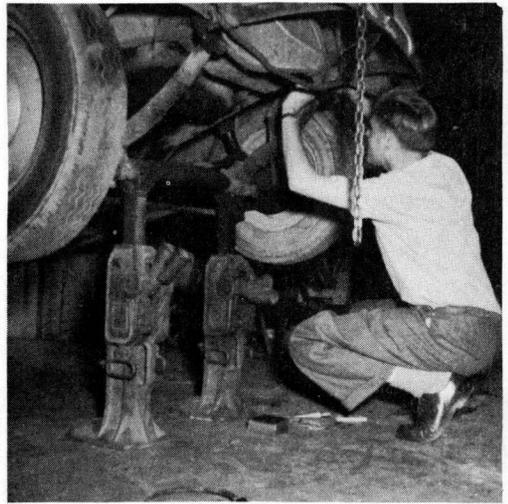
Figure 13. Marking frame to determine permanent deformation of different sections.

In order to determine the permanent deformation of different sections of the car frame, positions on each side of the frame were marked with metal screws at points approximately 1, 2, 3, 4, and 6 feet back from the front edge of the bumper (Fig. 13).² The dotted lines of Figure 12 show the deformation of the frame for the 10 reference points measured. The frame of the car was deformed by amounts which varied approximately in-

²The procedure followed in calibrating the frame consisted of driving the car onto a wide sheet of $\frac{3}{4}$ -inch plywood and projecting onto the latter, by the plumbbob technique, the points defined by the metal screws. Measurements were then made on the plywood surface. It was found that the marker points could be located with a reproducibility which did not vary more than 0.05 inch. Following the barrier crash, the car was again placed on the sheet of plywood, and the same reference points on the frame were projected, measured, and recorded. Since there was no evidence of deformation at the 6-foot point, this station was used as the base in evaluating the deformation of the other points.
