# Effect of an Inhibitor on the Corrosion of Autobody Steel by De-Icing Salt

G. O. GRANT, *Commissioner of Roads, Municipality of Metropolitan Toronto, Canada*

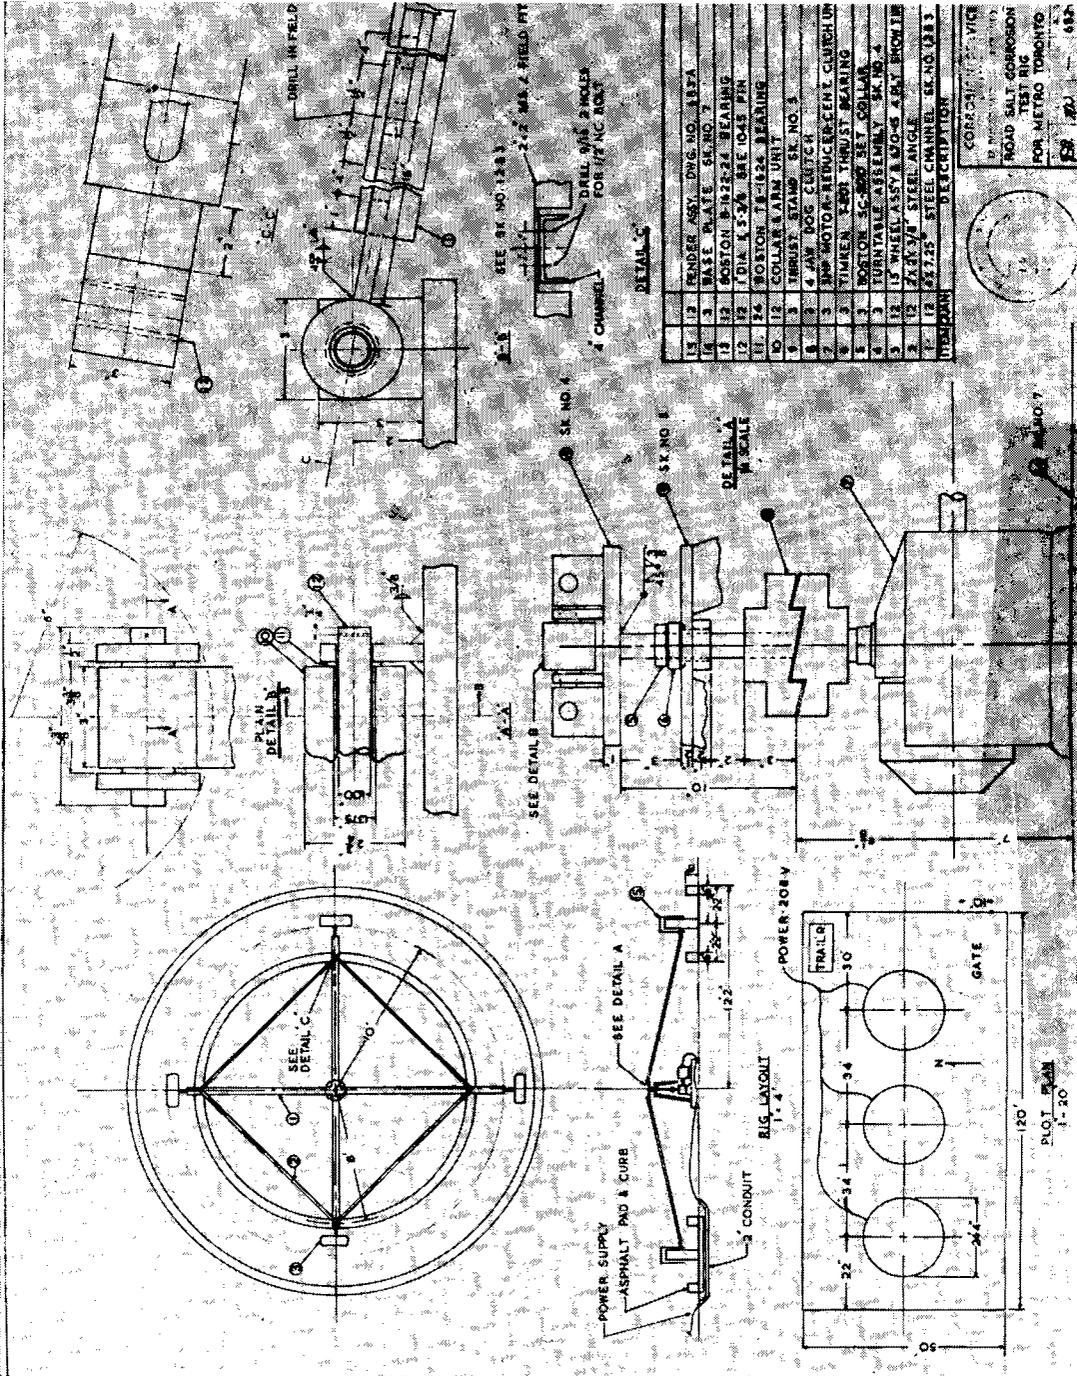
Three rigs were built to operate under three conditions: unsalted, salted, and inhibited salt. Figure 1 shows the design drawings of the rigs, and Figures 2 and 3 show the rigs operating on circular asphalt pads. The rigs were arranged with unsalted rig A to the west, salted rig B in the middle, and the inhibited salt rig on the east, so that the prevailing westerly winds would not blow spray

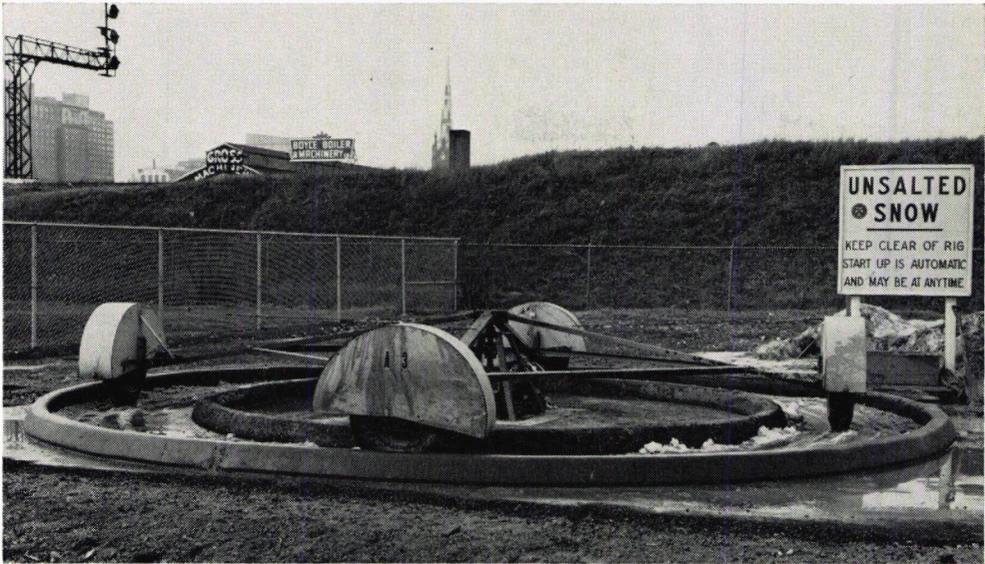
Figure 2. Rig operating on circular curbed asphalt pathway.

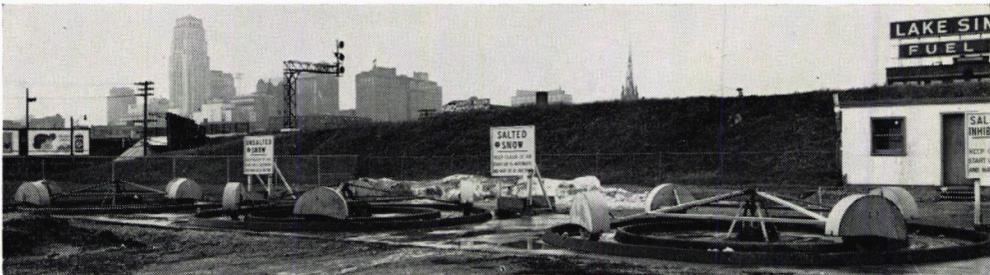
Figure 3. General view of the three rigs.

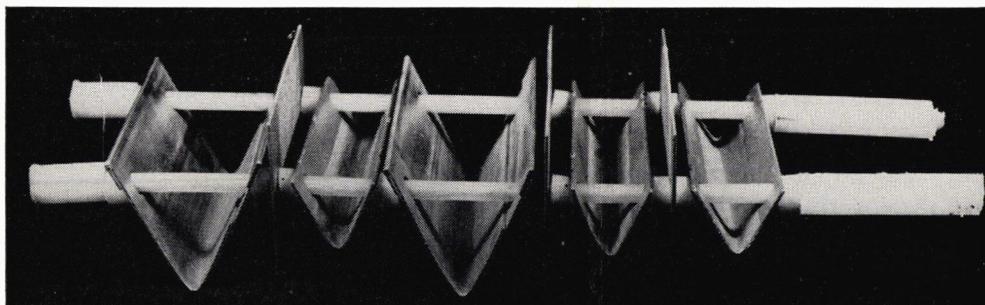
Figure 5. Set of coupons on polyethylene-coated rods.

The coupons were sheared from the sheet stock and fabricated to the required shape. Holes were punched in the coupons through which the polyethylene-coated rods passed. All test coupons were stamped according to the numbering system shown in Appendices A and B.

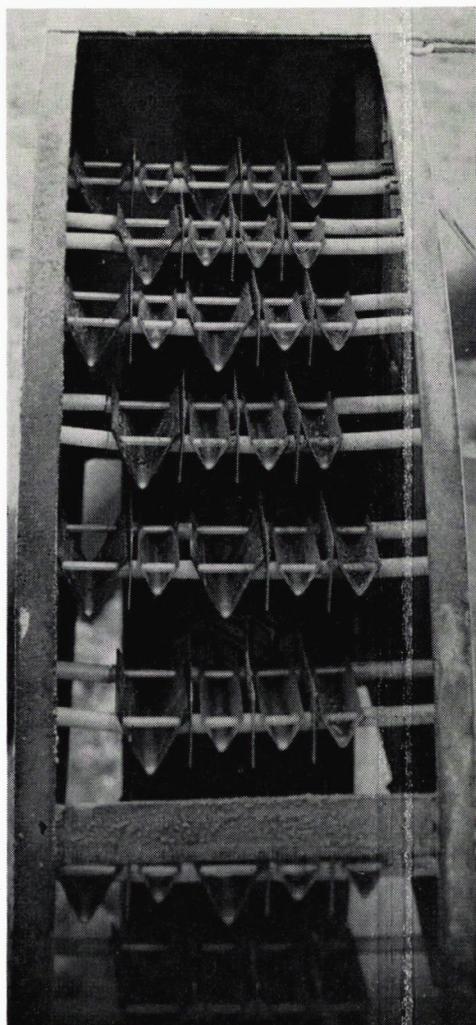
Figure 6. Fender and coupon rods. Inside location to right was sampled from top to bottom position.

The removal plan adopted selected coupons from the side of the fender facing inwards and from positions top to bottom. Examination of the data indicated that within the fender corrosion rates appeared high at the top inside, decreasing in the central region, and rising at the bottom inside. Also the rates appeared higher on the inside regions, decreasing midway across the fender, and flattening off toward the outside of the fender. Although the general results would remain the same had sampling included random removal across the fender as well as in the vertical direction, the curves for the three rigs would have altered their shape slightly in the case of rigs A and B, but more so in the case of rig C. This effect was attributed to the spray pattern. The wheels moving in a circular path would be unlike an automobile wheel because the spray would tend to angle vertically toward the outside of the fender. The spray distribution as visualized inside the rig fender would be less on the inside, greater in the central region, and maximum at the bottom outside. The spray pattern would affect rig C the most if proper coating of the coupons by the inhibited salt solution was not effective. However, examination at the site indicated that, although the above spray pattern existed, the fenders appeared to have been well covered over most of their internal surfaces.

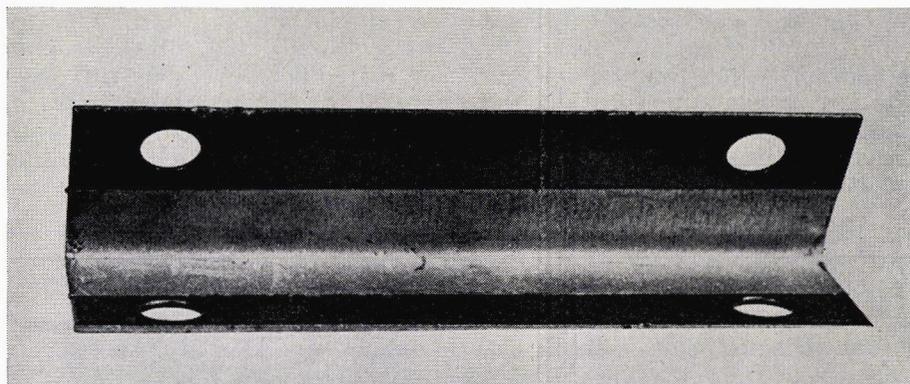
Figure 7. V-type coupon for crevice conditions. Bare portion sand blasted; full size.

The V and flat coupons were sand-blasted to ensure that the plastic coating applied to the panels would adhere, and both coupons were masked with suitable tape before plastic spraying. The V-coupons were masked in the crevice only covering an area of 26.3 sq cm. The flat coupons were masked in the midsection

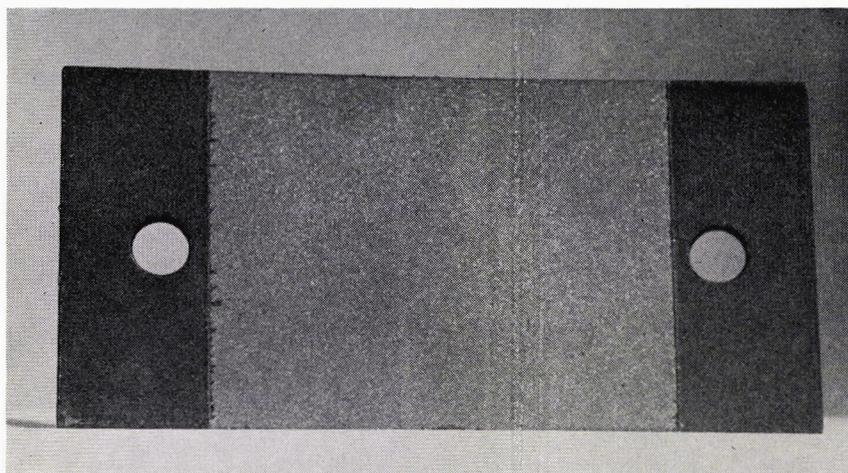
Figure 8. Flat-type coupon. Bare portion sand blasted; full size.

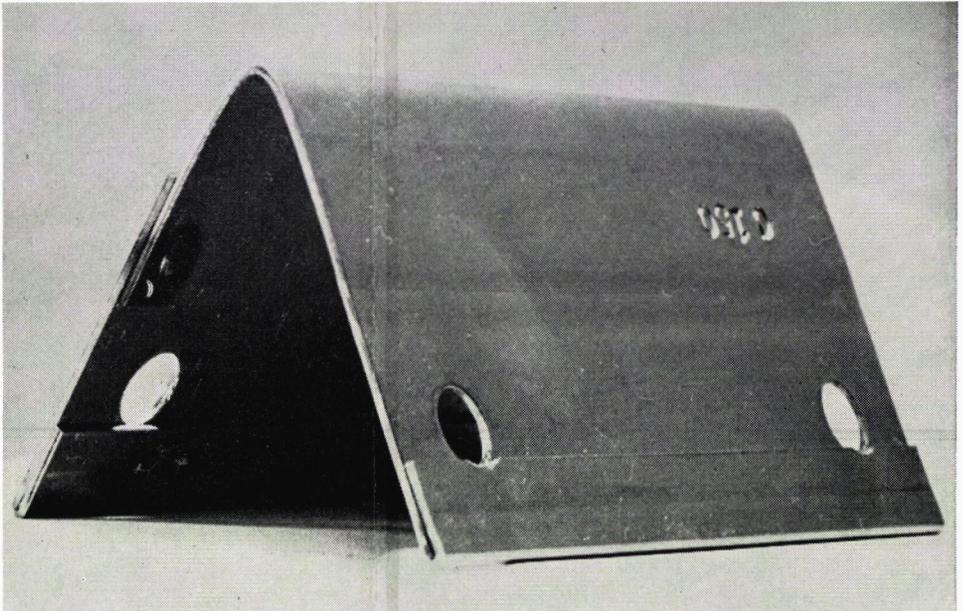
Figure 9. Caret-type coupon, not plastic coated. Surface cold rolled; full size.

The caret-type coupons, it will be recalled, were placed on the rods for a qualitative examination only. It was found that these coupons did not exhibit any significant corrosion under the beads, under the spot welded lap joint, or along the cold worked area. The period of 91 days was too short to develop undue corrosion in these areas, and consequently

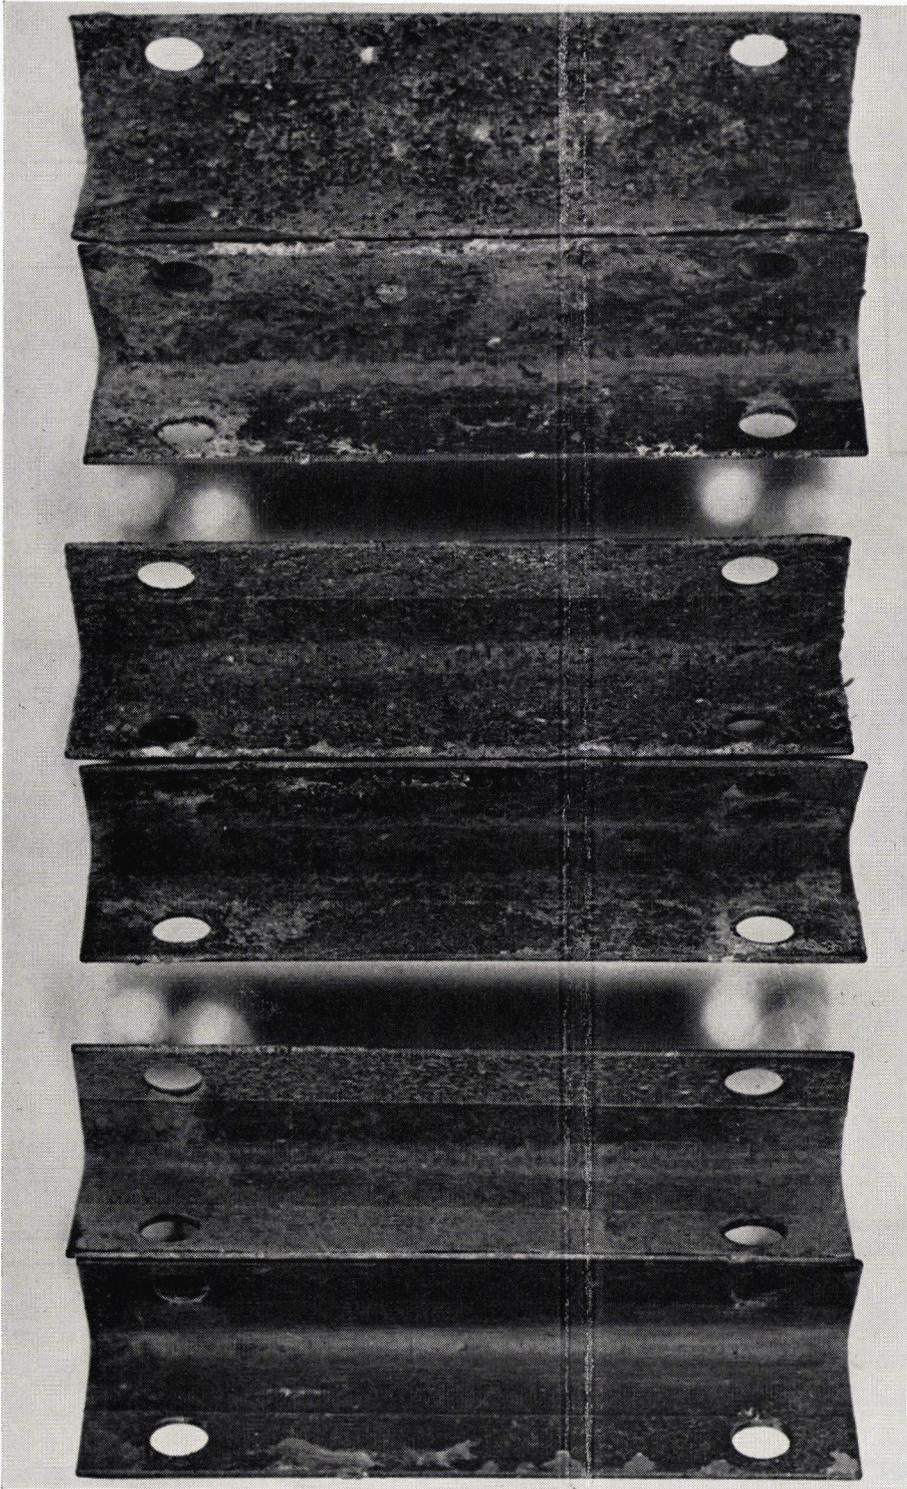
Figure 10. Poultrice build-up at end of 21 days, V-type coupons; (left) no salt, (center) salted, (right) salt with inhibitor.

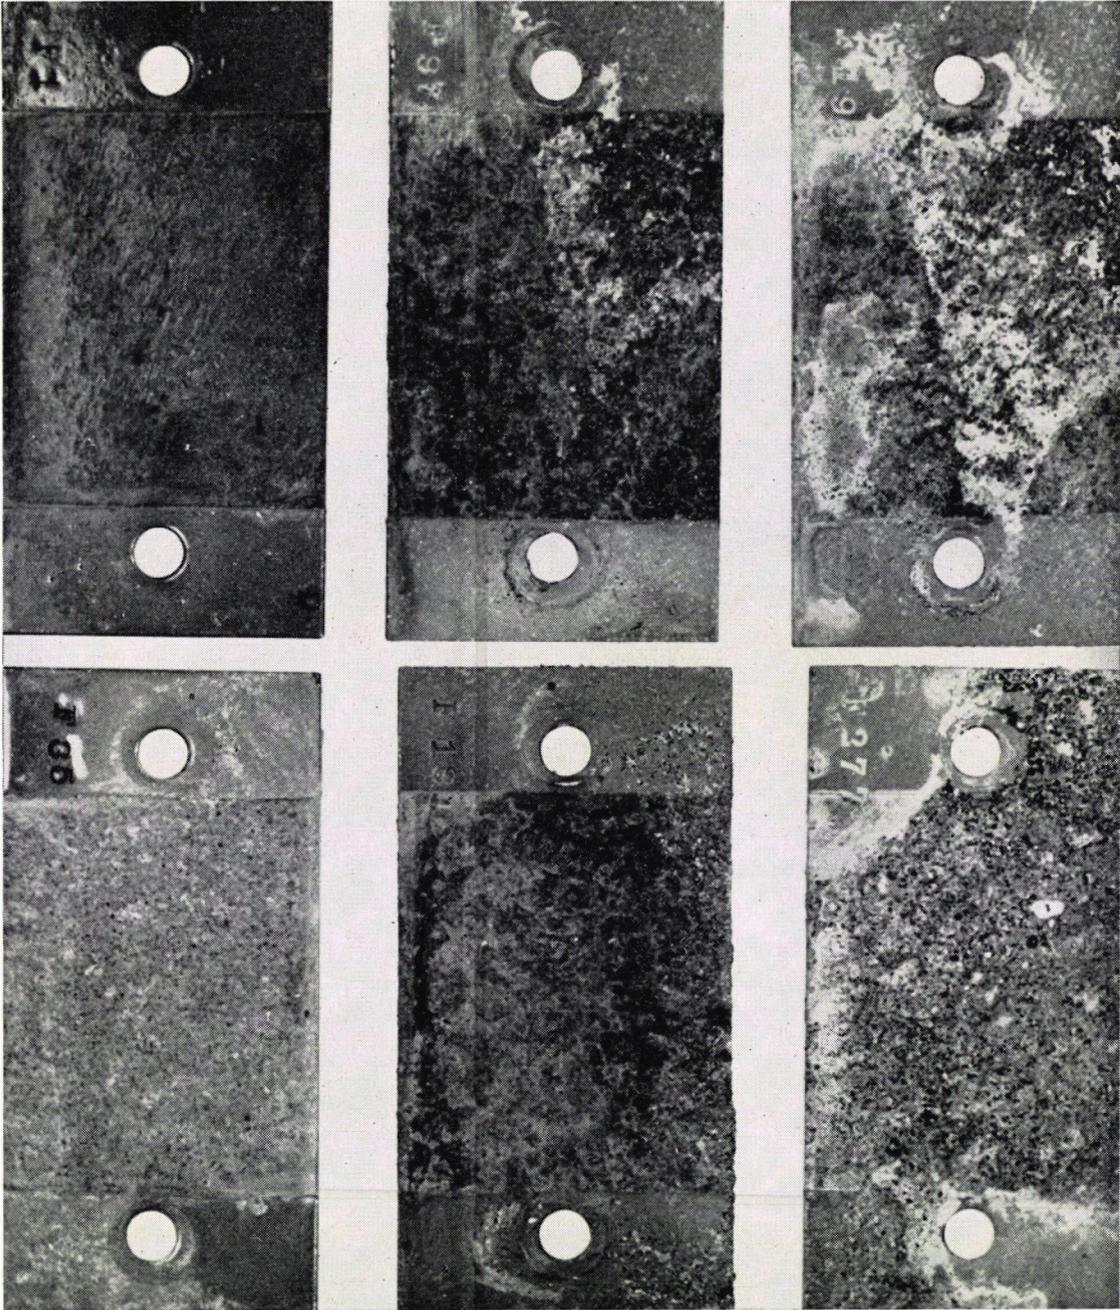
Figure 11. Poultrice build-up at end of 21 days, flat-type coupons; (left) no salt, (center) salted, (right) salt with inhibitor.

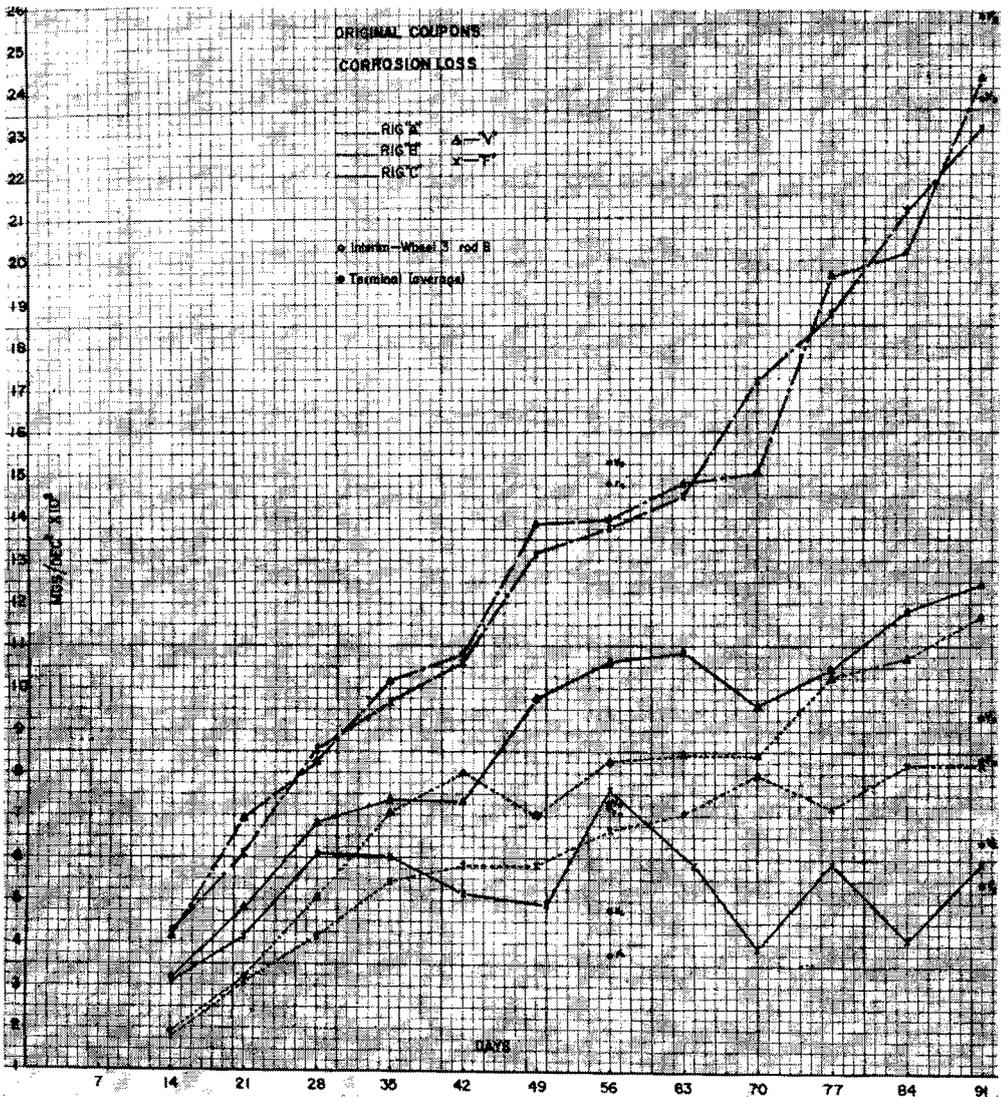
Figure 12. Corrosion losses of original coupons in the three rigs including interim losses from wheel 3 rod 8 and losses of terminal coupons.

The weight losses for each removal period of the original coupons placed on February 1, 1961, for each rig are shown in Figure 12. The values up to February 21 represent the average value of four V-type coupons, and four flat coupons taken off in pairs according to the removal program in Appendix B. After February 21 the values for wheel 4 of each rig were excluded as this wheel was heated to 40 F after this date. This was done because the heating reduced the corrosion slightly in rig A (unsalted), increased corrosion very markedly in rig B (salted), and produced erratic corrosion in rig C (inhibited).

The corrosion of the salted rig is definitely more severe than the other two rigs, and at the end of the 91-day period, the rates were still ascending steeply. The curves for each coupon type are somewhat erratic, and one crosses the other at several points. By and large, the corrosion rate for both the V-coupon and the flat coupons does not differ to any great extent, although the poultice effect in the case of the V-coupon was much more severe than the flat coupon. It was previously pointed out that coupons from this rig were easily cleaned. The rust formation was loosely adhering and porous, consequently the saline solutions were able to penetrate the layer of dirt and rust to attack the underlying metal. Even after 91 days, the rate of attack appears to be undiminished.

In the unsalted rig A, the corrosion losses show a divergence as the test proceeds with the V-coupon showing a more severe loss than the flat coupons. Towards the end of the 91-day

period, the tendency was to approach a constant rate of attack. These curves show that the crevice type of surface represented by the V-coupon corrodes at a slightly higher rate than a plain surface represented by the flat coupon. The accumulation of dirt in the V-coupon acting as a

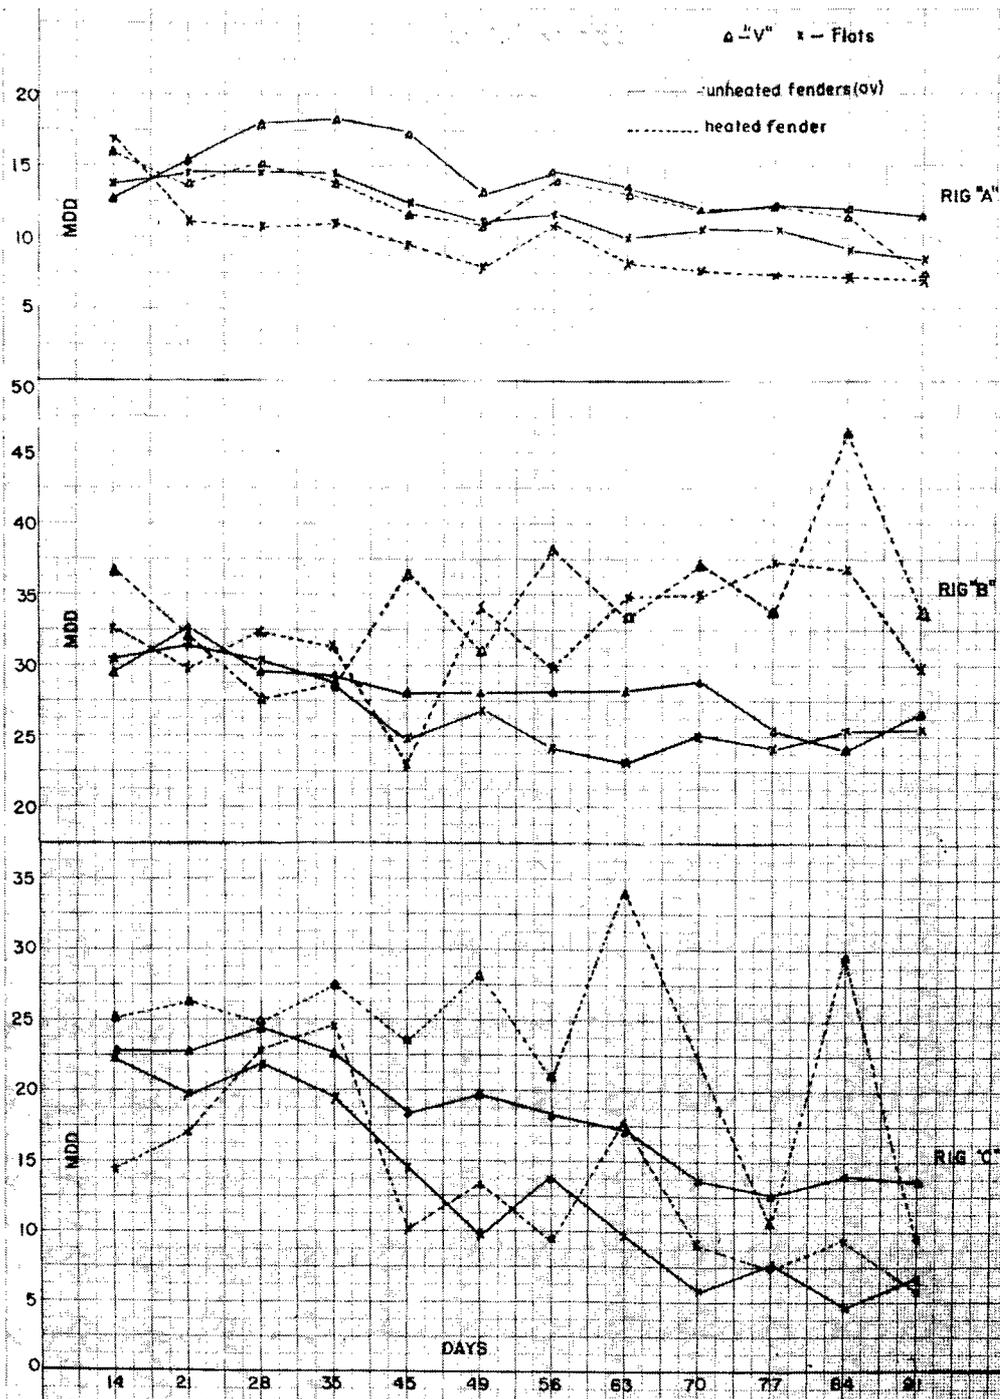
Figure 13. Corrosion rates for coupons in the three rigs and in the heated fender.

The corrosion rates in milligrams per square decimeter per day (mdd) over the period of the test are shown in Figure 13. Included on the chart are the corrosion rates for No. 4 wheel which had been heated to 40 F from February 21 to May 2. From this chart the corrosion rates for the three rigs can be compared; these rates pertain only to the original coupons placed on the rigs February 1. The interesting aspect of these data is the increase in corrosion rate of the heated wheel on rig B where the chemical activity of the salt solutions has been increased by raising the temperature of this fender when not operating. Heating tends to reduce the rate of the unsalted rig, whereas the condition in the inhibited rig C is somewhat erratic. The V-coupons in rig C show wide variation possibly related to the poultice effect reducing the efficiency of the inhibiting process.

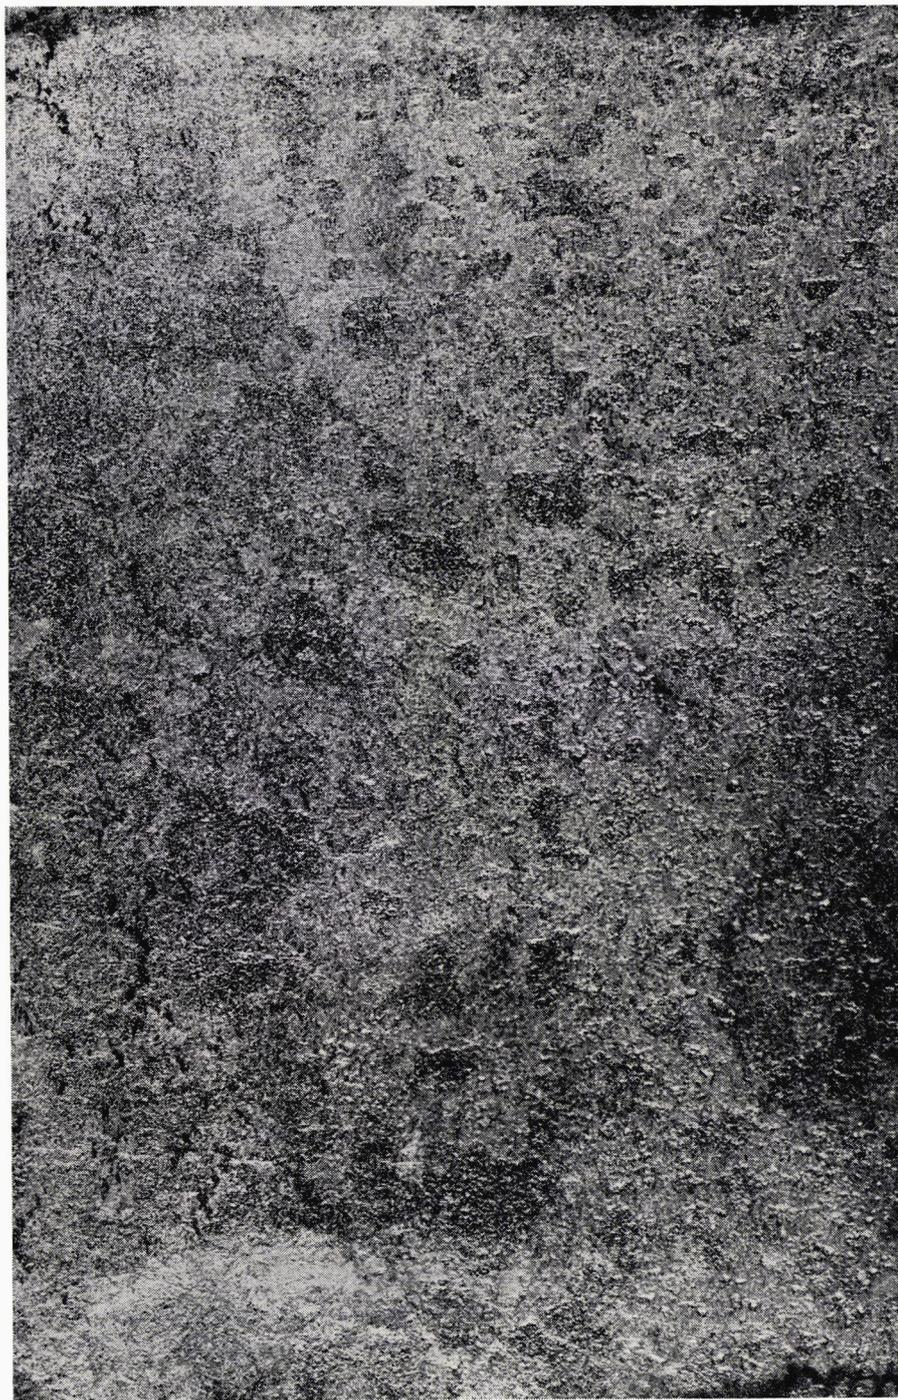
Figure 15. Photomicrograph of flat-type coupon after 91 days, rig B (salted). Surface generally etched. (Mag.  $\times 3\frac{1}{2}$ )

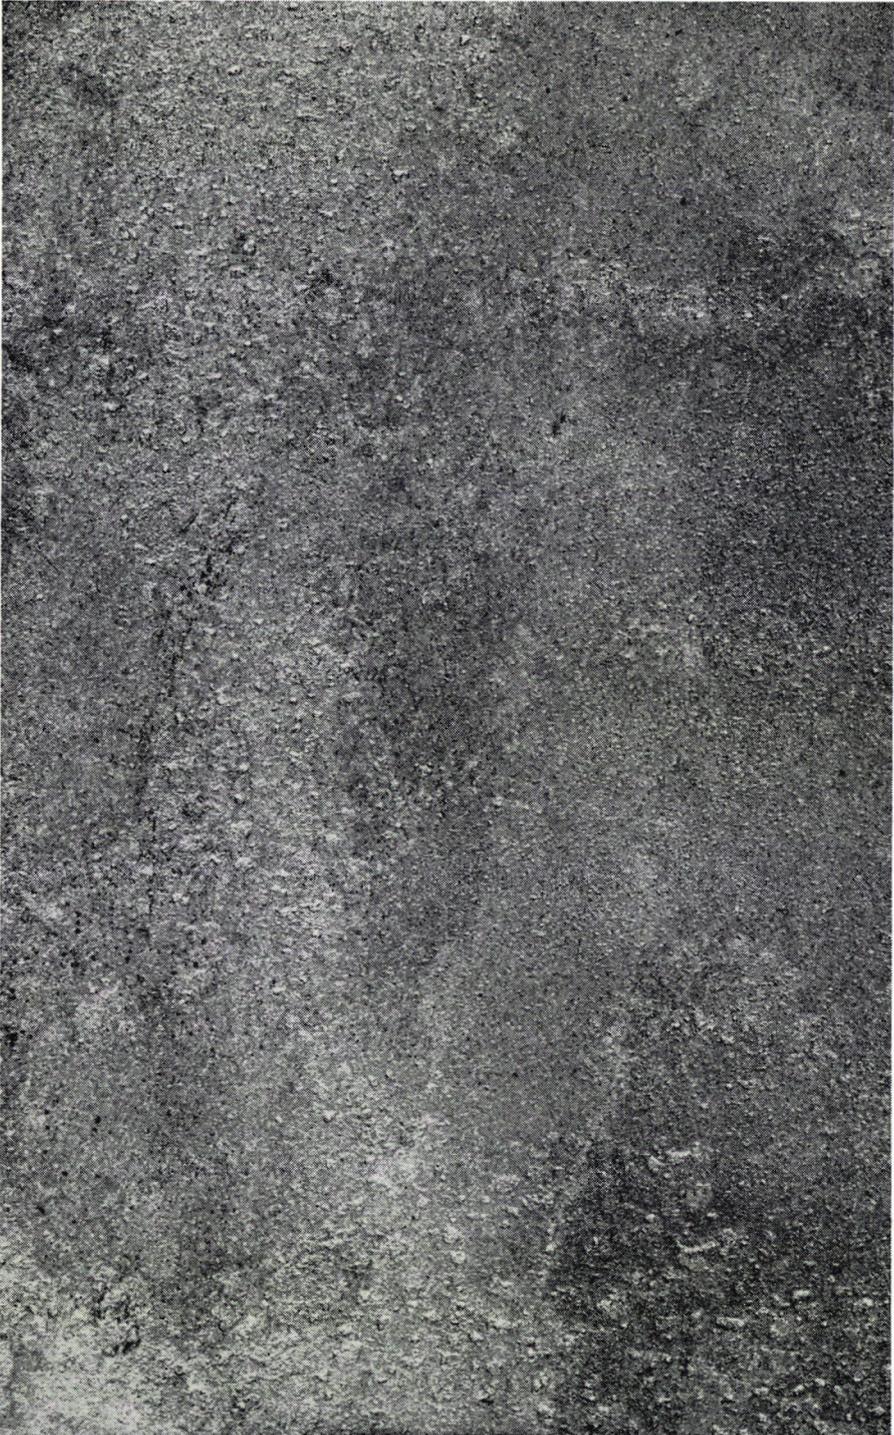
Figure 16. Photomicrograph of flat-type coupon after 91 days, rig C (inhibited salt). General etching under poultice at top; lower unpoulticed areas less attacked. (Mag.  $\times 3\frac{1}{4}$ )

It was pointed out earlier that the poultice effect appeared to be most noticeable on the flat coupons of rig C. Under the poultice area at the top, the corrosion rate was higher as judged by the etching effect. On the lower surface a tighter oxide coating was evident and here the corrosion rate appeared lower. Figures 14, 15, and 16 show photomicrographs of the surface of flat panels from each rig after the full period of 91 days. The surface of the sample from rig A (Fig. 14) is still relatively smooth. In this case pit-type corrosion is developing at the dark spots but the surface is not severely etched. Figure 15 showing a sample from rig B indicates severe etching more or less uniformly over the entire surface. Figure 16 (rig C) shows some area of etching at the top whereas at the bottom there are smooth patches. The rough patches were located under the dirt poultice and here the scale was very similar to that formed on

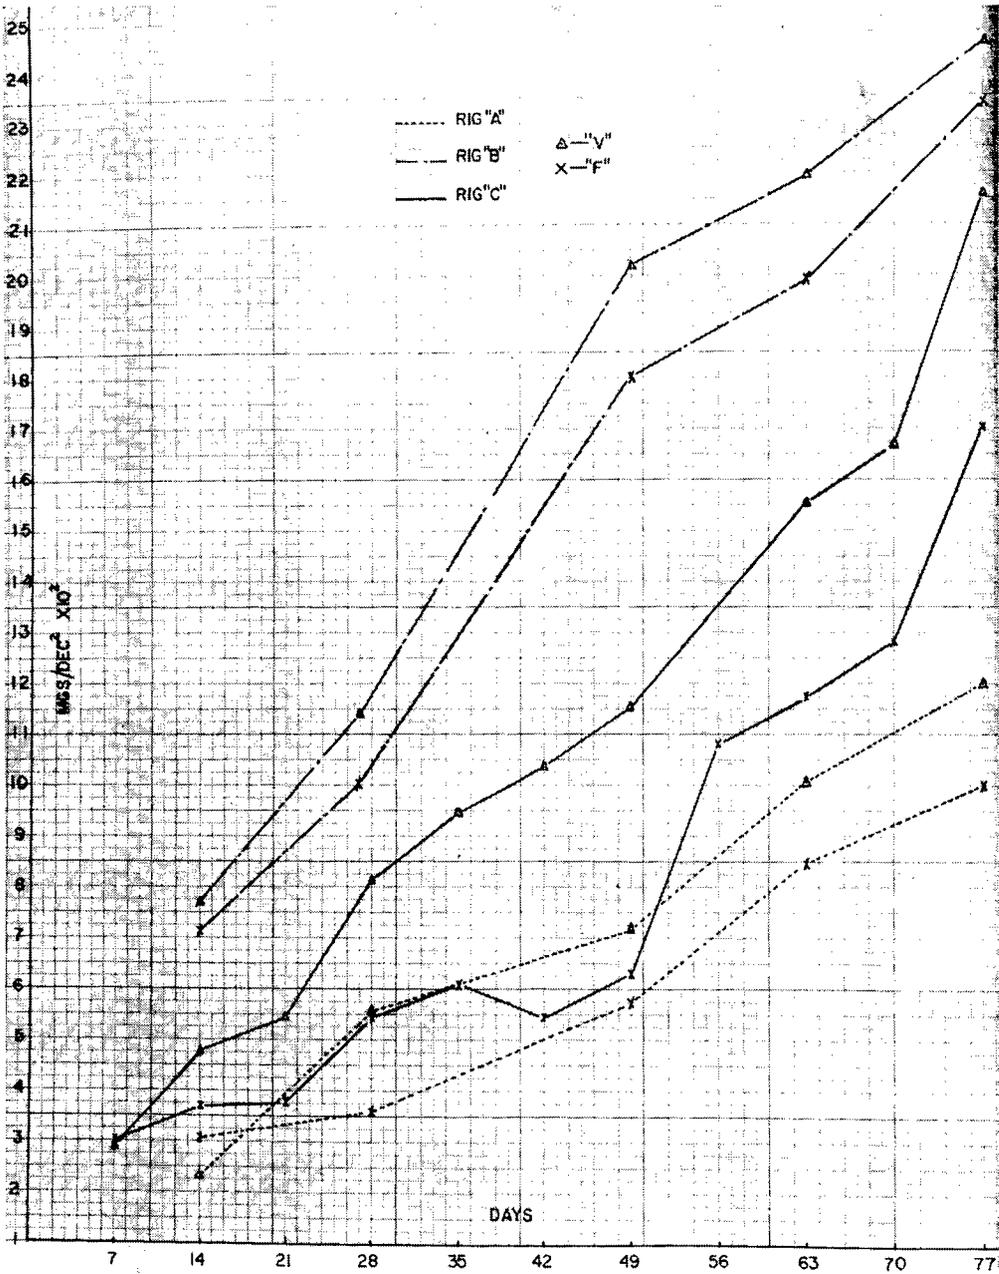
Figure 17. Corrosion losses of replacement coupons.

The replacement coupon weight losses for each rig appear in Figure 17, and it can be readily seen that, although the curve for each rig occupies a similar location to those in Figure 12, the losses are somewhat higher, and there is little or no tendency to level off. Rig C, the inhibited rig, shows some retardation of corrosion, but after 49 days the corrosion losses remained above those for rig A (unsalted).

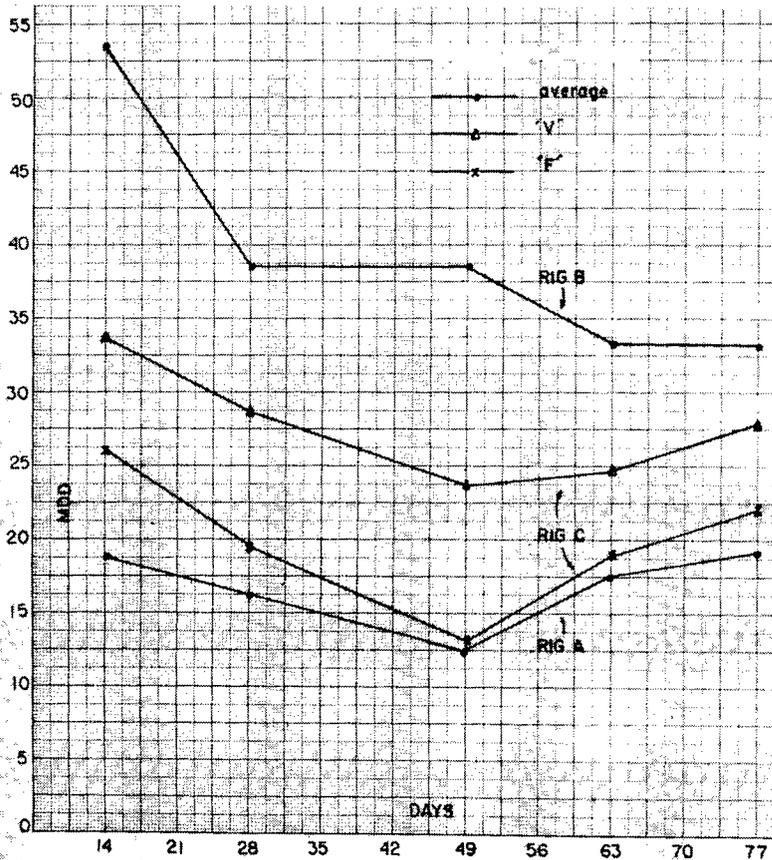
Figure 18. Corrosion rates of replacement coupons.

Figure 18 shows the corrosion rates for the replacement group. In this case the values for rig A and B are the average of the V and the flat coupons. This average was taken as the rates for each type of coupon were not too widespread. In the case of rig C the rates for each type of coupon are shown, as there was a considerable spread in their rates.

The rates for the flat-type coupons of rig C appear very close to those shown for rig A.

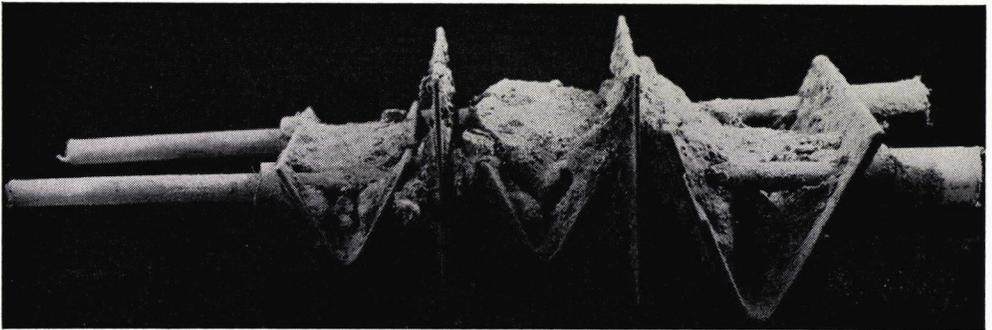
Figure 19. Poultice build-up typical of 8 cars (Table 3).

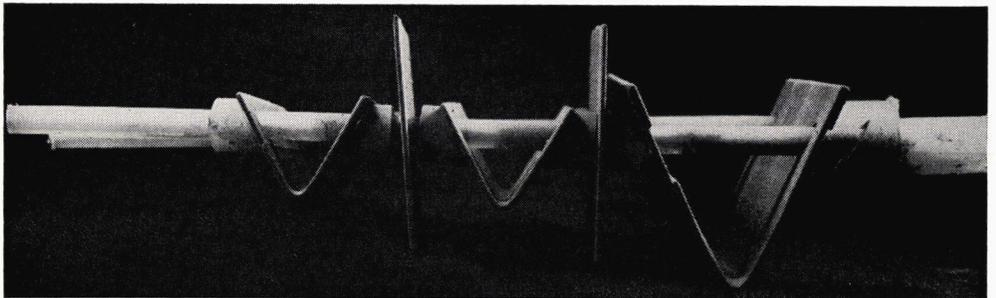
Figure 20. Light poultice build-up on 2 cars (Table 3).
