# FIELD EVALUATION OF BALLAST FOULING CONDITIONS USING MACHINE VISION

## IDEA Program Final Revised Report

University of Illinois at Urbana-Champaign

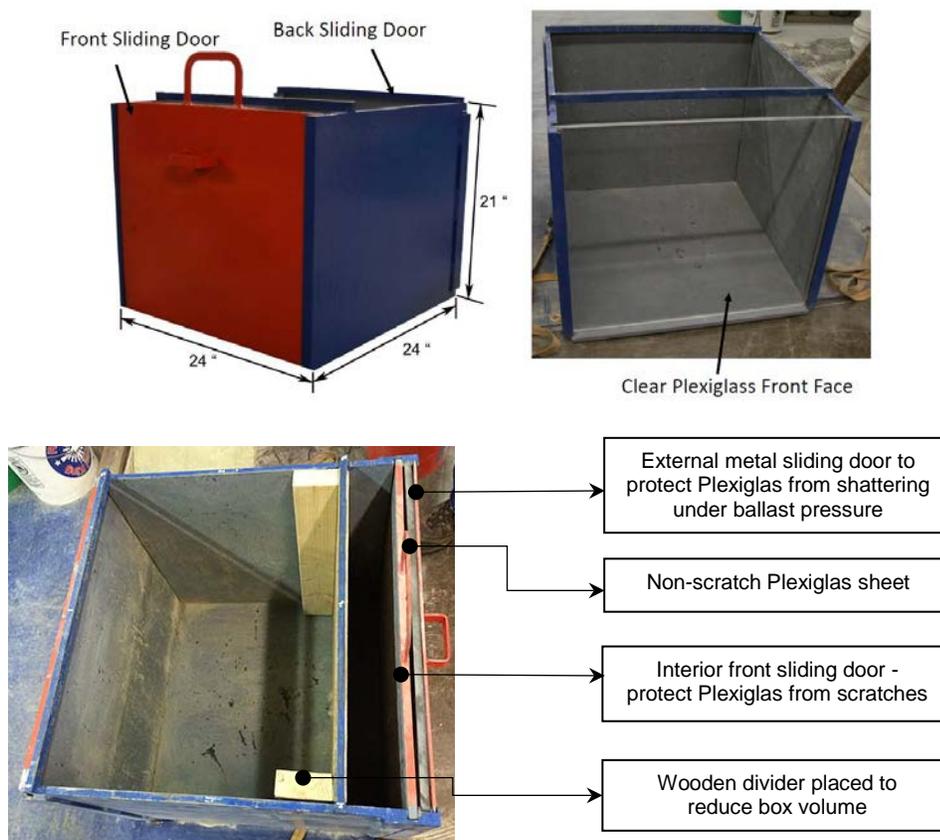
**FIGURE 7. New metal box with the wooden divider and front facing clear Plexiglas**

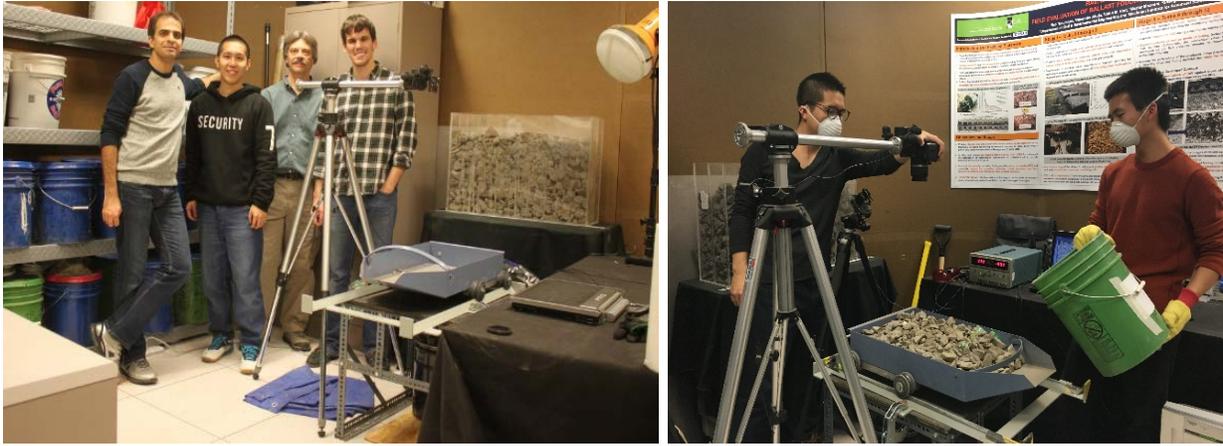
**FIGURE 8. Foreground: Ballast Imaging Tray System, Background: Bucket samples and Plexiglas box (left) - Pouring bucket containing ballast sample into the imaging tray (right)**

Finally, a tray-based design was developed for capturing top views of ballast samples using a camera placed above the tray (see Figure 8). The design enables easy loading of ballast samples onto the tray. Additionally, unloading was done by a rolling and tilting method to pour the contents for the tray back into the bucket. The detail process of capturing the top views of ballast cross section can be found in Appendix II. This process could be rapidly repeated as in a production-like setting. This provided different cross-sectional views of the same ballast sample to generate additional images for constructing an image database for use in developing our image processing algorithms.

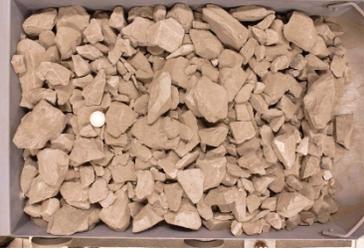
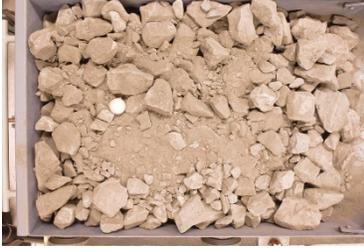
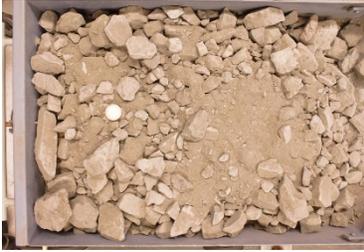
TABLE 2. Sample Image Segmentation Results for Ballast Placed Inside a Tray with Low, Medium, and High Degradation Levels, whose Top View Images Are Shown Left to Right

Selig's Fouling Index = 2.09	Selig's Fouling Index = 12.94	Selig's Fouling Index = 26.90

<b>Average Percent Degraded Segments = 56.37 %</b>	<b>Average Percent Degraded Segments = 64.03 %</b>	<b>Average Percent Degraded Segments = 69 %</b>

The image processing methodology described in the previous section was applied to all the 125 top view images of the field-collected ballast samples inside the tray. For each image, the average PDS was computed and compared with the associated Selig's FI value obtained through sieve analysis for the corresponding sample. As an example, Table 2 presents a typical image segmentation result for three representative images collected at low, medium, and high degradation levels.

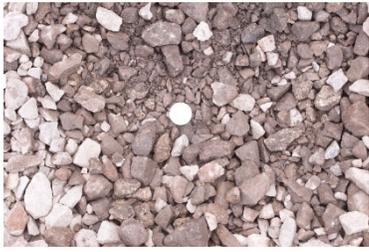
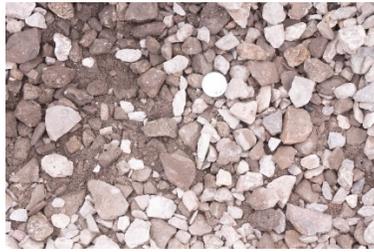
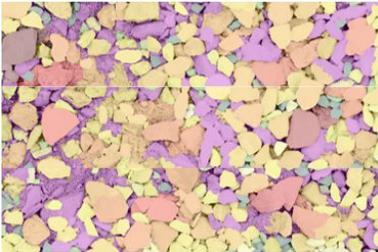
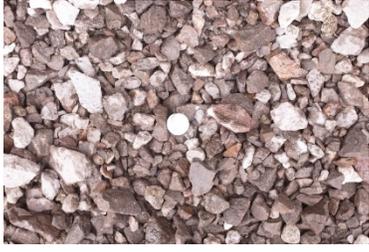
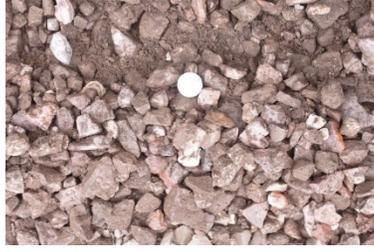
<b>Location One</b>	<b>Location Two</b>
		<i>Image ID: 145 FI =1.96</i>	<i>Image ID: 151 FI =9.00</i>
<b>Before SBC Pass</b>	<b>Original Image</b>

<b>PDS (%)</b>	35.94	34.87
<b>After SBC Pass*</b>		<i>Image ID: 163</i>	<i>Image ID: 184</i>
	<b>Original Image</b>

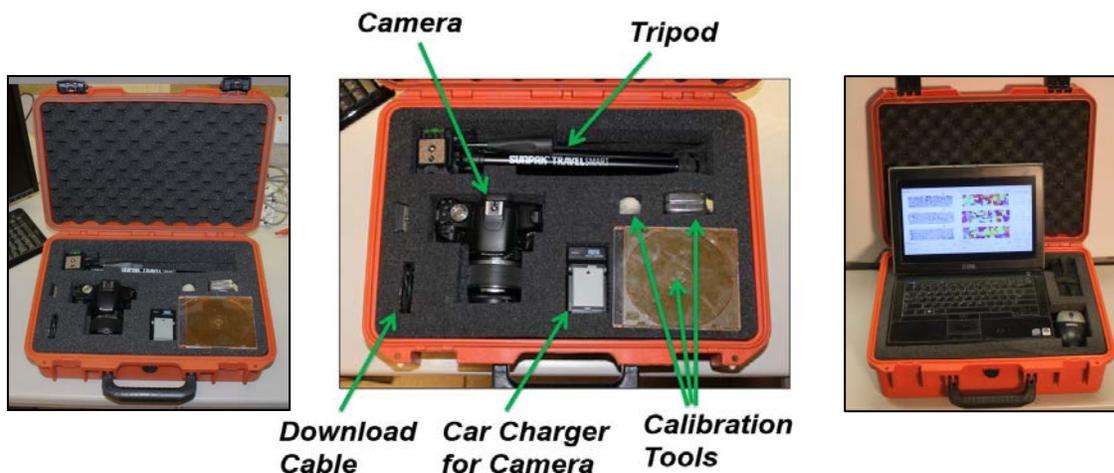
**FIGURE 27. Ballast Imaging Kit (BIK) for practitioners and ballast inspectors to capture cross section images on-site (photo on the left and content description in the center); Ballast Evaluation Kit (BEK) to process images and quantify PDS (conceptual design on the right)**

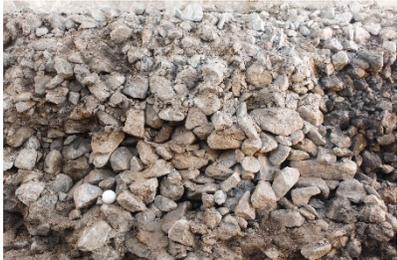
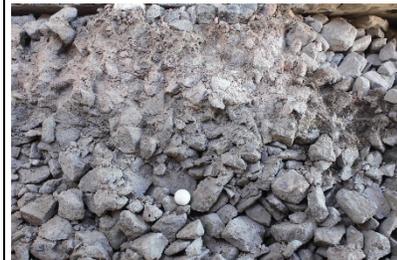
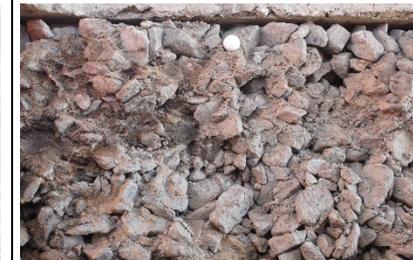
<p><b>Image ID = 5-1557-C2</b> <b>FI = 8.87</b></p>	<p><b>Image ID = 1-1050-C2</b> <b>FI = 10.6</b></p>	<p><b>Image ID = 1-1050-C1</b> <b>FI = 11.34</b></p>

Image capture was assisted by connecting the camera to a laptop running camera control software to view and capture the images remotely. This eliminated the need for personnel to be in the trench and allowed the camera to be placed up against the opposite wall, thus maximizing the field of view of the camera. The main considerations in capturing the images involved proper exposure, consistent spatial resolution and a reduction of any distortions of the ballast particles in the image. Adequate sunlight was cast evenly across the section for proper exposure but needed to be diffused in order not to cast shadows, in addition, a triple exposure setting was used to capture three consecutive images; the auto metered exposure and one image with a slightly lighter setting and the third with a slightly darker setting. This ensured that one or more field images would be suitable for processing since these images could not be retaken once the trench was refilled with ballast for continuing train operations. Captured ballast cross section images and corresponding fouling indices are presented in the table below.

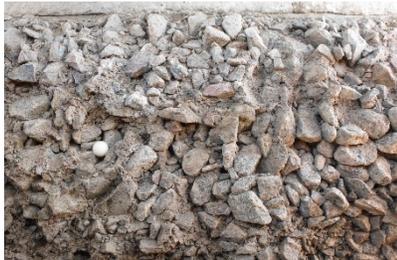
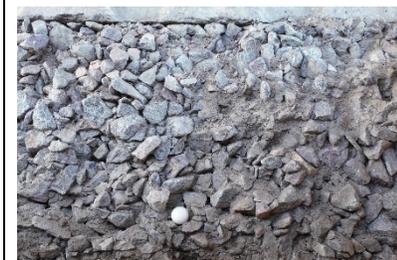
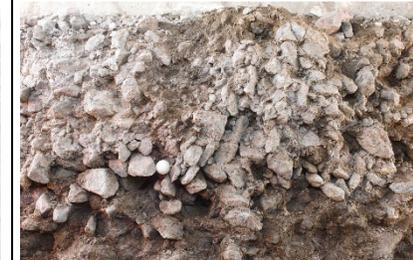
<p><b>Image ID = 4-1460-C2</b> <b>FI = 13.71</b></p>	<p><b>Image ID = 2-1308-C2</b> <b>FI = 14.19</b></p>	<p><b>Image ID = 5-1557-C1</b> <b>FI = 16.26</b></p>

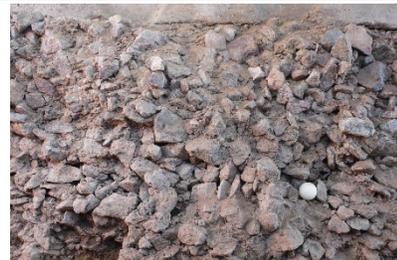
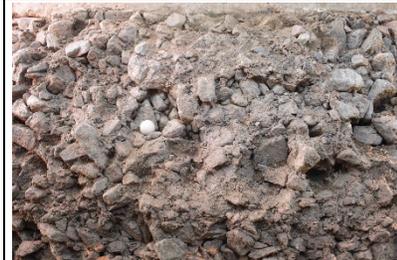
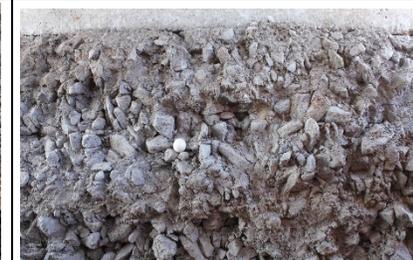
<p><b>Image ID = 2-1308-C1</b> <b>FI = 16.9</b></p>	<p><b>Image ID = 4-1460-C1</b> <b>FI = 17.25</b></p>	<p><b>Image ID = 3-1354-C1-Wall2</b> <b>FI = 17.78</b></p>

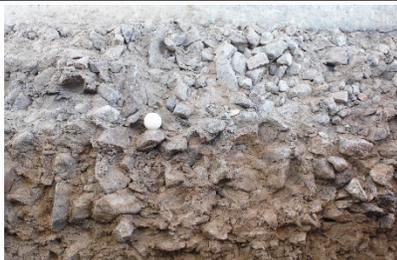
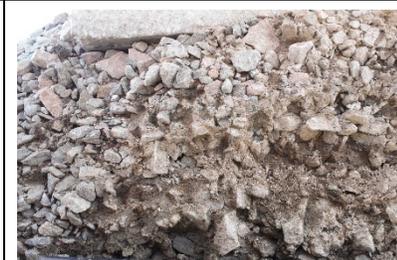
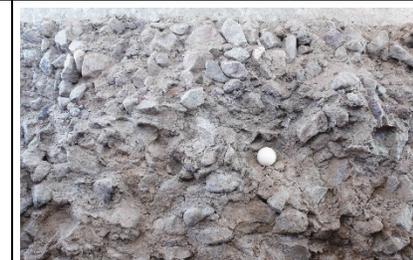
<p><b>Image ID = 3-1396-C2</b> <b>FI = 20.07</b></p>	<p><b>Image ID = 3-1354-I1</b> <b>FI = 20.11</b></p>	<p><b>Image ID = 3-1396-C1</b> <b>FI = 20.79</b></p>

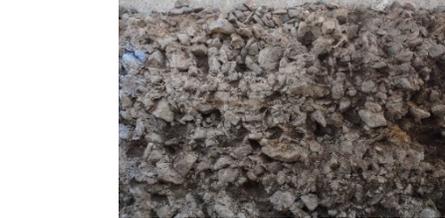
<p><b>Image ID = 3-1354-C1</b></p>	<p><b>FI = 22.81</b></p>	<p><b>Image ID = 3-1354-C2-Wall2</b></p>	<p><b>FI = 22.98</b></p>

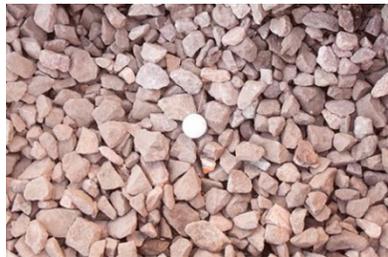
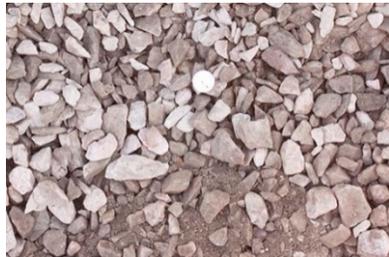
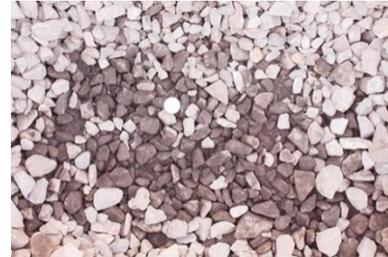
<p><b>Image ID =75-76-77</b> <b>FI = 4.75</b></p>	<p><b>Image ID = 07-08-09</b> <b>FI = 4.79</b></p>	<p><b>Image ID = 39-40-41</b> <b>FI = 5.03</b></p>

First, a mini-backhoe was used to dig down through the shoulder to a depth of 6-in. (152 mm) below the tie. After a horizontal shoulder cross section was exposed, three top view images with 24 in. (609 mm) × 16 in. (406 mm) size at three different exposure levels were captured with a DSLR camera. The 1-in. (25.4 mm) ball was placed on the surface of the cross section for calibration purposes; during image processing, this calibration ball would help identify the spatial resolution of the image. Following optical imaging, a thermographic camera was used to capture the corresponding infrared image of the exposed shoulder cross section. This was part of a preliminary experiment to collect temperature signatures to study the level of degradation and moisture conditions of in-service ballast cross sections. A light diffuser was used at all stages to ensure uniform levels of natural light on the area of interest and prevent unwanted shadows in the image. After imaging, the ballast material corresponding to the imaged area was collected using chisels and mini-shovels and stored in 5-gallon buckets for future laboratory sieve analysis. Captured ballast cross section images and corresponding fouling indices are presented in the table below.

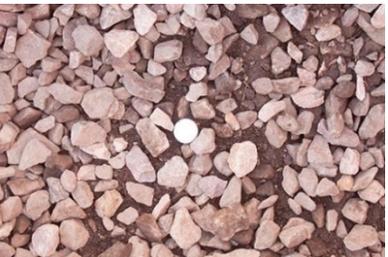
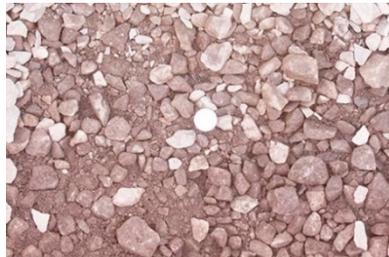
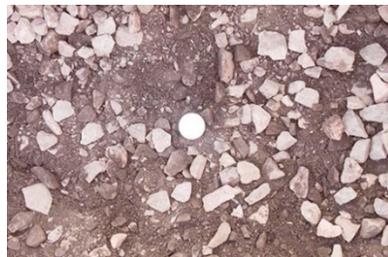
<p><b>Image ID = 78-79-80</b> <b>FI = 5.25</b></p>	<p><b>Image ID = 87-88-89</b> <b>FI = 13.94</b></p>	<p><b>Image ID = 50-51-52</b> <b>FI = 25.46</b></p>

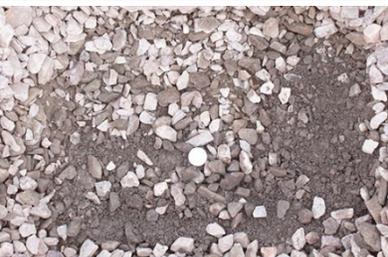
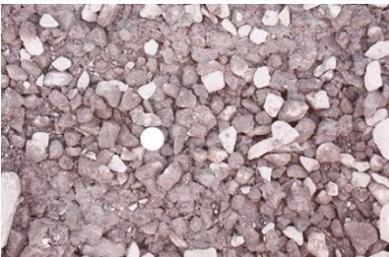
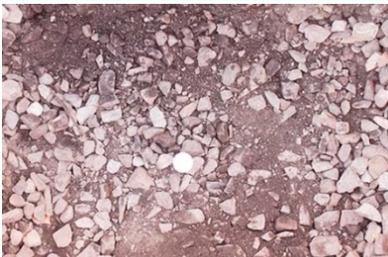
<p><b>Image ID = 34-35-36</b> <b>FI = 26.81</b></p>	<p><b>Image ID = 47-48-49</b> <b>FI = 27.73</b></p>	<p><b>Image ID = 38-39-40</b> <b>FI = 28.92</b></p>

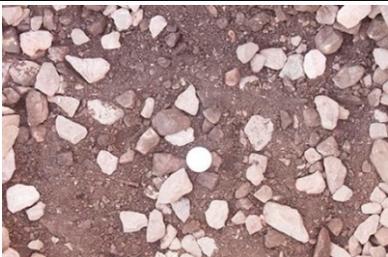
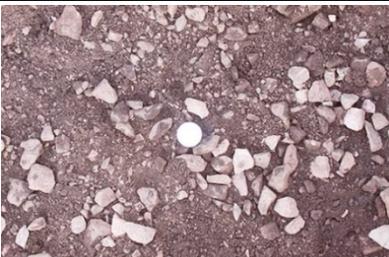
<p><b>Image ID = 81-82-83</b> <b>FI = 33.32</b></p>	<p><b>Image ID = 63-64-65</b> <b>FI = 35.30</b></p>	<p><b>Image ID = 20-21-22</b> <b>FI = 46.04</b></p>
